**Operator: BONANZA CREEK ENERGY OPERATING CO.**

**Location Name: State North Platte O-26 Pad**

**Loc ID: 434745**

**Inspection: 707603671**

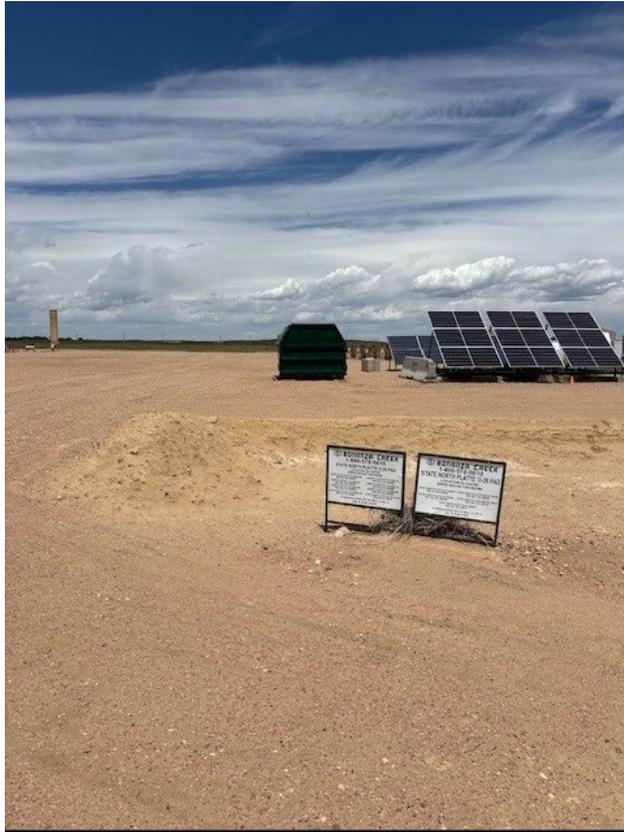
**Exhibit A**

**CA:** Unnecessary equipment at Location site. See North side of Location site. Unnecessary equipment includes: Frac tank w/ spill pad. Refer to Rule 606 for guidance. Remove unnecessary equipment from Location site. Comply with Rule 606. Corrective Action date: 03/21/2025. (30 days). See photo(s) #1, 2, 3. \*Please attach photo(s) to FIRR to verify Corrective Action(s) have been resolved.

**CA Resolution:** Operator has removed the equipment in order to comply with Rule 606.
