Facility Closure Investigation and Environmental Summary

Trebor B12-05 Wellhead

ECMC Remediation Project #35844

Weld County, Colorado

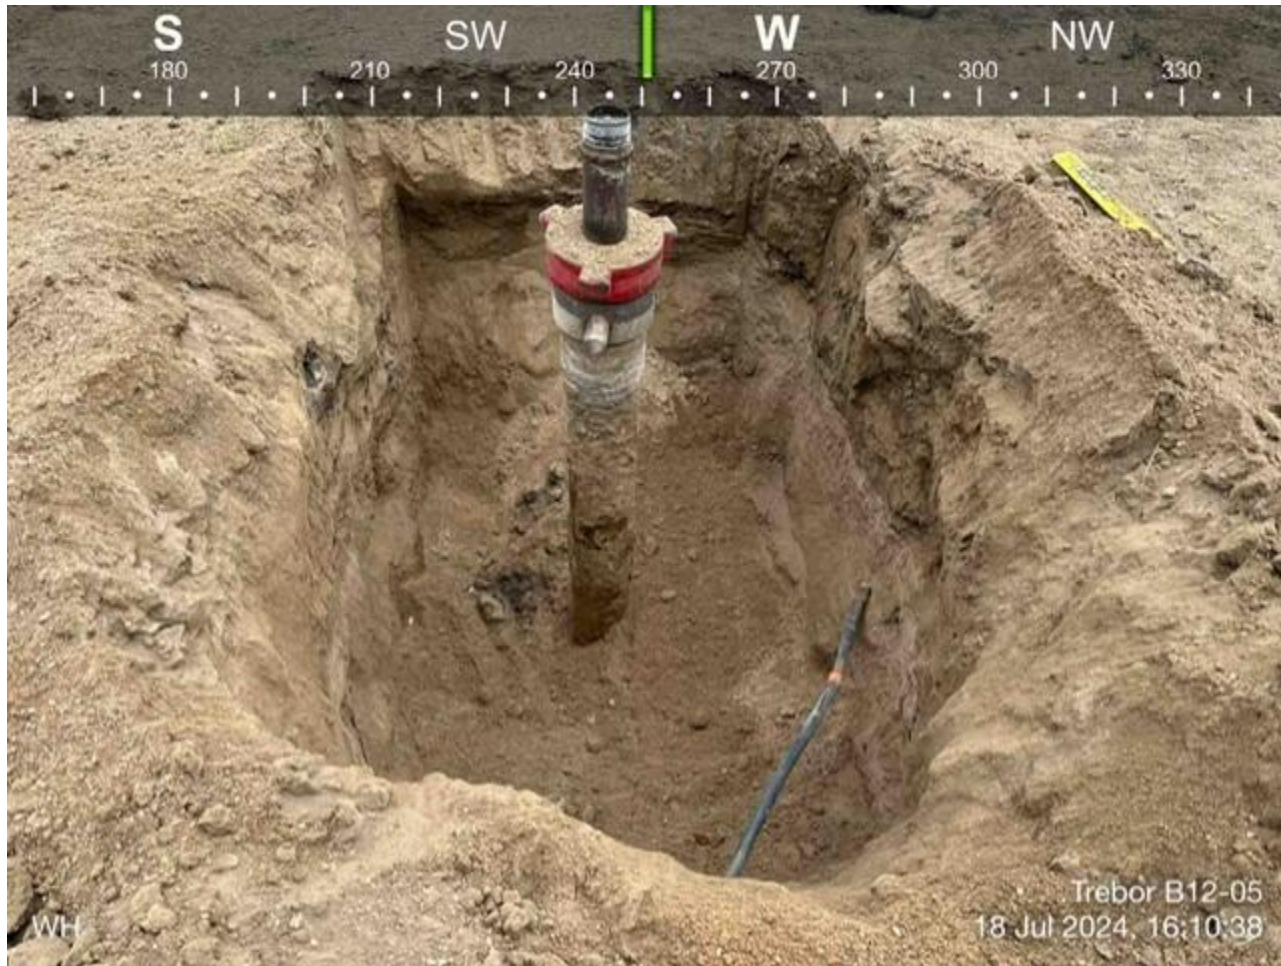
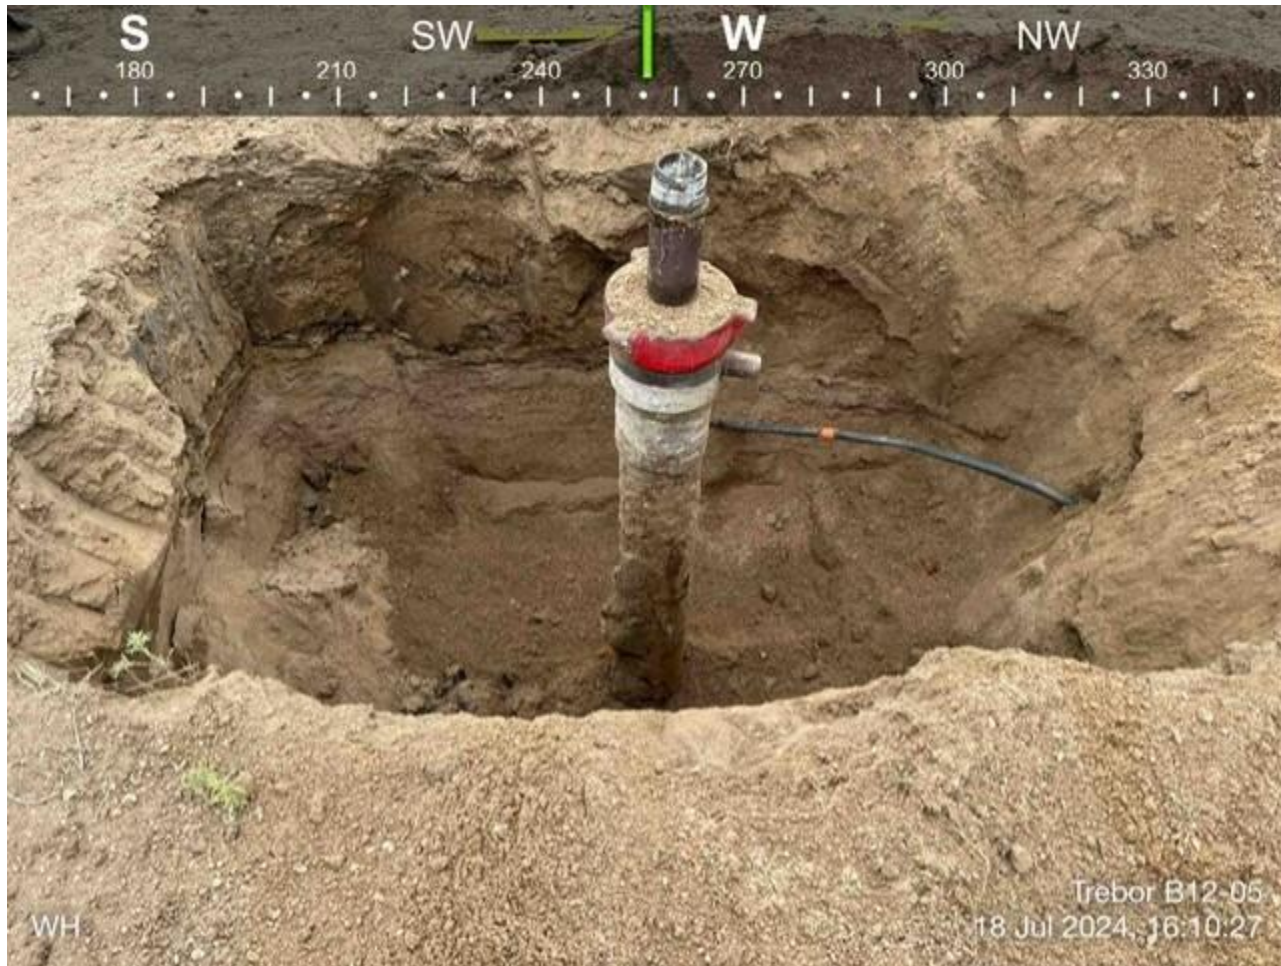
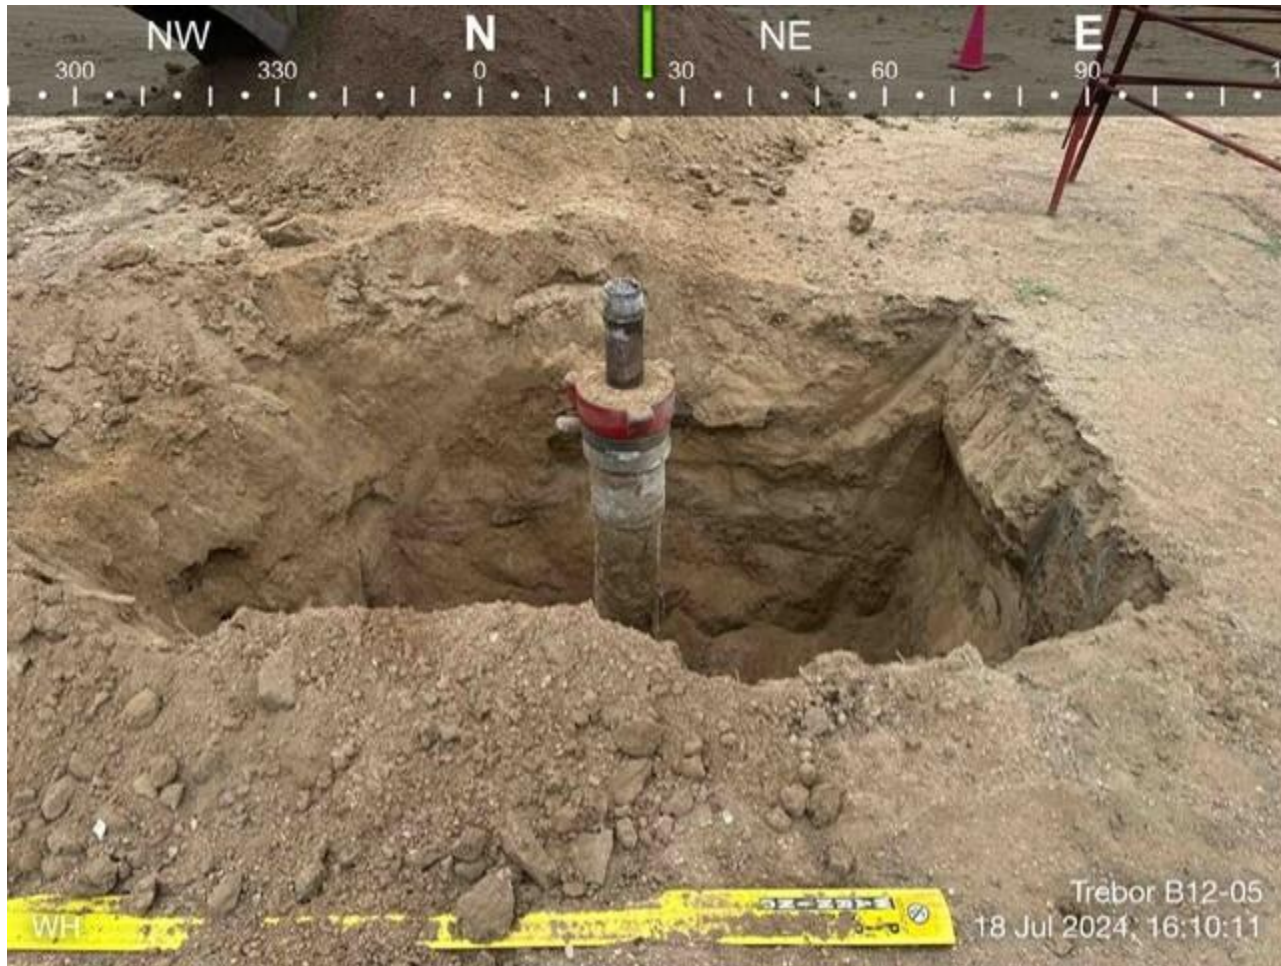
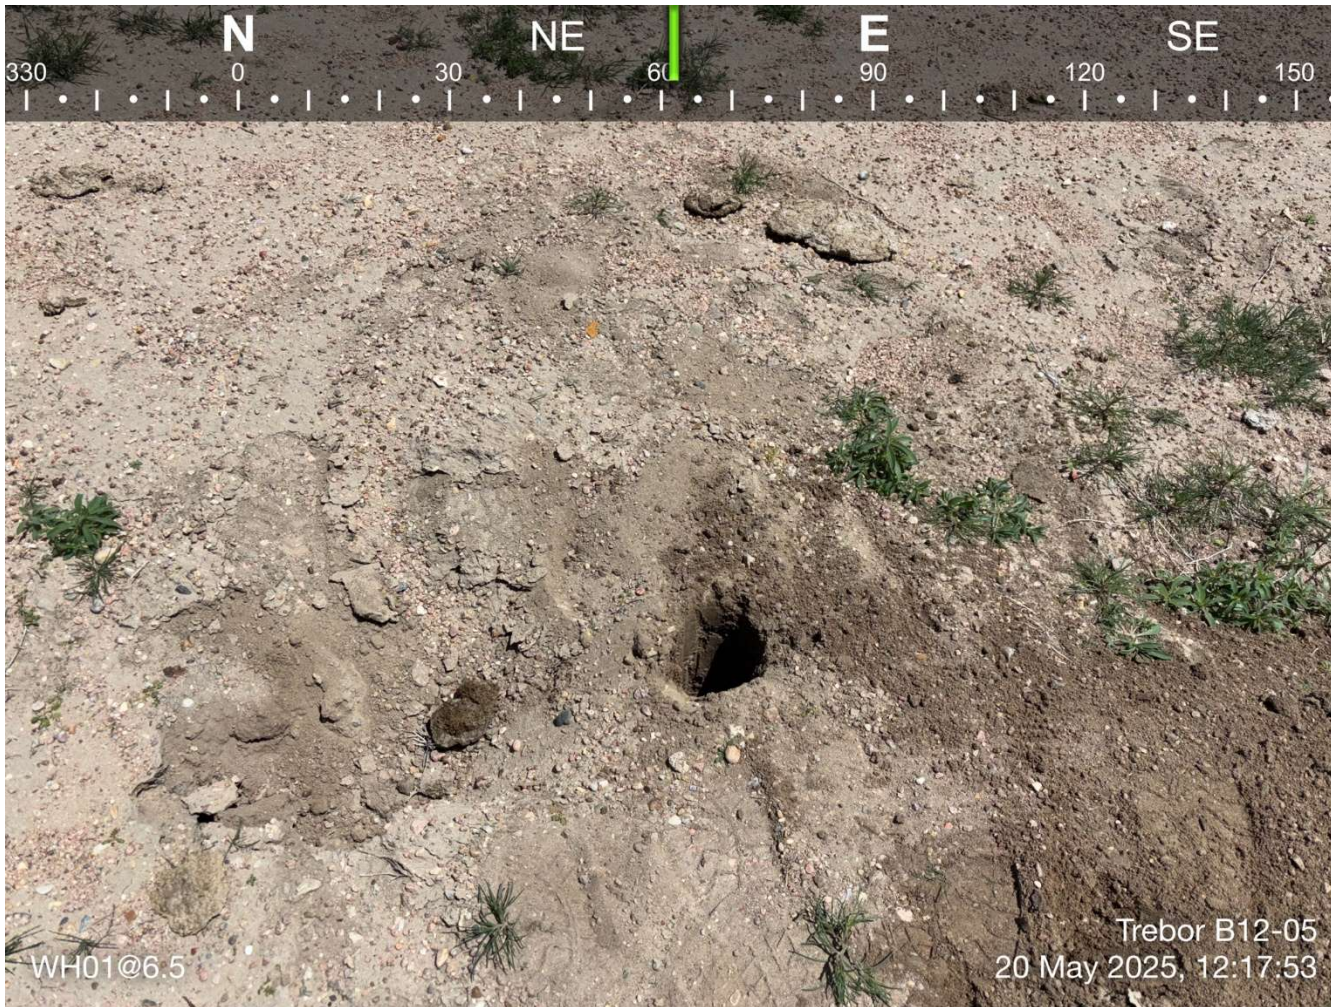
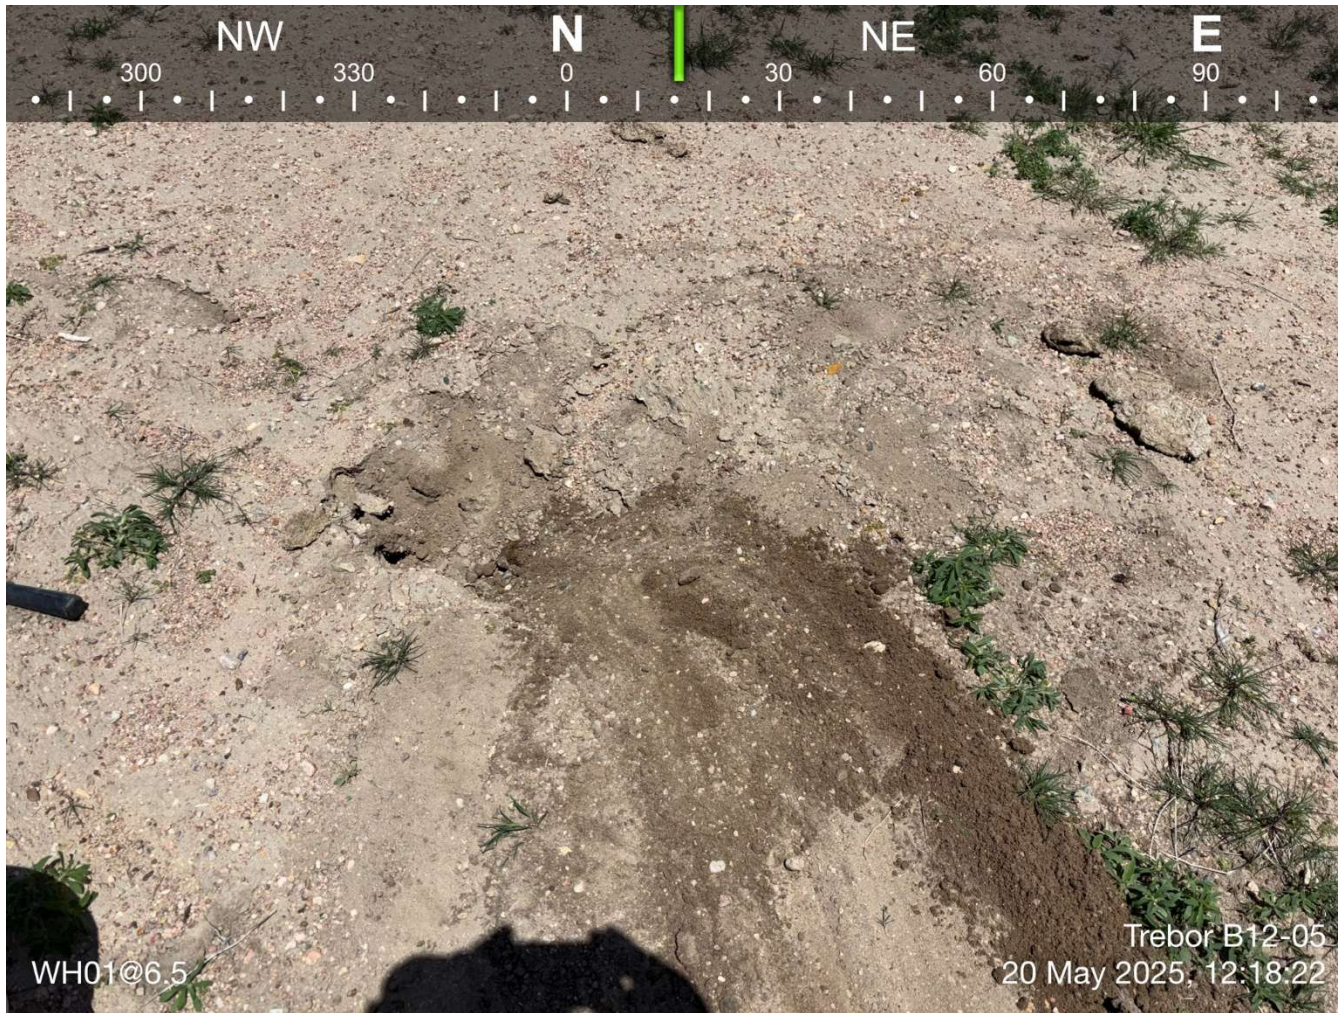
Well API	05-123-13776						
Age	1/1/1988-spud date						
Condition of surface around wellhead	Good						
PID Readings	0.0 ppm						
Condition of subsurface (staining present)	Good						
PID Readings	0.0 ppm						
Sample taken? Location/Sample ID#	WH01@6.5						
Photo Number(s)	1-7
