**RAT Observation**

T165-1 RES - PETERSON SUSAN K - 23603 CR 70 WELD  
Photo Log | Rapid Assessment Technique (RAT)

Incident Bishop LOC  
Incident Date April 7, 2025  
City Galeton, CO  
County Weld

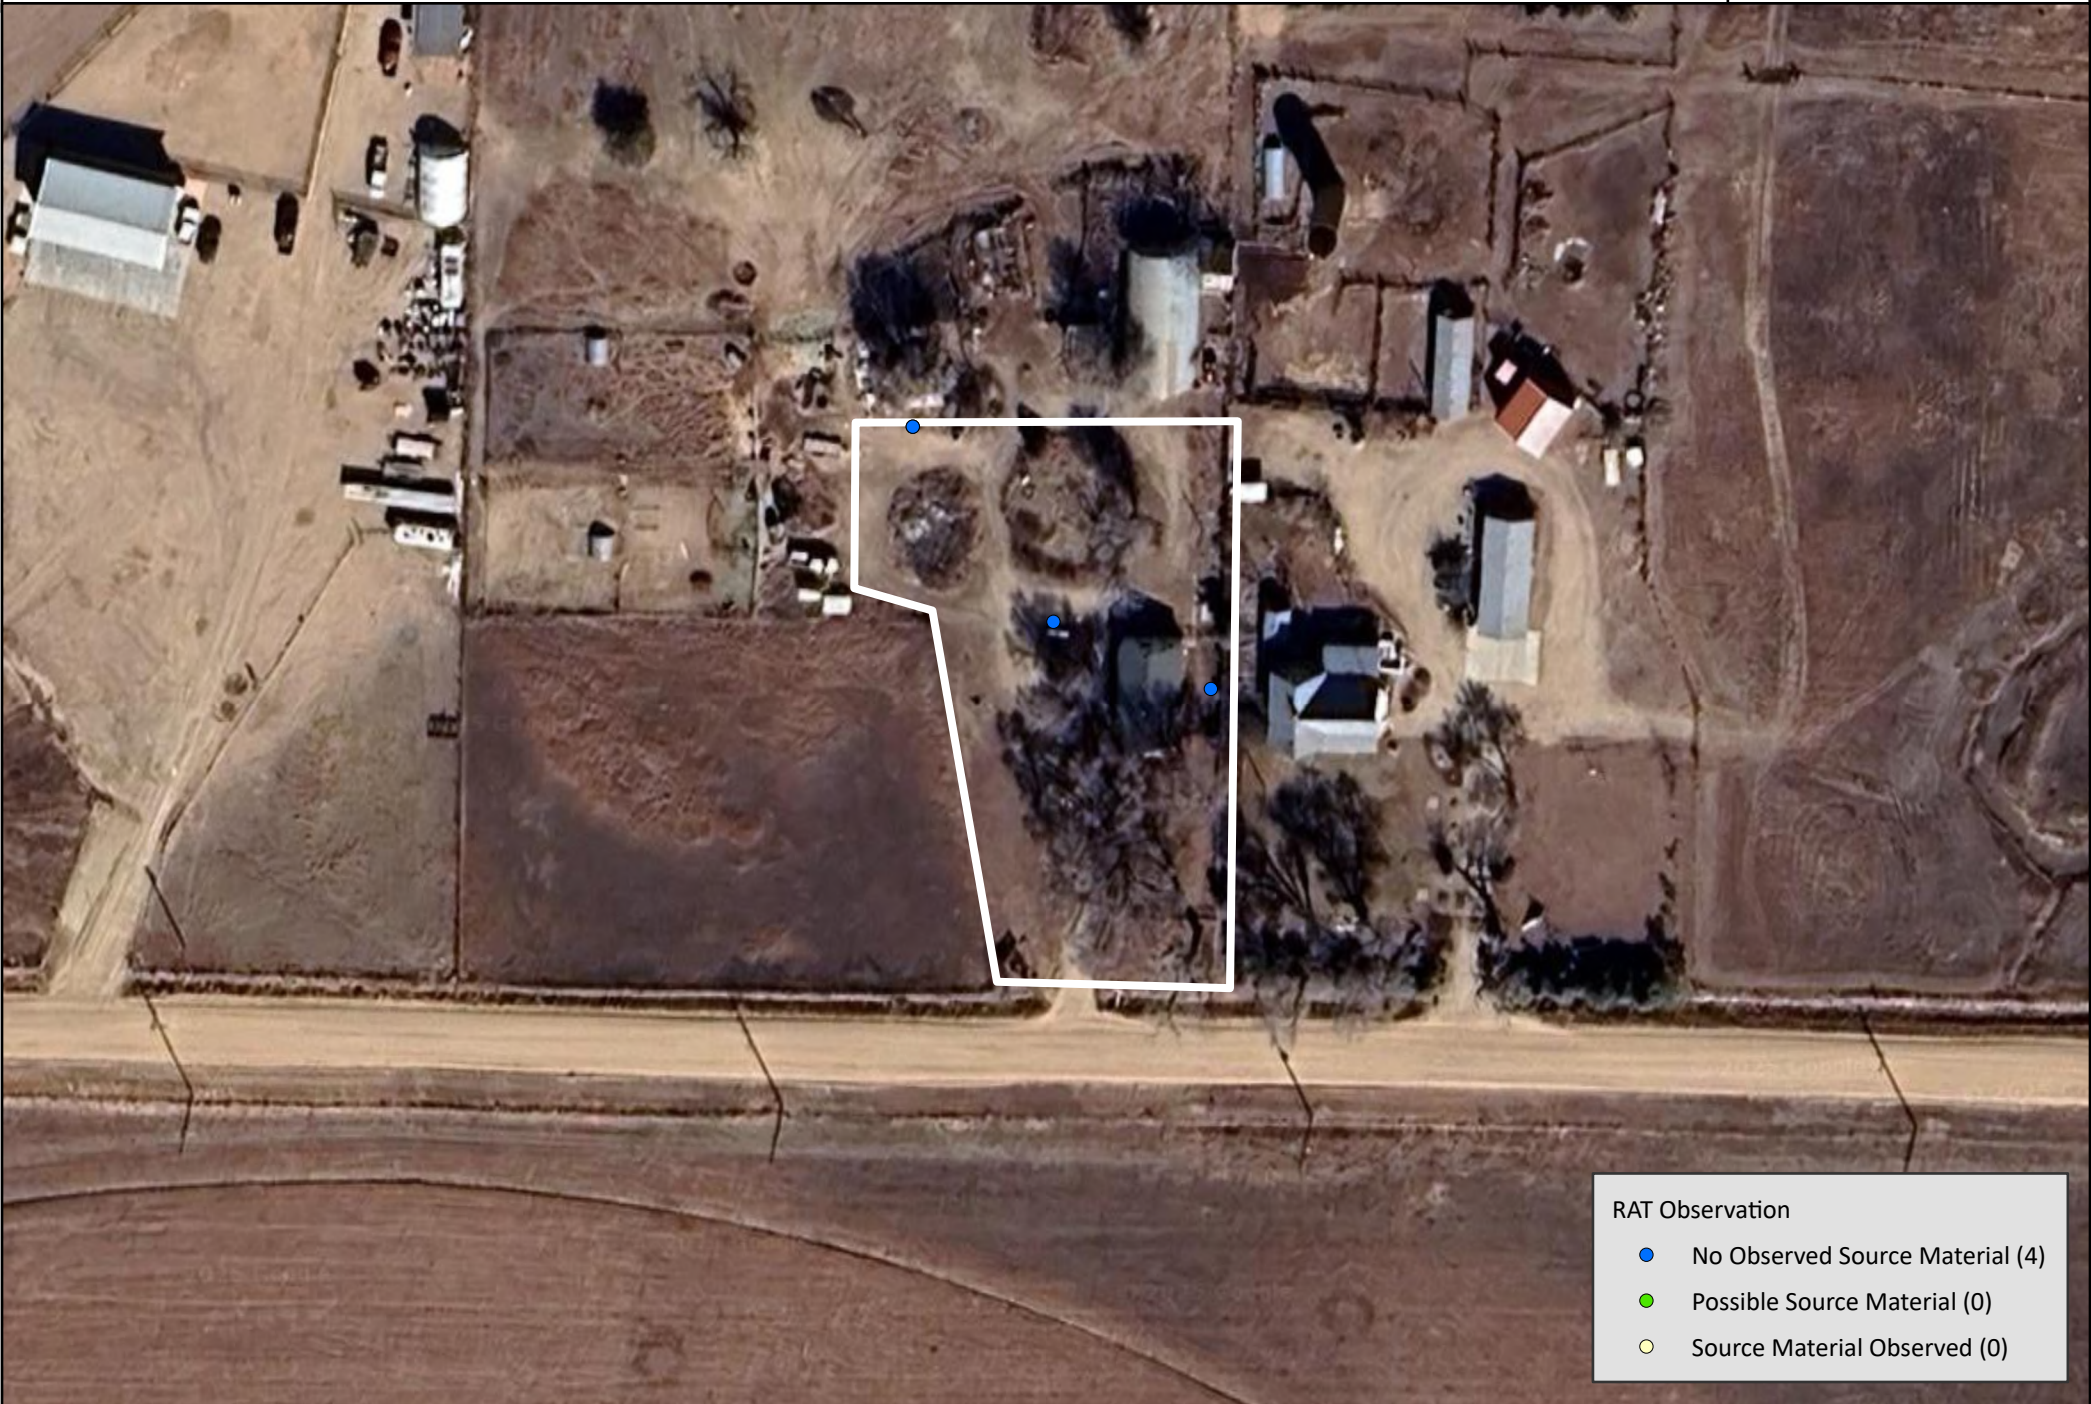
Oiling Observation: **0 No Observable Oil** | Id: 560100 | 5/30/2025 2:05:16 PM  
(40.493999, -104.60993)

No obvious signs of hydrocarbon on either horse trailer or lowboy trailer Northwest of residence

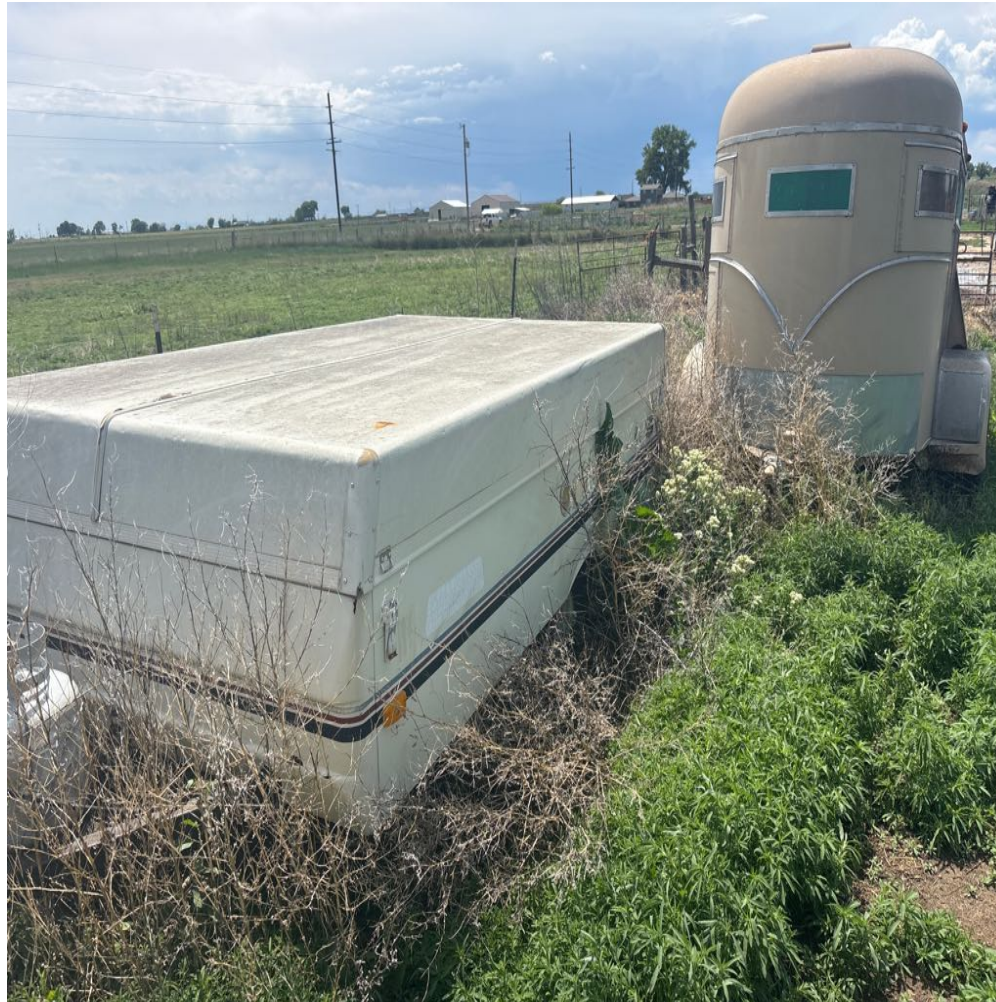
Oiling Observation: 0 No Observable Oil | Id: 560092 | 5/30/2025 2:07:15 PM  
(40.493999, -104.60993)

No obvious signs of hydrocarbons and small tan horse, trailer or present on collapsed camper trailer in front of horse trailer west of residence

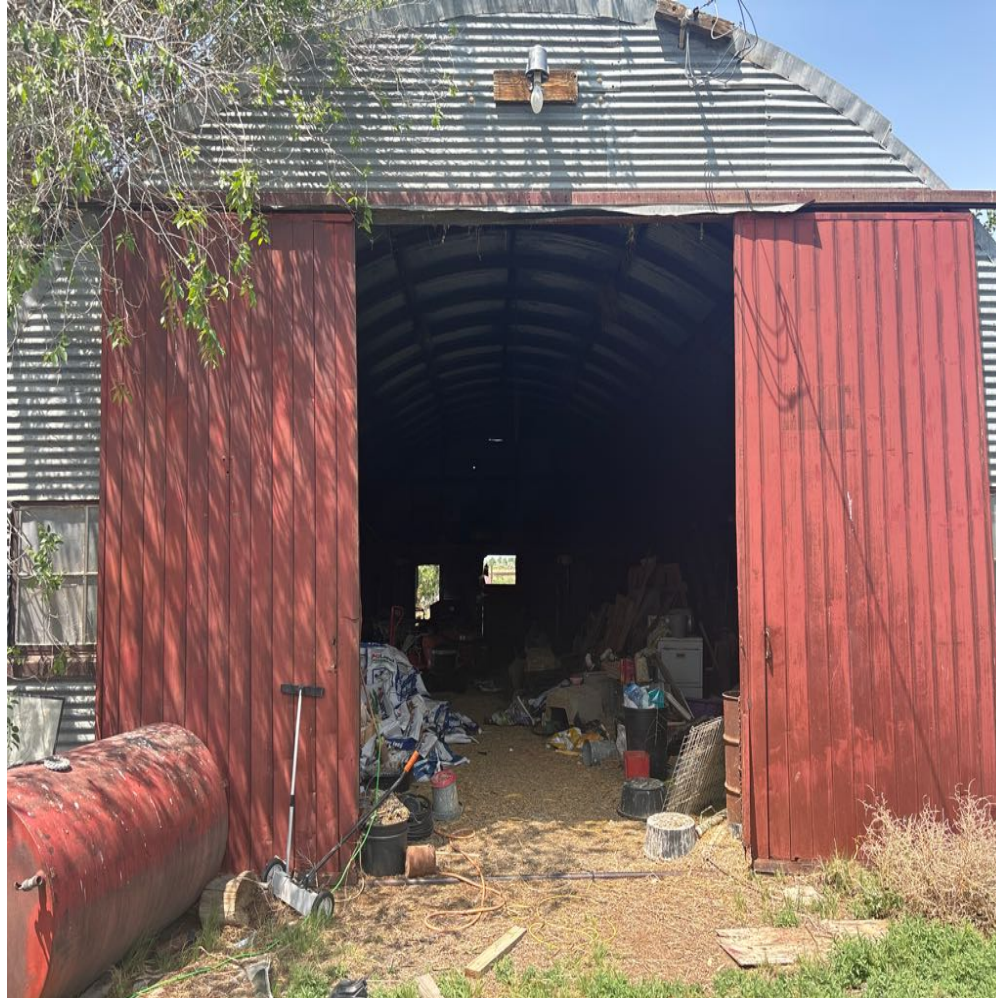
Oiling Observation: 0 No Observable Oil | Id: 560082 | 5/30/2025 2:12:21 PM  
(40.493683, -104.609469)  
No obvious signs of hydrocarbon on hanger style barn north of residence

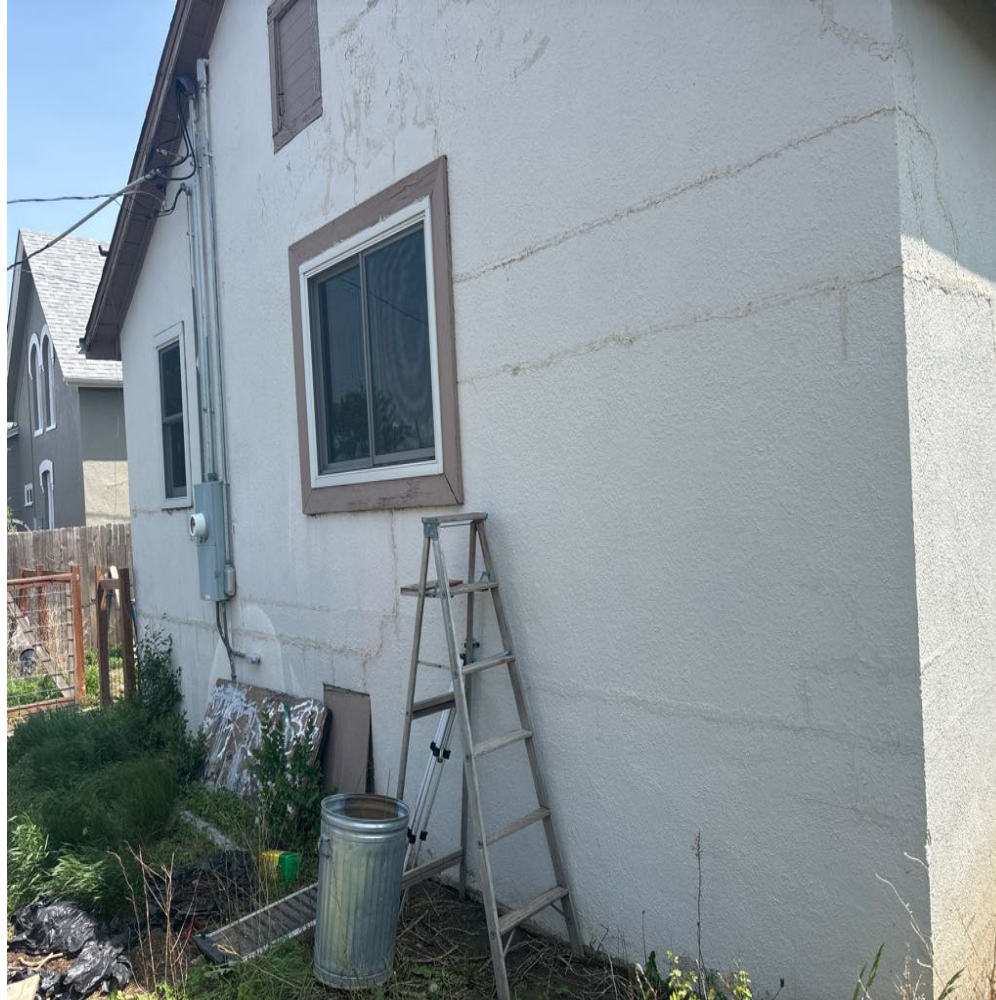
Oiling Observation: 0 No Observable Oil | Id: 560097 | 5/30/2025 2:13:29 PM  
(40.493765, -104.609714)

No obvious signs of hydrocarbon spray on either north or west side where affected area would be
