Closure Checklist

Closure Type: Active Release

Site Name: Pluss L 11-2D

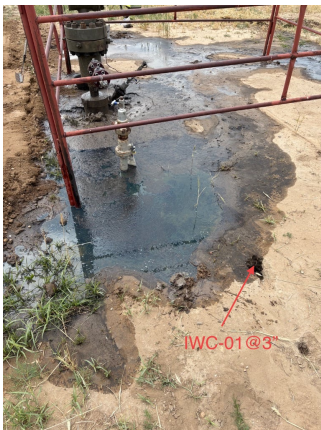
1 - P1

#	Date	Time	Sample ID	PID	Visual	Olfactory	Equipment	Lab
1	06/23/2025	14:45 PM	IWC-01@3"	205	Strong Staining	Strong odor	Wellhead	Yes
2	06/23/2025	14:55 PM	IWC-02@3"	416	Strong Staining	Strong odor	Wellhead	Yes
3	06/23/2025	15:05 PM	IWC-03@3"	522	Strong Staining	Strong odor	Wellhead	Yes
