WELL NAME: SPIRIT MOUNTAIN 32-28, API #: 071-08382, INSP. # 716301284

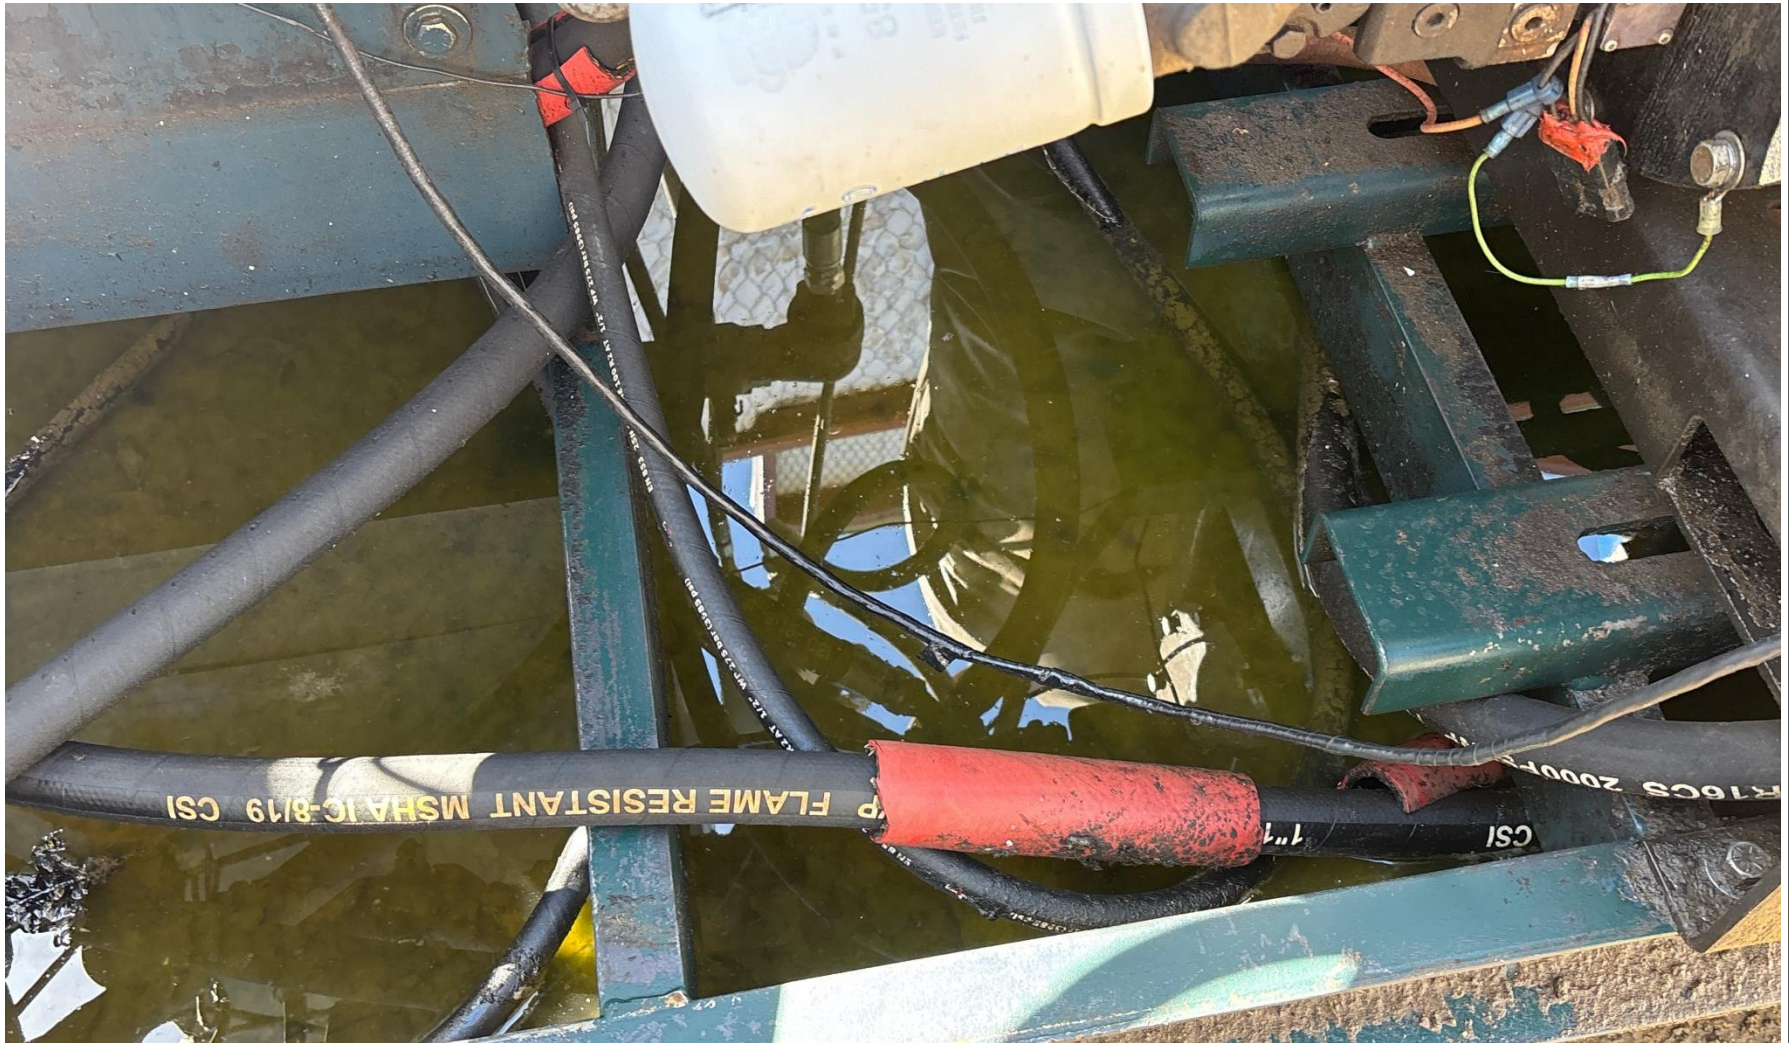
PHOTO 5: OILY WASTE AND APPEARS THERE MAY BE ANTIFREEZE IN PRIME MOVER SKID. DRAIN OILY WASTE REPAIR ALL LEAKS AND REMOVE IMPACTED SOIL PER RULE 1002..(2).D & 1002.f.(2)B, Comply with general provisions of the oil and gas act for wildlife protection AND SB-181.
