WELL NAME: SPIRIT MOUNTAIN 32-28, API #: 071-08382, INSP. # 716301432

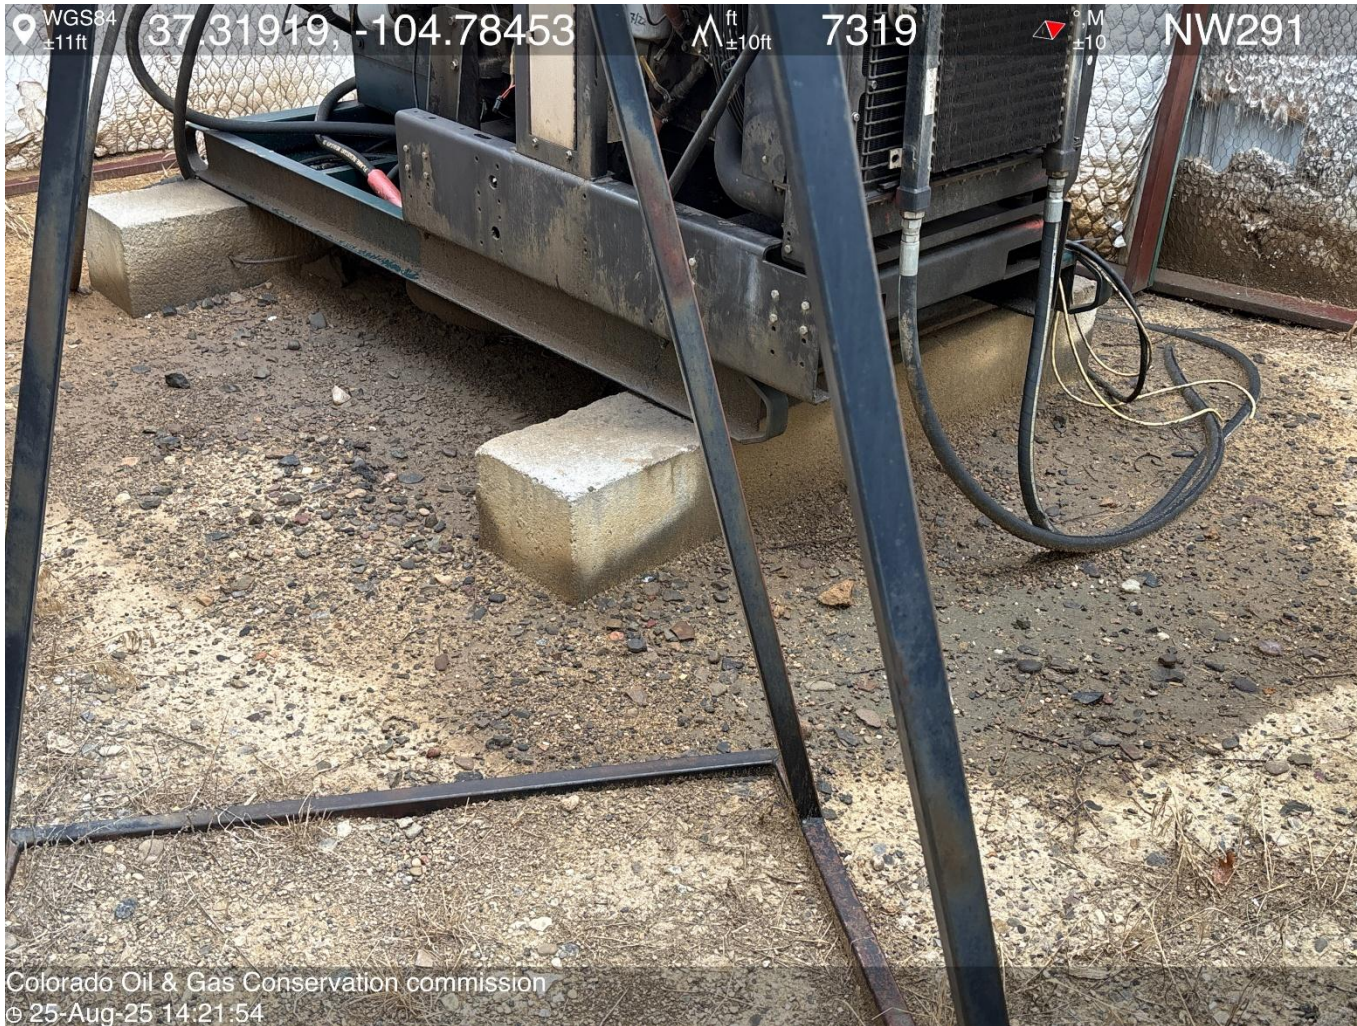
PHOTO 4: AREA OF IMPACTED SOIL AROUND PRIME MOVER SKID. Conduct maintenance on equipment, cleanup stained material and review self inspection processes. COMPLY WITH RULE 1002,(2).D, THIS IS THE SECOND NOTICE FOR THIS CA, IMMEDIATE ACTION IS REQUIRED.

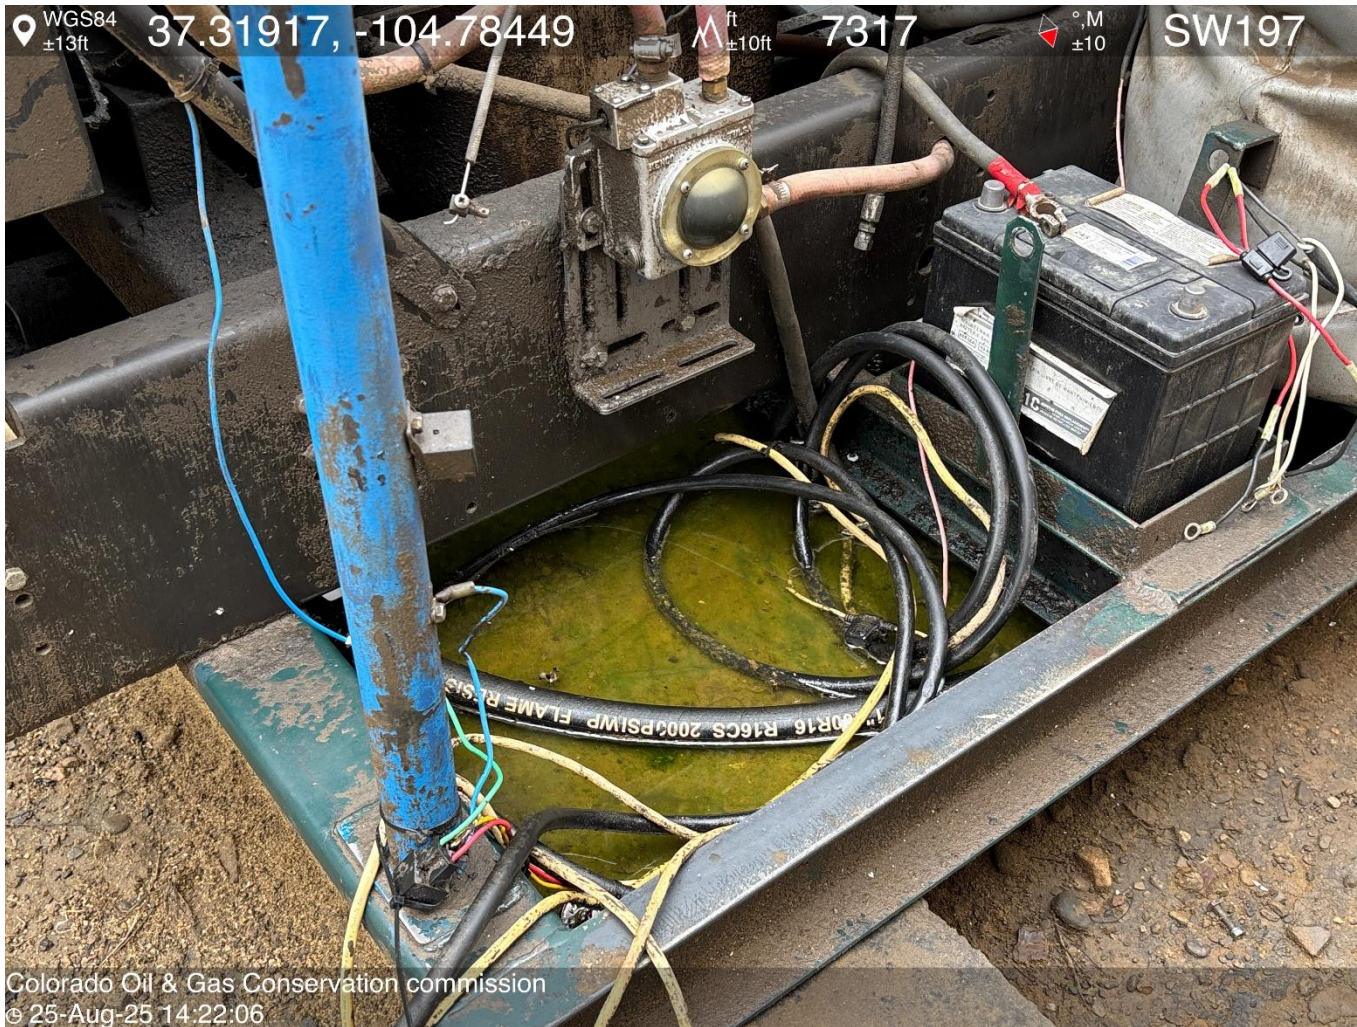
PHOTO 5: OILY WASTE AND APPEARS THERE MAY BE ANTIFREEZE IN PRIME MOVER SKID. DRAIN OILY WASTE REPAIR ALL LEAKS AND REMOVE IMPACTED SOIL PER RULE 1002..(2).D & 1002.f.(2)B, Comply with general provisions of the oil and gas act for wildlife protection AND SB-181, THIS IS THE SECOND NOTICE FOR THIS CA, IMMEDIATE ACTION IS REQUIRED.
