Final Reclamation Inspection

Operator: STRACHAN EXPLORATION INC - 83130

Location ID: 330787

Inspection Photos
Location Name: HILL #31-14-7
Location ID: 330787

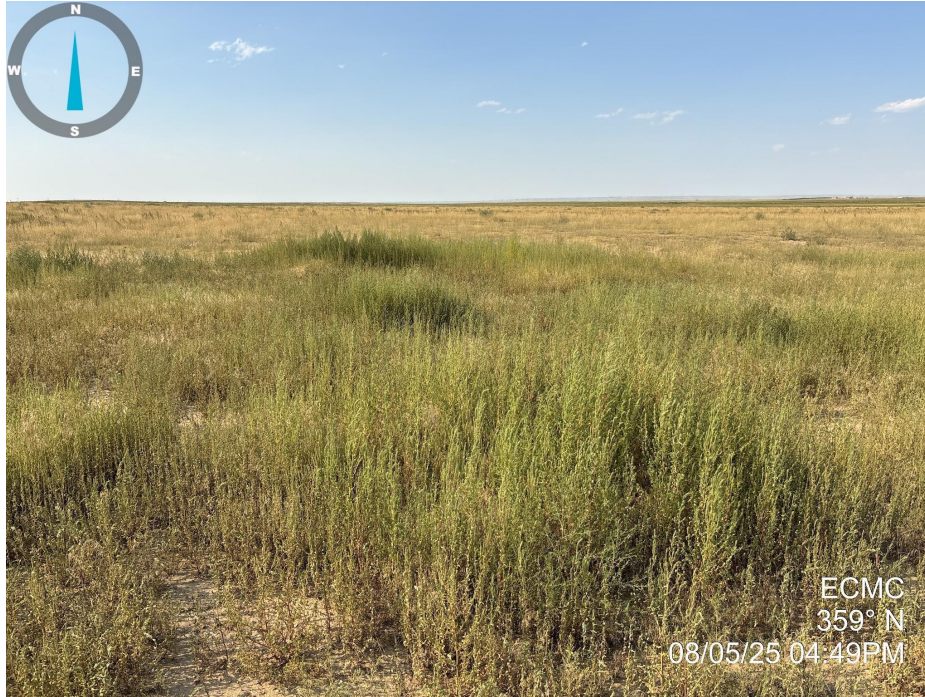
Photo 1. Photo taken of the well location, facing north. Photo illustrates that final reclamation activities have taken place, but vegetation establishment does not meet Rule 1004 standards. Weedy annual vegetation, including kochia (*Bassia scoparia*) and cheatgrass (*Bromus tectorum*), was observed across the location.

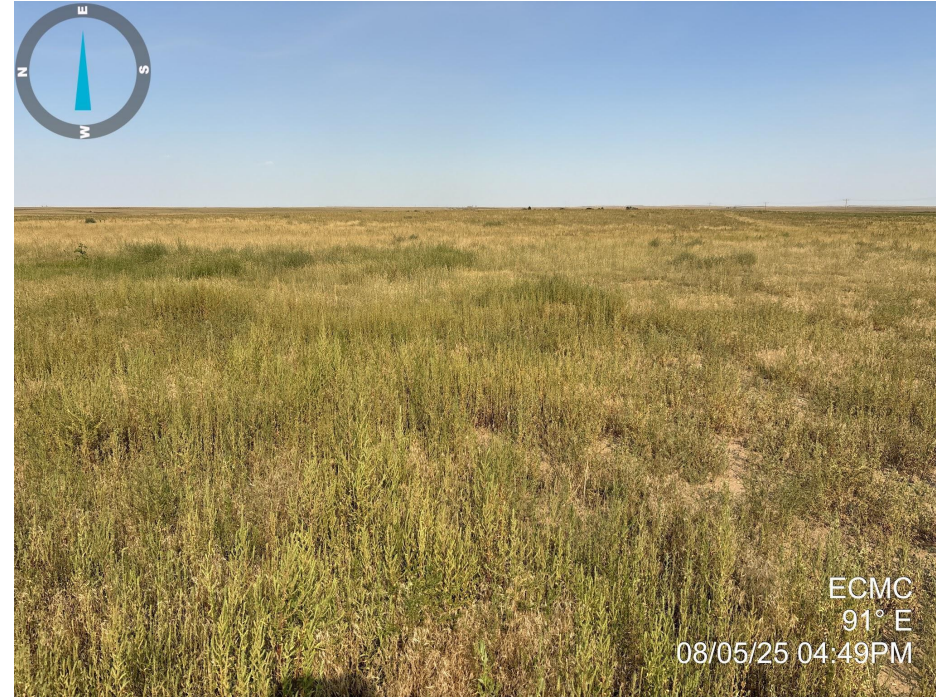
Photo 2. Photo taken of the well location, facing east. See comments under Photo 1.

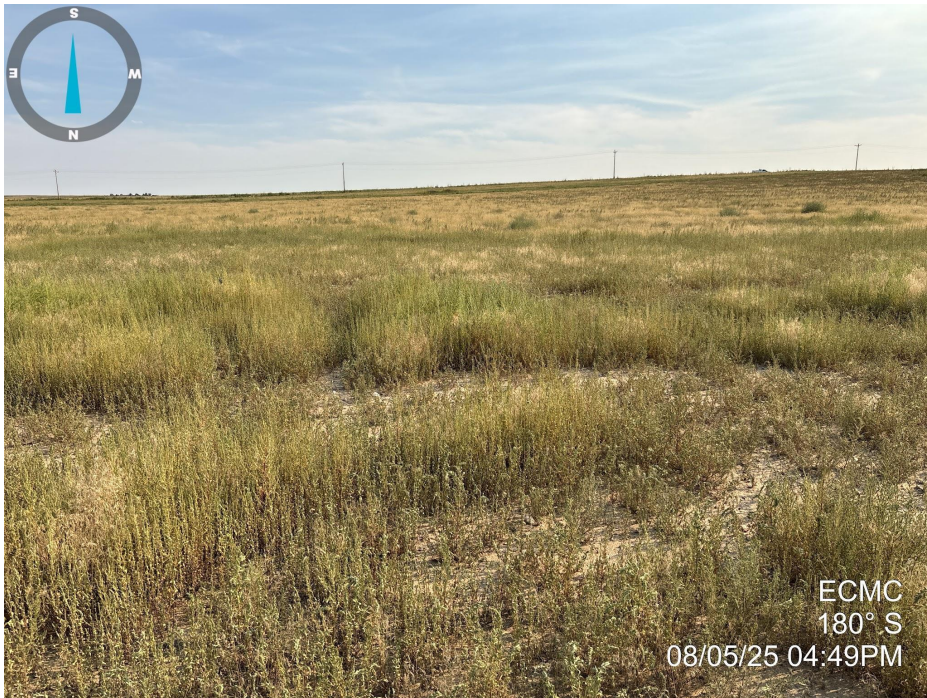
Photo 3. Photo taken of the well location, facing south. See comments under Photo 1.

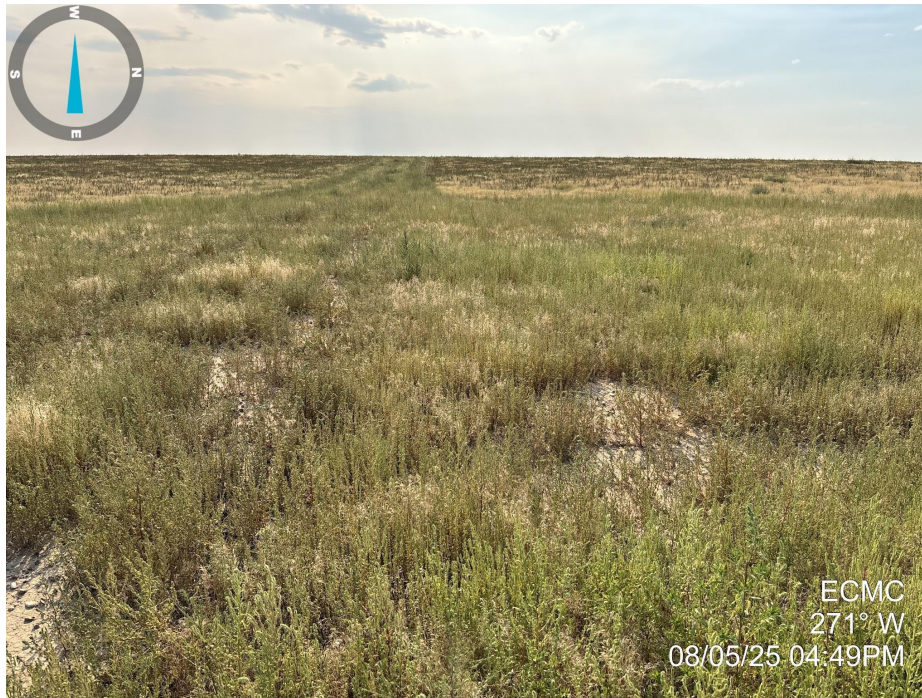
Photo 4. Photo taken of the well location, facing west. See comments under Photo 1.

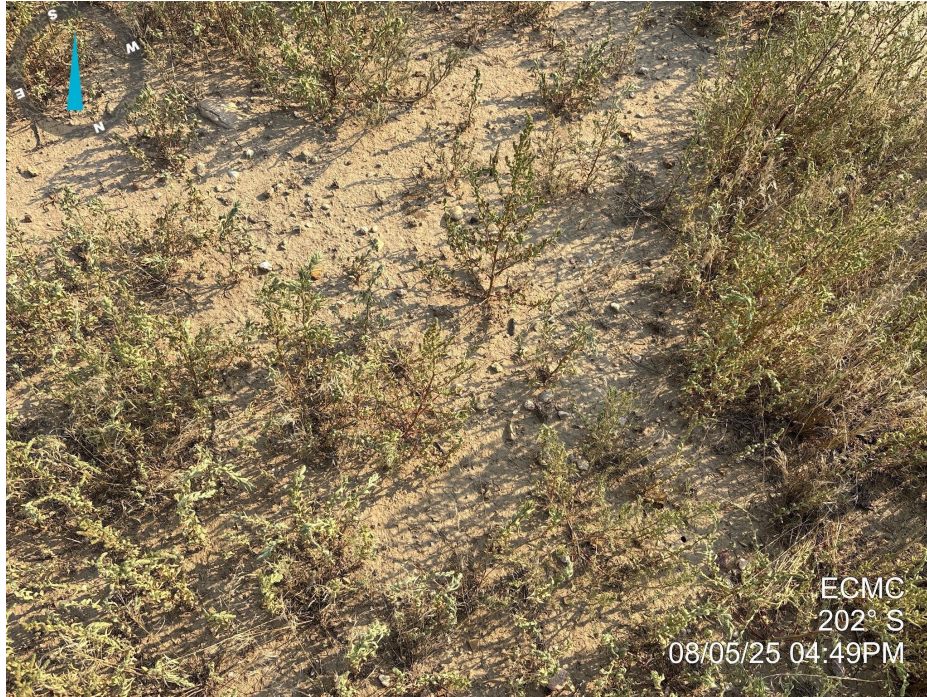
Photo 5. Photo taken of ground cover at the well location. Photo illustrates weedy annual vegetation including Kochia (*Bassia scoparia*) and Cheatgrass (*Bromus tectorum*), a List C Noxious Weed species.

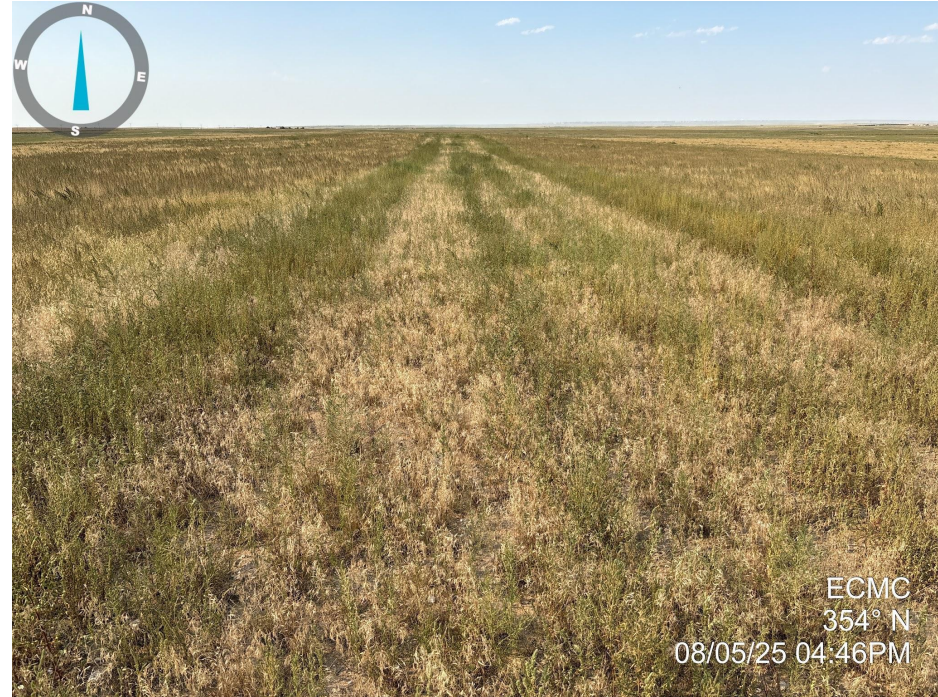
Photo 6. Photo taken of the access road to the location, facing north. Photo illustrates that the access road does not meet Rule 1004 standards as gravel and weedy annual vegetation remain along the road.

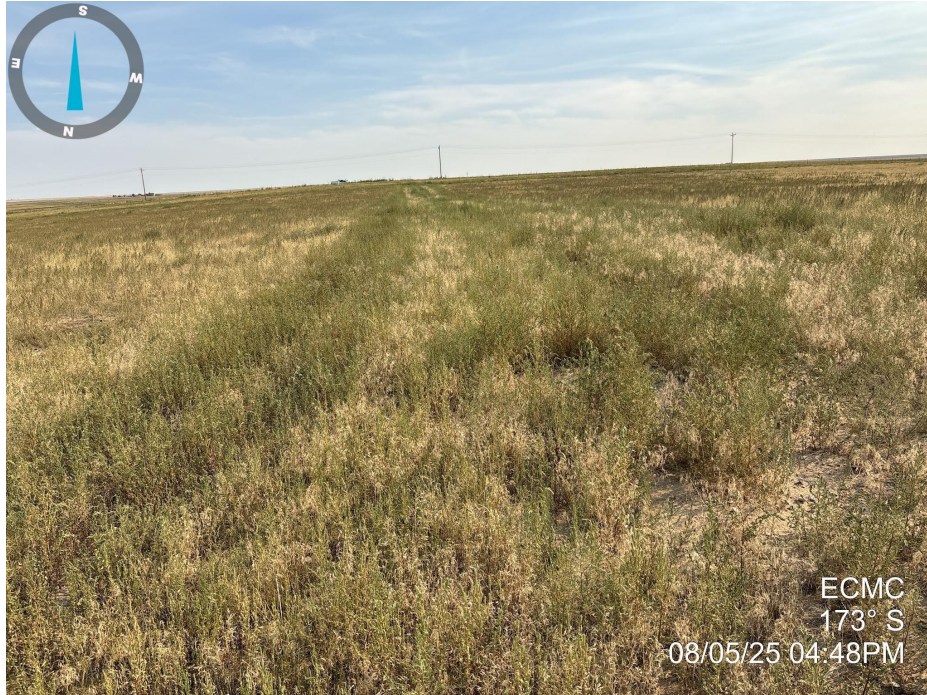
Photo 7. Photo taken of the access road to the well location, facing south. See comments under Photo 6.

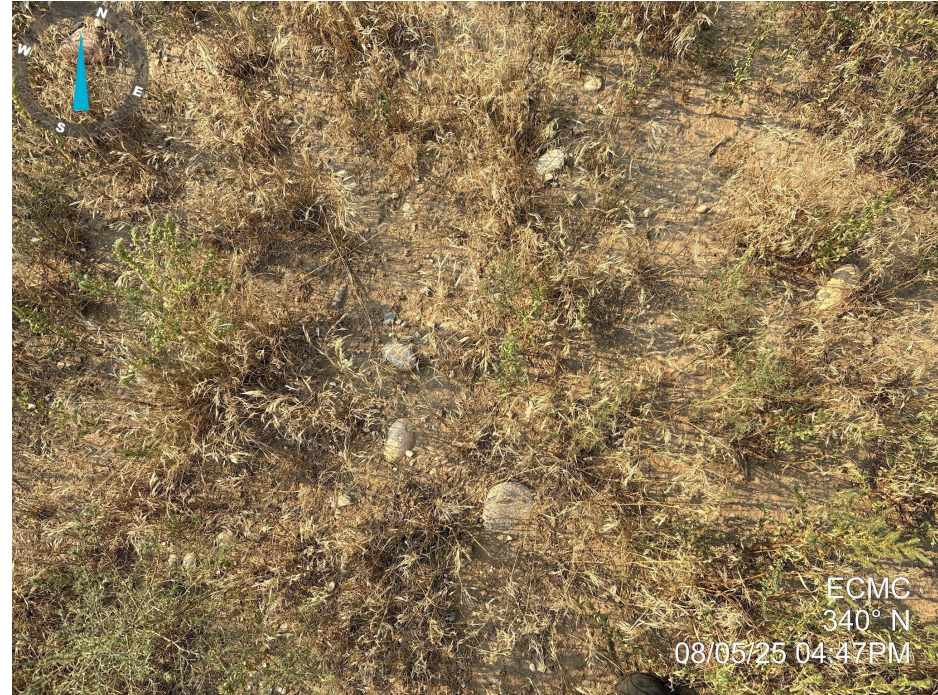
Photo 8. Photo taken of ground cover along the access road. Photo illustrates gravel and weedy annual vegetation, including kochia (*Bassia scoparia*) and cheatgrass (*Bromus tectorum*).

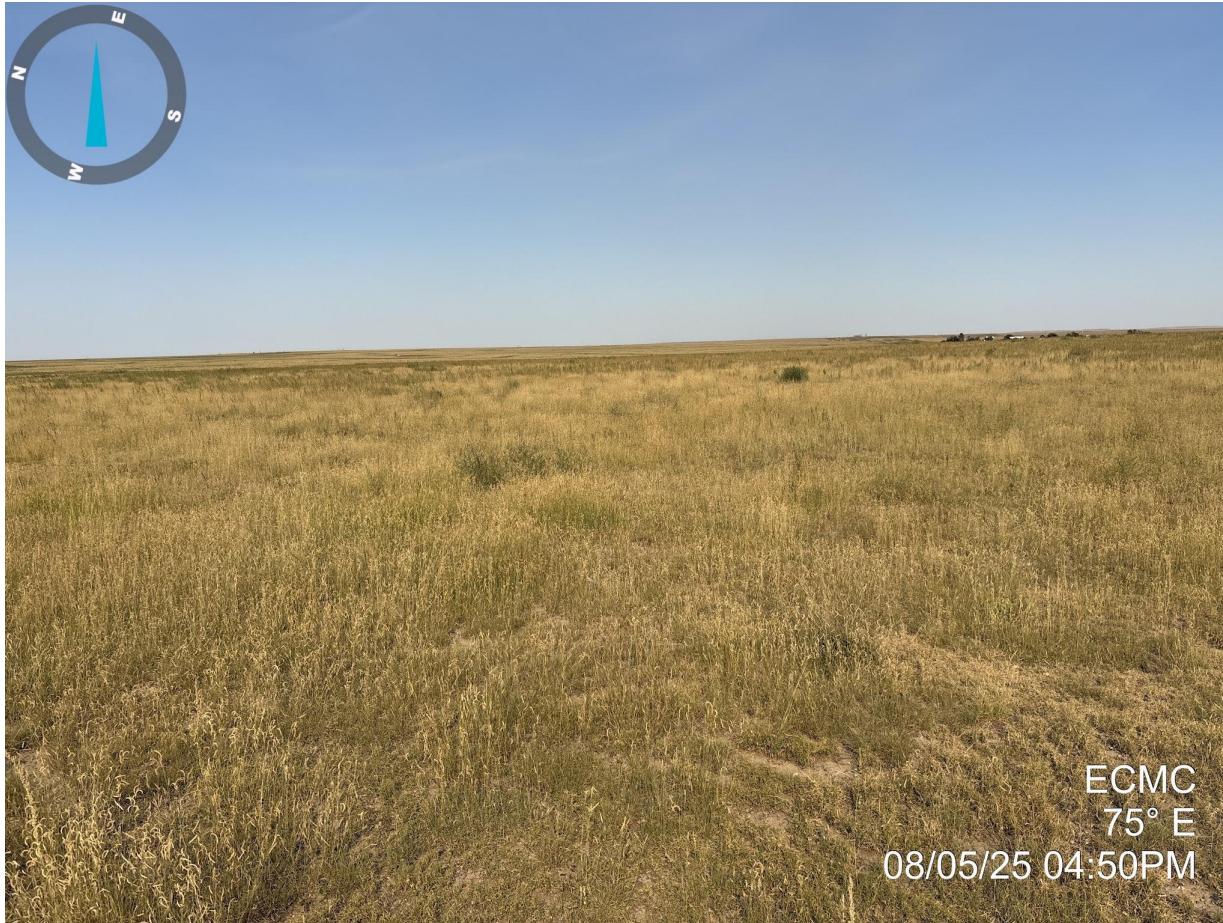
Photo 9. Photo taken of the reference area to the location, east of the location, facing east. Photo illustrates perennial grass vegetation.
