# Final Reclamation Inspection

Operator: FOUNDATION ENERGY MANAGEMENT LLC -  
10112

Location ID: 304152

Inspection Photos  
Location Name: SIMMONS #5-19  
Location ID: 304152

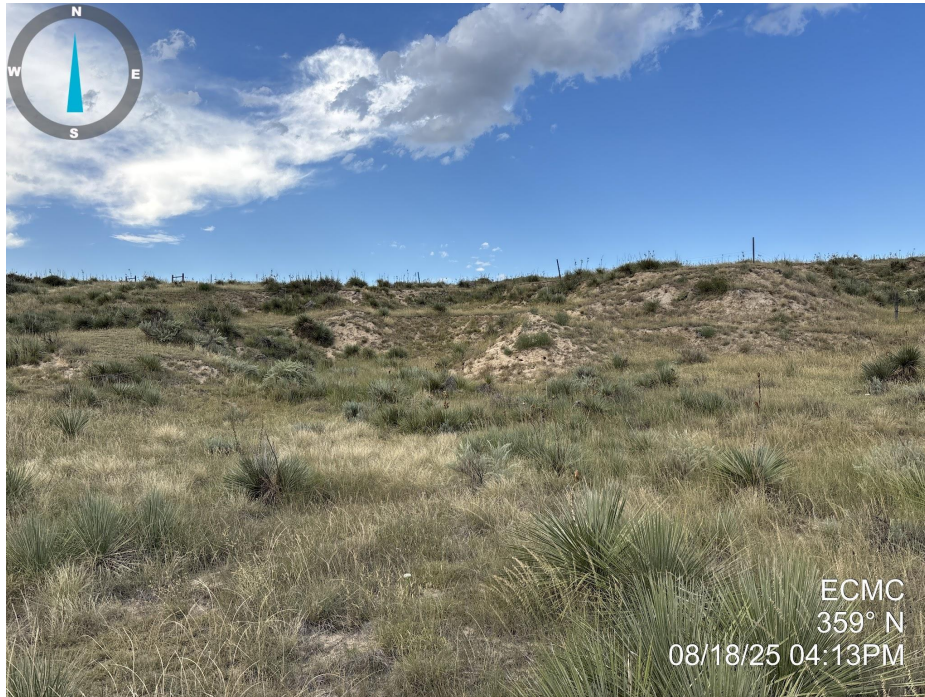
**Photo 1.** Photo taken from the well location, facing north. Photo illustrates that final reclamation meets Rule 1004 standards at the well location. However, the location does not meet reclamation regulations as gravel and stormwater erosion were observed along the access road.

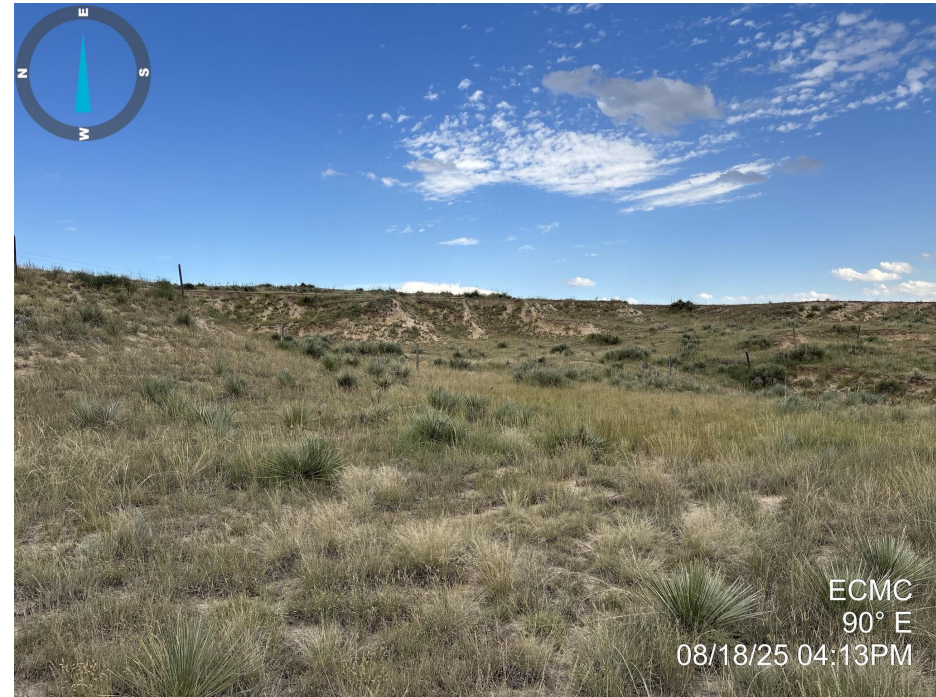
**Photo 2.** Photo taken from the well location, facing east. See comments under Photo 1.

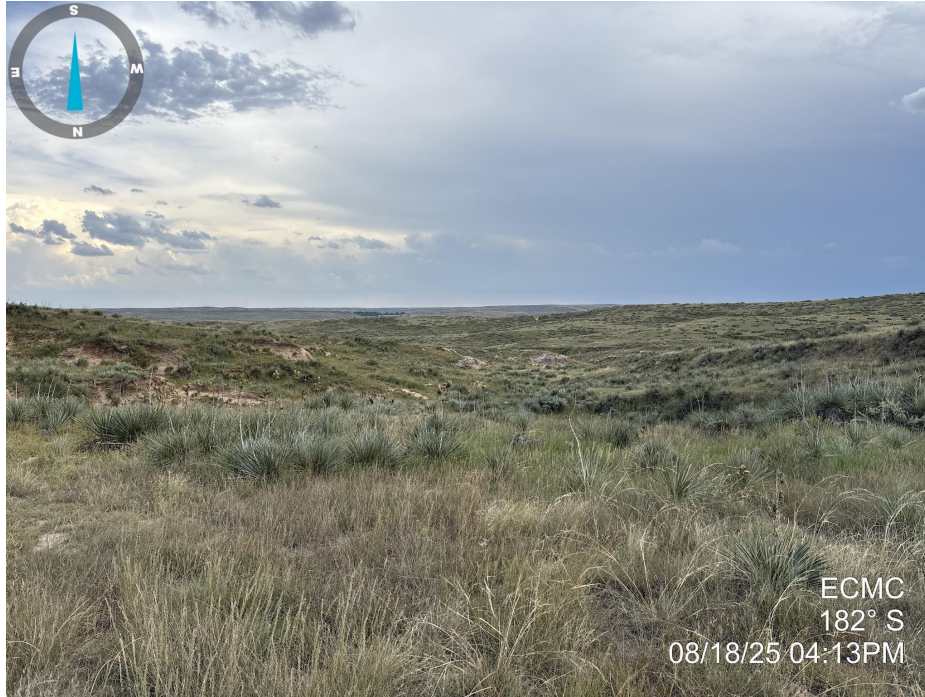
**Photo 3.** Photo taken from the well location, facing south. See comments under Photo 1.

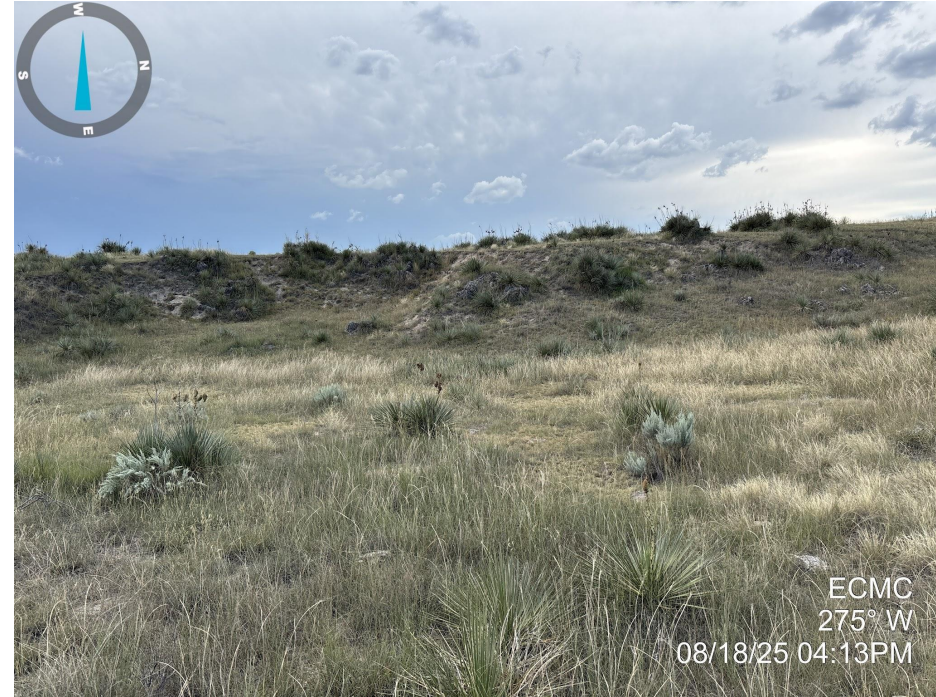
**Photo 4.** Photo taken from the well location, facing west. See comments under Photo 1.

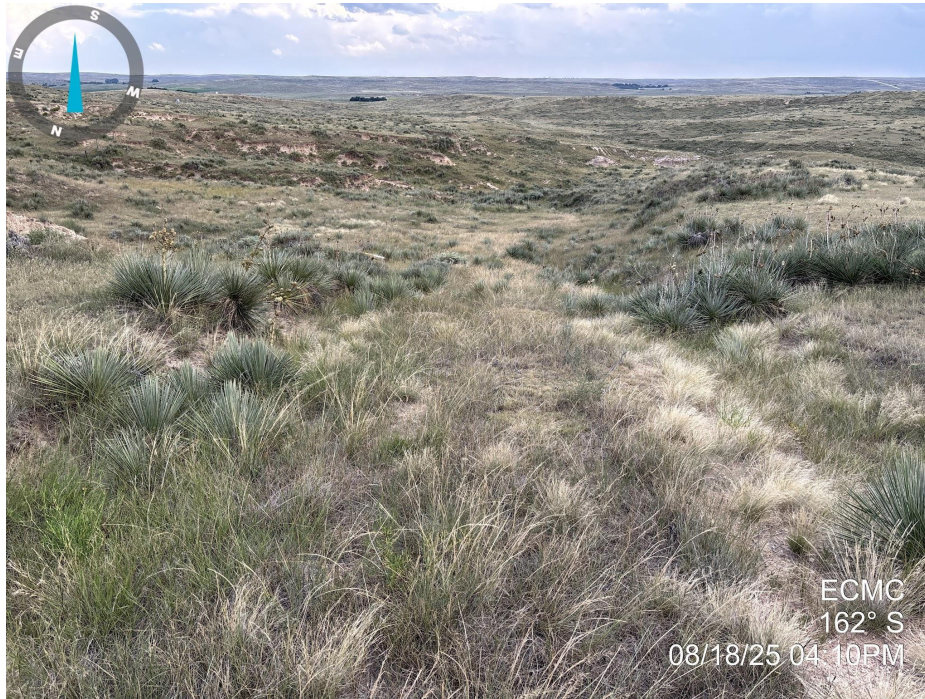
**Photo 5.** Photo taken of the access road to the well location, facing south, towards the location. Photo illustrates final reclamation activities appear to have taken place, but gravel remains along the road and stormwater erosion was observed.

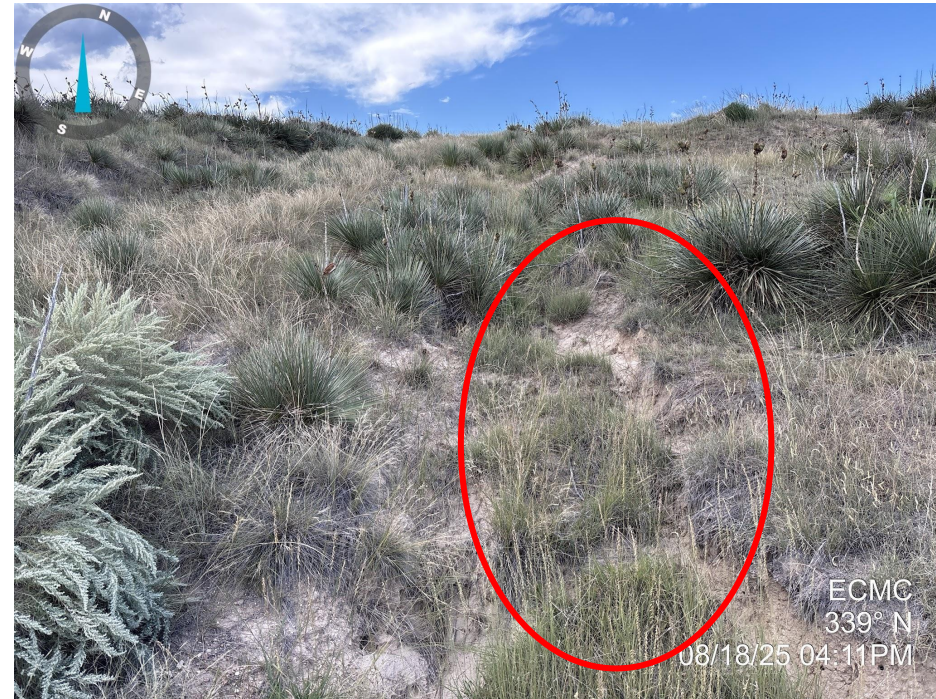
**Photo 6.** Photo taken of the access road to the well location, facing north, away from the location. Photo illustrates stormwater erosion, highlighted in red.

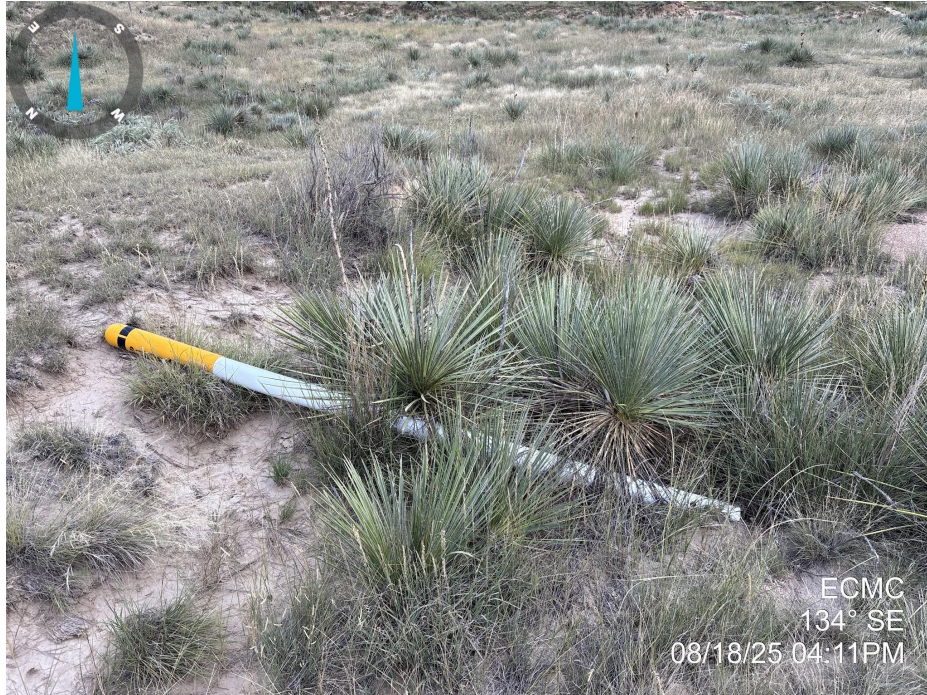
**Photo 7.** Photo taken from the access road, facing southeast. Photo illustrates midstream equipment that has fallen over.

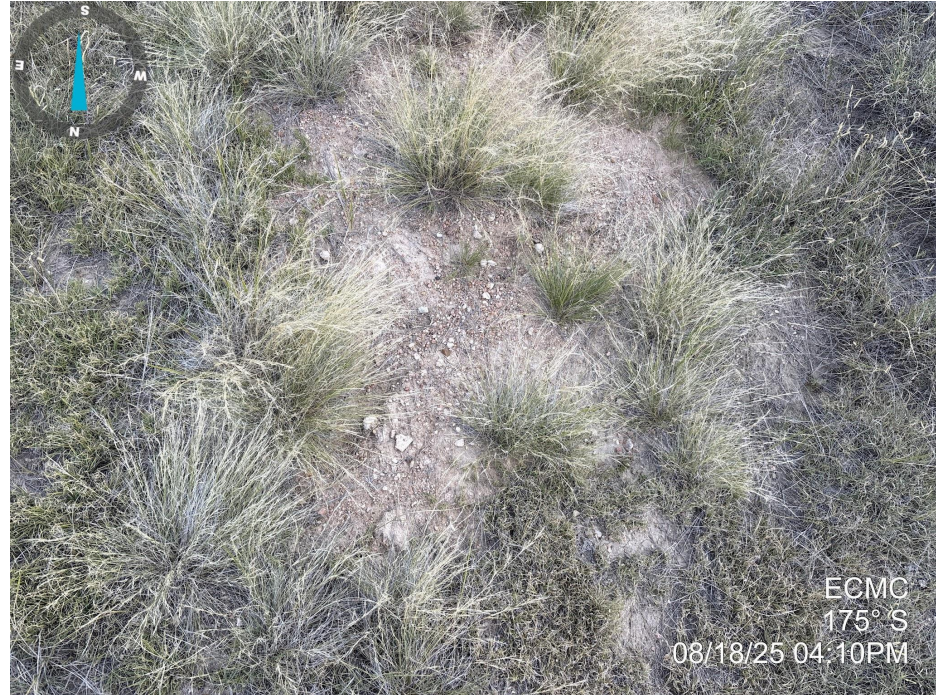
**Photo 8.** Photo taken of ground cover along the access road. Photo illustrates that gravel remains.

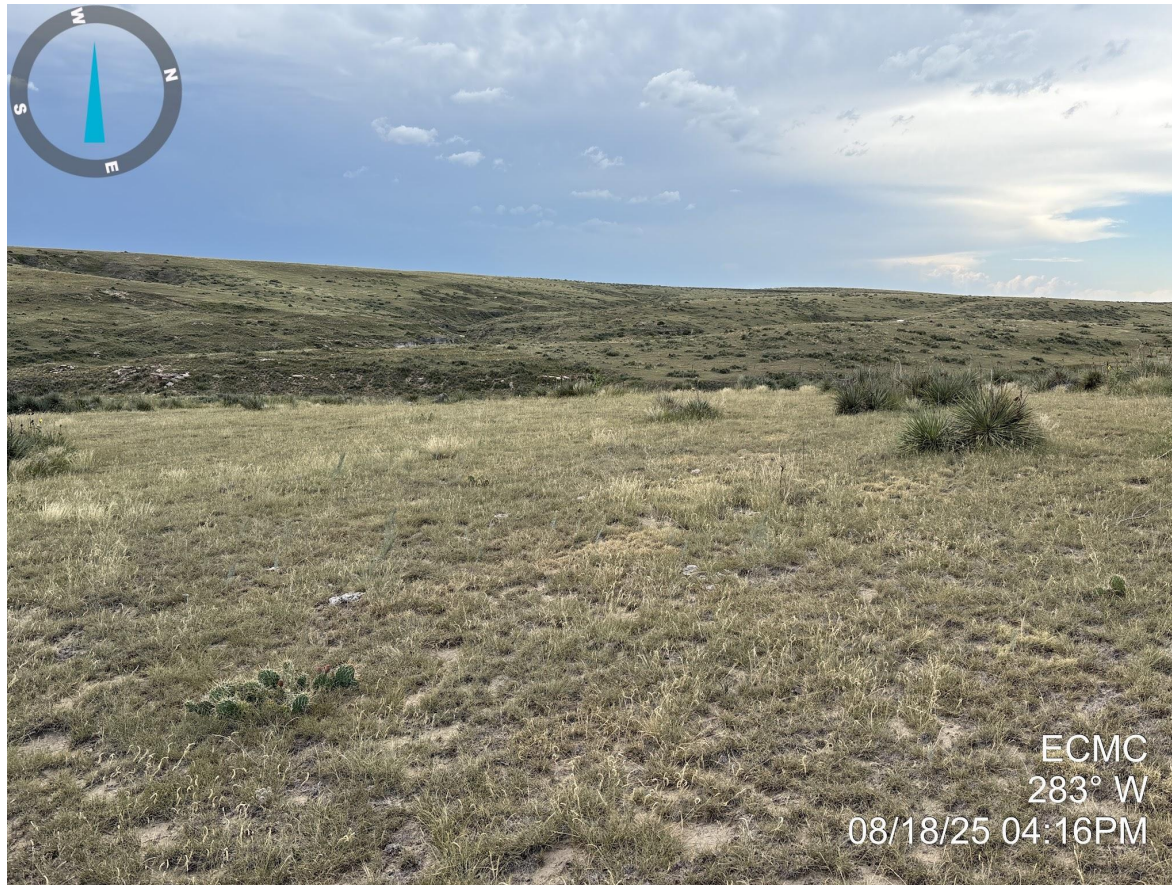
**Photo 9.** Photo taken of the reference area to the location, northwest of the location, facing west. Photo illustrates perennial grass vegetation.
