**RE: Fuqua 18-15 Pad Separator Release Additional Site Investigation
and Remediation Work Plan - Project #012-0225**

Laramie Energy II
Fuqua 18-15 Additional Site Investigation
May 15, 2012

Olsson Associates
Golden, CO
Project # 012-0225

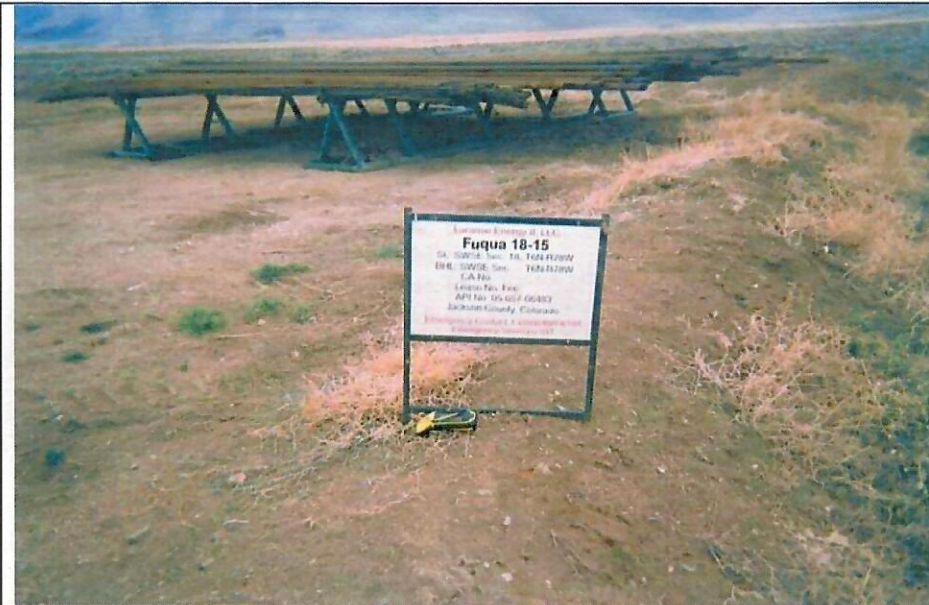
Subject: The Fuqua 18-15 well pad sign and other points on the well pad, including the well head, were recorded using a Trimble GPS unit with submeter accuracy.

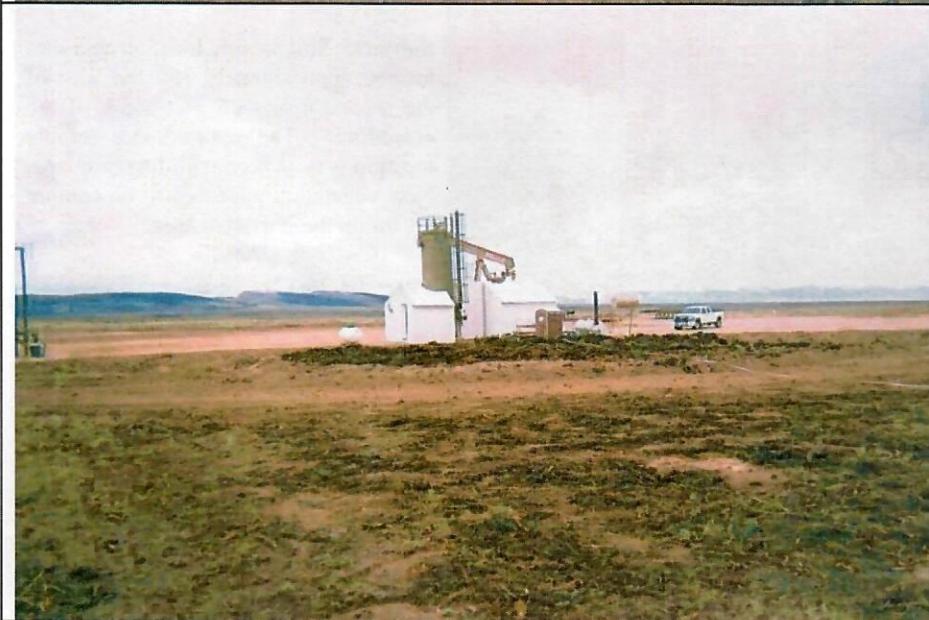
Subject: A top valve seal on the vertical separator failed resulting in the January 29, 2012 condensate release. Impacted vegetation and soils were scraped up using a loader and placed within secondary containment to the east of the separator. Stained soils and vegetation are shown in the foreground.

The mixture also contains nutrients that will help the native soil microbes to further break down the petroleum hydrocarbons. Since the release was caused by a seal blowing out at the top of the vertical separator and the wind carrying the petroleum hydrocarbons out over the impact area, the impacts are limited to vegetation and surface soils. Wetting the soils and keeping them moist will be necessary to bioremediate the impacted soil; however, tilling is not expected to be necessary because of the thin layer of impact. No hazardous byproducts, residues, or hydrocarbon mobilization are expected from the application of the hydrocarbon surfactant solution.

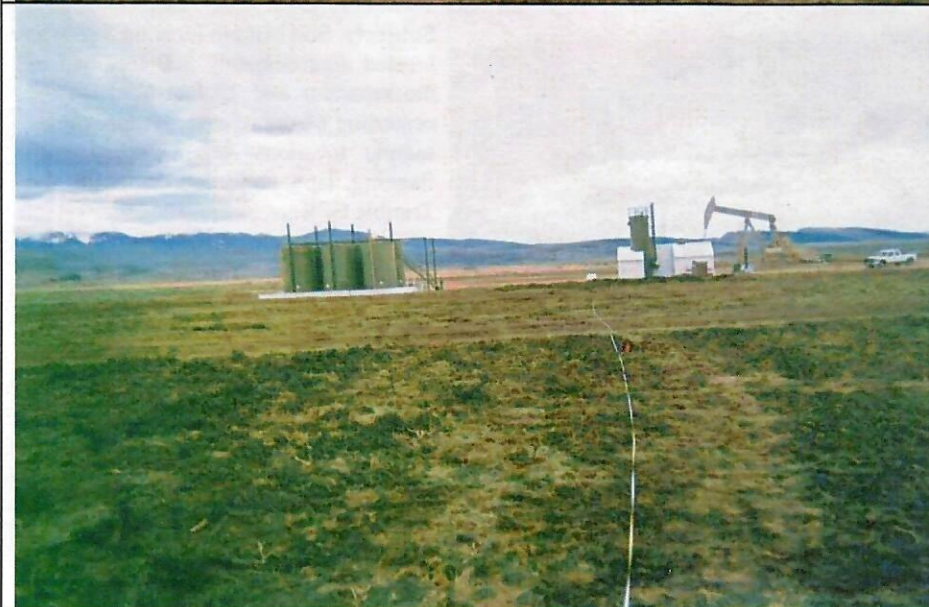
Subject: Photograph shows the approximate centerline of the release at a distance of approximately 250 feet from the vertical separator. Stained soil and vegetation are shown in the foreground. The orange pinflag marks the location of SS9.

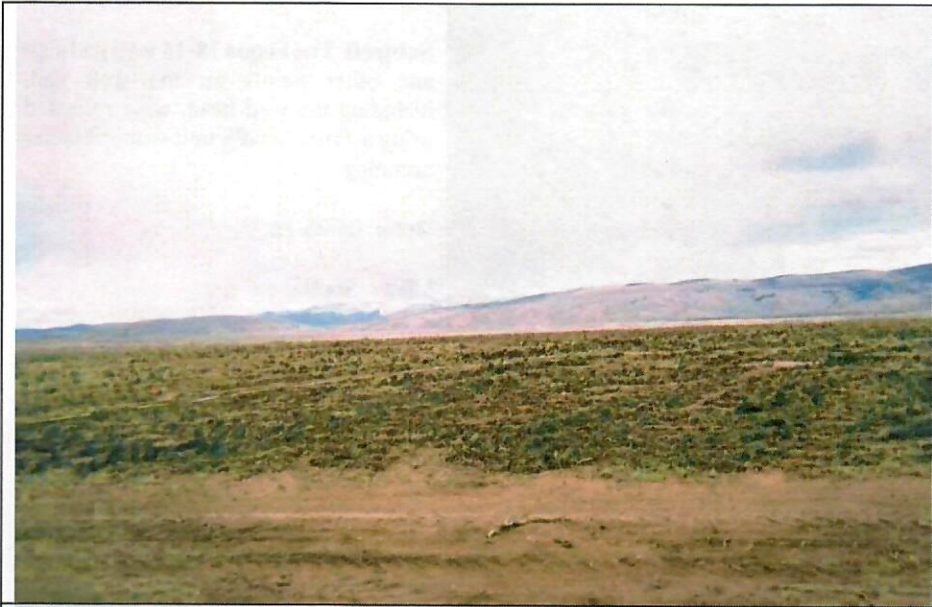
Subject: Photograph taken from the access road showing the impacted area of surface soils and vegetation. The impact area fanned out from the vertical separator to the east of the well pad and was between 160 feet and 200 feet wide. Measurements of the impact area were taken using the Trimble GPS unit based on visual extent of staining. The primary impact area extended out approximately 450 feet from the separator.

It appeared that the wind had carried the release more to the southeast at approximately 450 feet from the separator; however, the majority of the impacted vegetation was within this impact area as shown on **Figure 3**. The width of the impact area "fanned out" from the vertical separator and ranged from 160 feet to 200 feet at its widest aperture. "Fingers" and localized spots of impacted vegetation were noted where the wind had carried the petroleum hydrocarbons further out, but were more isolated. Petroleum hydrocarbon impacts were not noted out along the eastern extent of the fire break.

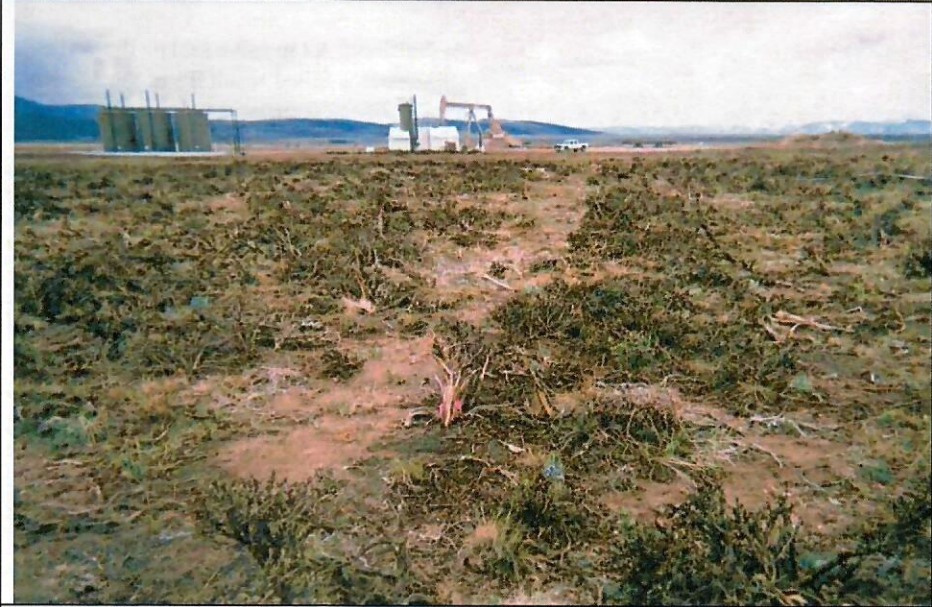
Subject: Soil sample location SS5 was located approximately 300 feet east of the separator and 25 feet south of the centerline. The approximate sample location was marked with flagging tape. New vegetation appeared to be coming up within the impacted area.

Fiberglass tape measures and a Trimble GPS unit were used to document the soil sample locations. Soil samples SS-5 and SS-6 were collected approximately 300 feet east of the vertical separator and 25 feet south and 25 feet north of the centerline of the release, respectively. Soil samples SS-7 and SS-8 were collected approximately 400 feet east of the vertical separator, and 25 feet south and 15 feet north of the release centerline, respectively. Soil sample SS-9 was collected approximately 250 feet from the vertical separator, on the east side of the access road, and close to the centerline of the release.

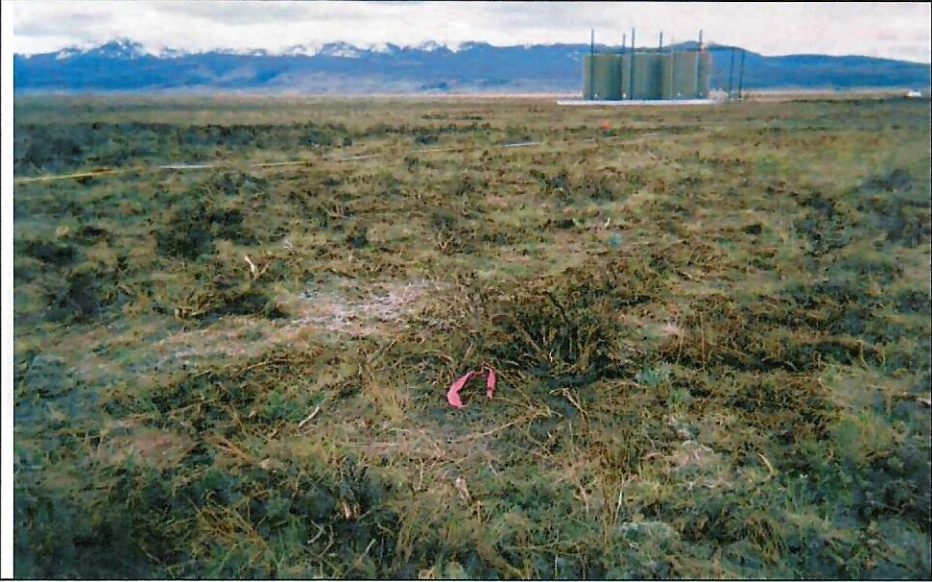
Subject: Soil sample location SS6 was located approximately 300 feet east of the separator and 25 feet north of the centerline of the release. Approximate sample locations were marked with flagging tape and recorded with the Trimble GPS.

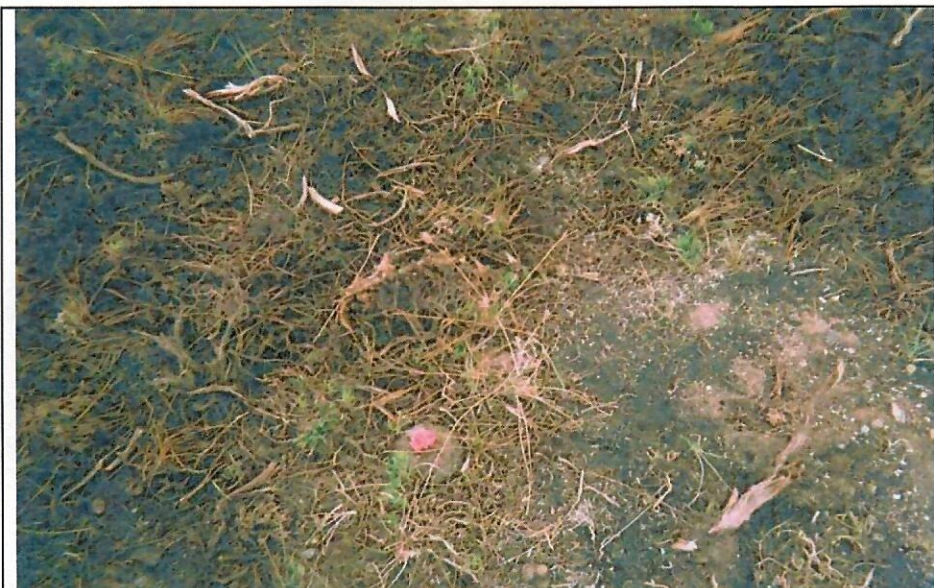
Subject: Barrel cacti were observed in bloom and other plants were observed coming up within the stained and impacted vegetation area.

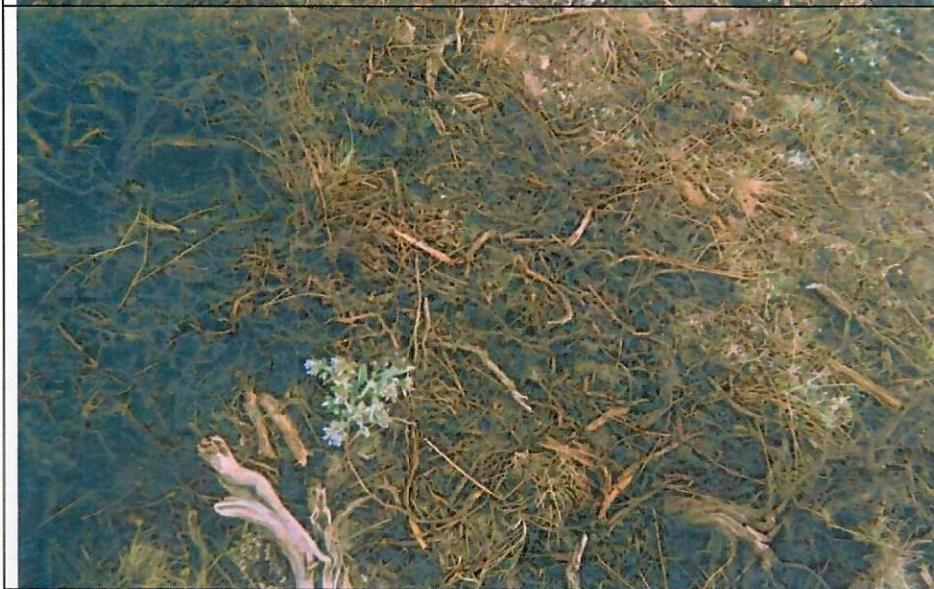
Subject: Flowering plants and grasses were observed coming up within the impact area. Photograph shows soil and vegetation staining.

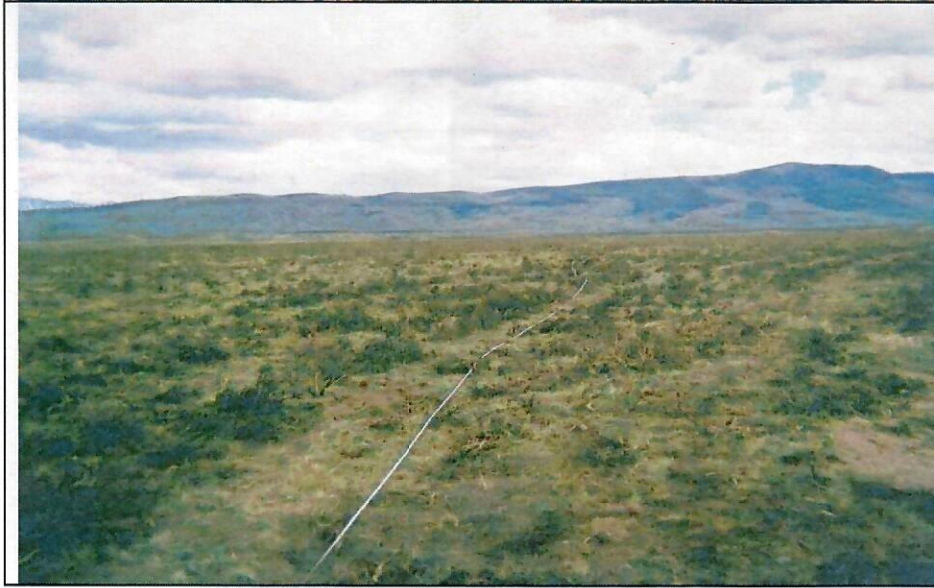
Subject: Photograph shows the approximate centerline of the release looking to the east of the Fuqua 18-15 well pad. The extent of primary impact and the soil sample locations were measured using fiberglass tape measures. The photograph was taken near the locations of SS7 (right – south ~25 feet) and SS8 (left – north ~15 feet) from the release centerline.

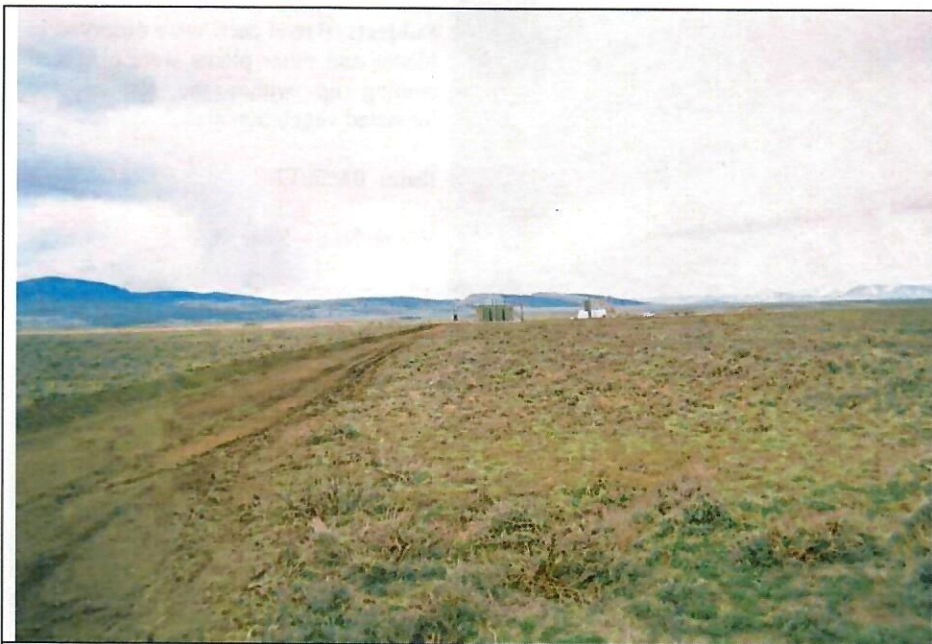
Subject: Photograph shows the Fuqua 18-15 well pad from the southeast corner of the fire break. The soils and vegetation were not observed to be impacted out this far; however, there were “fingers” and spots of staining that extended from the primary impact area that are included within the extent of the fire break.

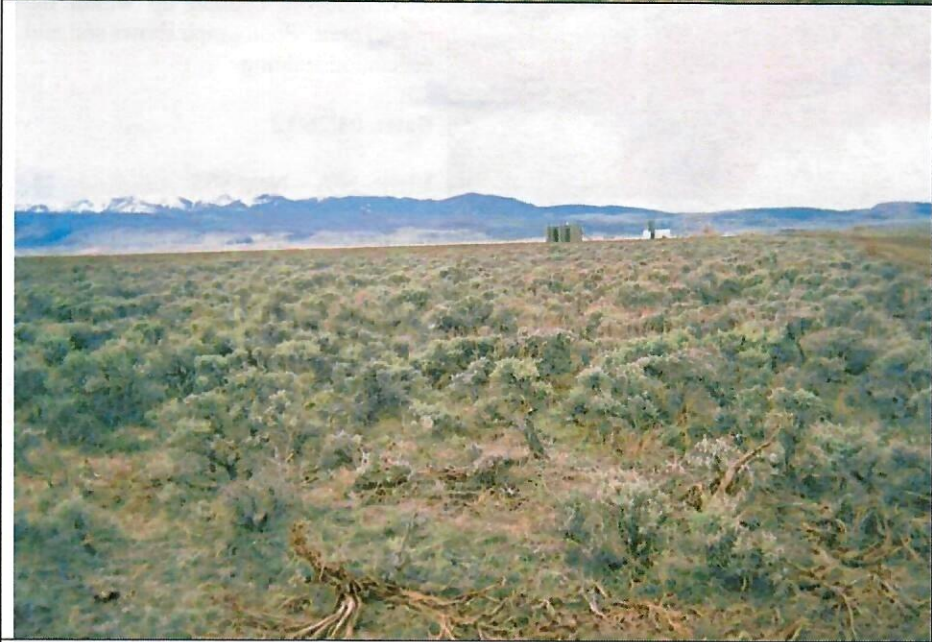
Subject: Photograph shows the area contained within the fire break from the northwest corner. The sagebrush, grasses, and soils in this area were not impacted.

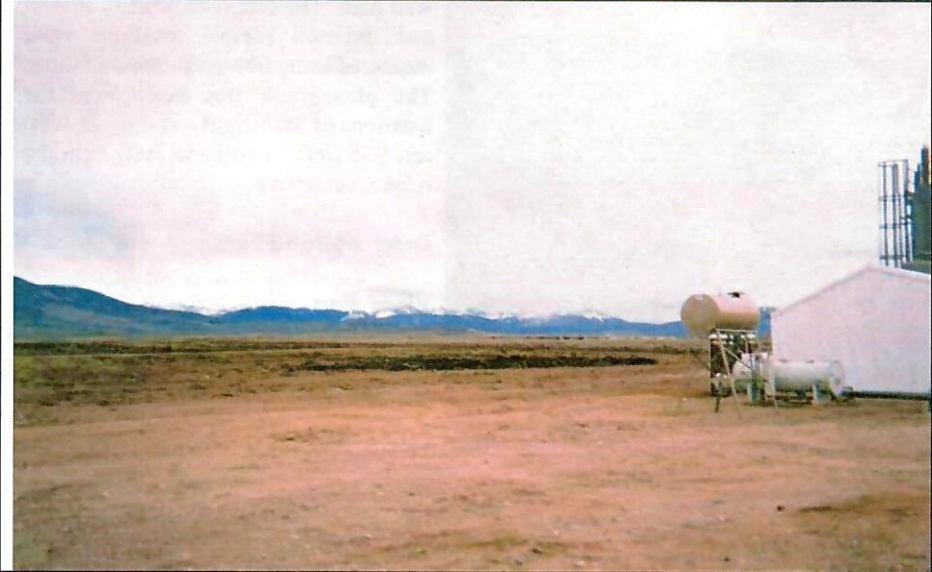
Subject: Photograph shows the stockpiled vegetation and stained soils and the vertical separator (right). Soil sample SS10 was collected from the stockpiled vegetation and soils located within an earthen containment berm.

A composite sample of the impacted sage brush and soils from the stockpile was collected to provide an estimate of the highest concentrations that may be expected. Stained soils and paraffin were observed and were represented in the sample, SS-10. Site photographs are presented in **Attachment C**.

The impacted vegetation in the stockpile will be broken up into smaller pieces by mechanical means, either using heavy equipment with track to spread out and drive over the pile or through use of chains. The impacted stock pile will be treated with the surfactant solution to break up the hydrocarbons. Once other areas have met the Table 910-1 standard of 500 mg/kg for both DRO and ORO the fire break will be reclaimed using the shredded stockpiled vegetation as mulch. The resulting mulch will need to meet Table 910-1 standards before being used to restore the fire break. The fire break area will be covered with soil and will be re-seeded with a suitable dry land pasture grass seed mix as recommended by the local USDA Natural Resources Conservation Service office and approval of the Fuqua Ranch.
