# Inspection Photos

API: 017-06632

Operator: **WILLIFORD ENERGY COMPANY**

Inspection Date: 9/5/2025

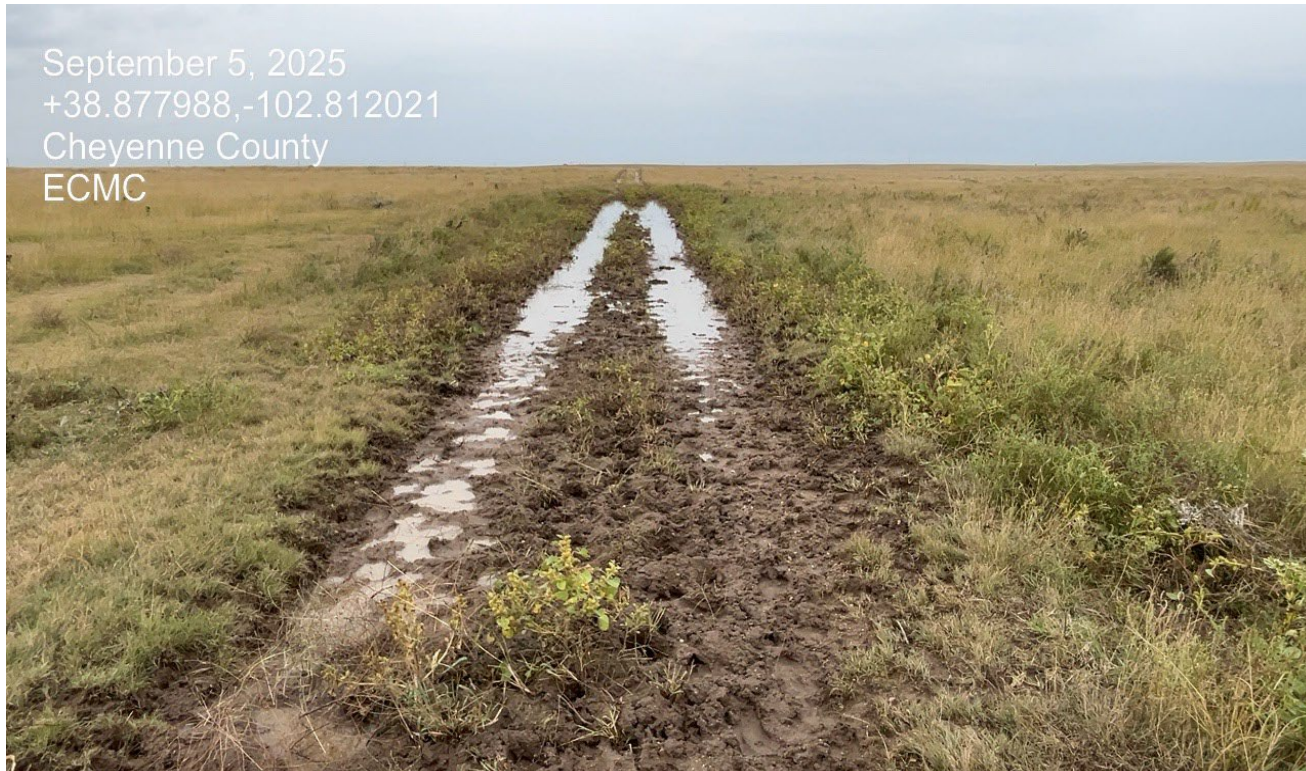
**Photo 1.** Facing southeast toward the access road. The access road is impassible due to stormwater accumulating along the road. Since the well has been PA'd the road will need to be decompacted, regraded, and reclaimed.

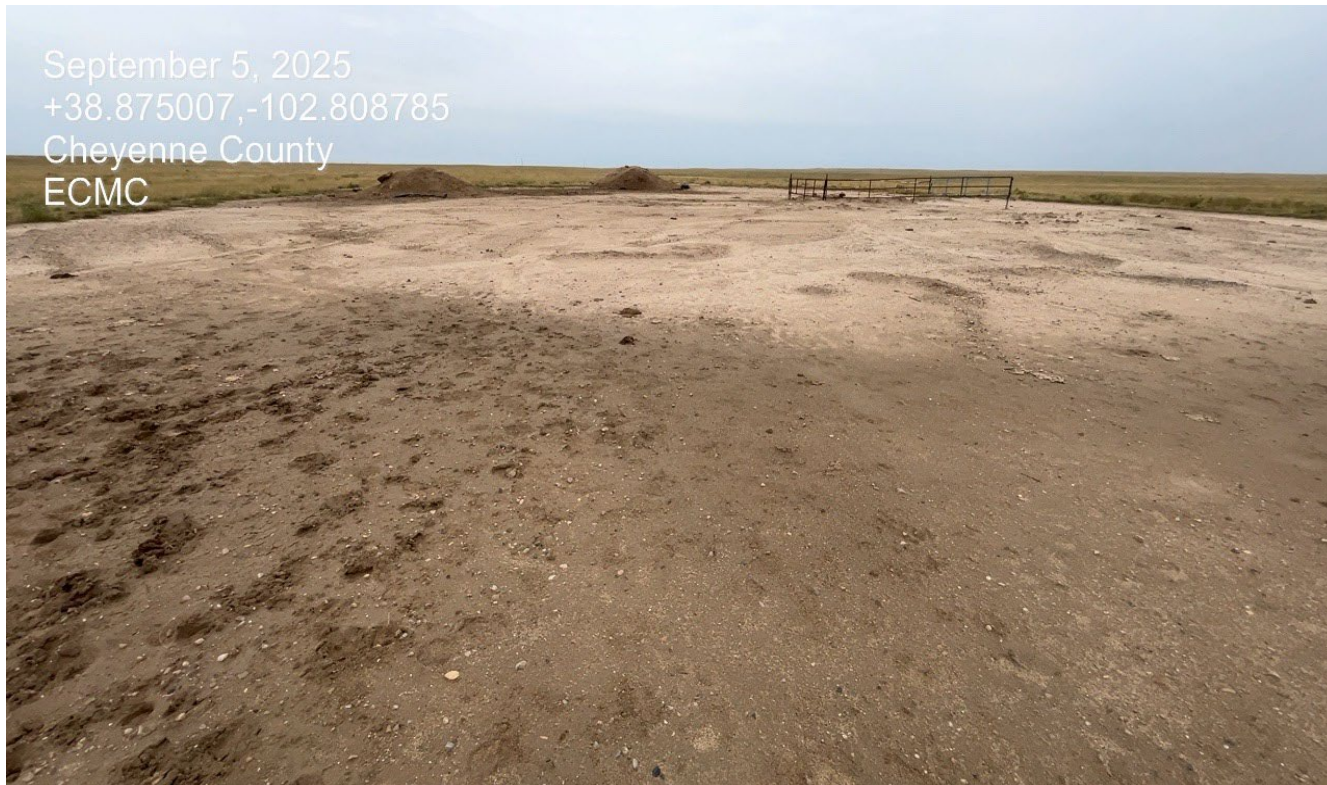
**Photo 2.** Facing southeast toward the location.

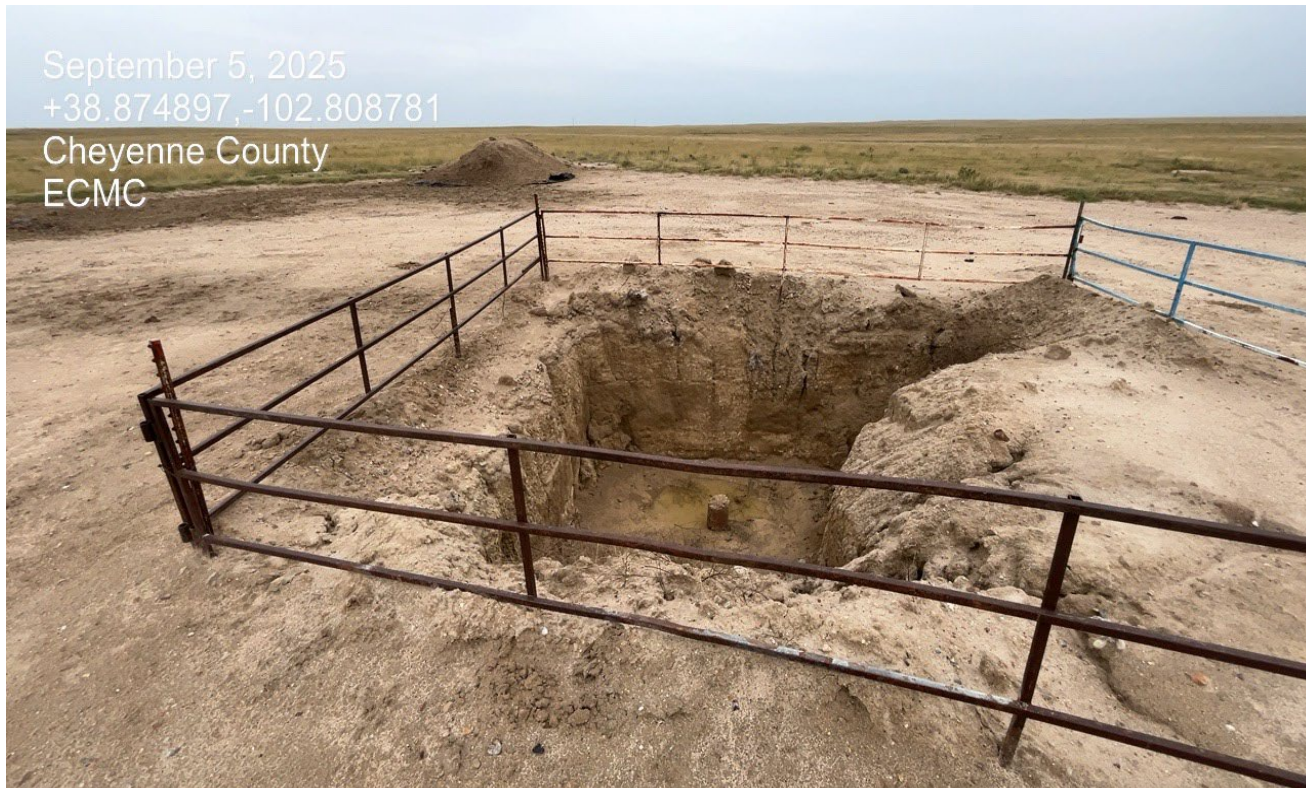
**Photo 3.** Facing toward the cut/capped wellhead. Contaminated material has been excavated from the wellhead and placed at the southeast side of the location.

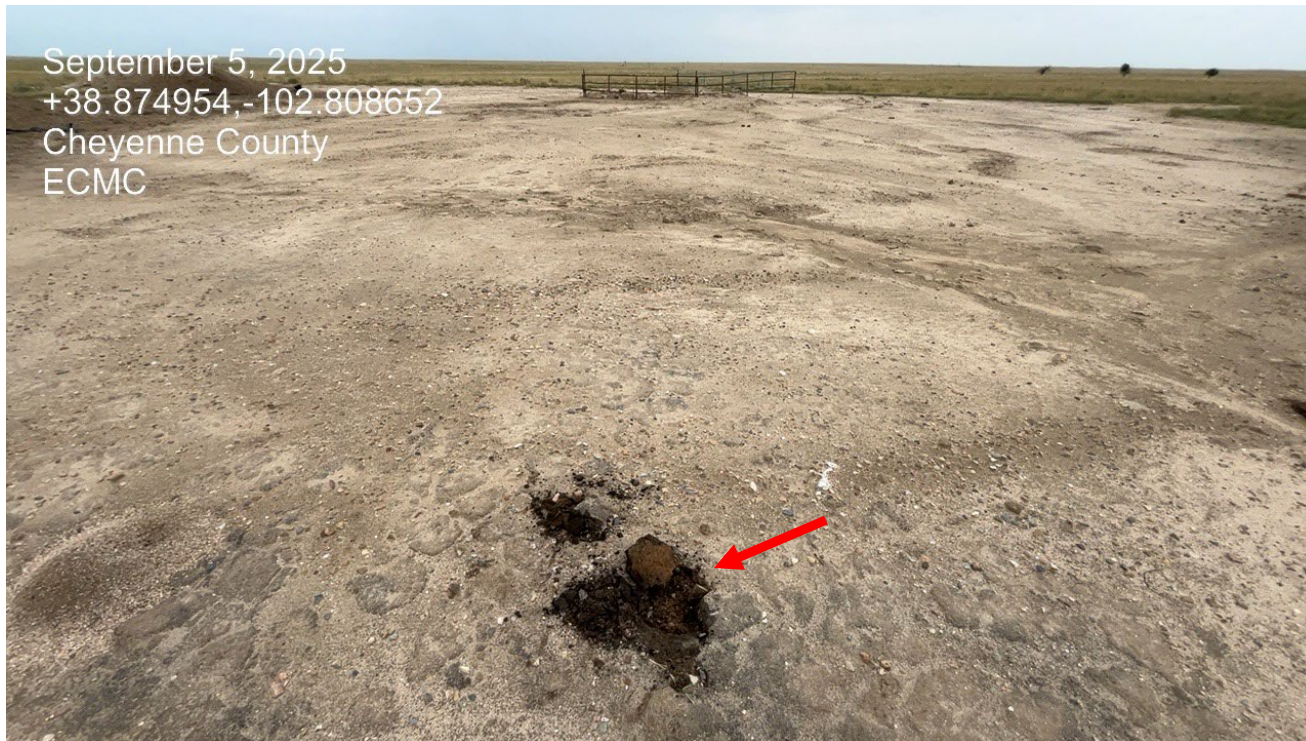
**Photo 4.** East side of the location facing southwest. There are blacked stained soils at the east side of the location.

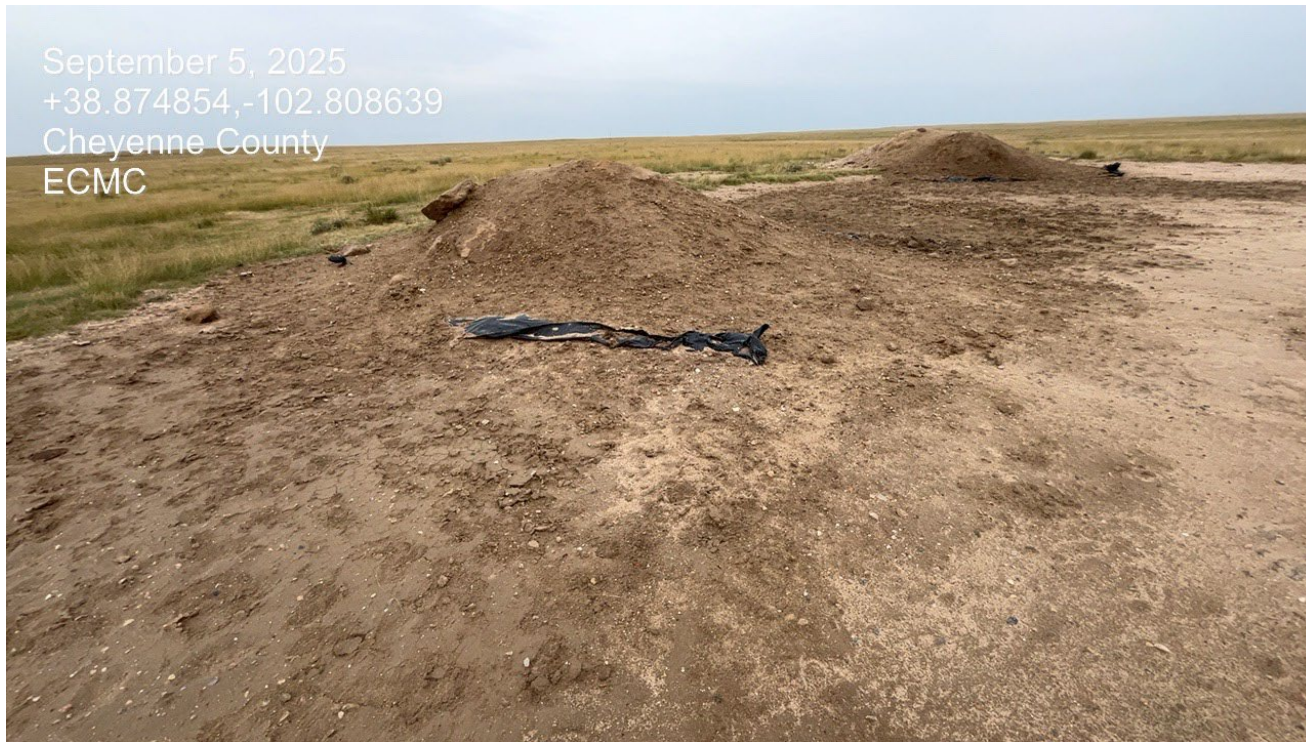
**Photo 5.** Facing toward southeast side of the location. The excavated impacted material was placed on a piece of plastic with no containment and some of the material has fallen outside of the liner. The plastic was also torn and compromised.

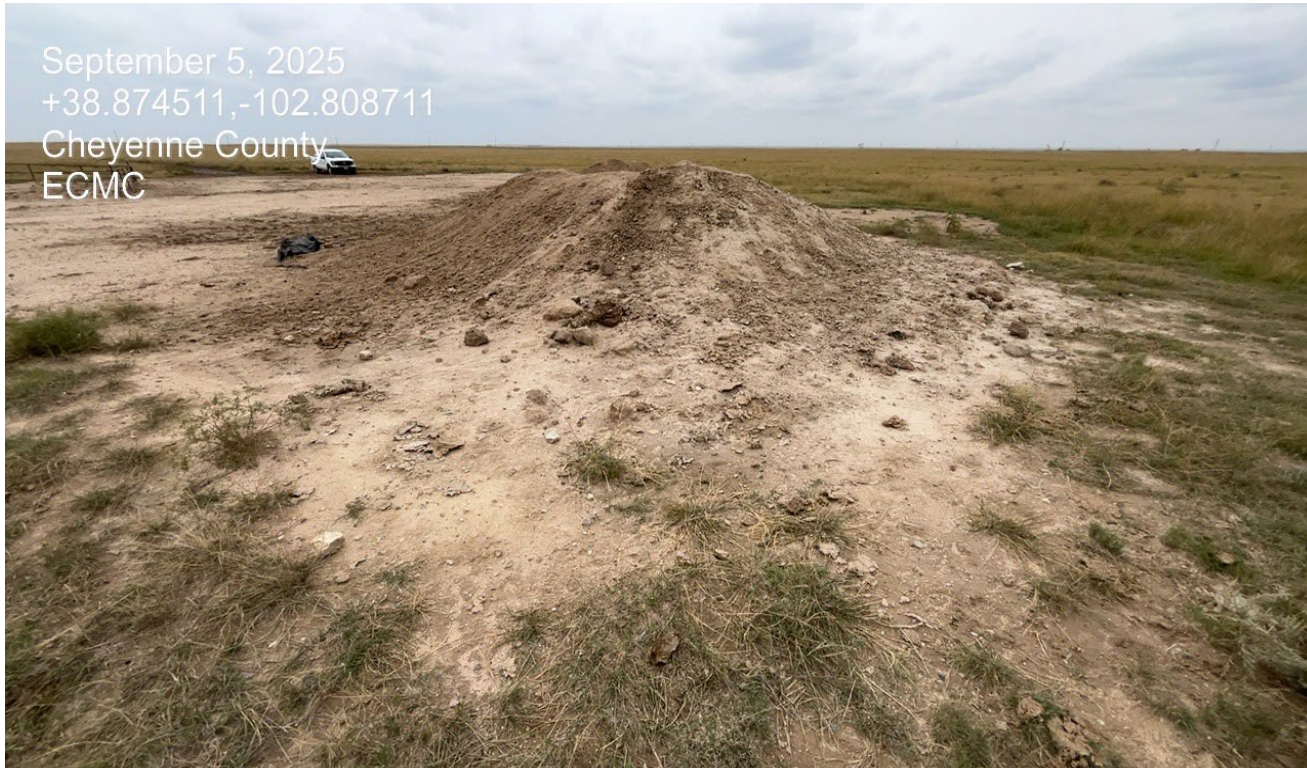
**Photo 6** . Facing northeast. The excavated impacted material was placed on a piece of plastic with no containment and some of the material has fallen outside of the liner. The plastic was also torn and compromised.
