FLOWLINE ABANDONMENT REPORT
SPEICHER 31-15 FLOWLINE

ECMC REMEDIATION # 39249

**SOIL SAMPLE
 LOCATION MAP
 (FLOWLINE)**

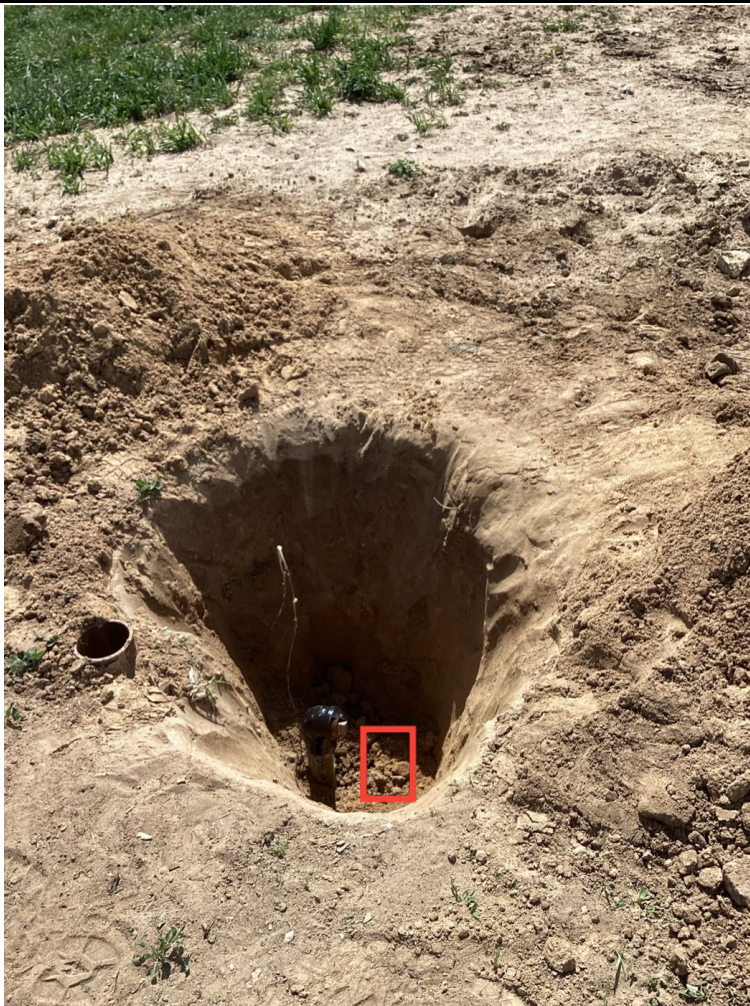
Equipment ID: FL01R-W@3'		Equipment Type: Flowline		Equipment ID: BKG01@3'		Equipment Type:	
Material: Steel	Volume:	Contents: Oil/Gas/Water		Material:	Volume:	Contents:	
Notes/Conditions: Facing south				Notes/Conditions: Facing east
