Inspection Photos

Operator: TEP Rocky Mountain LLC #96850

Location ID: 324061

Inspection Doc: 719200282

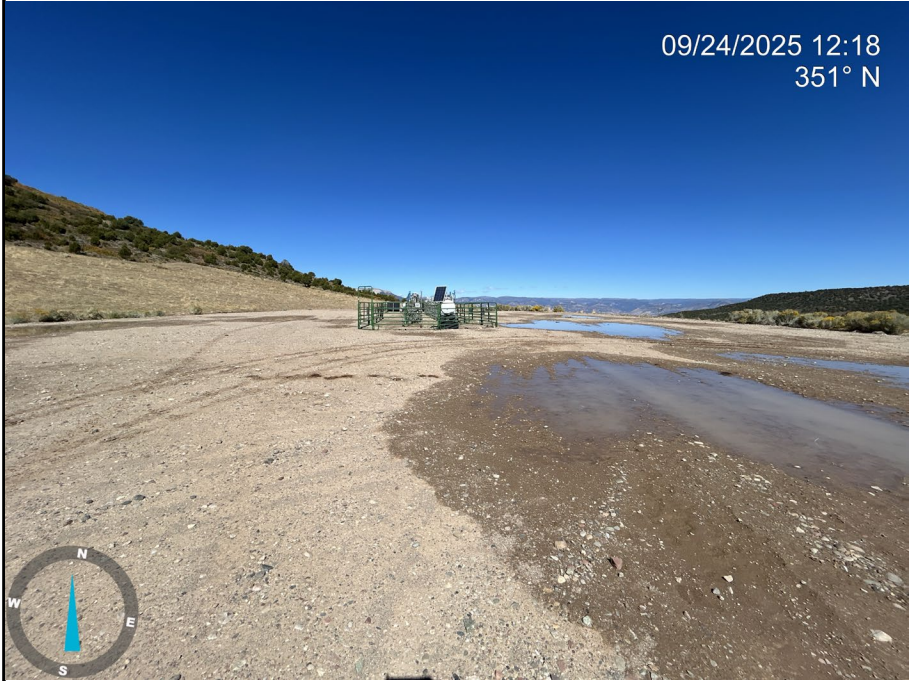
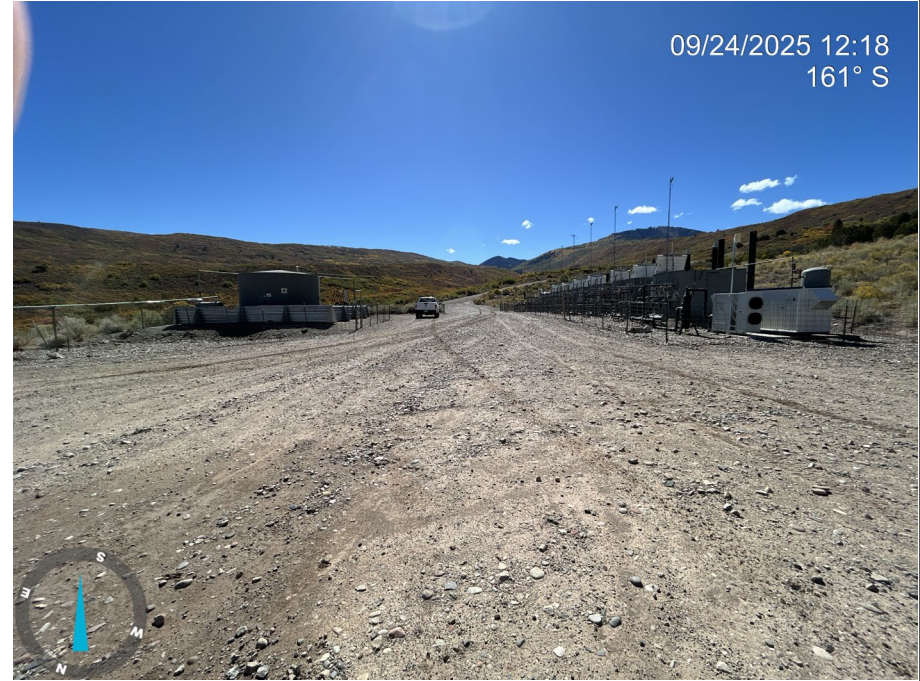
Photo 1: Photos showing an overview of the location looking north and south, respectively.

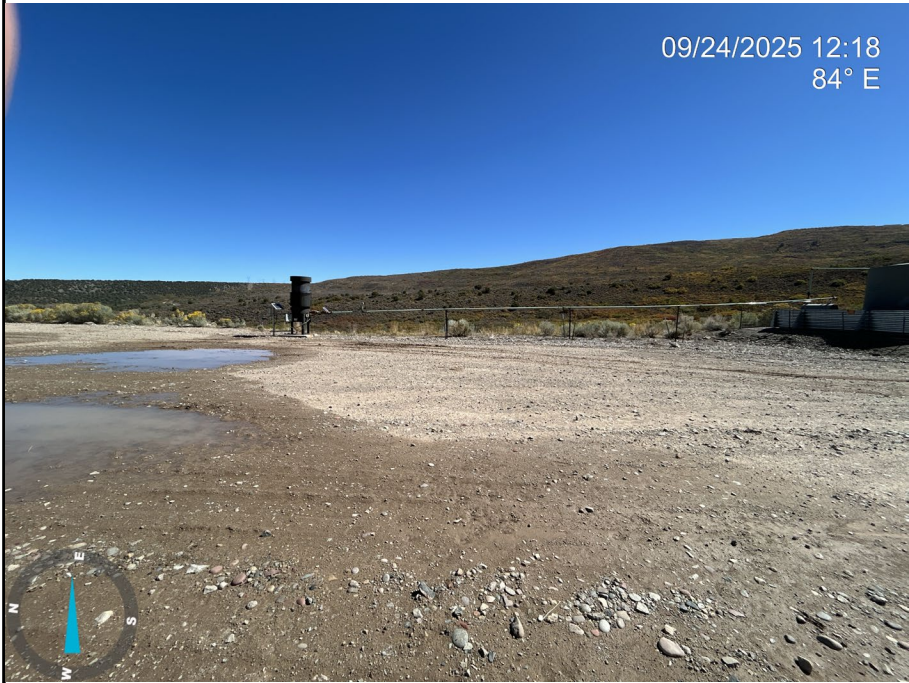
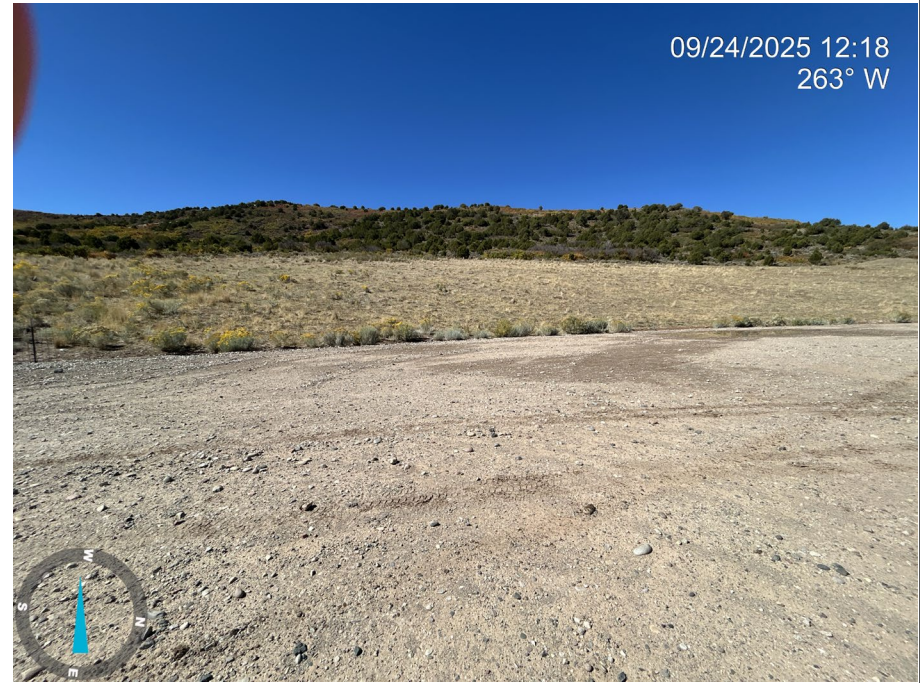
Photo 2: Photos showing an overview of the location looking east and west, respectively.

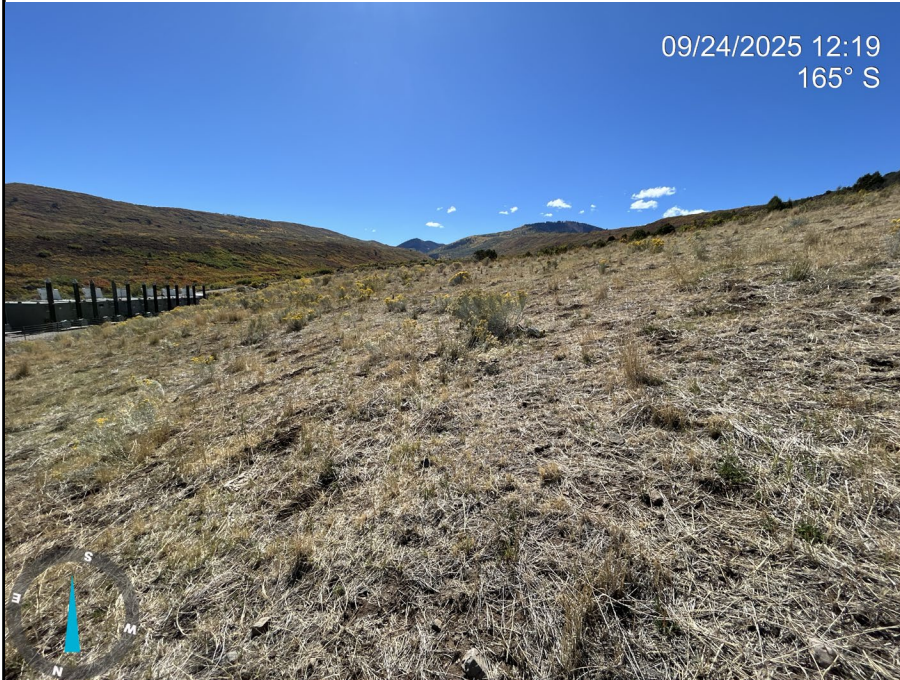
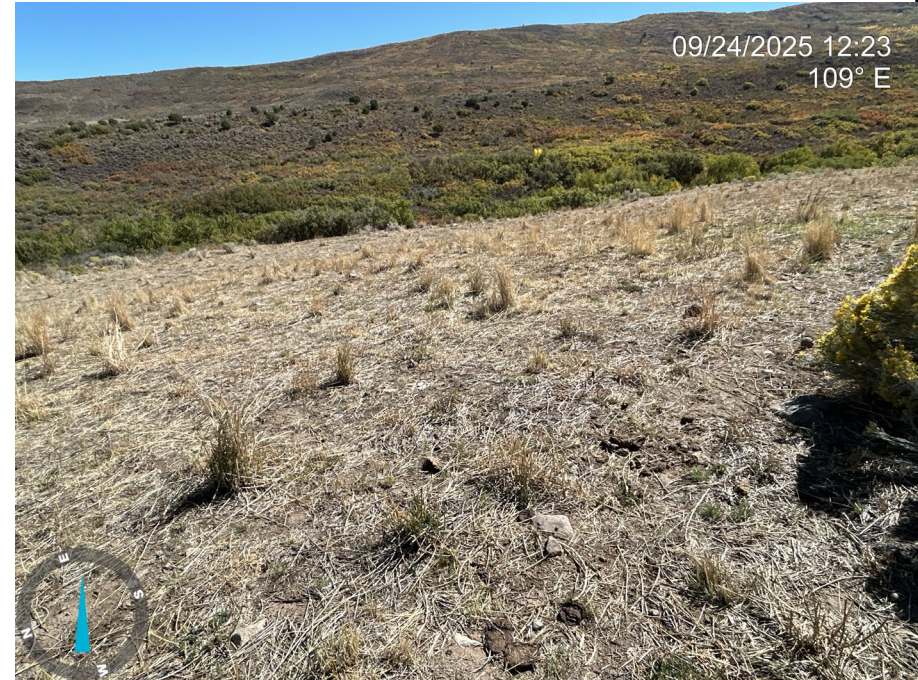
Photo 3: Photos showing the western and eastern interim areas, respectively. Interim areas are composed of intermediate wheatgrass, alfalfa and secondary amounts of rubber rabbitbrush. Some areas are used by cattle. The interim areas are progressing towards 1003 reclamation requirements.

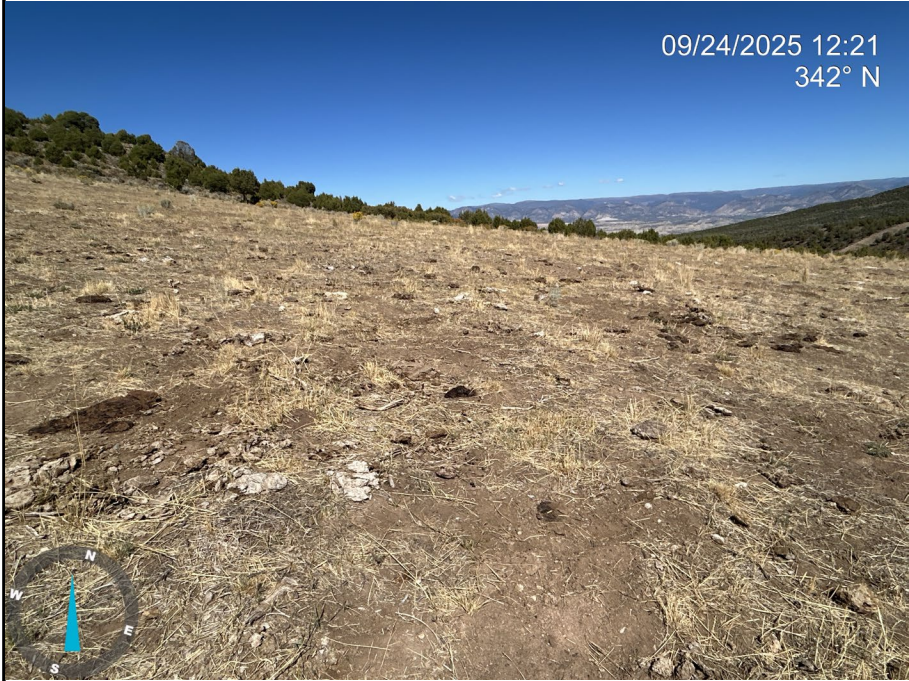
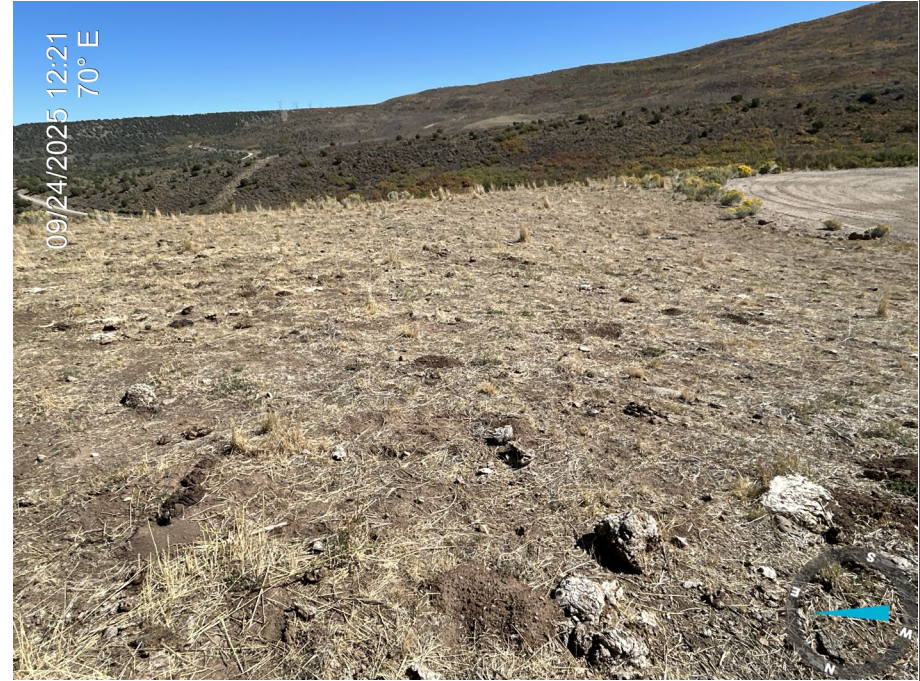
Photo 4: Photos showing the northwestern and northern interim areas, respectively. Interim areas are composed of intermediate wheatgrass, alfalfa and secondary amounts of rubber rabbitbrush. Some areas are used by cattle. The interim areas are progressing towards 1003 reclamation requirements.

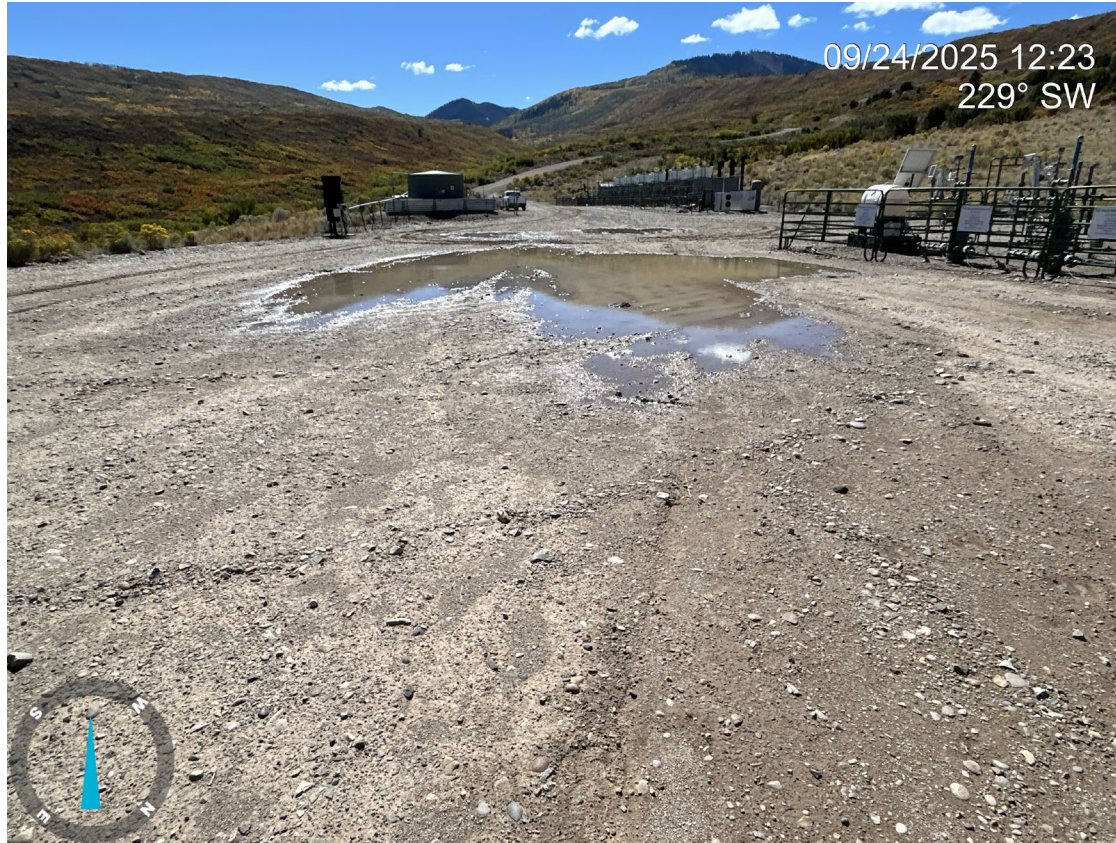
Photo 5: Photo showing ponded water on the working pad surface. Gravel is sparse in some areas. Comply with 1002.f. and implement or maintain stormwater BMPs.
