# Final Reclamation Inspection

Operator: PDC ENERGY INC - 69175

Location ID: 332201

Inspection Photos  
Location Name: STATE CORSAIR #13-36  
Location ID: 332201

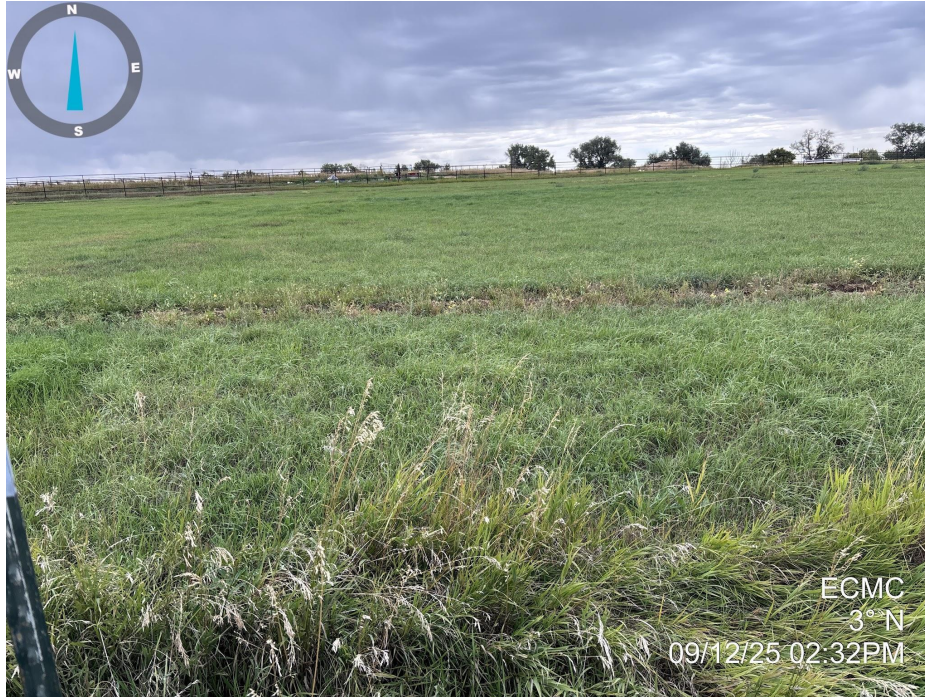
**Photo 1.** Photo taken of the the well location, facing north. Photo illustrates that the location meets Rule 1004 standards.

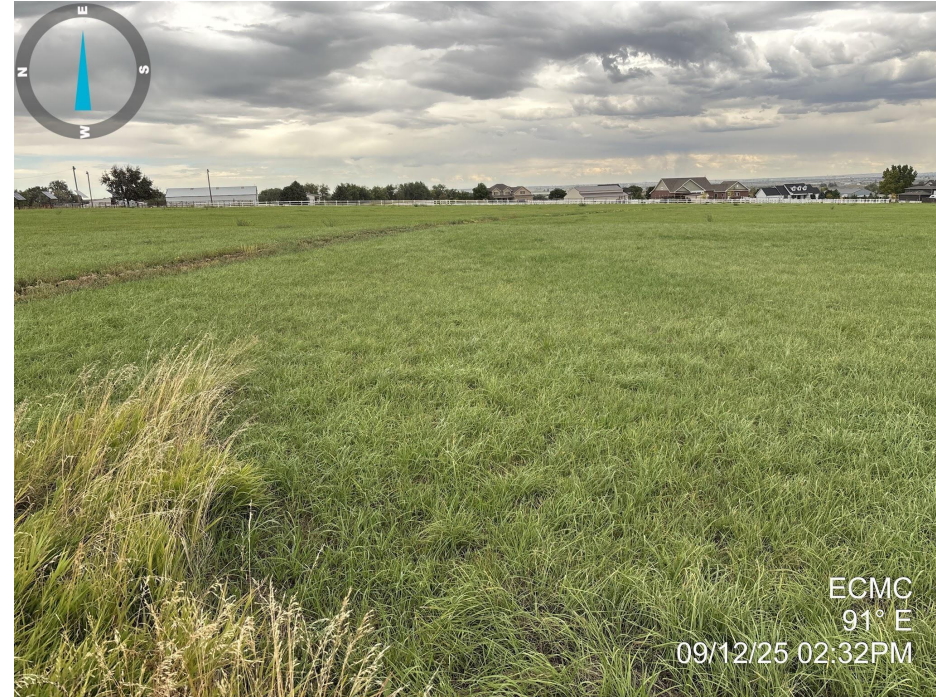
**Photo 2.** Photo taken of the well location, facing east. See comments under Photo 1.

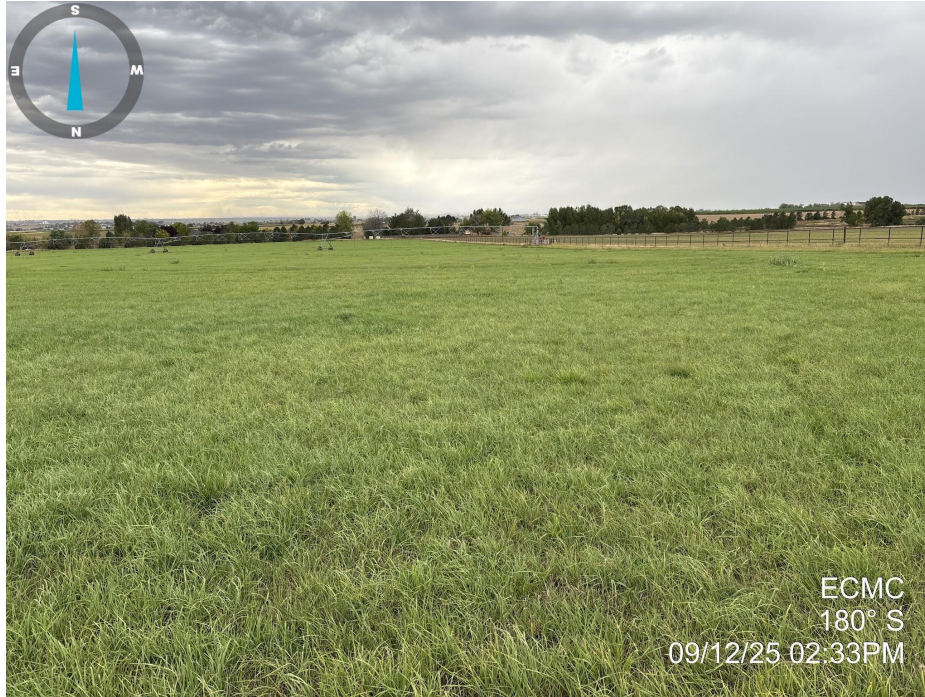
**Photo 3.** Photo taken of the well location, facing south. See comments under Photo 1.

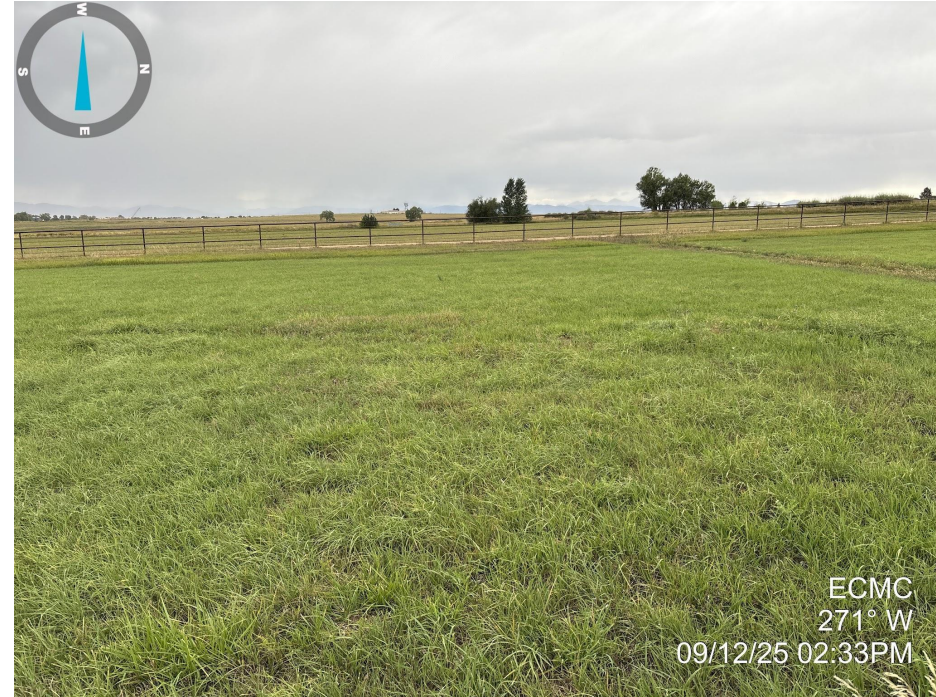
**Photo 4.** Photo taken of the well location, facing west. See comments under Photo 1.

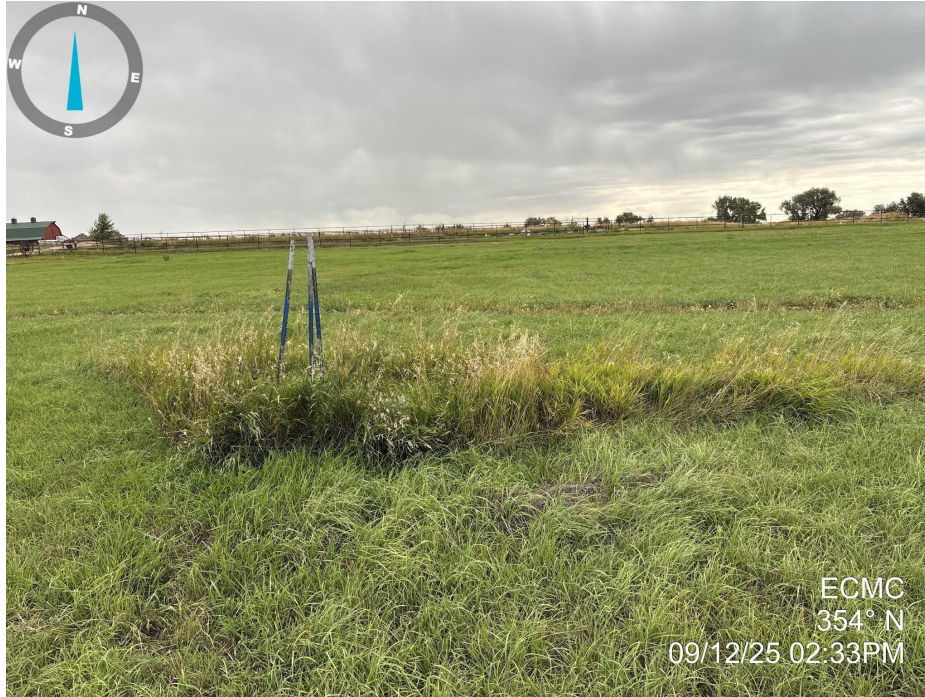
**Photo 5.** Photo taken of the well location, facing north. See comments under Photo 1.

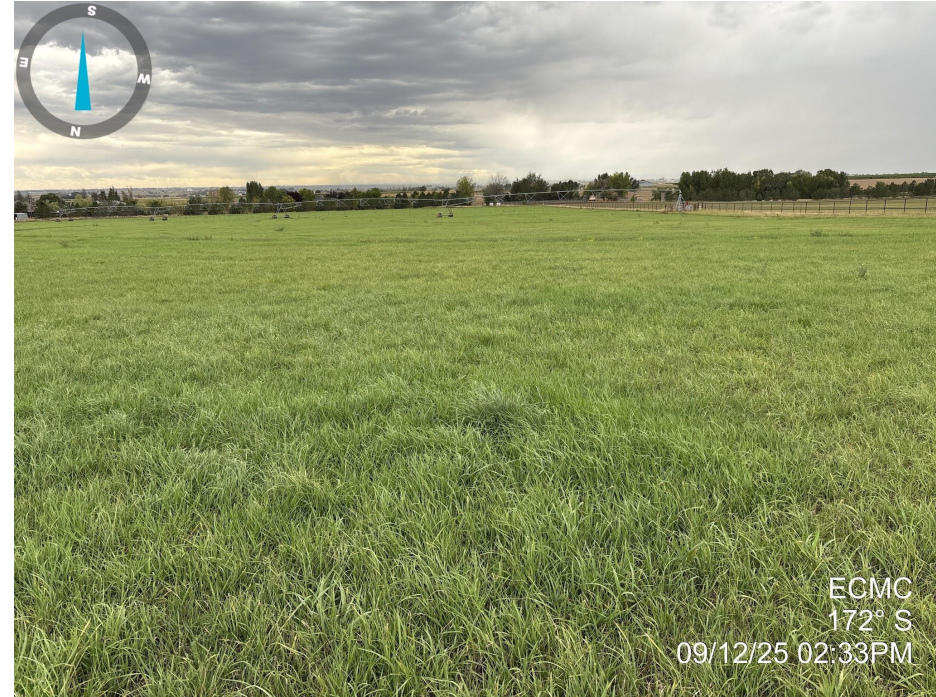
**Photo 6.** Photo taken of the reference area to the well location, south of the location, facing south. Photo illustrates perennial grass vegetation.

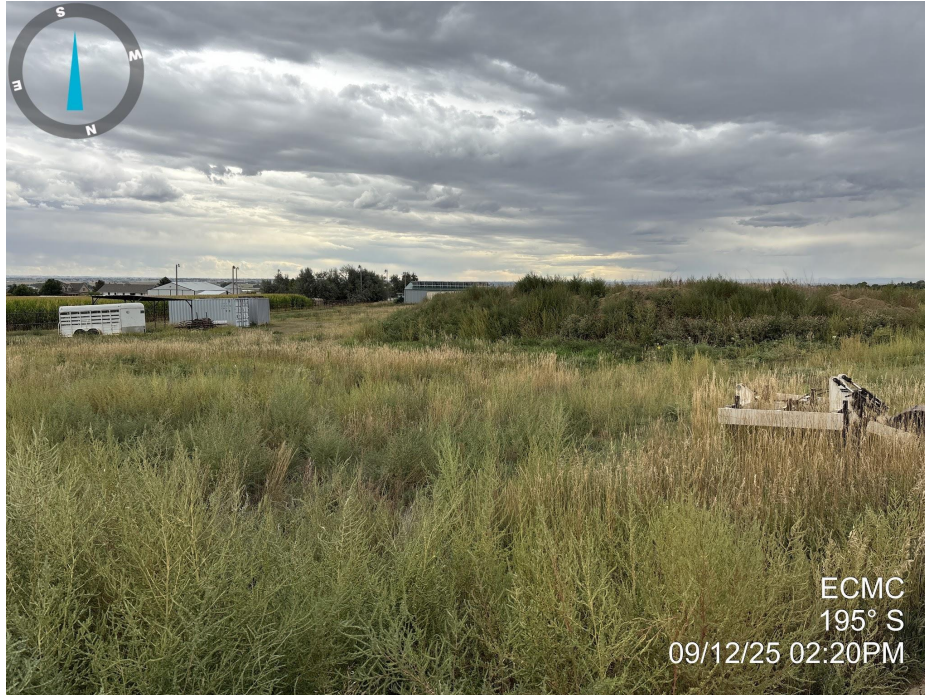
**Photo 7.** Photo taken of the tank battery location, facing south. Photo illustrates that final reclamation activities have taken place, but vegetation establishment does not meet Rule 1004 standards as weedy annual vegetation was observed across the location.

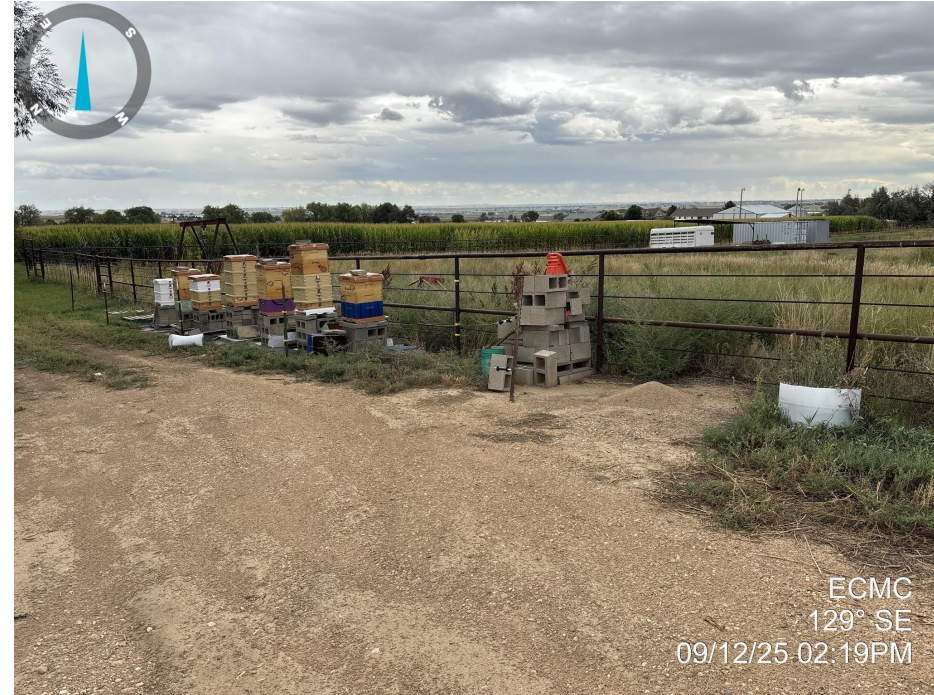
**Photo 8.** Photo taken of the tank battery location, at the entrance to the location, facing southeast. Photo illustrates that the access road to the location remains in use by the landowner.

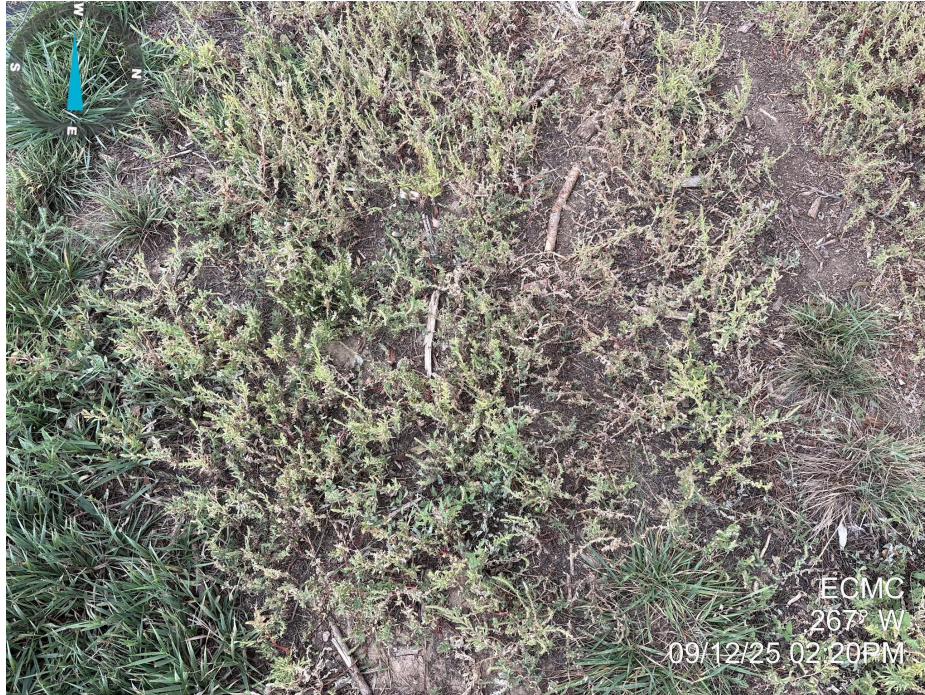
**Photo 9.** Photo taken of ground cover at the tank battery location. Photo illustrates weedy annual vegetation including Kochia (*Bassia scoparia*).

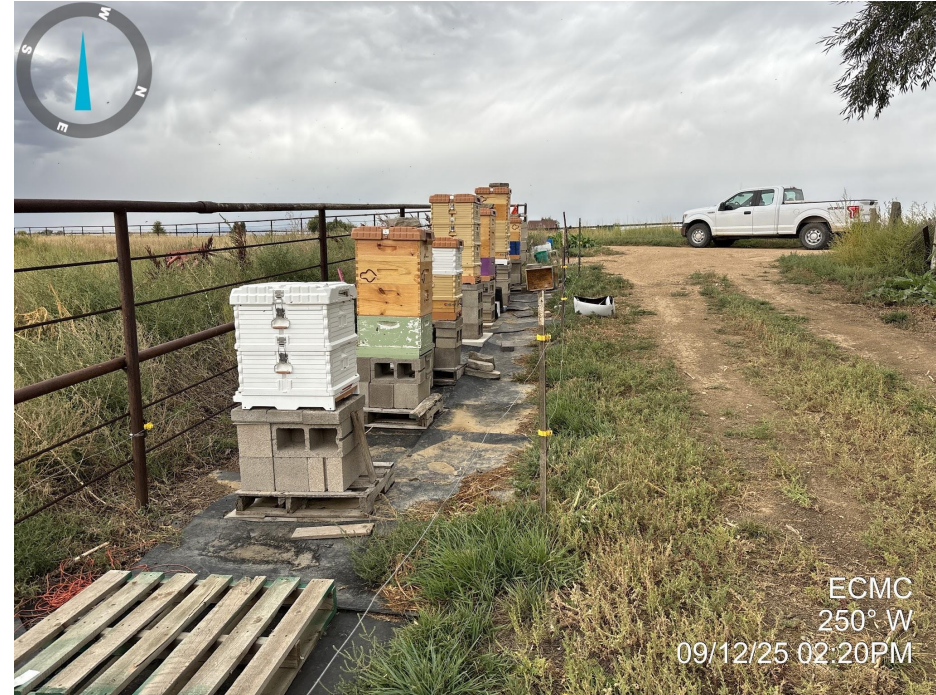
**Photo 10.** Photo taken of the entrance to the tank battery location, facing west. See comments under Photo 8.
