WELL NAME: LAVIZ 12-7, API #: 071-07540, INSP. # 716301597

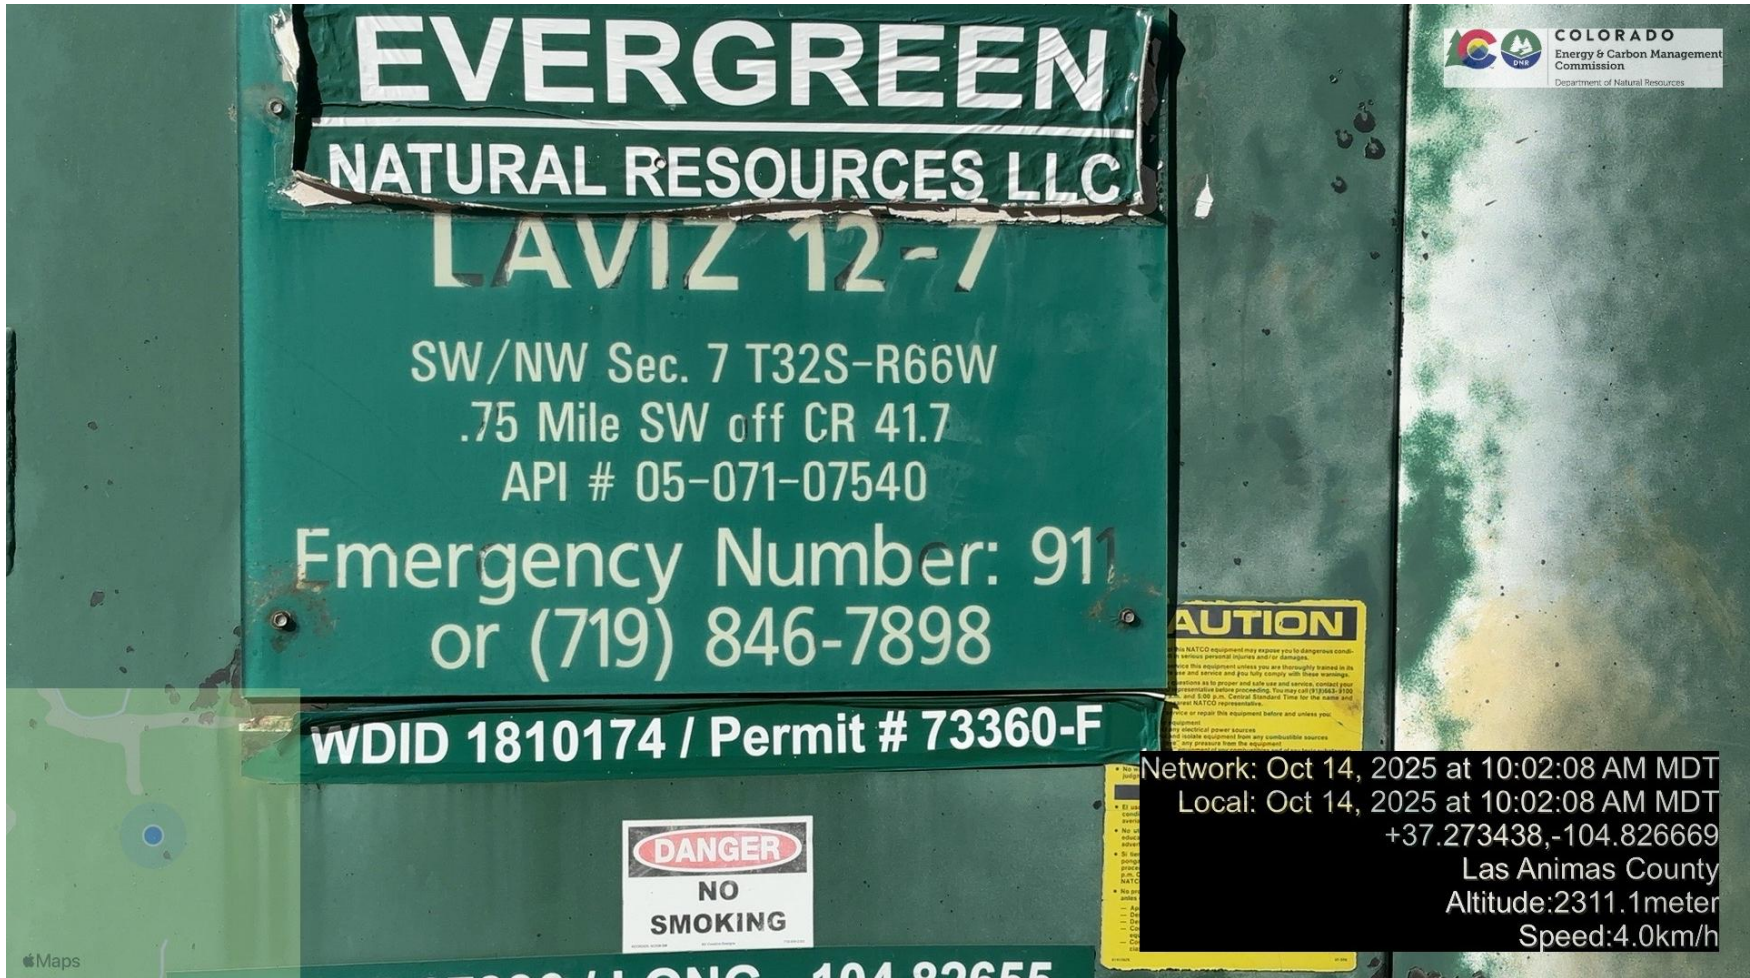
PHOTO 1: WELL SIGN

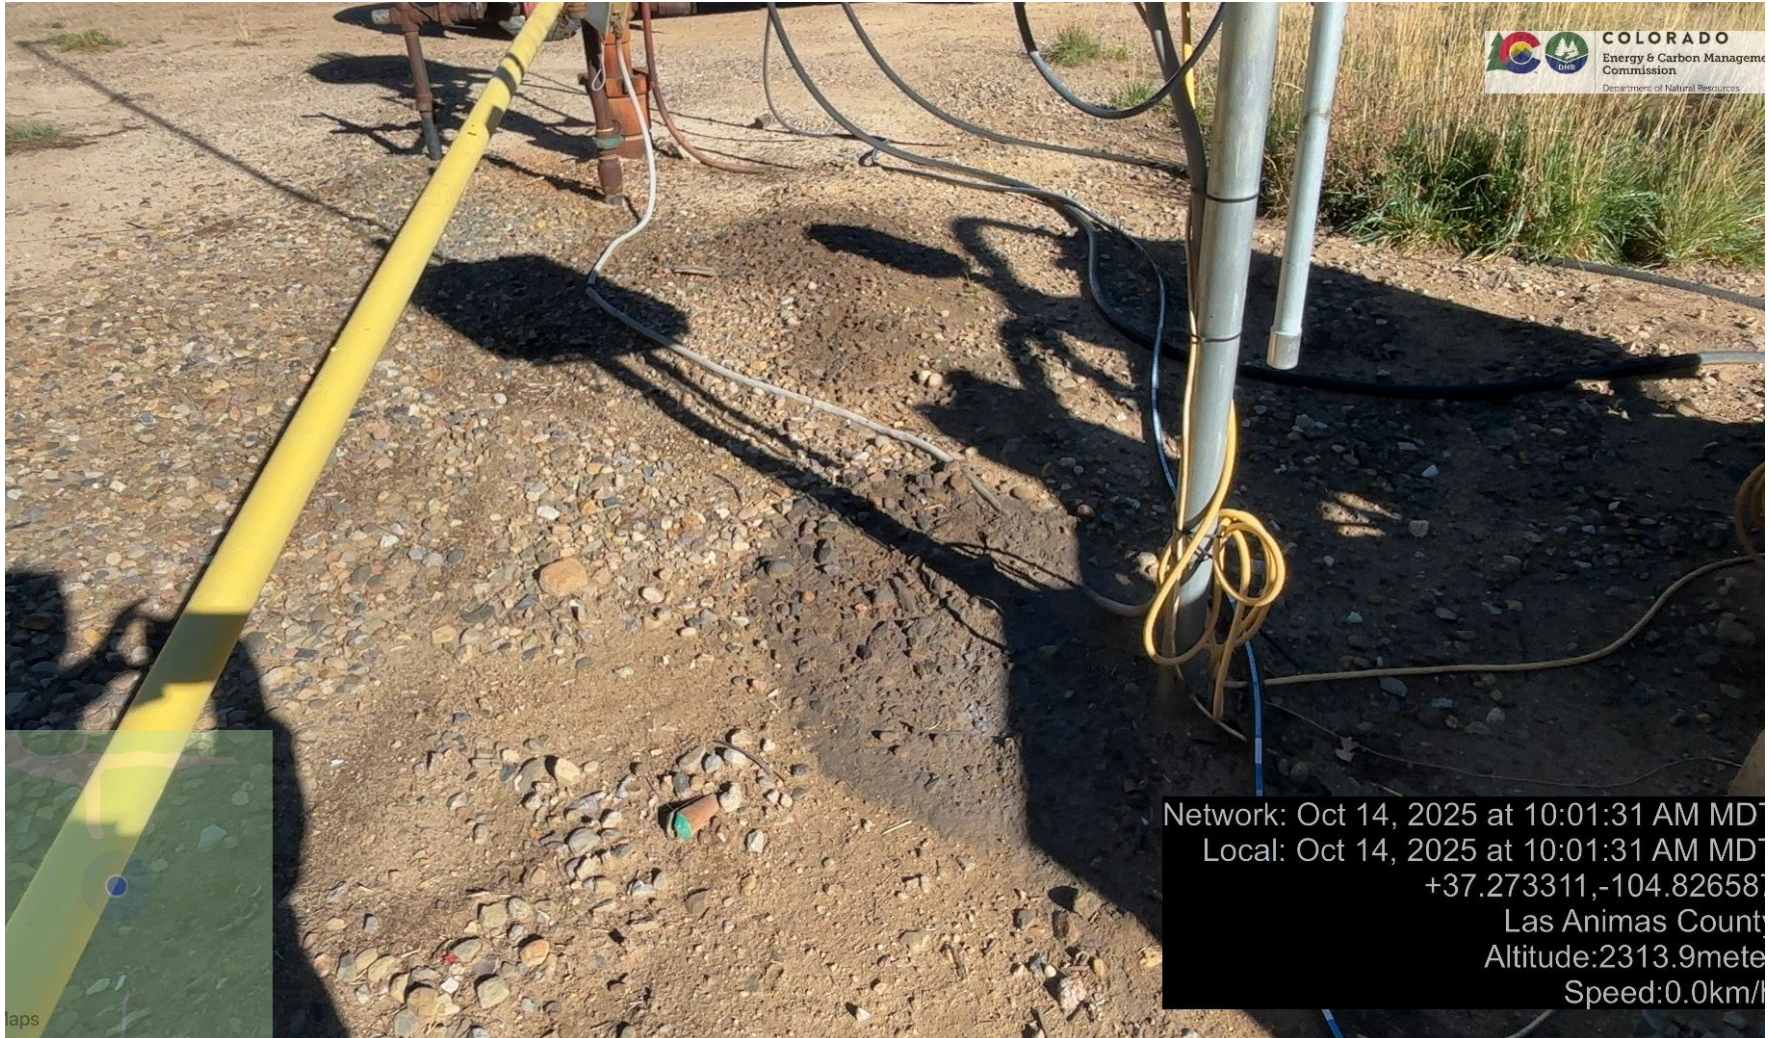
PHOTO 3: AREA OF IMPACTED SOIL BETWEEN WELLHEAD AND PRIME MOVER APPEARS TO BE LEAKING HYDRAULIC HOSE. Conduct maintenance on equipment, cleanup stained material and review self inspection processes. COMPLY WITH RULE 1002,(2).D. CA DATE 11-14-2025.

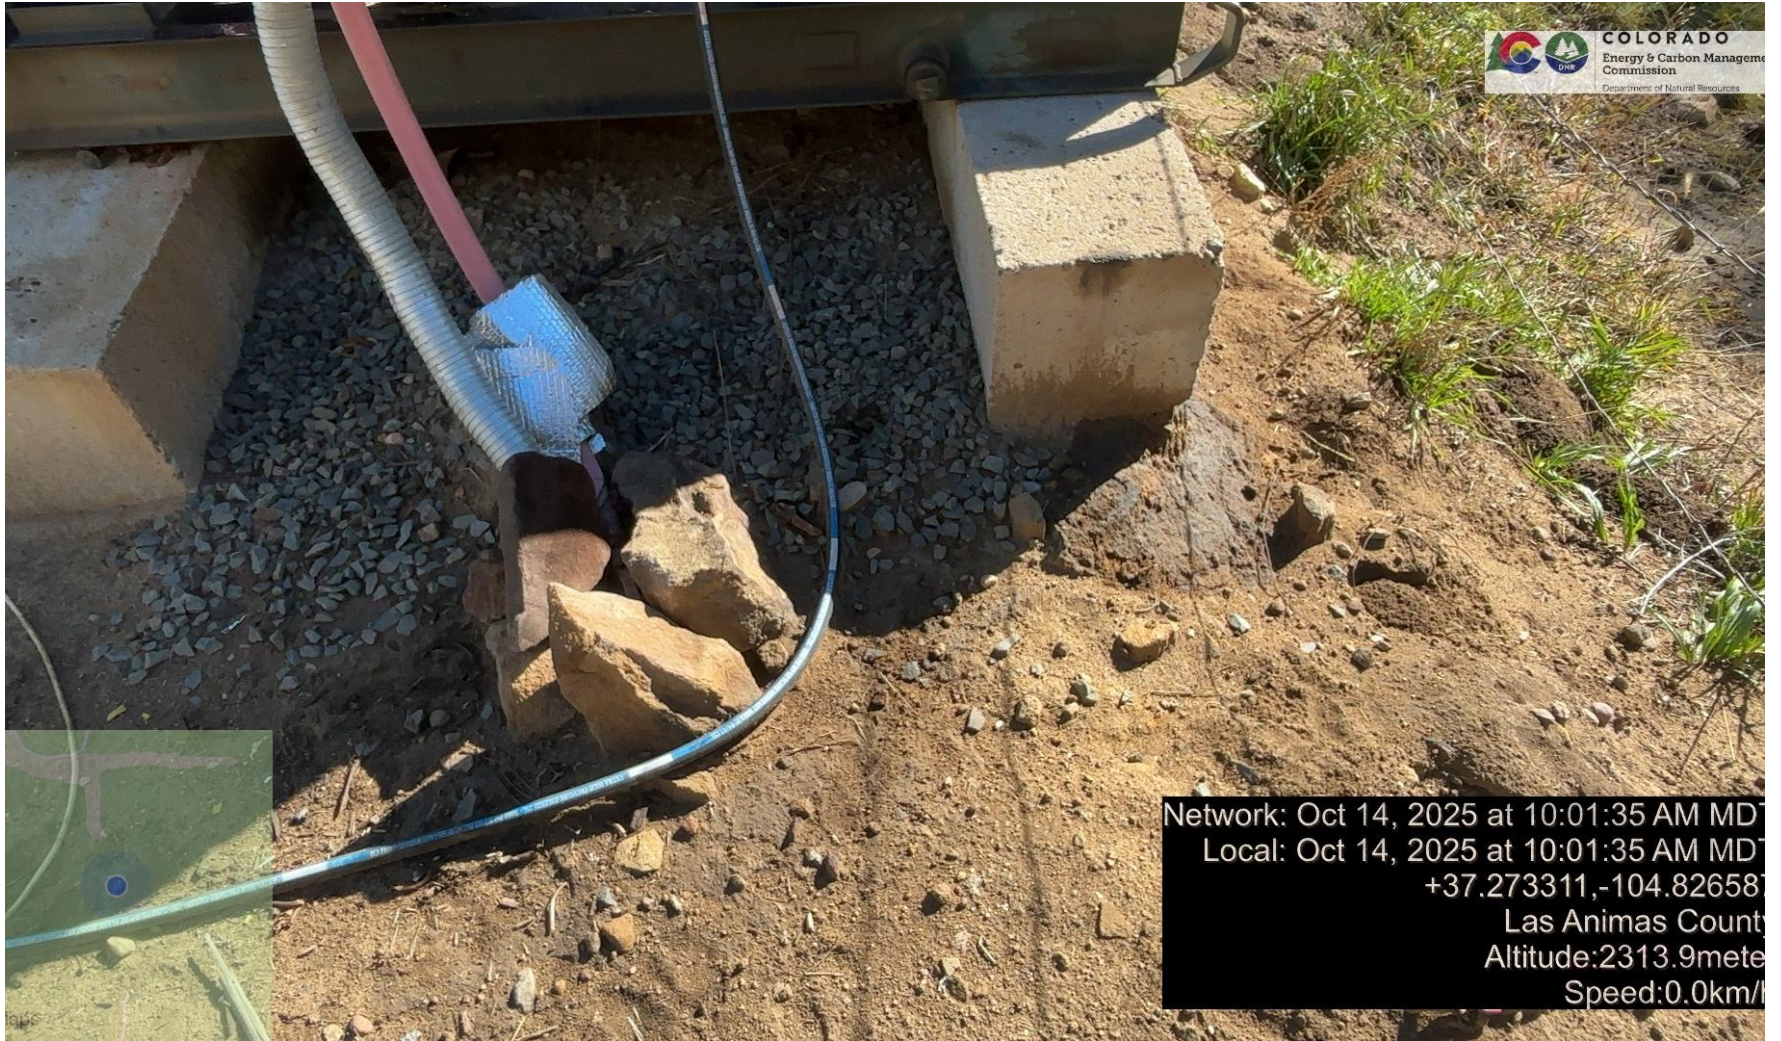
PHOTO 4: AREA OF IMPACTED SOIL NEAR PRIME MOVER. Conduct maintenance on equipment, cleanup stained material and review self inspection processes. COMPLY WITH RULE 1002,(2).D. CA DATE 11-14-2025.
