# Dutch Lake 24-22H (430123): Wellhead Cut/Cap and Equipment Removal

Highpoint Operating (10071)

# Dutch Lake 24-22H (430123): ¼ Mile Buffer - Wildlife and Hydrology Map

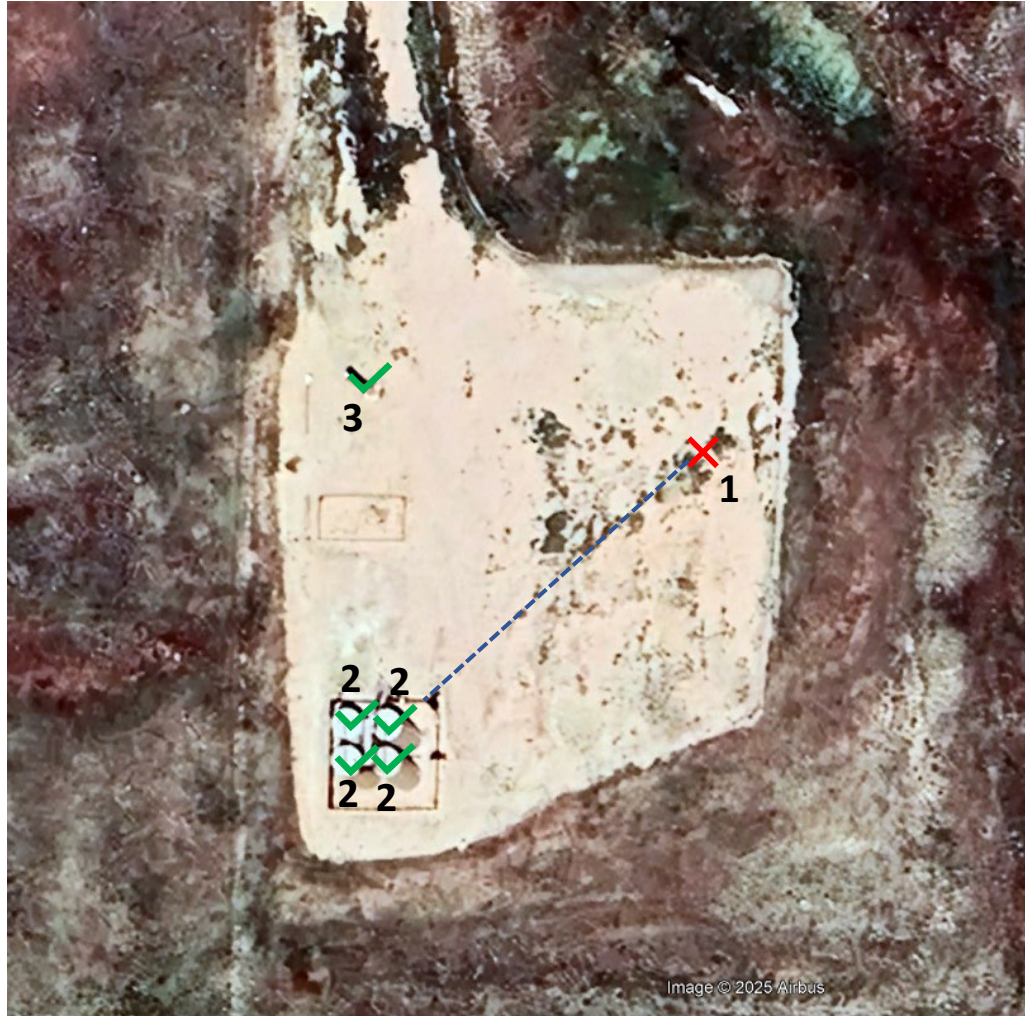
Equipment to be Removed		
Legend	Equipment On-Site	# Pieces of Equipment
1	DUTCH LAKE 24-22H (05-123-36055) 40.479156, -104.314461	1
2	Oil Tank	4
3	ECD	1

Legend	
Site Investigation Points	
✓	Visual Inspection Point
✗	Visual Inspection and Soil Sample
---	On-Location Flowline Corridor

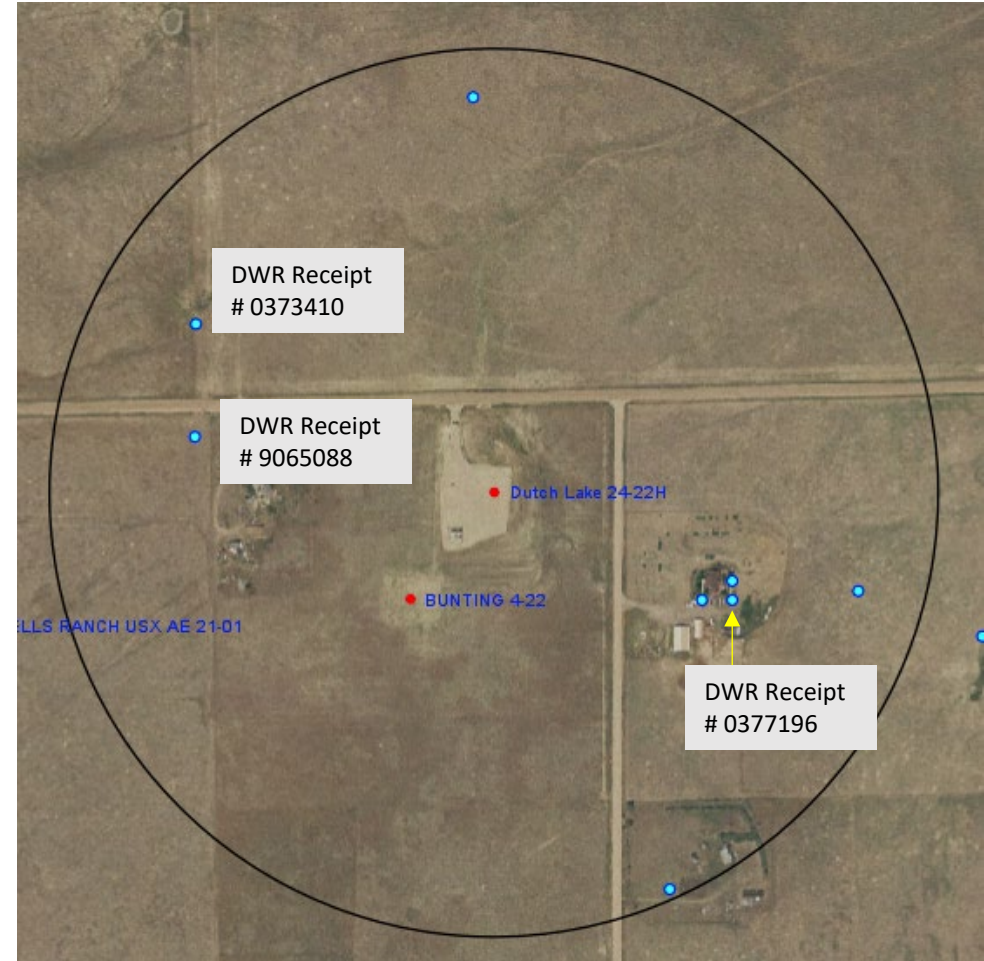
Receptor	DWR Receipt (Permit)	Distance (ft)	Direction	Well Depth(ft)	Static Water Level (ft)
Domestic Well	0377196 (177620--A)	785	SE	280	126
Domestic Well	9065088 (66633-)	815	NW	240	70
Livestock Well	0373410 (181708-)	870	NW	208	109

NO HPH WITHIN ¼ MILE
