WELL NAME: PARROTHEAD 31-31 TR, API #: 071-08610, INSP. # 716301631

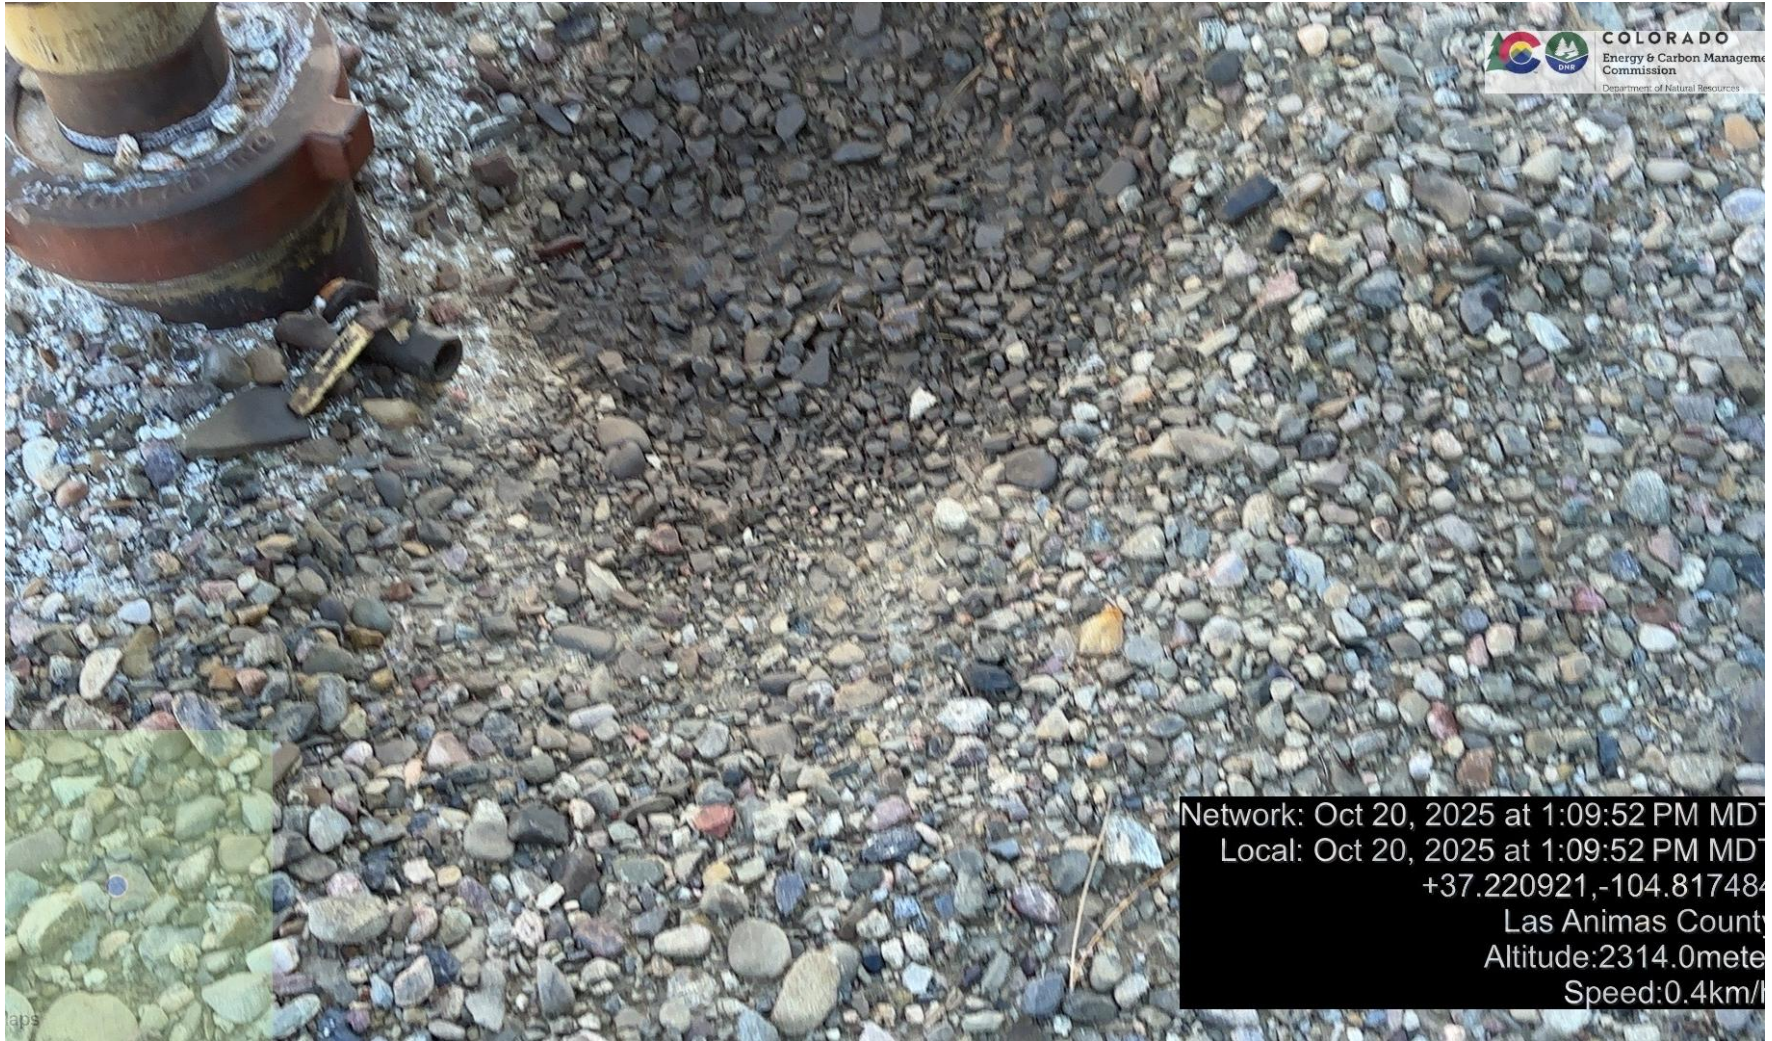
PHOTO 3: AREA OF IMPACTED SOIL FROM LEAKING DRIVEHEAD ON TR WELL. Conduct maintenance on equipment, cleanup stained material and review self inspection processes. COMPLY WITH RULE 1002,(2).D. CA DATE 11-20-2025.

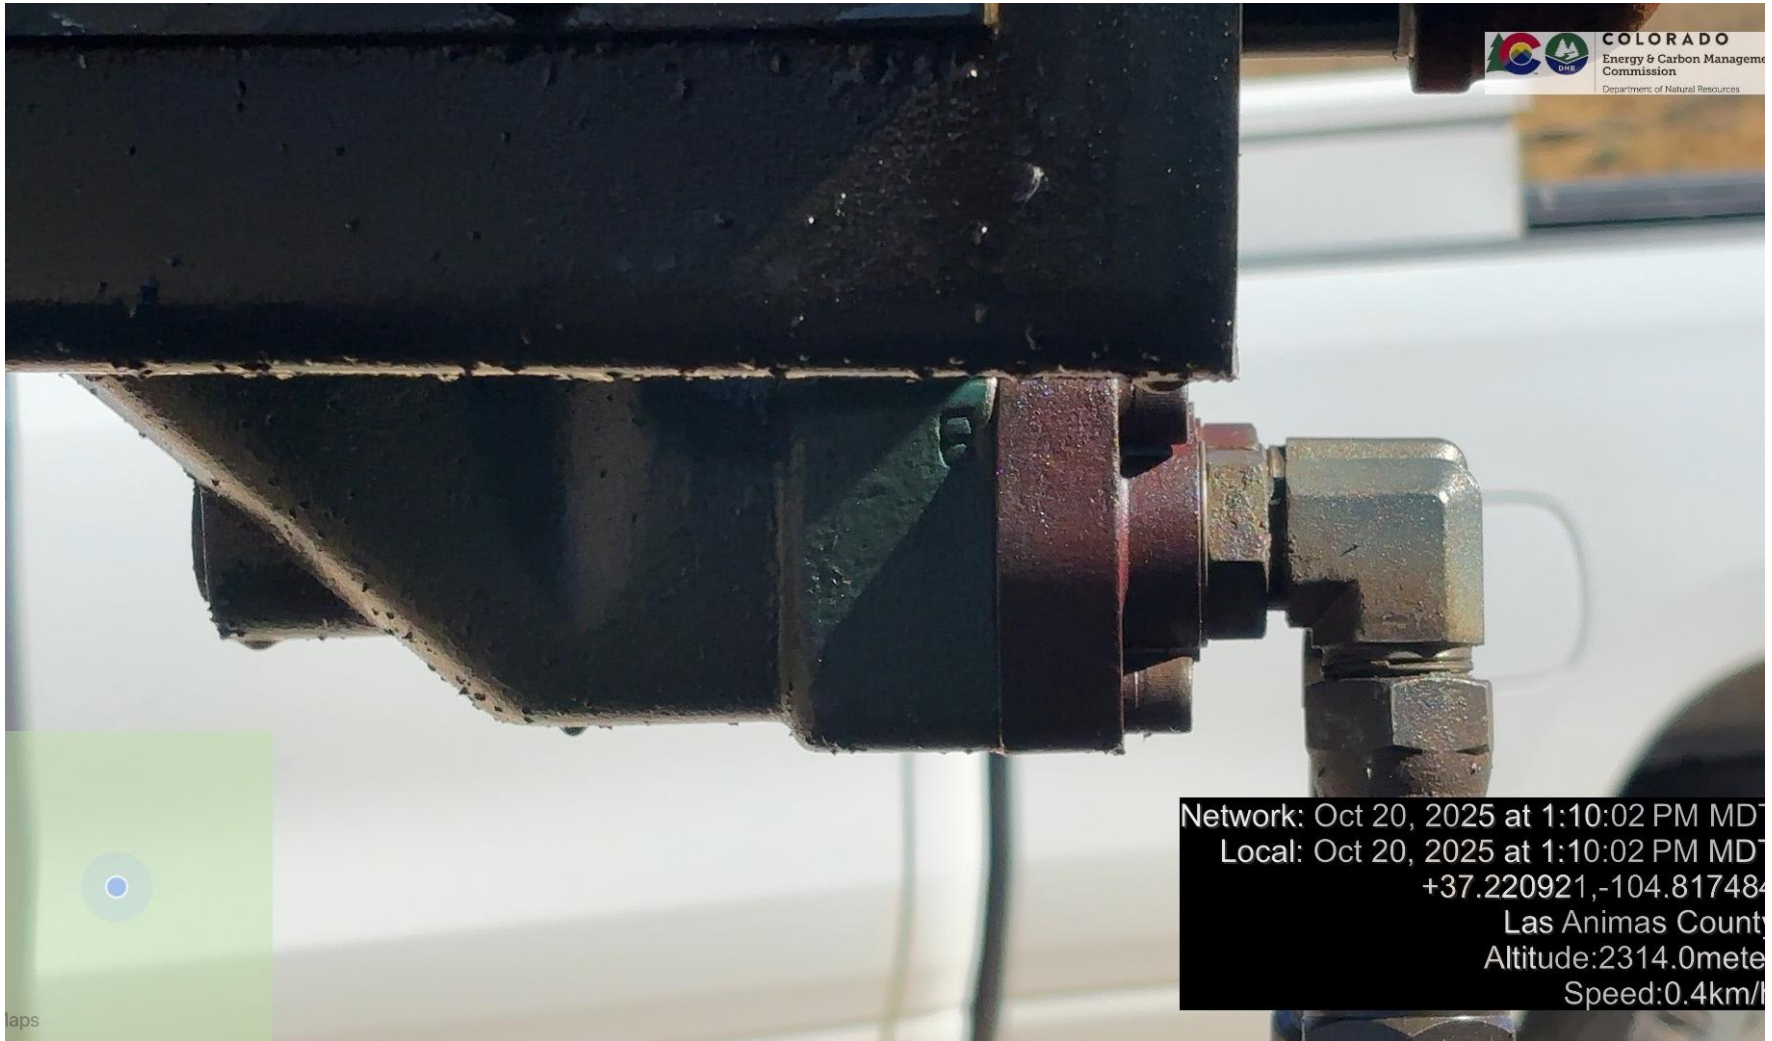
PHOTO 4: DRIVEHEAD IS LEAKING HYDRAULIC OIL. Securely fasten all valves, pipes, fittings, and Production Facilities to ensure good mechanical condition, inspect at regular intervals and maintain in good mechanical condition per Rule 608.e. CA DATE 10-21-2025.
