# Inspection Photos

Operator: TEP Rocky Mountain LLC #96850

Location ID: 335108

Inspection Doc: 719200344

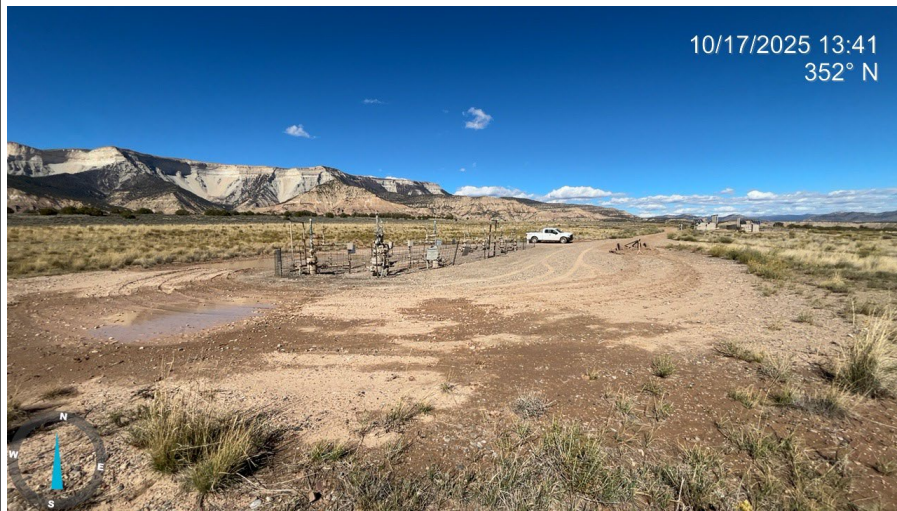
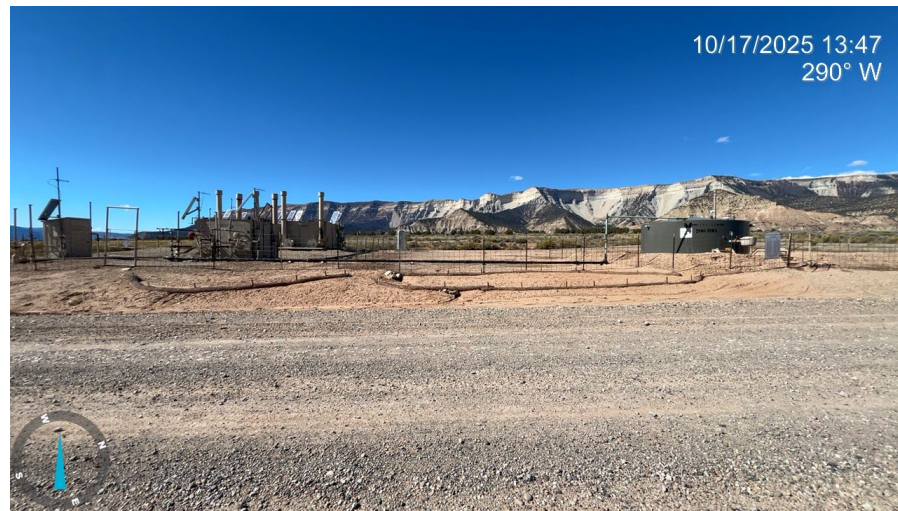
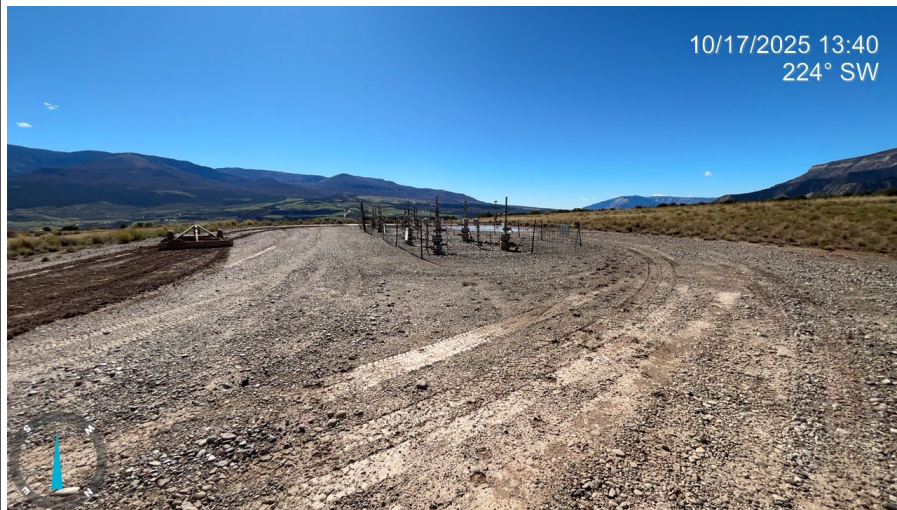
**Photo 1:** Photos showing an overview of the location looking north and southwest (left top and bottom, respectively) and the production equipment shared with locations #335215 and #324187 looking north (top right).

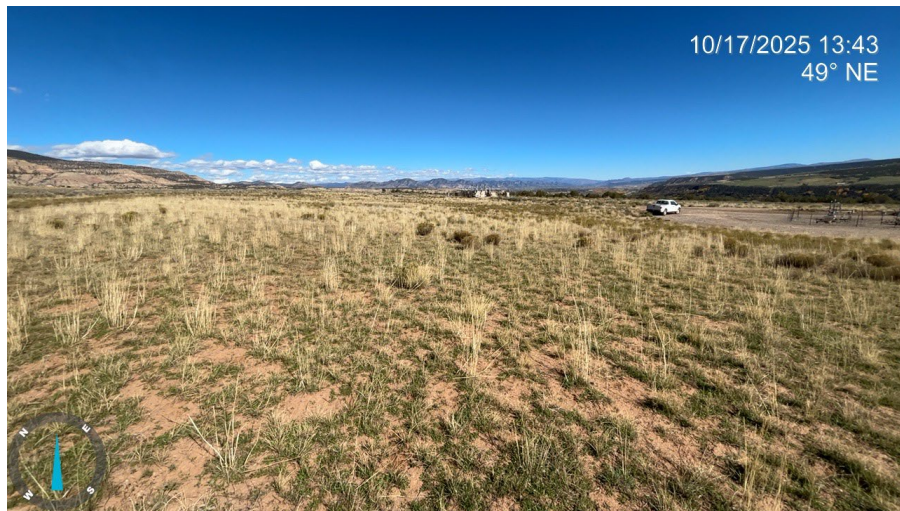
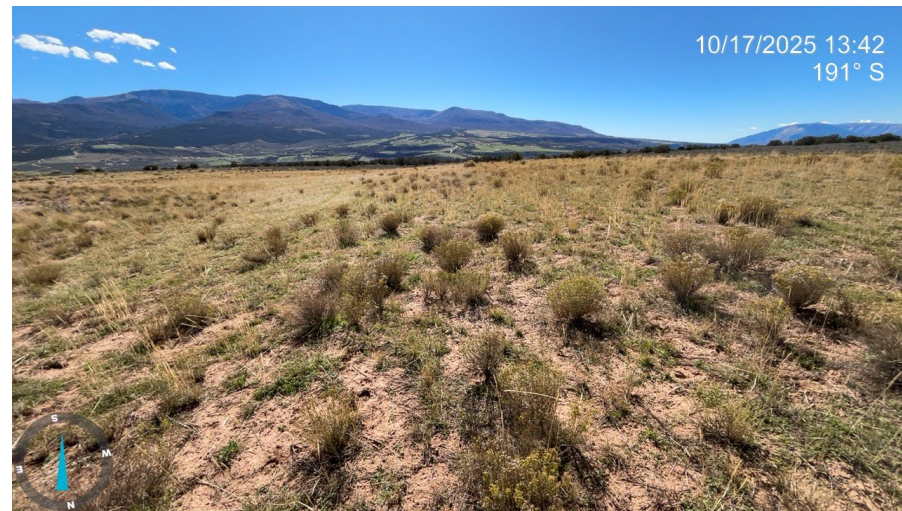
**Photo 2:** Photos showing an overview of the northwestern interim area. Interim areas are composed of Russian wildrye and intermediate wheatgrass, with secondary to trace amounts of broom snakeweed. Desirable, perennial and uniform plant establishment is evident. Interim areas are progressing towards 1003 reclamation requirements.

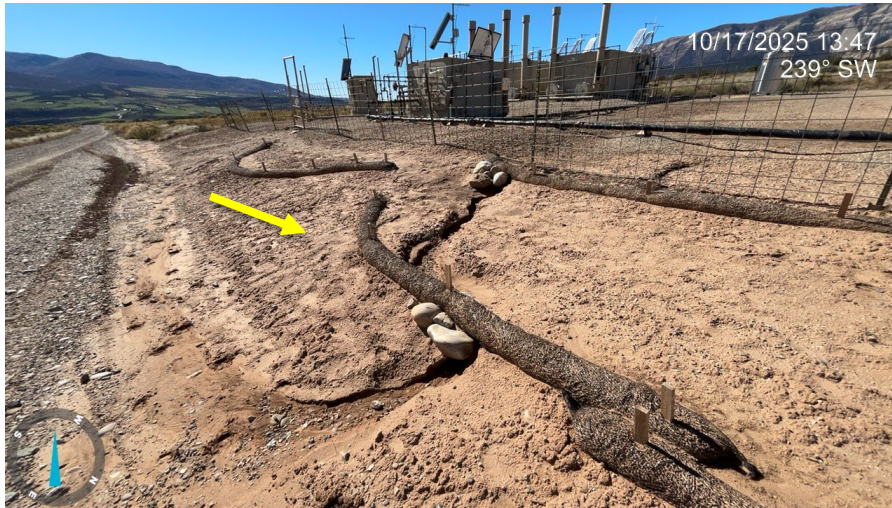
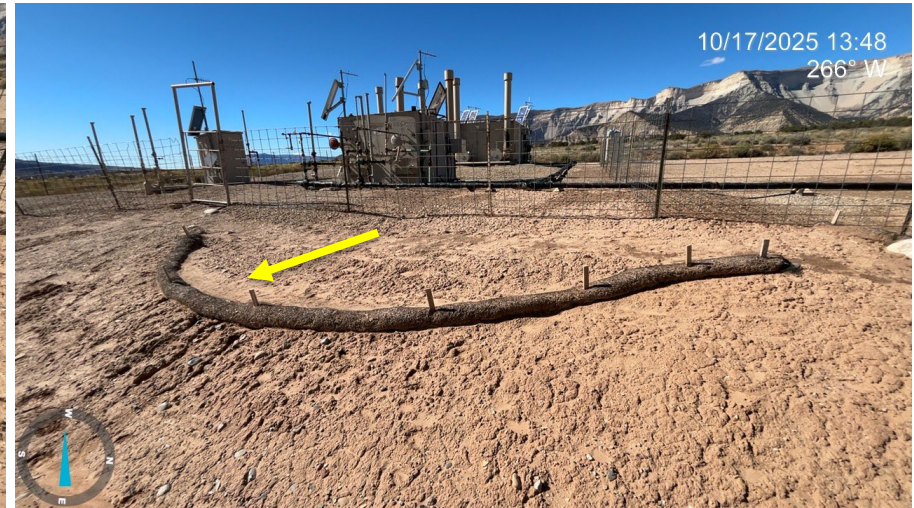
**Photo 3:** Photos showing production equipment shared between multiple locations. Erosion, rilling and degradation is evident, and some wattles are laden with sediment. Stormwater BMP's appear to be missing or insufficient. Comply with Rule 1002.f.

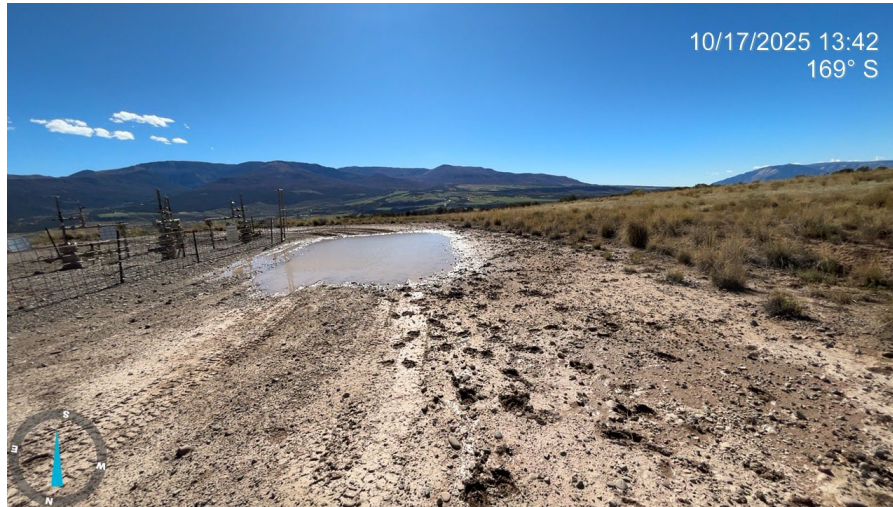
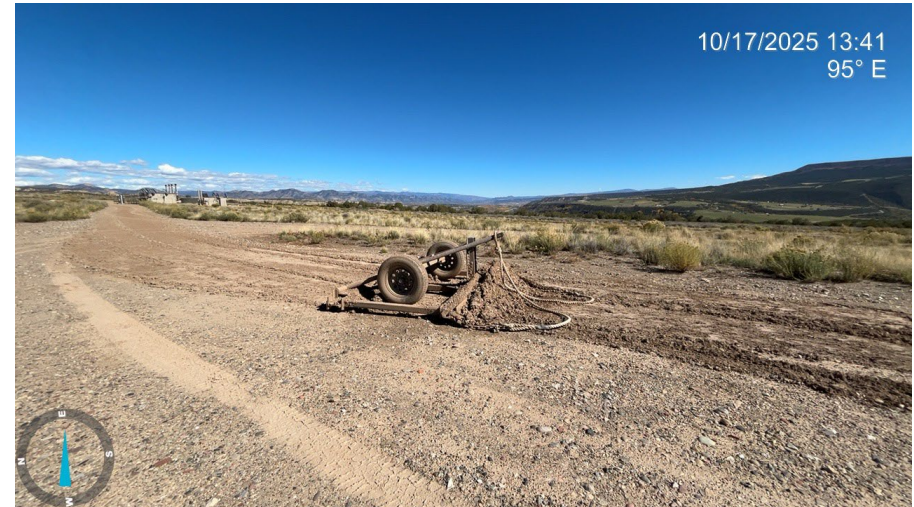
**Photo 4:** Photos ponding and vehicle tracking occurring on the wellhead working pad surface; gravel appears to be sparse in some places. Unused equipment appears to be present on the working pad. Comply with Rule 1002.f. and implement or maintain stormwater BMPs. Comply with 606.a. and remove unused equipment.
