Inspection/Audit Photos

Location Name: TEP ROCKY MOUNTAIN LLC FEDERAL PA 412-28

Location ID: 335129

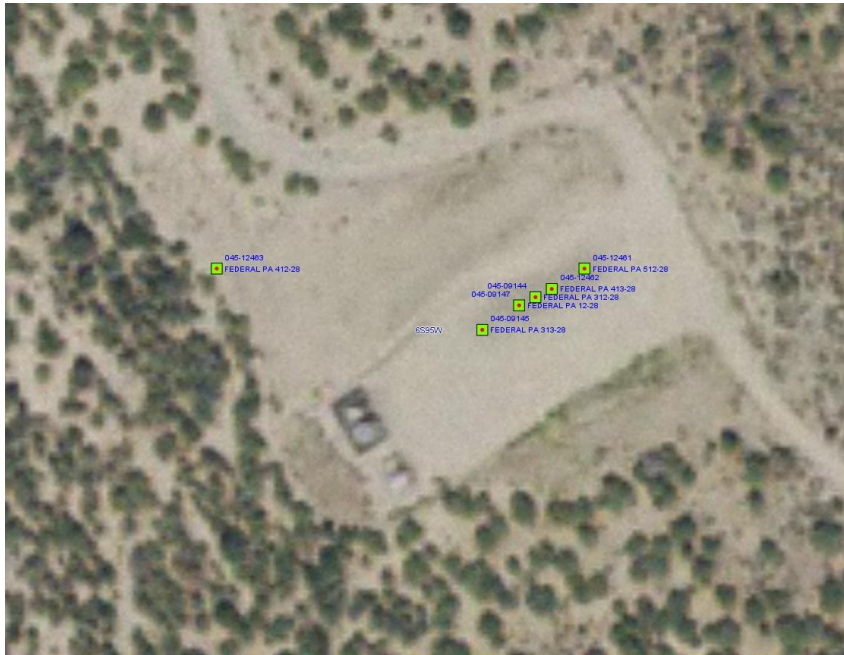
Photo # 1 FORM 5 Drilling Completion Report & Scout Card records "as drilled" coordinates show FEDERAL PA 412-28 well located N/NW of the location in the interim area - Coordinates appear to be off by approximately 230 ft ("as drilled" coordinates incorrect/not in compliance with CECMC Rules 216 & 414 – records require updating)

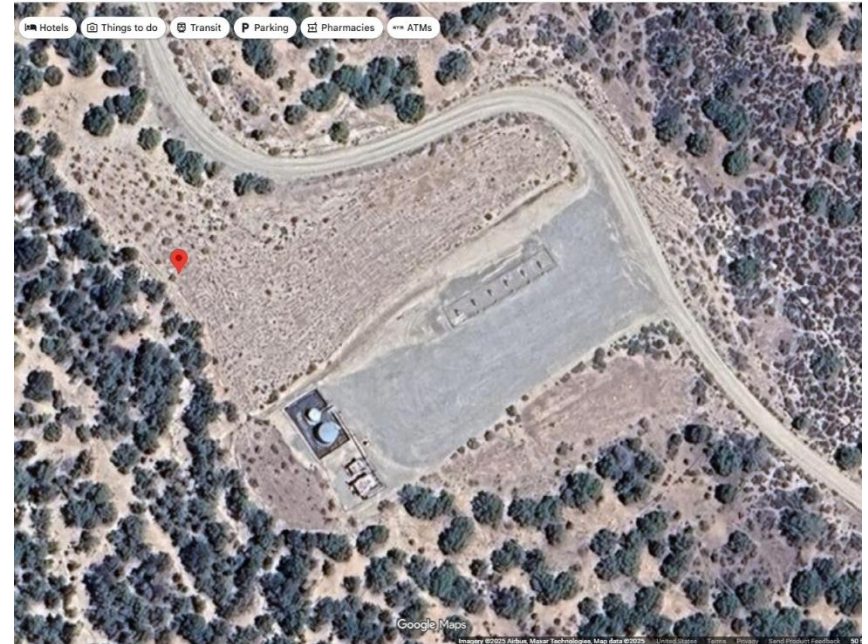
Photo # 2 FORM 5 Drilling Completion Report & Scout Card records "as drilled" coordinates show FEDERAL PA 412-28 well located N/NW of the location in the interim area - Coordinates appear to be off by approximately 230 ft ("as drilled" coordinates incorrect/not in compliance with CECMC Rules 216 & 414 – records require updating)
