Inspection/Audit Photos

Location Name: TEP ROCKY MOUNTAIN LLC EXXON PA 331-34

Location ID: 335333

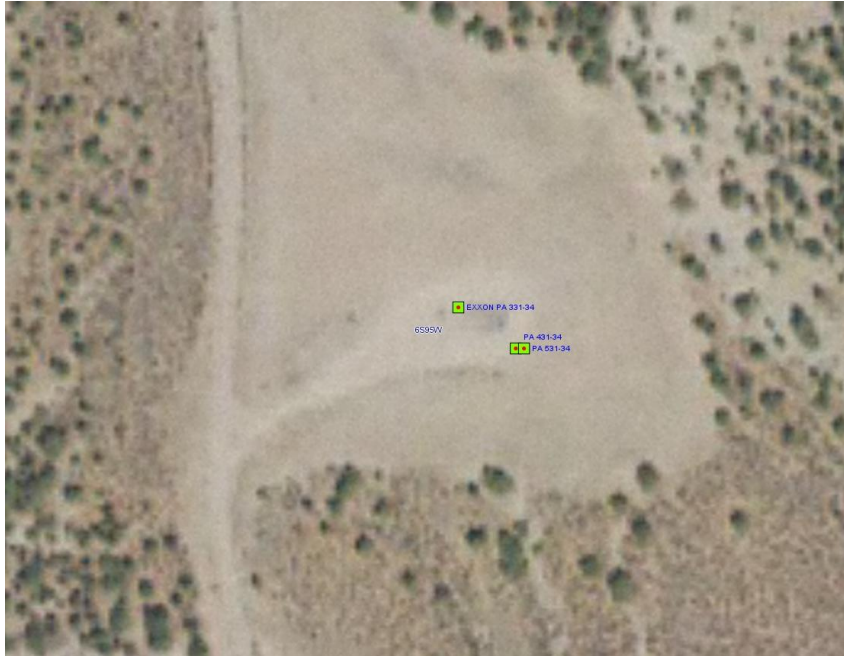
Photo # 1 Scout Card records show coordinates for the PA 531-34 & PA 431-34 wells located S/SE of the location on the edge of the interim area - Coordinates appear to be off by approximately 40 ft & 46 ft (coordinates incorrect/not in compliance with CECMC Rules 216 & 414 – records require updating)

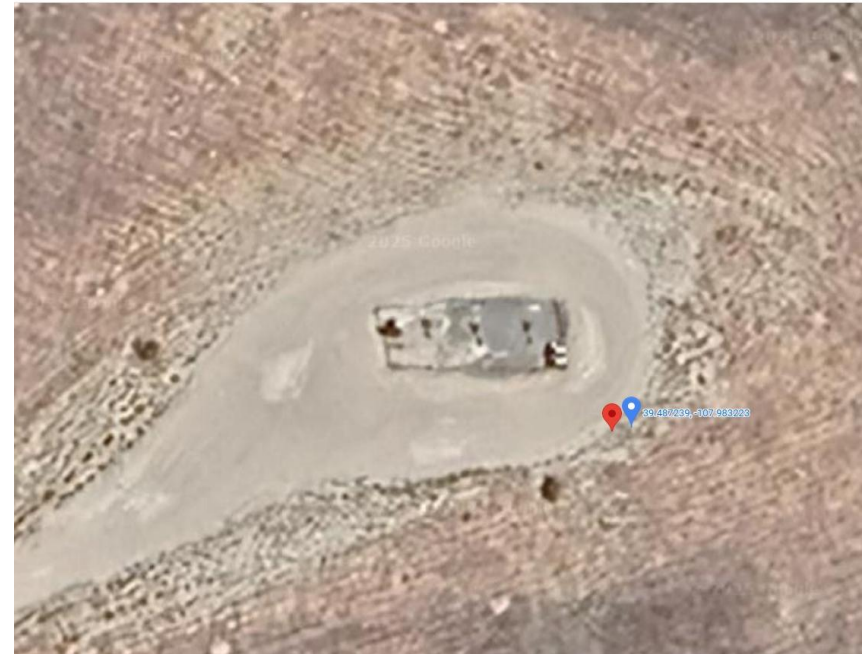
Photo # 2 Scout Card records show coordinates for the PA 531-34 & PA 431-34 wells located S/SE of the location on the edge of the interim area - Coordinates appear to be off by approximately 40 ft & 46 ft (coordinates incorrect/not in compliance with CECMC Rules 216 & 414 – records require updating)
