WELL NAME: HUNTER CANYON 23-9 & TR, API #: 071-06803, INSP. # 716301766

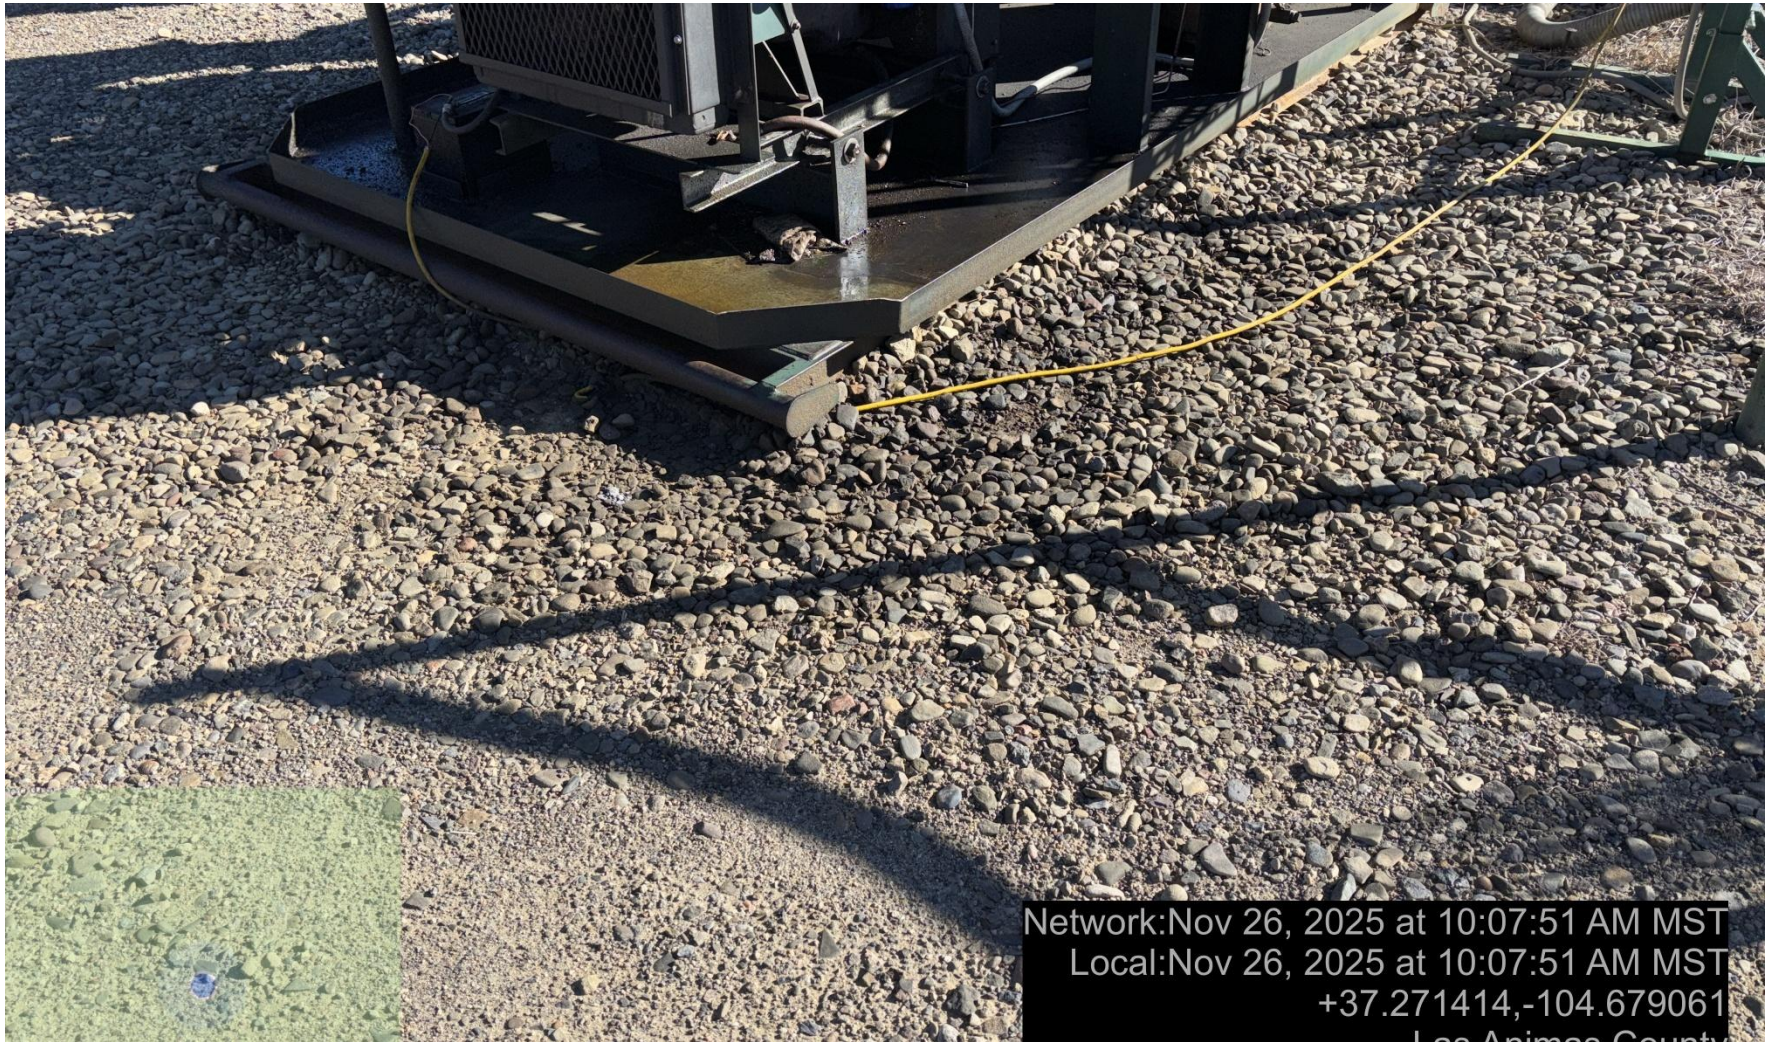
**PHOTO 4: AREA OF IMPACTED SOIL AROUND COMPRESSOR SKID. Conduct maintenance on equipment, cleanup stained material and review self inspection processes. COMPLY WITH RULE 1002,(2).D. CA DATE 12-3-2025.**

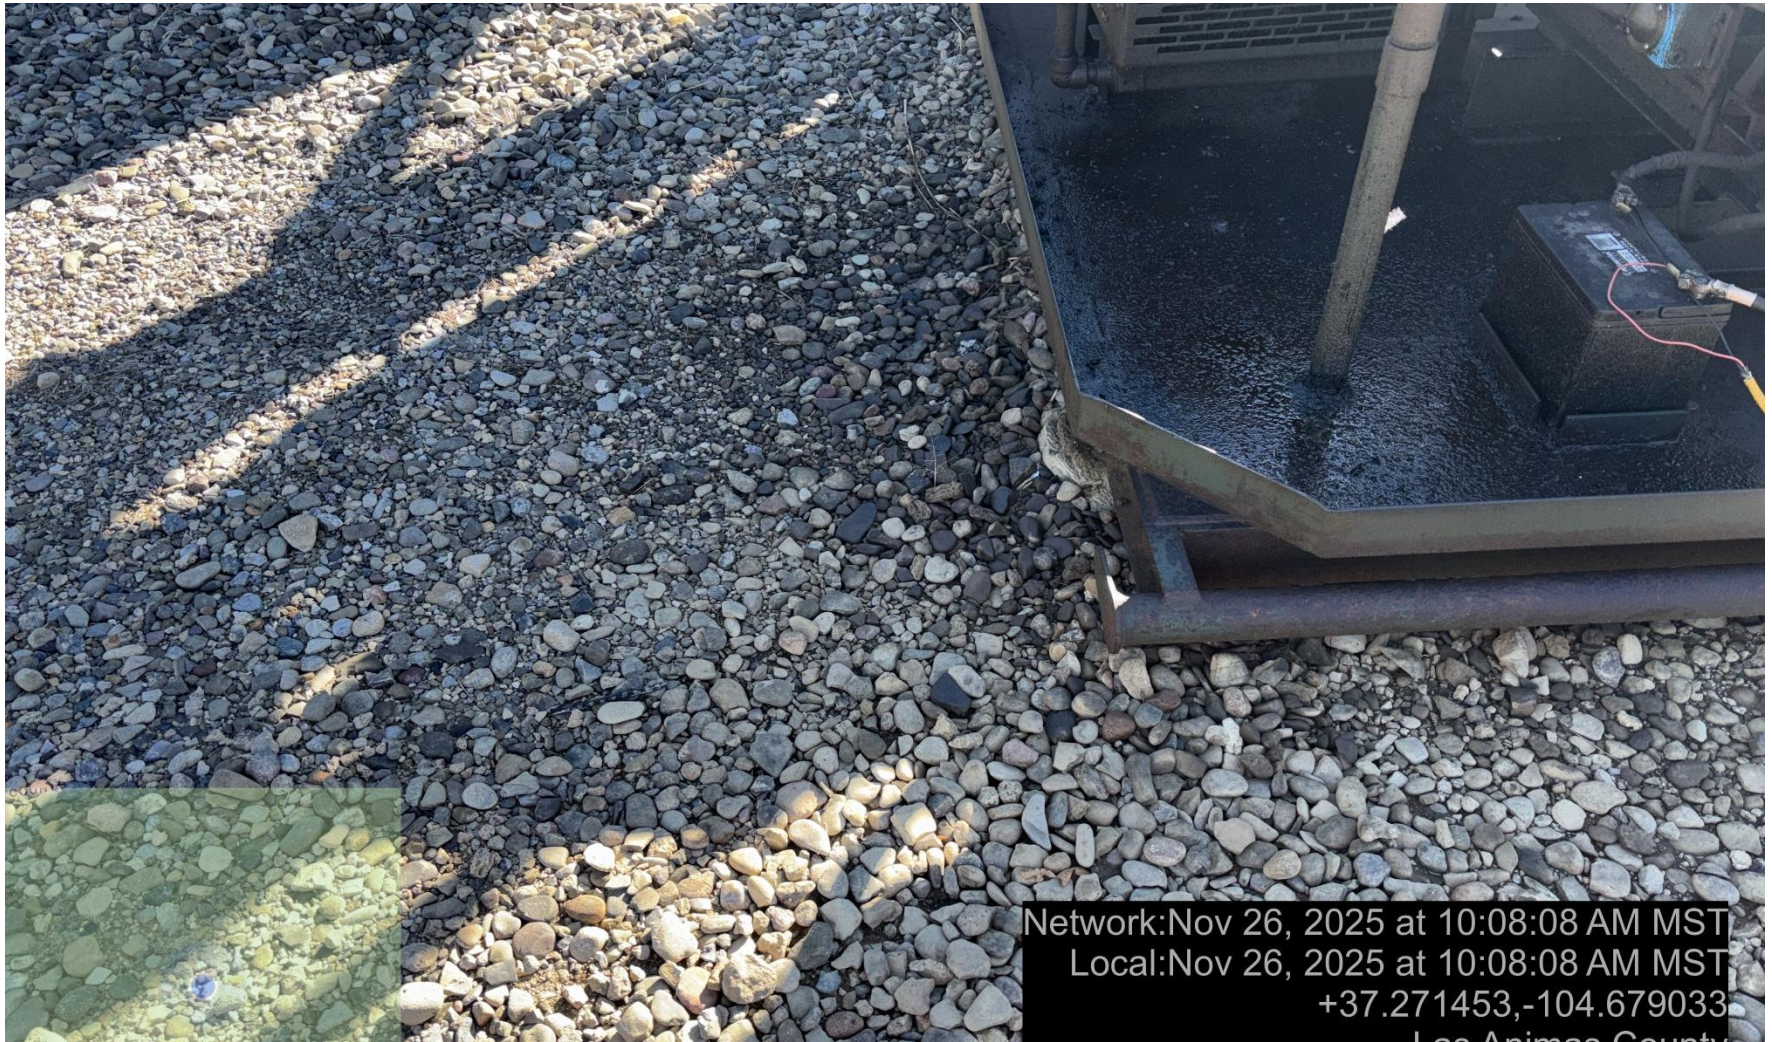
**PHOTO 5: AREA OF IMPACTED SOIL AROUND COMPRESSOR SKID. Conduct maintenance on equipment, cleanup stained material and review self inspection processes. COMPLY WITH RULE 1002,(2).D. CA DATE 12-3-2025.**

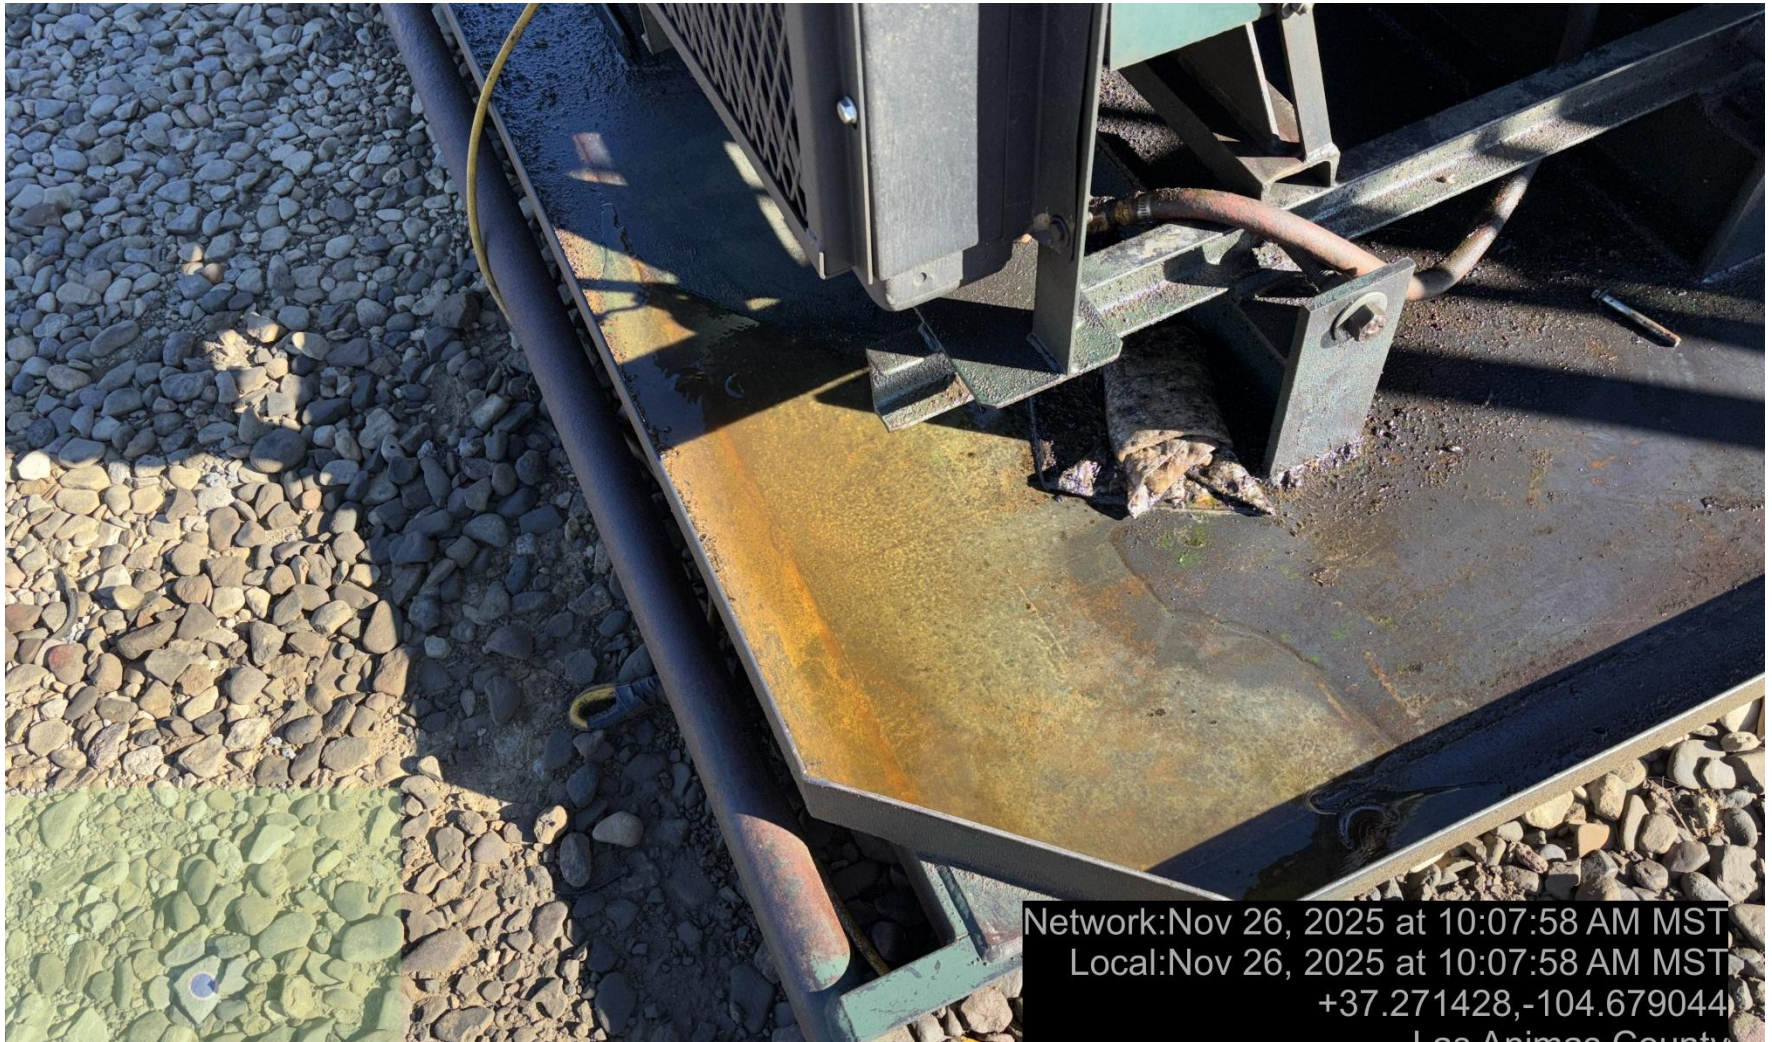
**PHOTO 6: OILY WASTE IN COMPRESSOR SKID. DRAIN OILY WASTE REPAIR ALL LEAKS AND REMOVE IMPACTED SOIL PER RULE 1002..(2).D & 1002.f.(2)B, Comply with general provisions of the oil and gas act for wildlife protection AND SB-181. CA DATE 11-27-2025.**

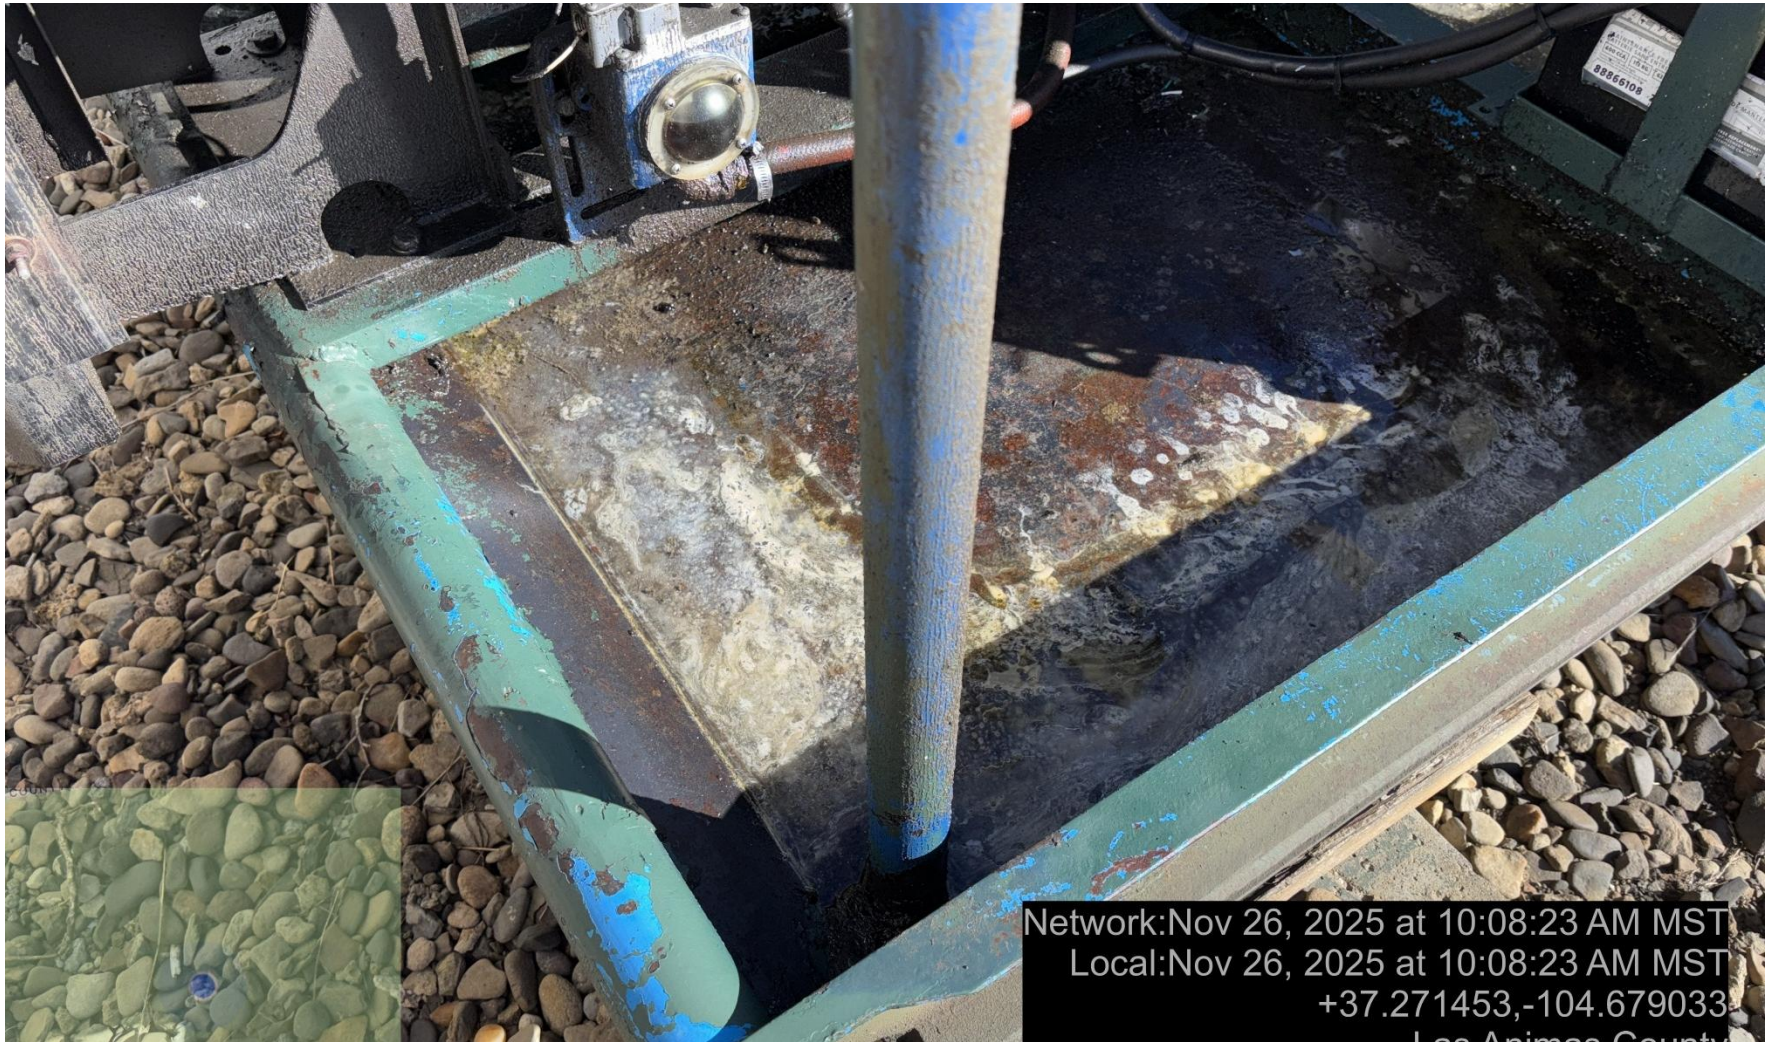
**PHOTO 7: OILY WASTE IN ORIG. WELL PRIME MOVER SKID. DRAIN OILY WASTE REPAIR ALL LEAKS AND REMOVE IMPACTED SOIL PER RULE 1002..(2).D & 1002.f.(2)B, Comply with general provisions of the oil and gas act for wildlife protection AND SB-181. CA DATE 11-27-2025.**
