Final Reclamation Inspection

Operator: NOBLE ENERGY INC - 100322

Location ID: 328366

Inspection Photos
Location Name: COBB #6-23
Location ID: 328366

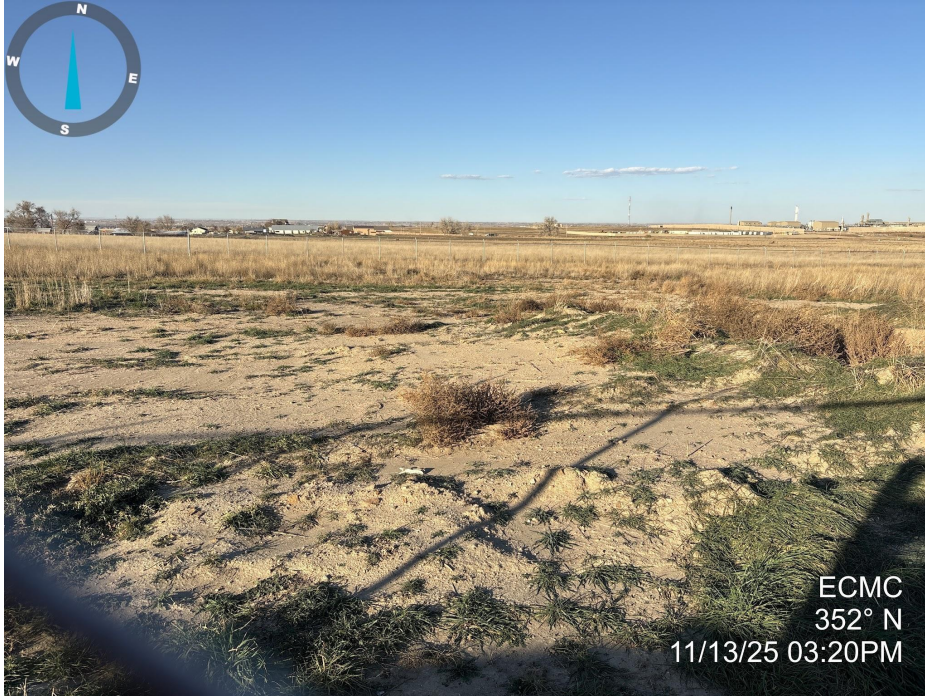
Photo 1. Photo taken of the well location, facing north. Photo illustrates that final reclamation at the location does not meet Rule 1004 standards. The well location is contained within a fenced area.

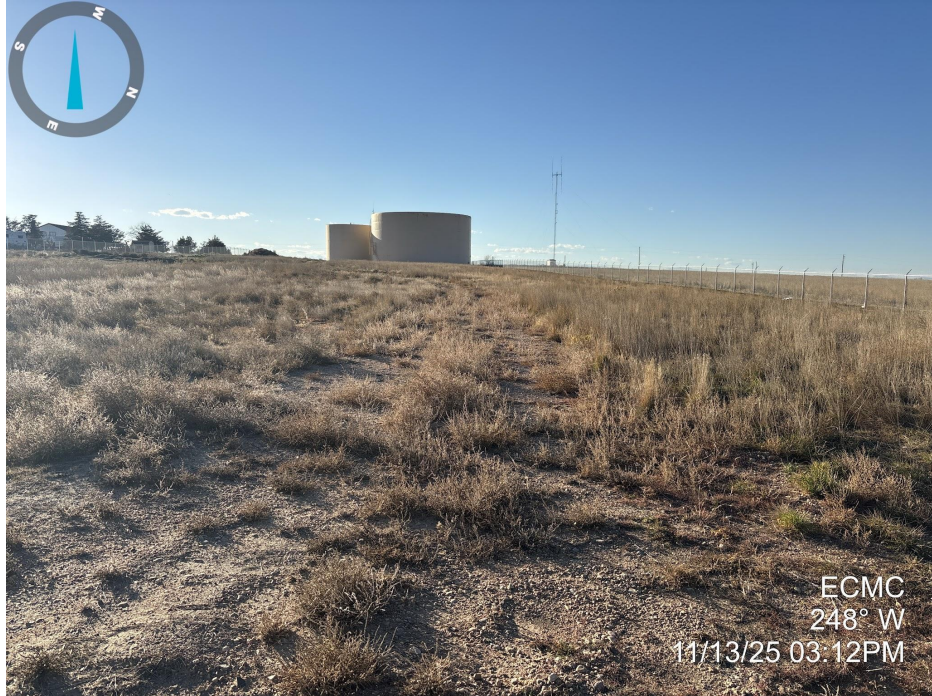
Photo 2. Photo taken of the well location, facing west. See comments under Photo 1.

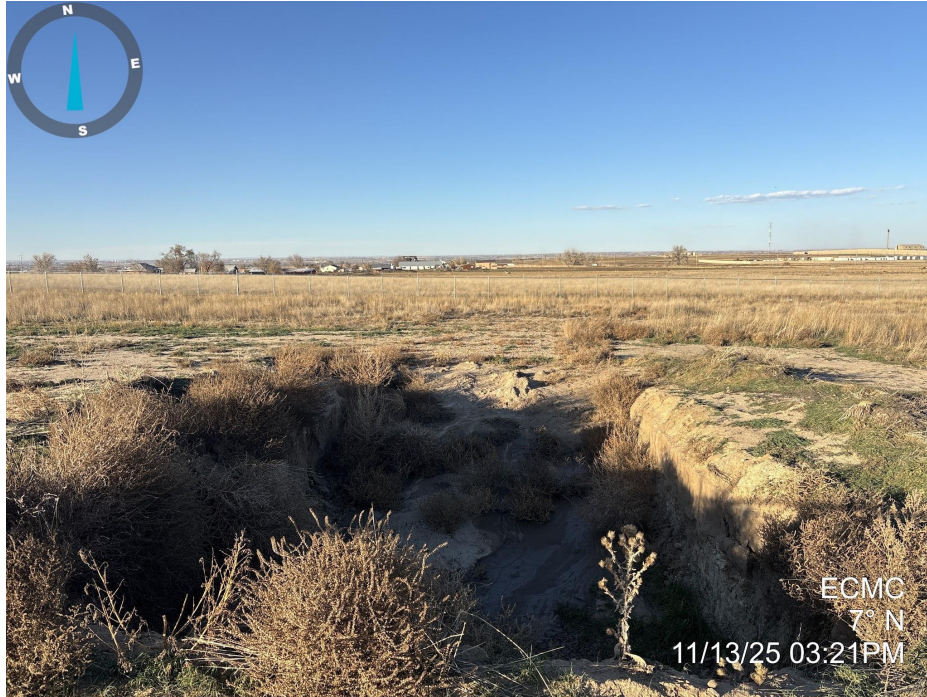
Photo 3. Photo taken of the well location, facing north. See comments under Photo 1. A pit has been dug adjacent to the well location.

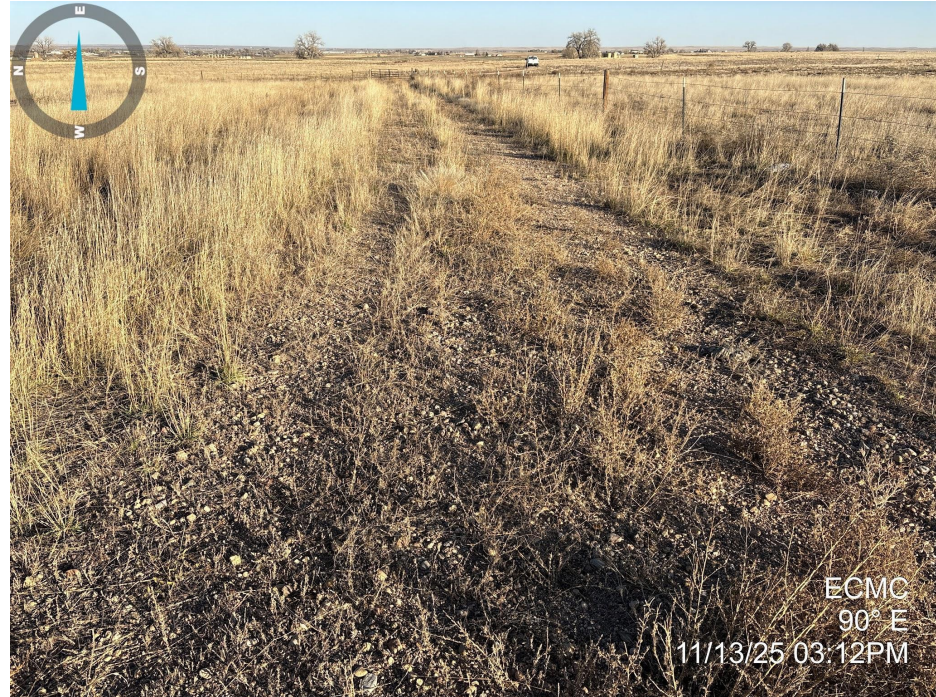
Photo 4. Photo taken of the access road to the well location, facing east, away from the location. Photo illustrates that final reclamation activities have not taken place along the access road and gravel remains.

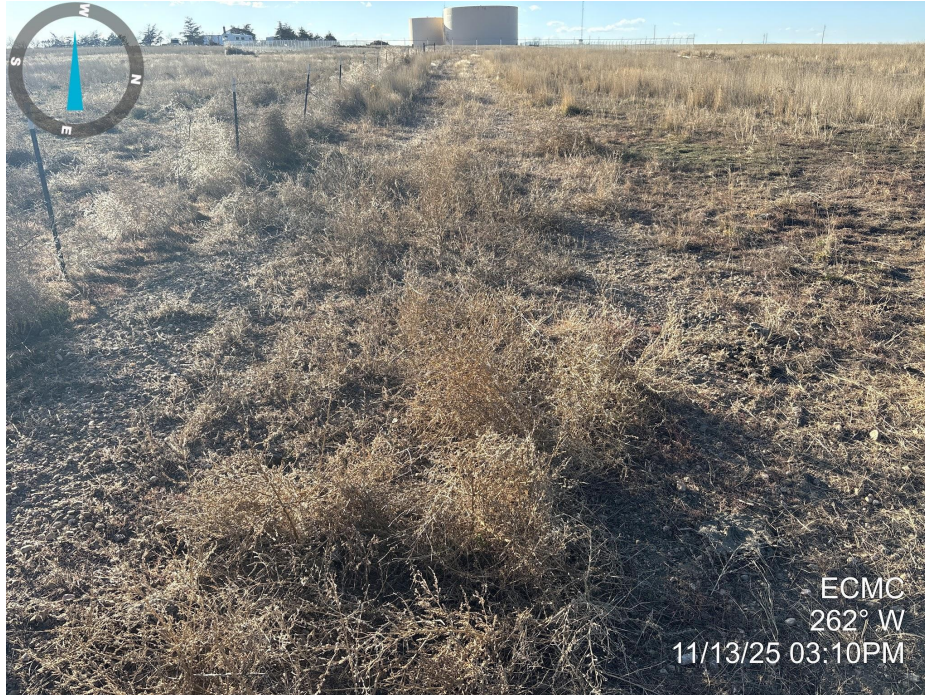
Photo 5. Photo taken of the access road to the well location, facing west, towards the location. See comments under Photo 4.

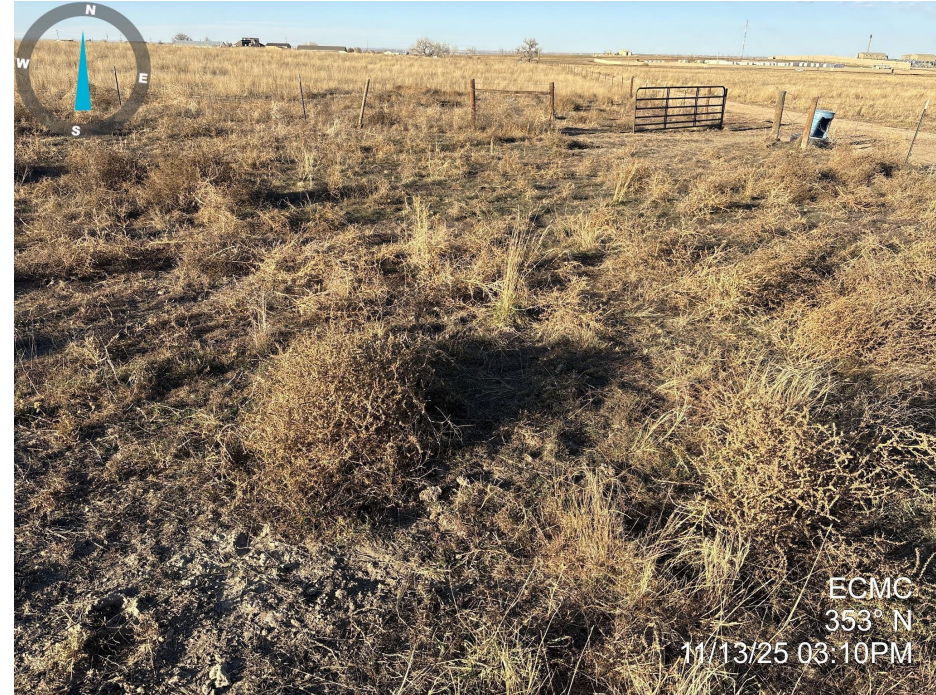
Photo 6. Photo taken of the tank battery location, facing north. Photo illustrates that final reclamation activities have taken place, but vegetation has not established to Rule 1004 standards. Gravel and weedy annual vegetation including russian thistle (*Salsola tragus*) were observed at the location.

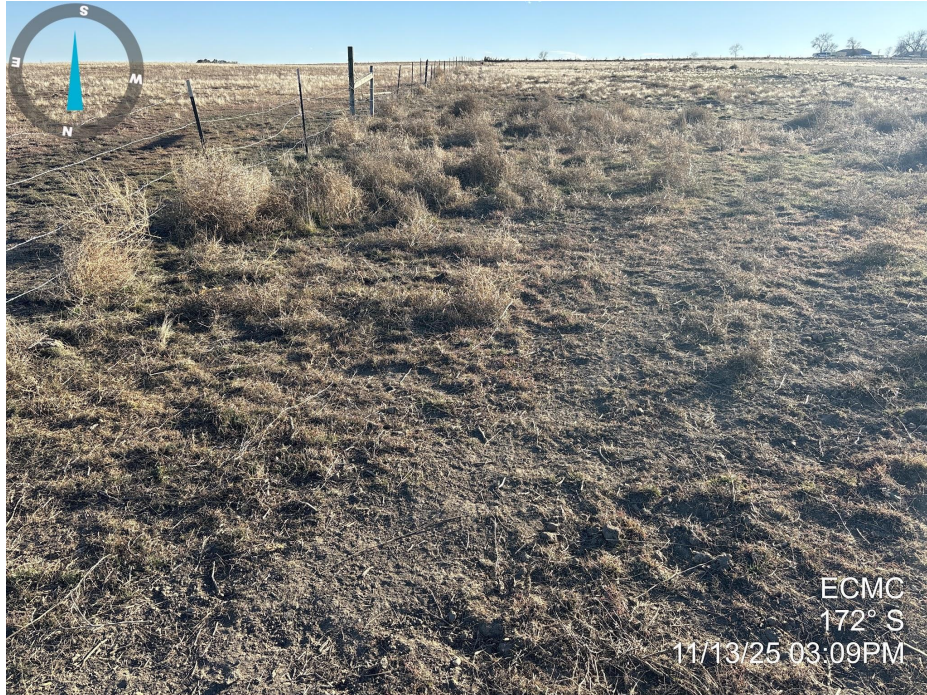
Photo 7. Photo taken of the tank battery location, facing south. See comments under Photo 6.

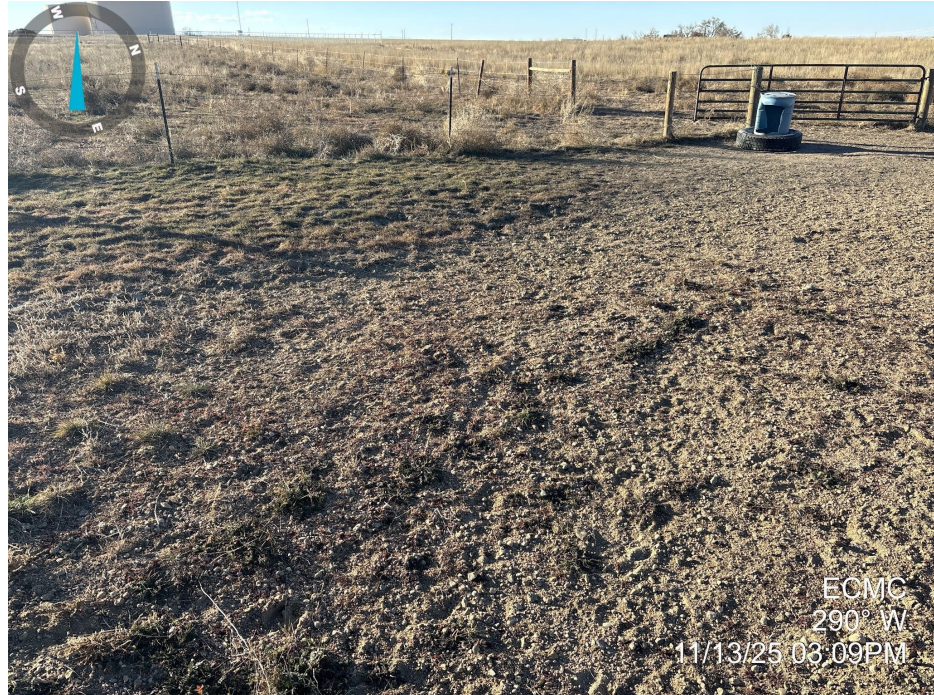
Photo 8. Photo taken of the tank battery location, facing west. See comments under Photo 6. The access road adjacent to the tank battery location remains in place.

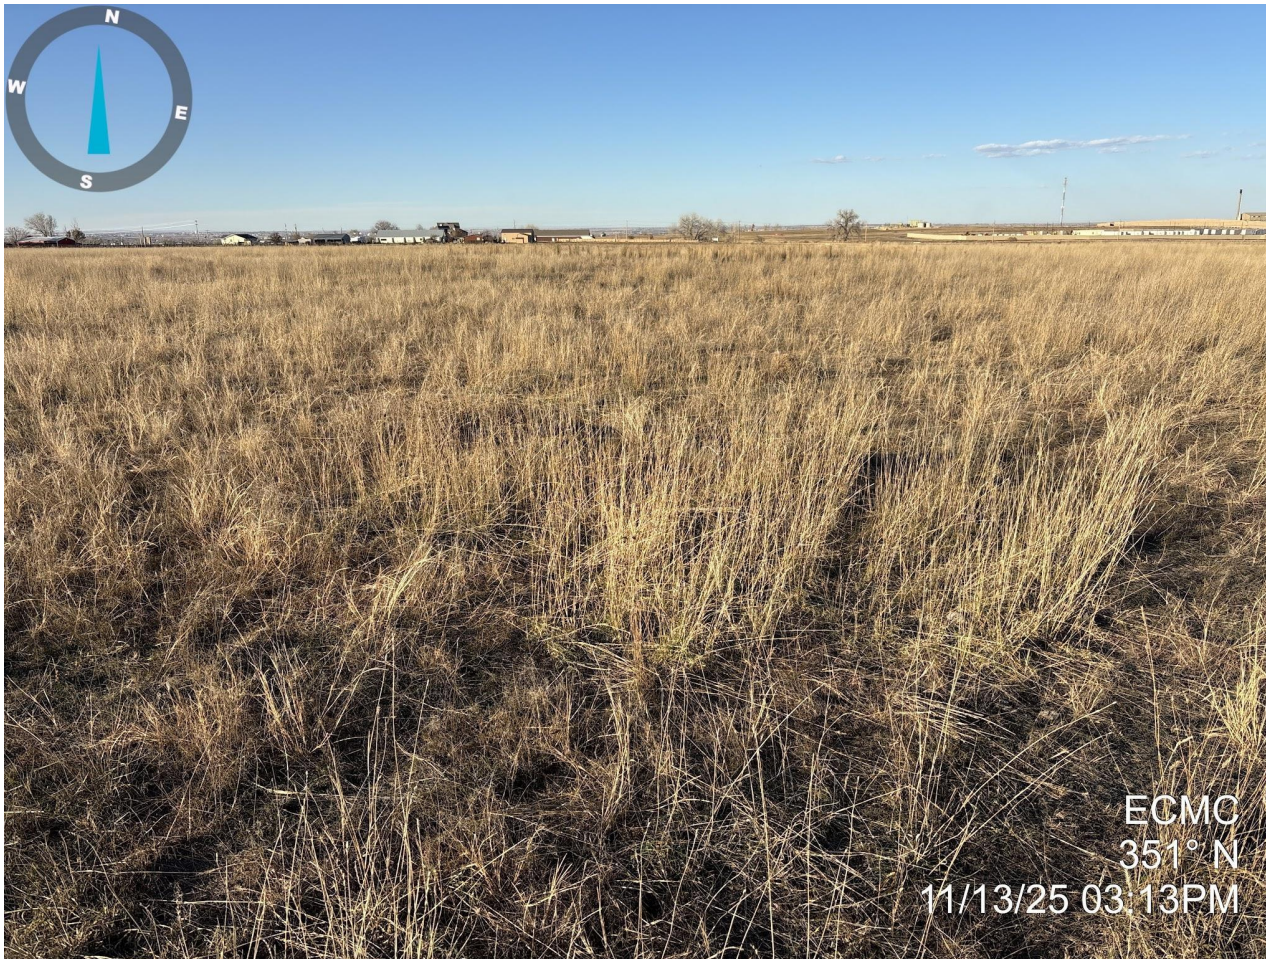
Photo 9. Photo taken of the reference area to the location, north of the location, facing north. Photo illustrates perennial grass vegetation.
