Looking at the former STATE #14 well and area of Spill/Release Point ID 492280. An open excavation is visible. The pumping unit has been removed.

ECMC : Environmental Inspection

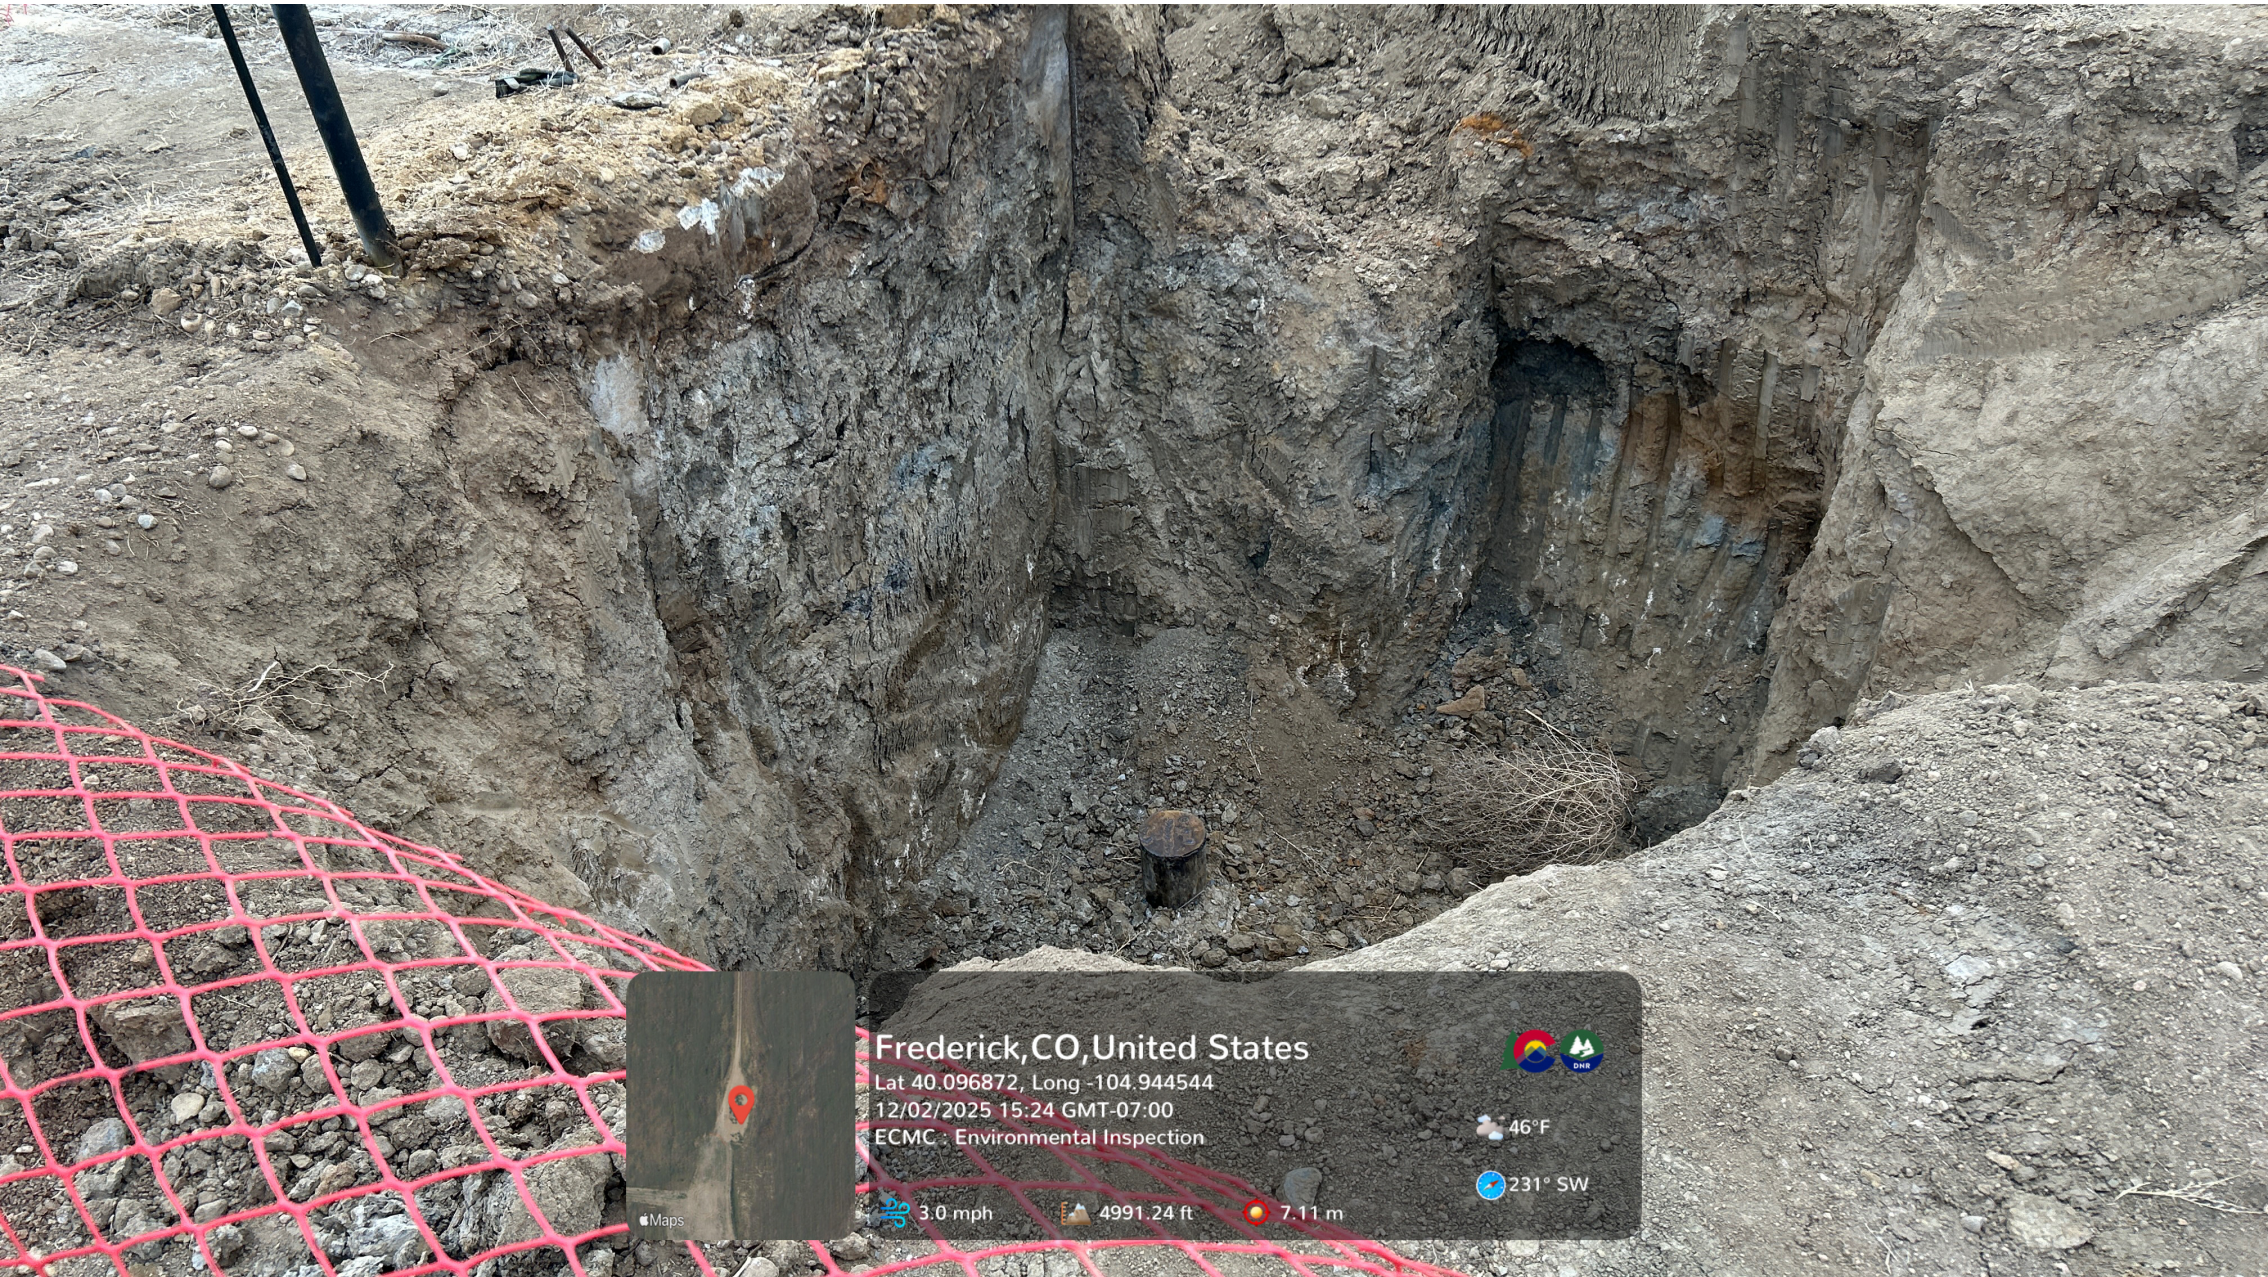
Gray staining is visible within the excavation.

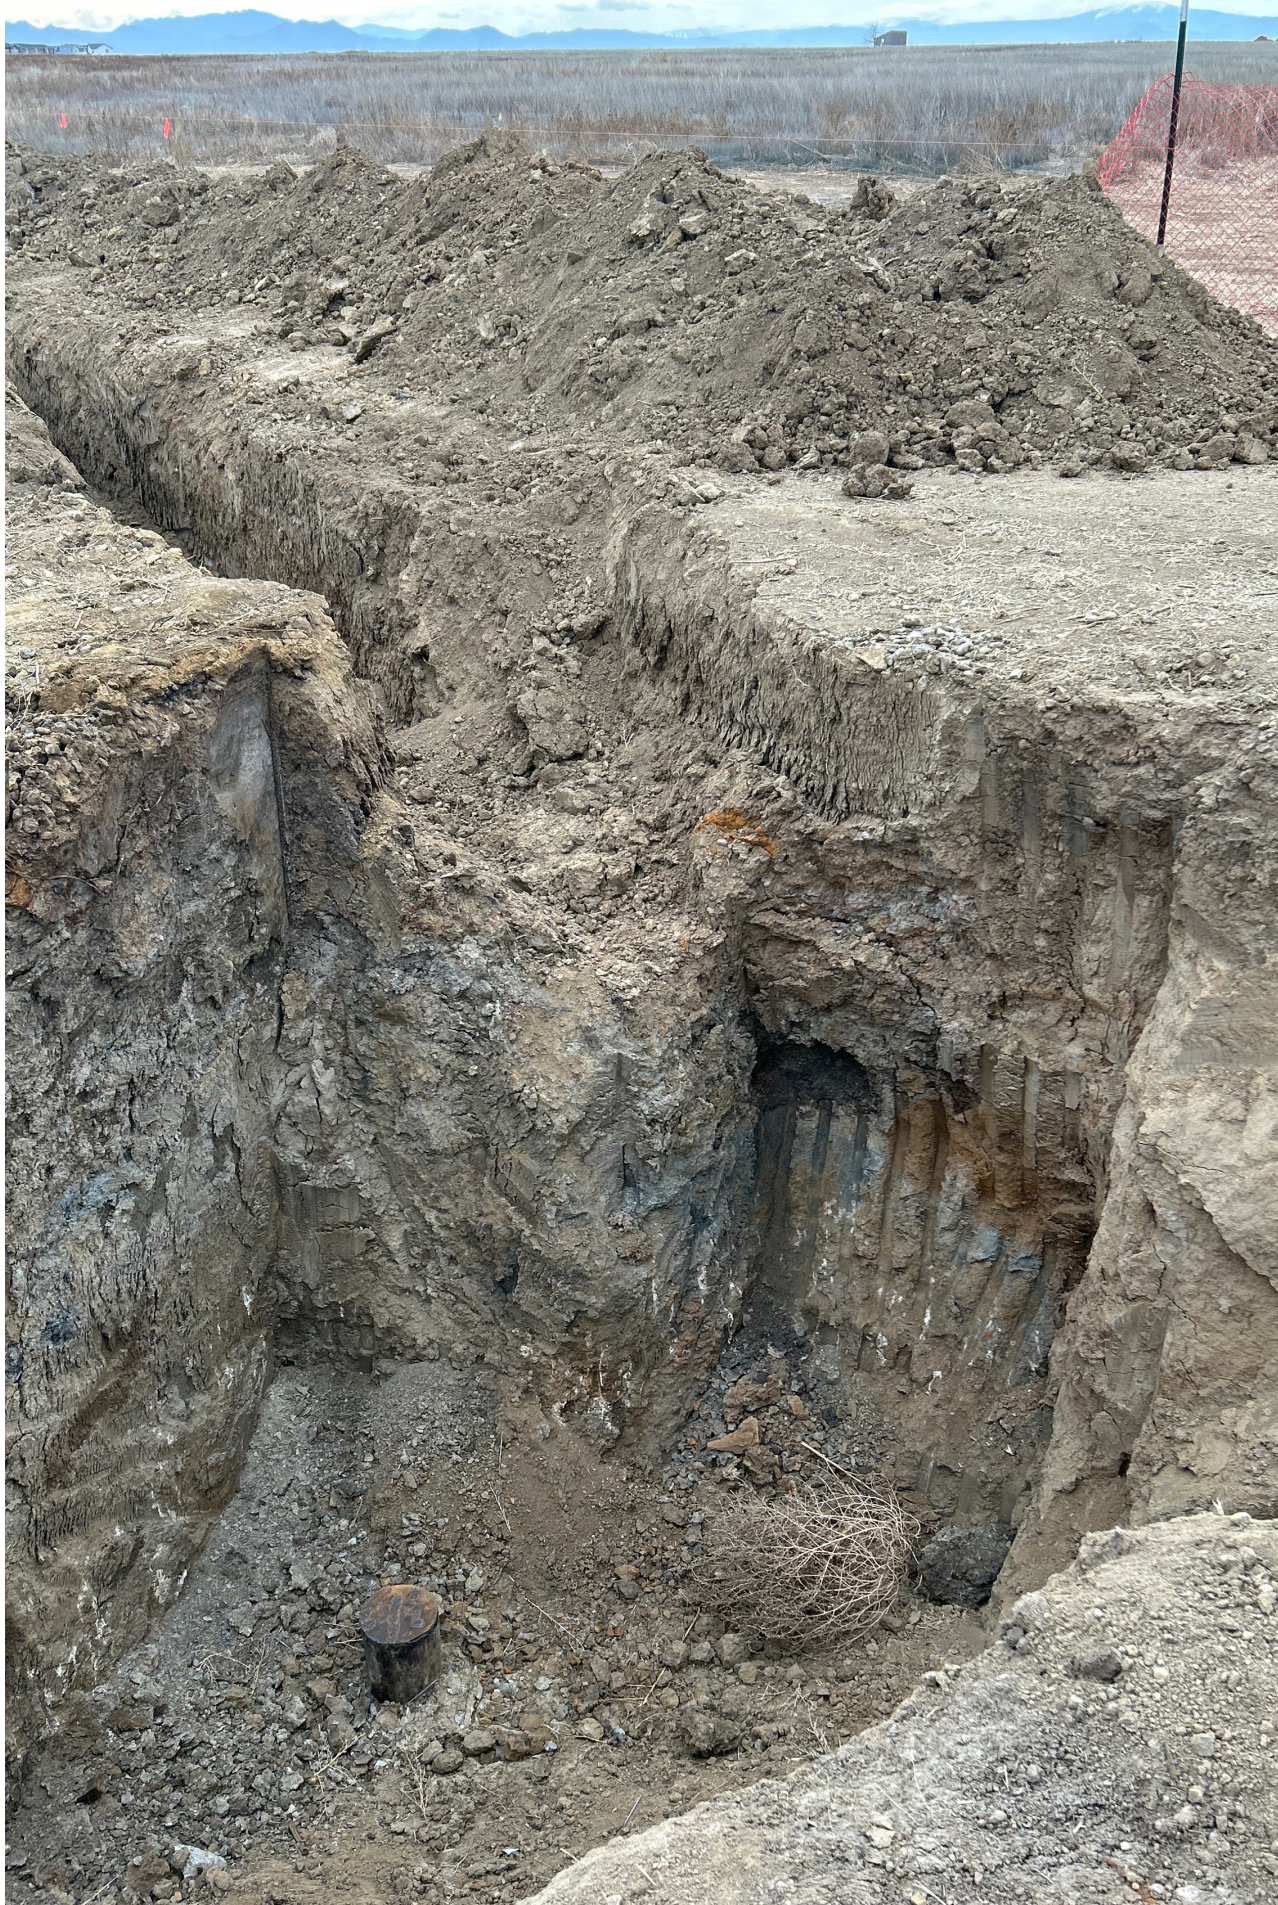
Orange construction fencing partially surrounds the excavation. A trench associated with Flowline Facility ID 476252 is visible running southwest from the former well and will be addressed in a separate Field Inspection Report.
