Inspection Photos

Operator: CITATION OIL AND GAS CORP- #17180

Location ID: 313058

Location Name: Sand Hills Federal #21-4 Pad

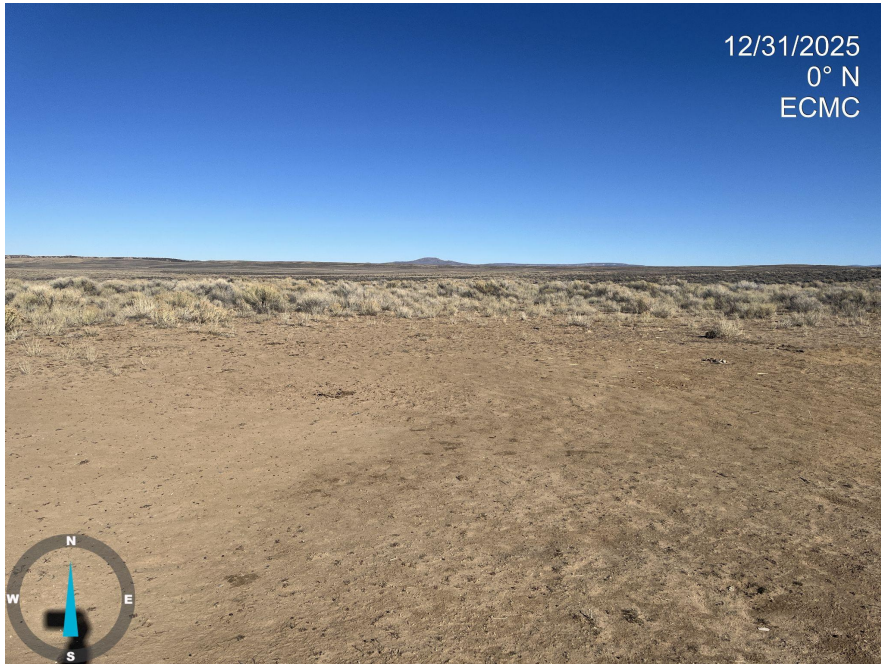
Photo 1. Photos 1-4 taken at the center of the previous Location disturbance, facing north, east, south, and west. Photos illustrate that final reclamation activities have not been conducted.

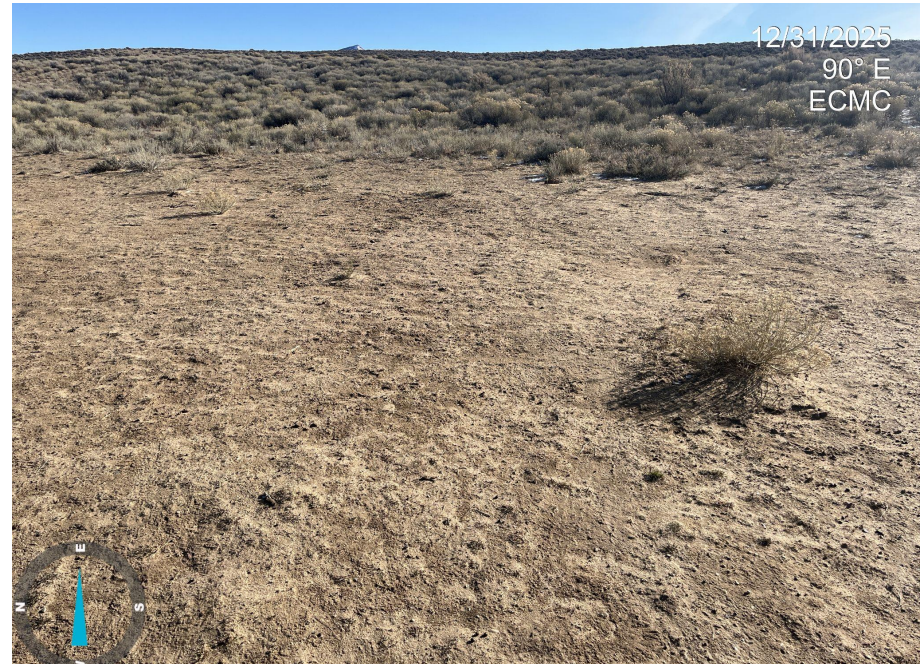
Photo 2. See comments under Photo 1.

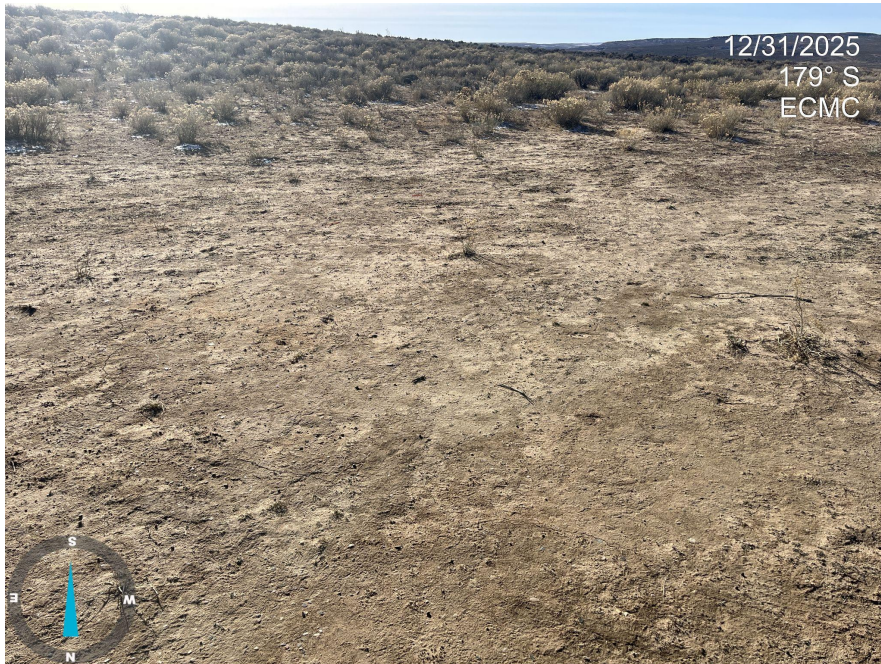
Photo 3. See comments under Photo 1.

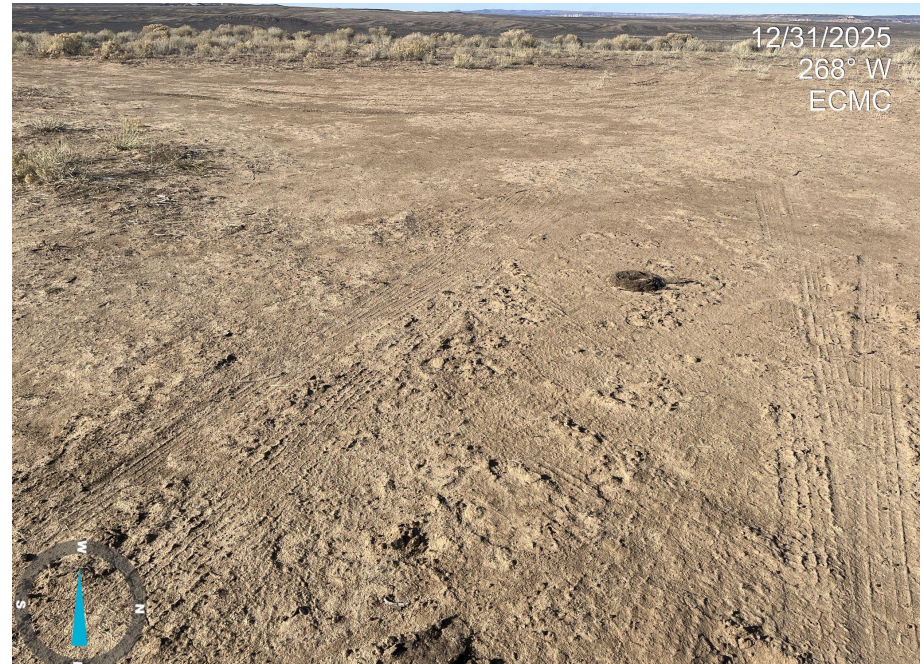
Photo 4. See comments under Photo 1.

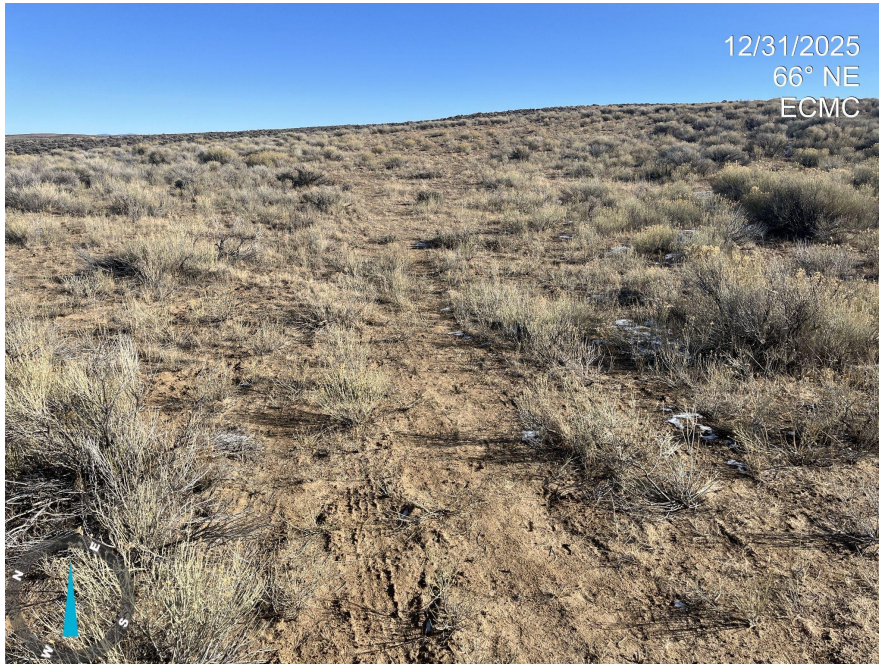
Photo 5. Photo taken from the northeastern portion of the Location, facing northeast, illustrating that the vegetation in the interim areas has established, including rabbitbrush and *Pleuraphis jamesii*. Cheatgrass was also observed on the Location.

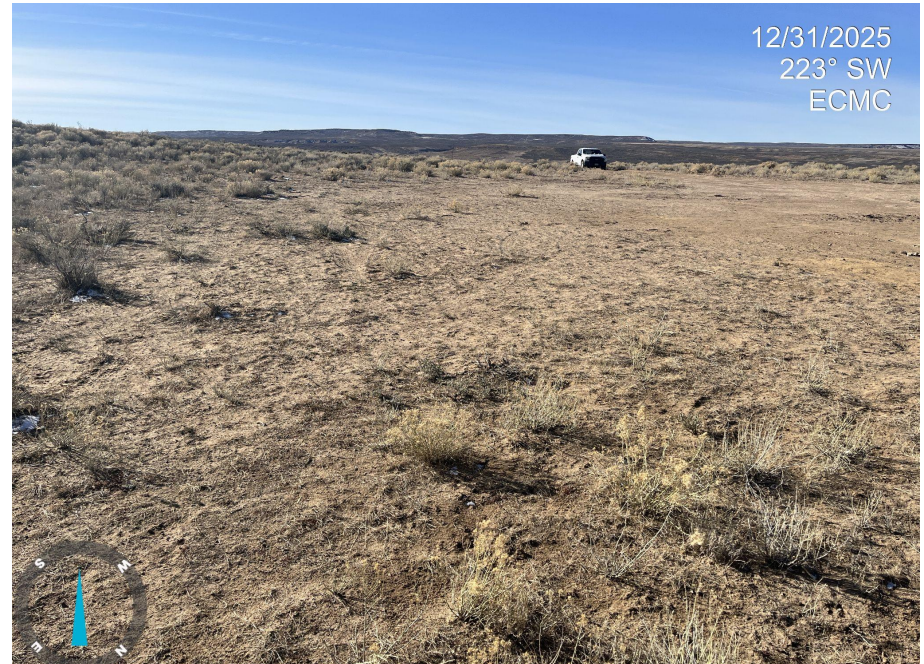
Photo 6. Photo taken from the northeastern portion of the pad, facing southeast. Photo illustrates an overview of the pad that has not been reclaimed; compaction is apparent, no additional seeding has occurred.

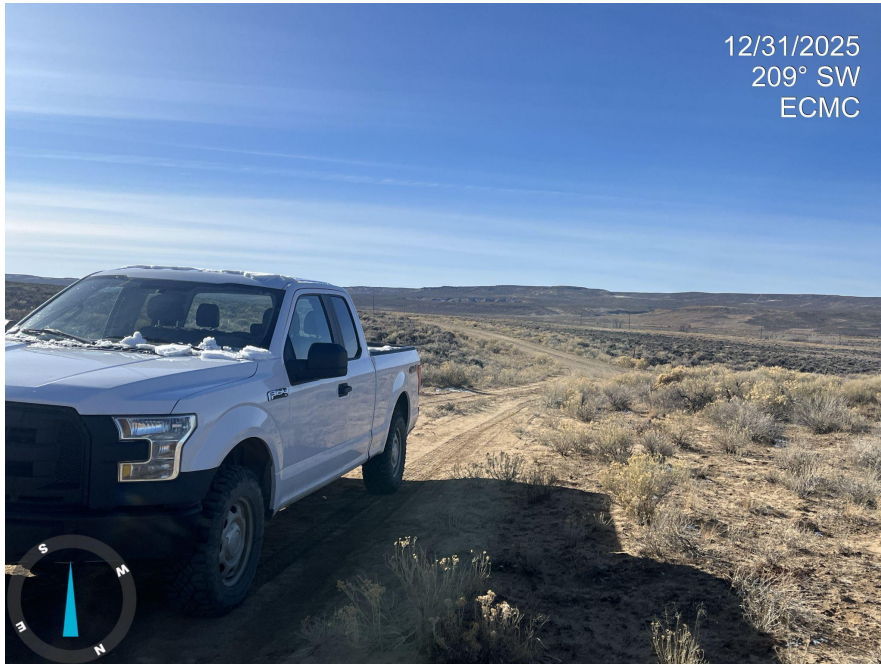
Photo 7. Photo taken from the southwestern portion of the pad, facing southwest towards the access road to the Location, which has not yet been reclaimed.

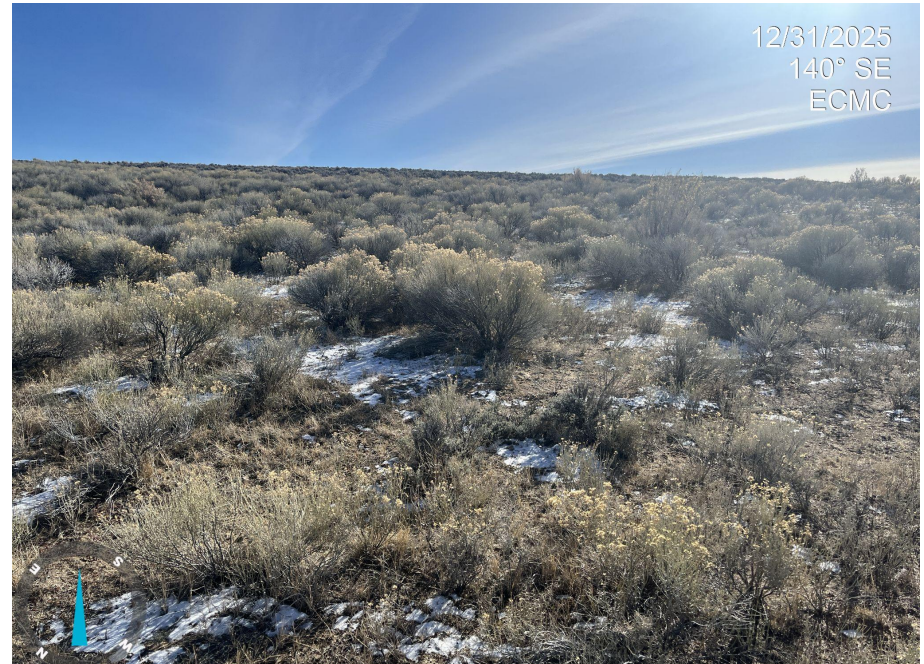
Photo 8. Photo taken from the eastern portion of the Location, facing southeast towards the progressing vegetation areas in what appeared to be the interim reclamation areas.
