Inspection Photos

Location Name: TEP ROCKY MOUNTAIN LLC FEDERAL GM 41-8 Pad

Location ID: 334794

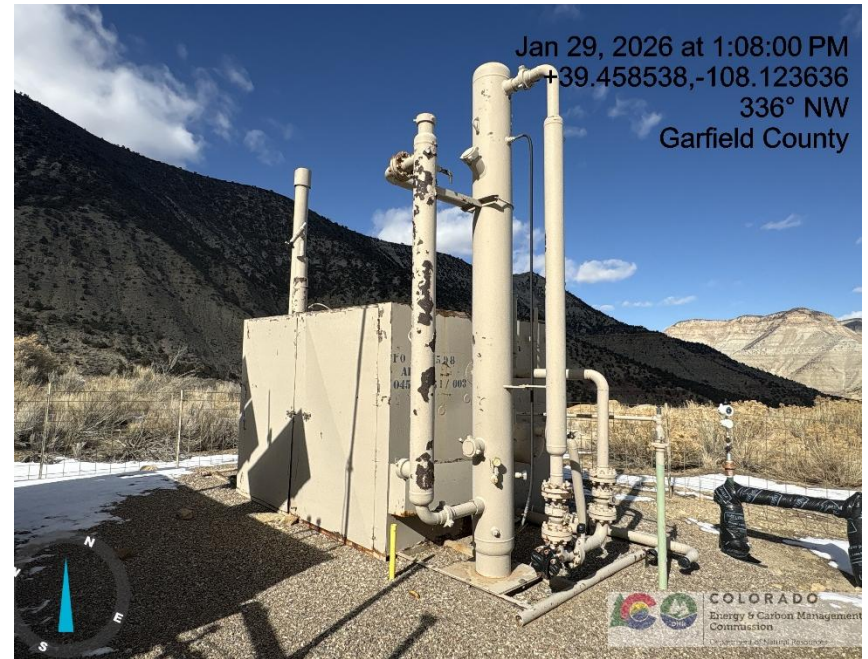
Photo # 7400 Dehy disconnected & not in use/unused equipment (Additionally equipment is not listed in operators FORM 2A)

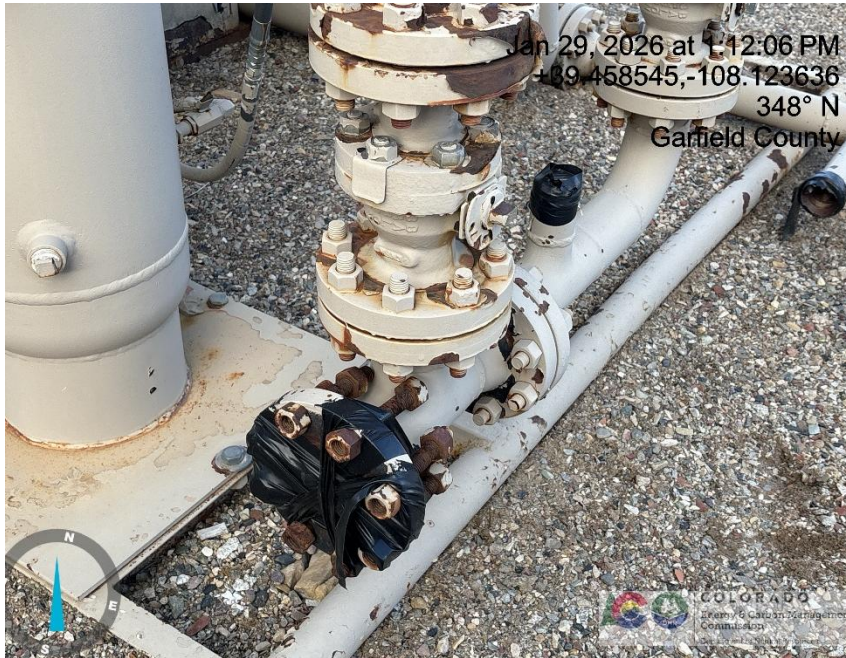
Photo # 7401 Piping on dehy disconnected/dehy not in use/unused equipment

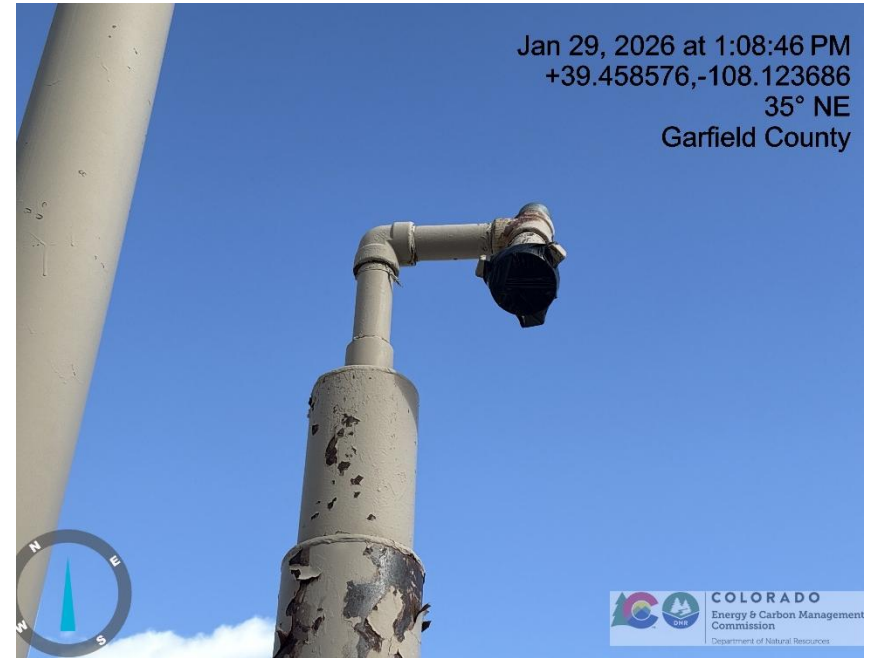
Photo # 7402 Still column piping on dehy disconnected/dehy not in use/unused equipment

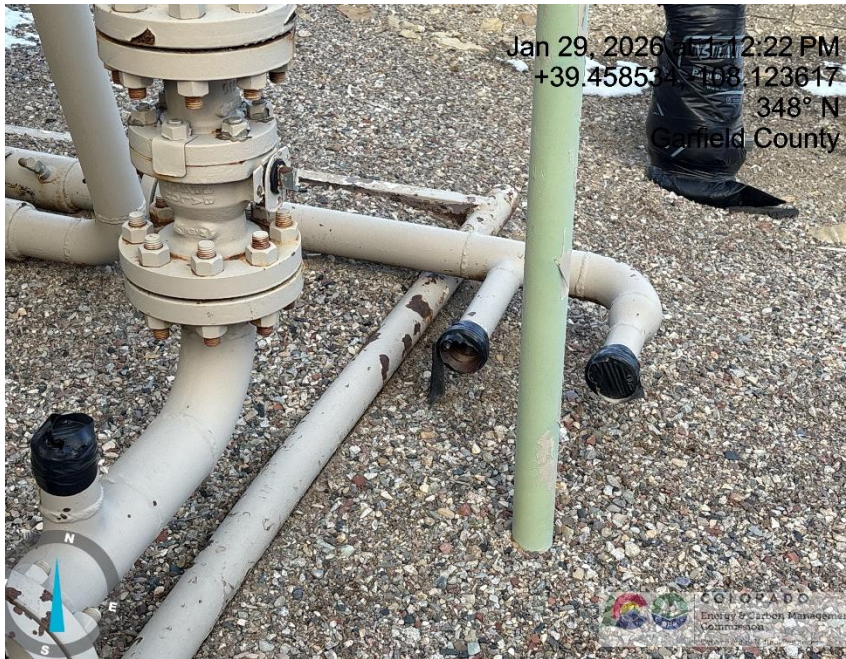
Photo # 7403 Piping on dehy disconnected/dehy not in use/unused equipment – Additionally open ended piping on dehy/wildlife hazard/available for entry by wildlife

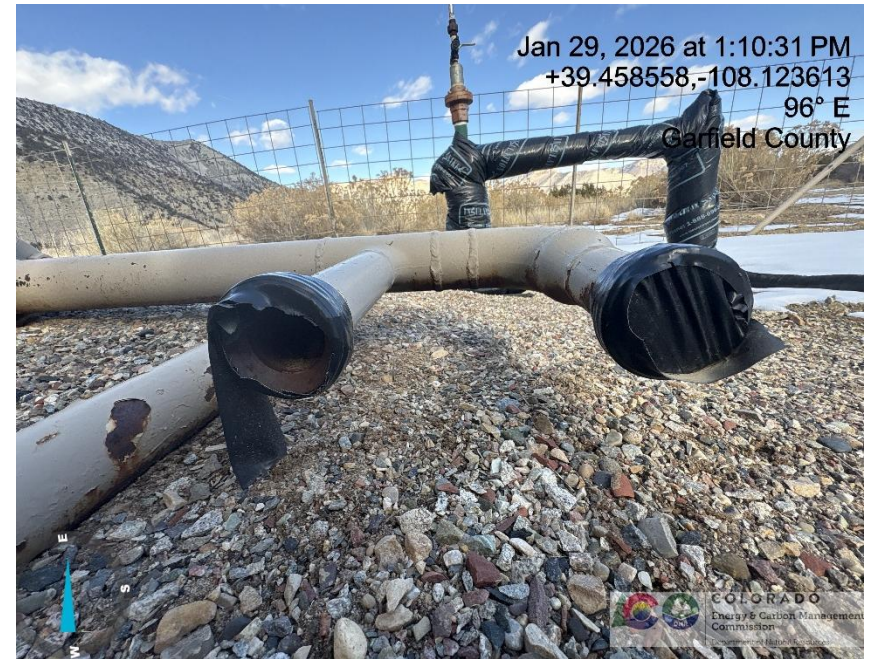
Photo # 7404 Piping on dehy disconnected/dehy not in use/unused equipment – Additionally open ended piping on dehy/wildlife hazard/available for entry by wildlife

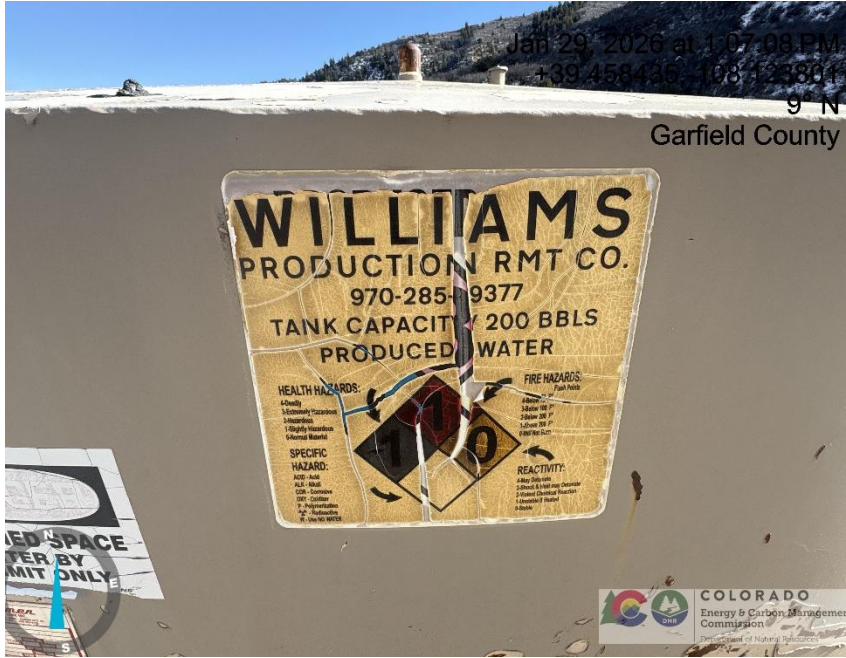
Photo # 7405 Tank label has previous operators name

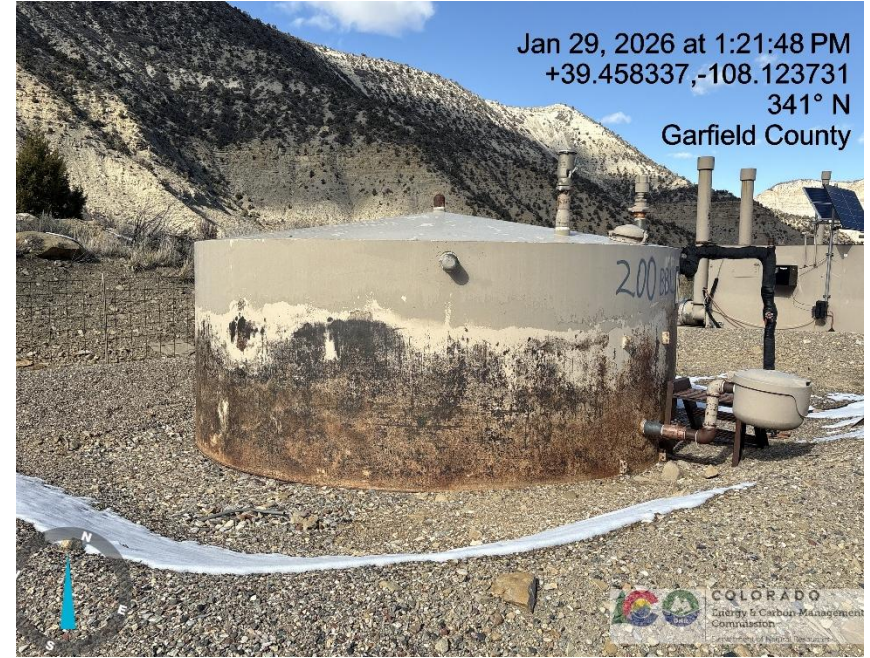
Photo # 7406 Paint peeling off production tank & tank starting to rust

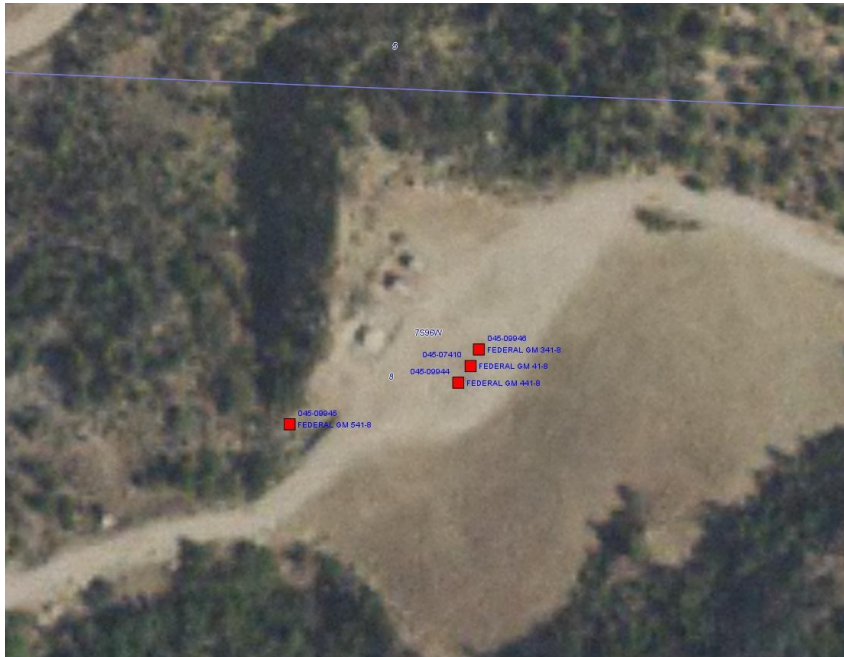
Photo # 7407 Scout Card record coordinates for the FEDERAL GM 541-8 well - Coordinates appear to be off by approximately 123 ft (coordinates incorrect/not in compliance with CECMC Rules 216 & 414 – records require updating)

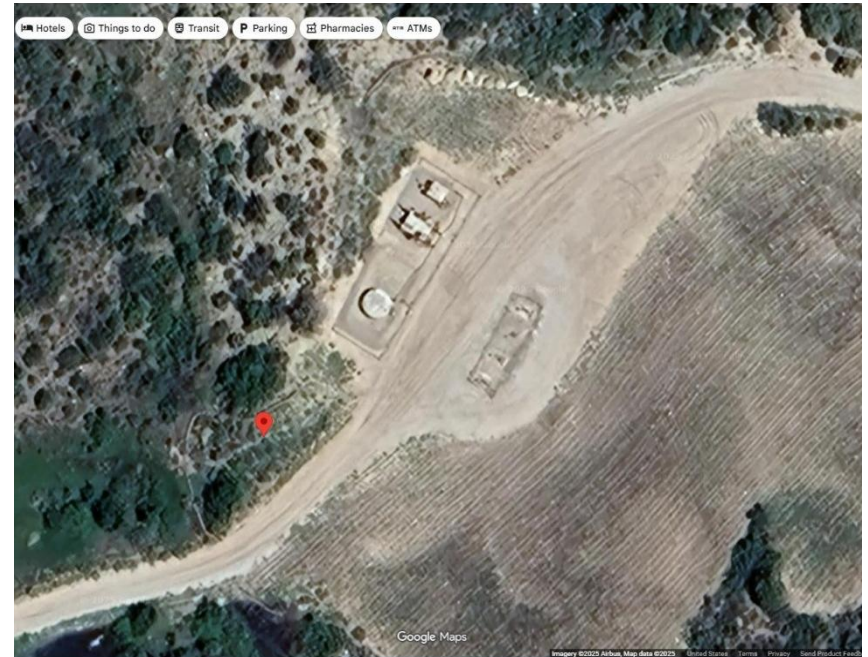
Photo # 7408 Scout Card record coordinates for the FEDERAL GM 541-8 well - Coordinates appear to be off by approximately 123 ft (coordinates incorrect/not in compliance with CECMC Rules 216 & 414 – records require updating)
