# Reclamation Inspection

Operator: NOBLE ENERGY INC - #100322

Location ID: 490053

Inspection Document #: 697506069

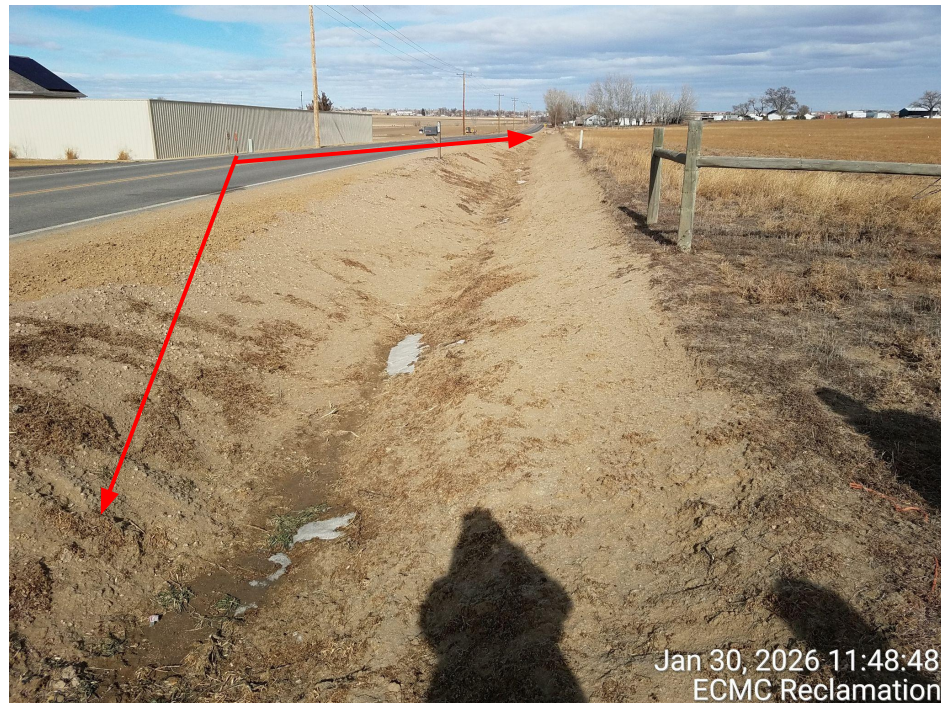
**Photo 1.** Photo taken from CR51 and the western portion of Parcel T089 at the surface owners driveway, facing North. Photo illustrates the Operator excavated soil from the roadside ditch.

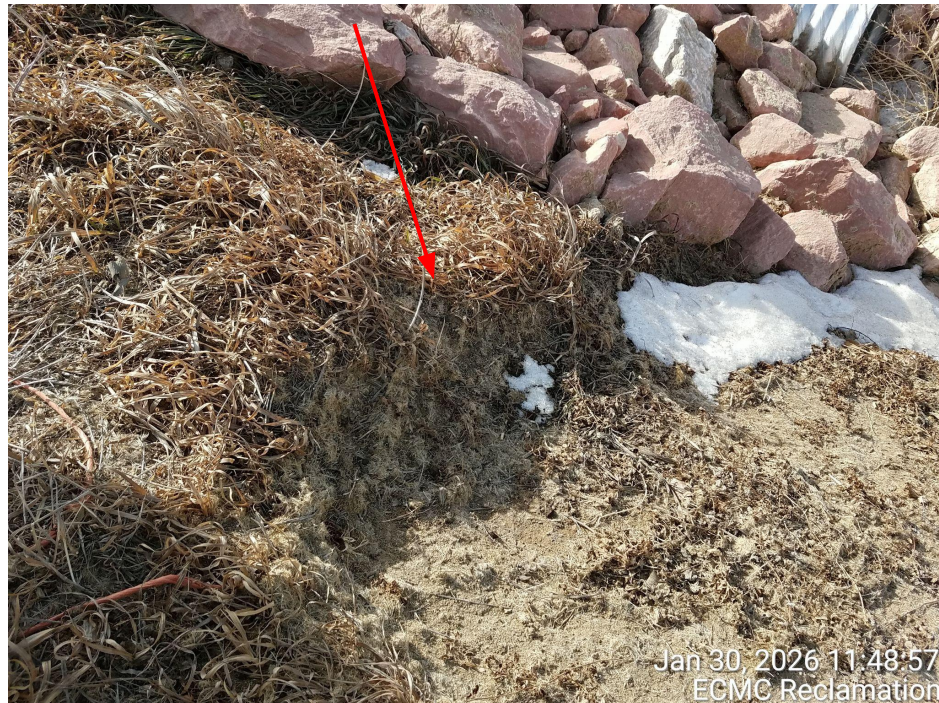
**Photo 2.** Close up photo taken from Photo #1 illustrating that not all soil has been brought back to pre-disturbance conditions. Photo illustrates ~3-4 inches of soil material has not been brought back to the original contour.

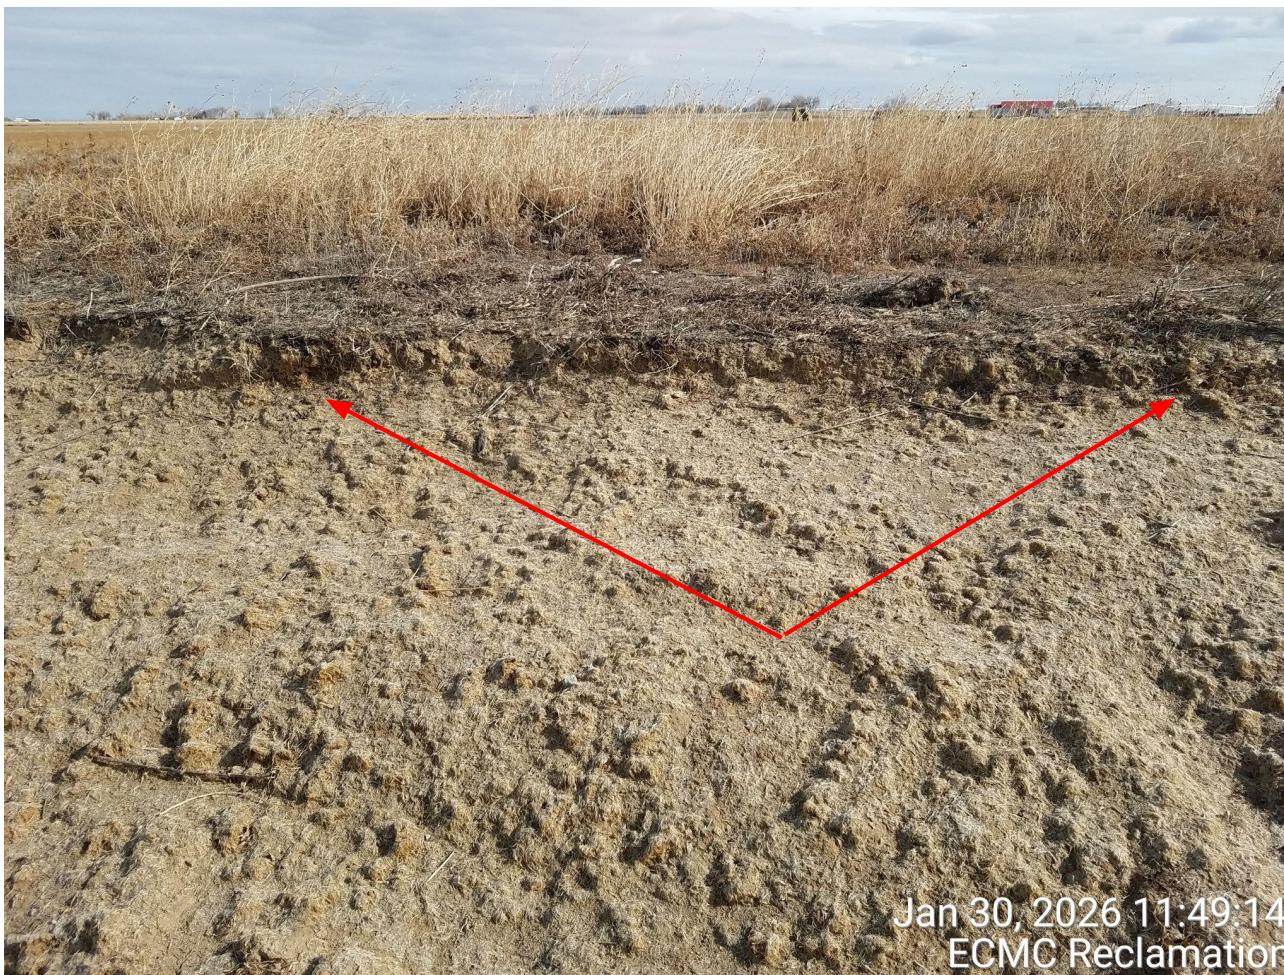
**Photo 3.** Photo taken from CR51 and the western portion of Parcel T089 near the surface owners driveway, facing East. Photo illustrates not all soil has been brought back to pre-disturbance conditions. Photo illustrates ~3-4 inches of soil material has not been brought back to the original contour.
