Final Reclamation and Stormwater Inspection

Location ID: 318193

Well Name: DUANE E. NELSON 41-33 (2-68) #1-X

Inspection Document #: 718601361

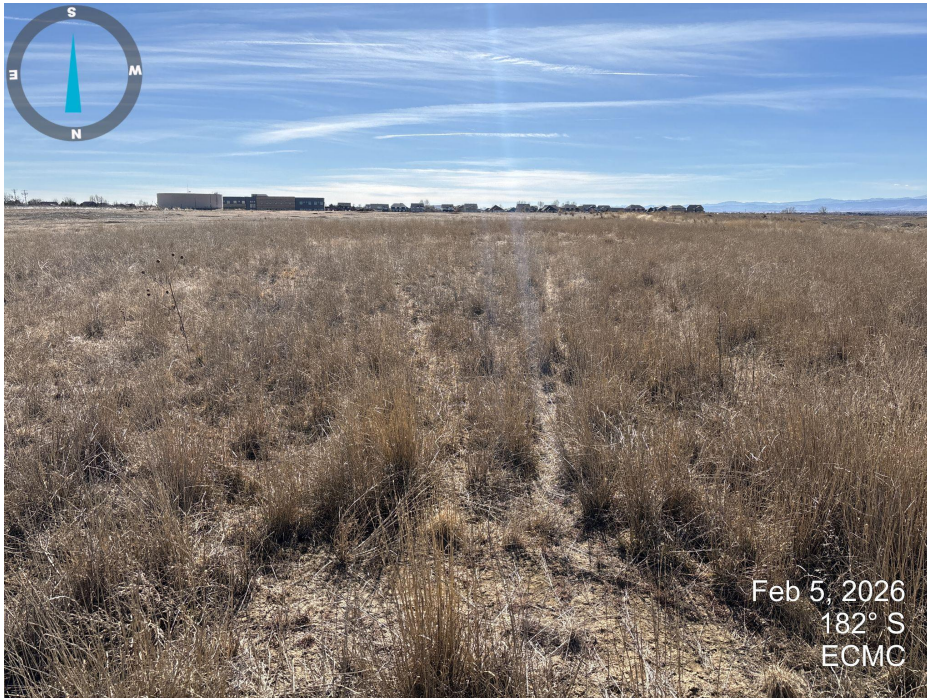
Photo 1. Looking south across the tank battery and well location. No oil and gas equipment remain on the location. Desirable perennial vegetation appears to have reached 80% coverage of the surrounding reference area.

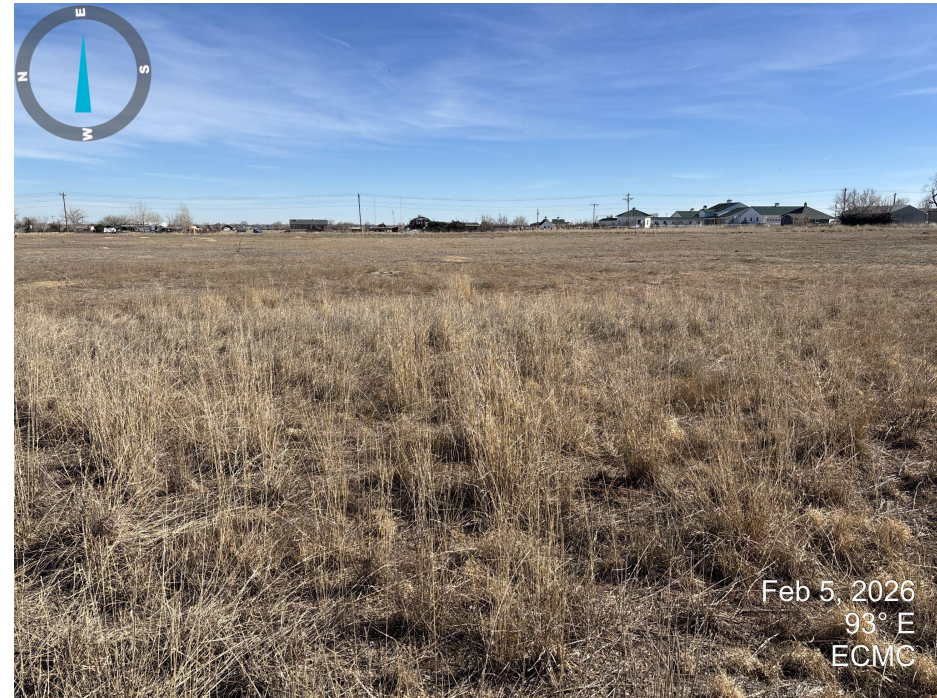
Photo 2. Looking east from the wellbore area. Desirable perennial vegetation appears to have reached 80% coverage of the reference area.

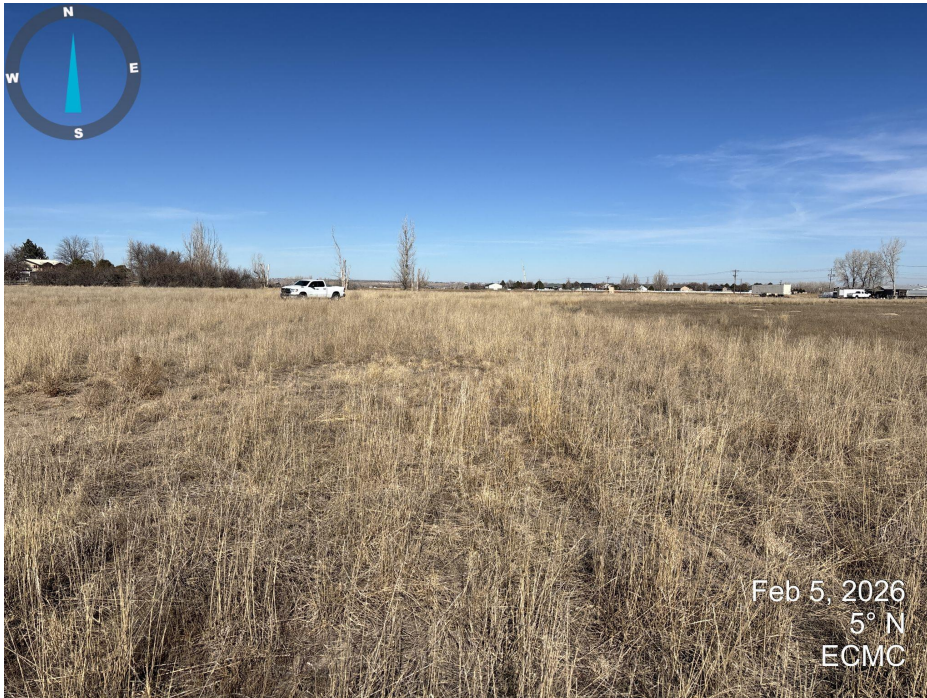
Photo 3. Looking north from the wellbore area. See photo 2 comments.

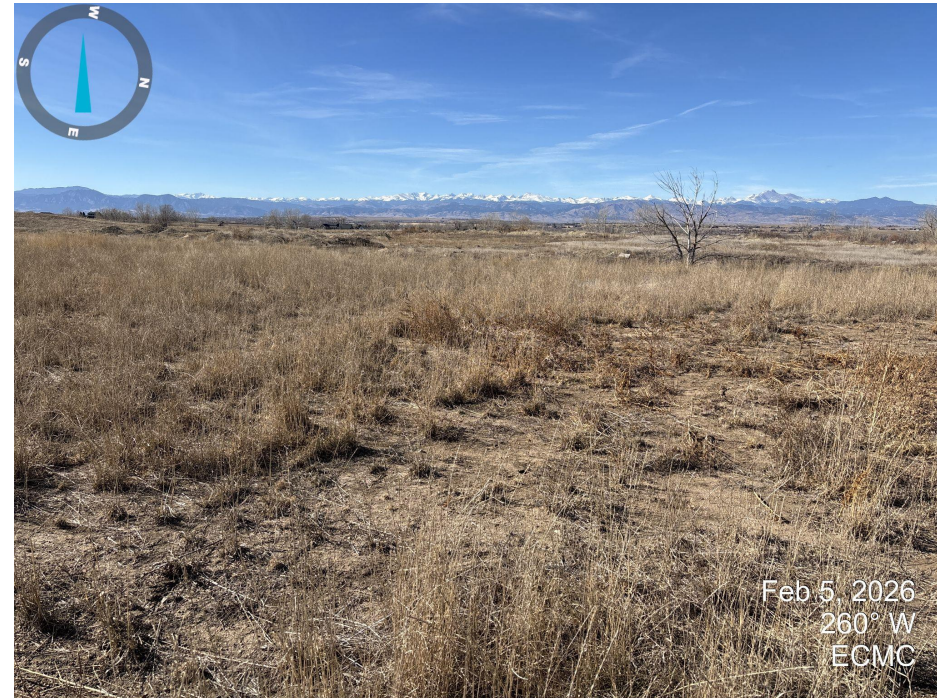
Photo 4. Looking west from the wellbore area. There is a prairie dog den in this area that has grazed vegetation. Desirable vegetation is present in this area and appears to have reached 80% coverage of the nearby reference area.

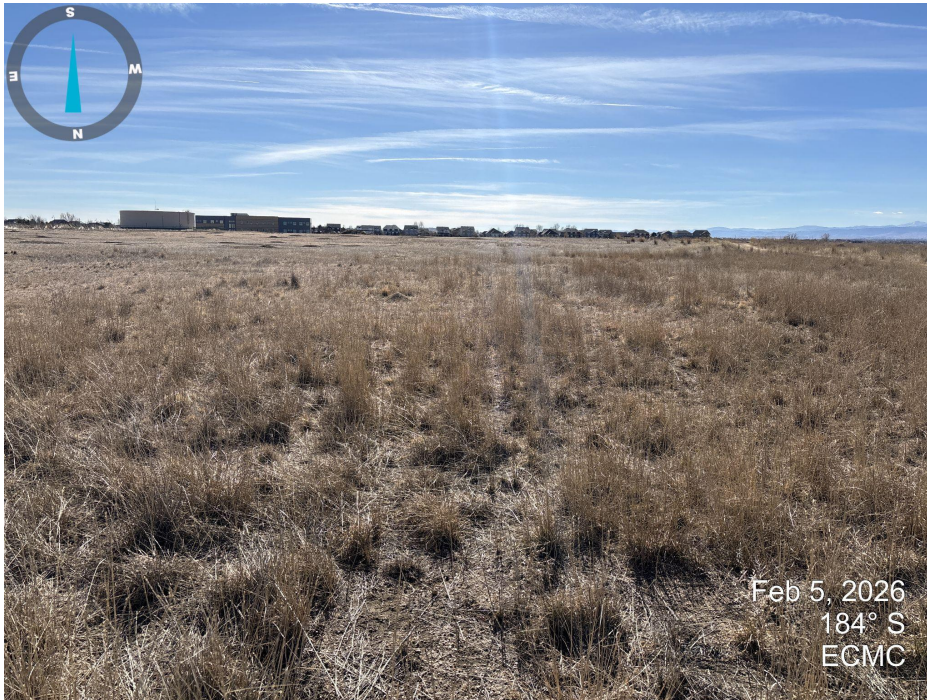
Photo 5. Looking south from the wellbore area. See photo 2 comments.

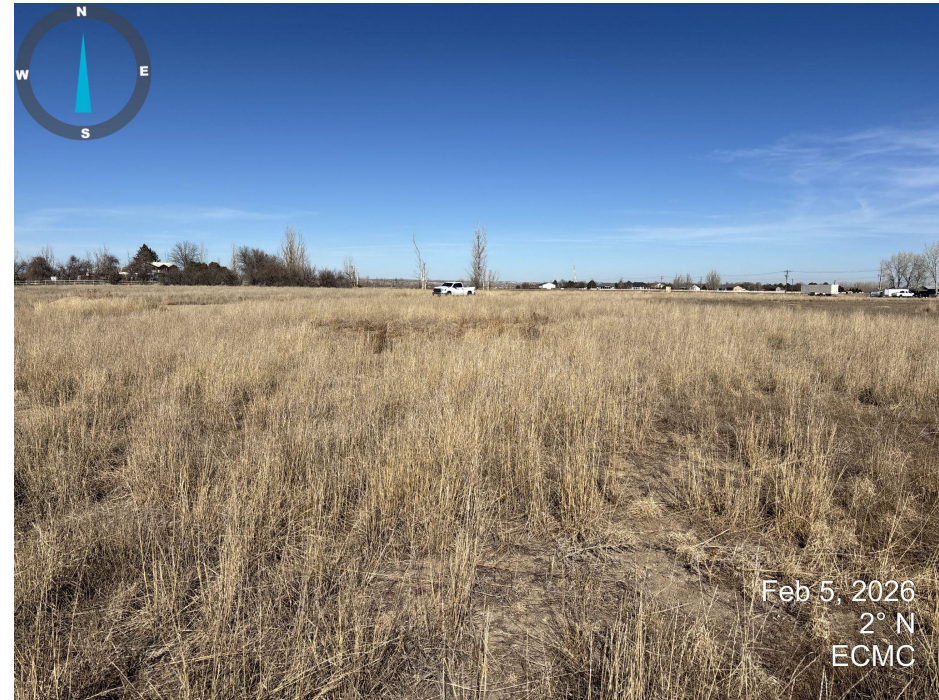
Photo 6. Looking north across the location from the south edge of the location. See photo 1 comments.

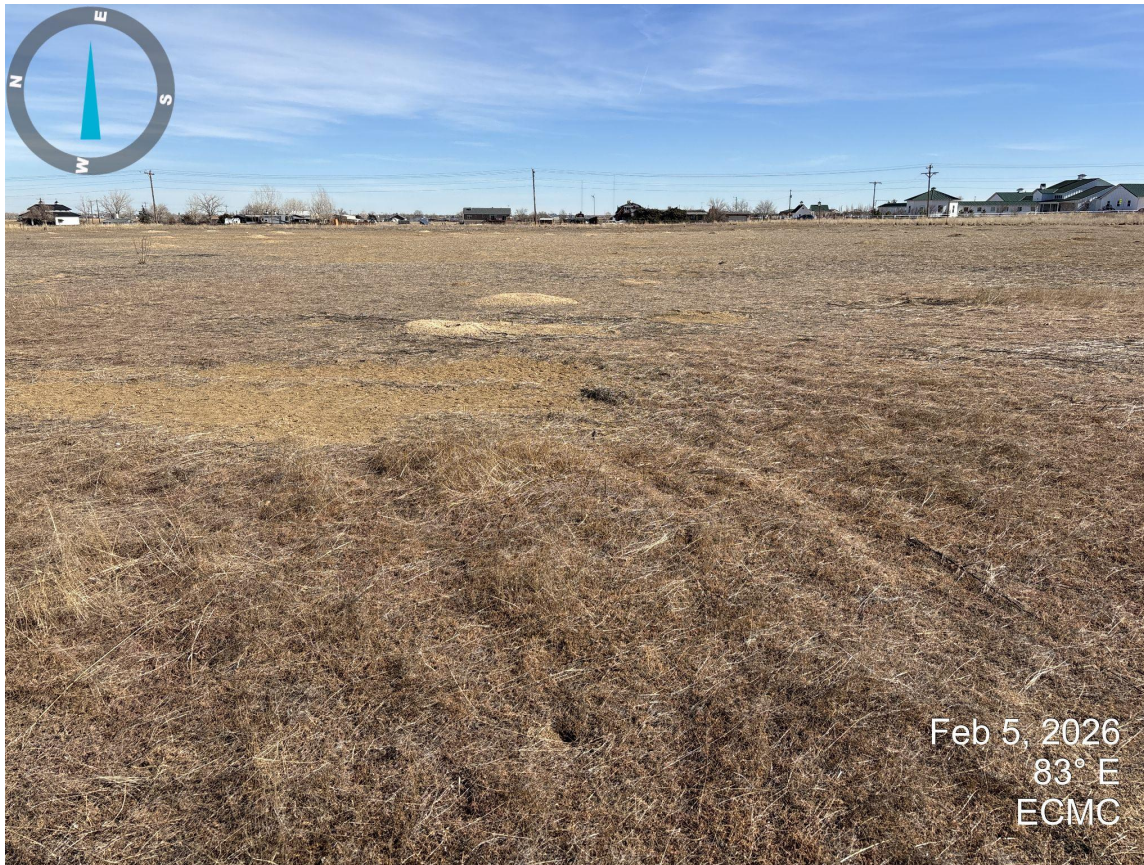
Photo 7. Reference vegetation to the east of the well location.

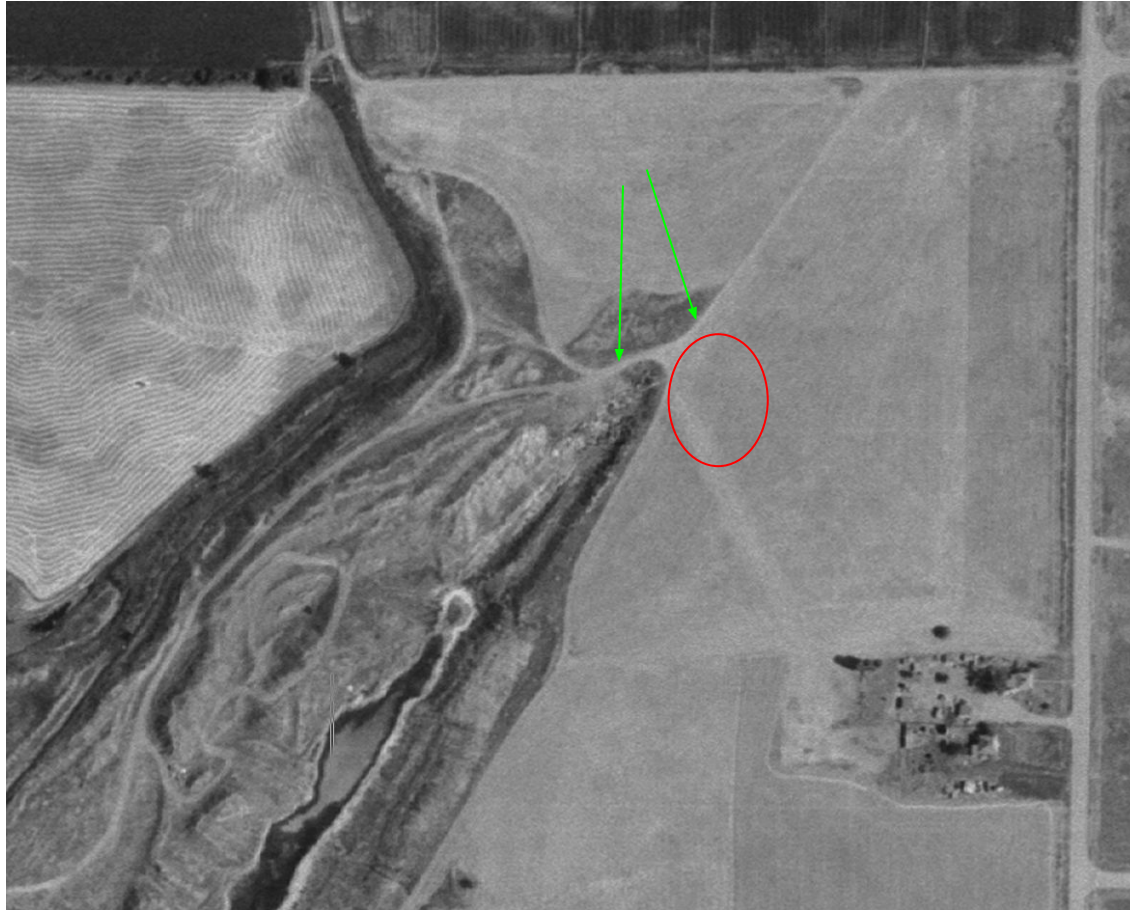
Photo 8. Historical aerial imagery taken 08/1971. The main access road (green arrows) appears to be preexisting to oil and gas. Red circle approximate location of well and tank battery.
