Subject: Lone Pine #1A - 2025 Soil Sampling

Thank you for the opportunity to support Gunnison Energy with their 2025 plug and abandonment soil sampling in Delta and Gunnison County, Colorado. This report outlines the results and data from in field soil sampling.

Lone Pine #1A

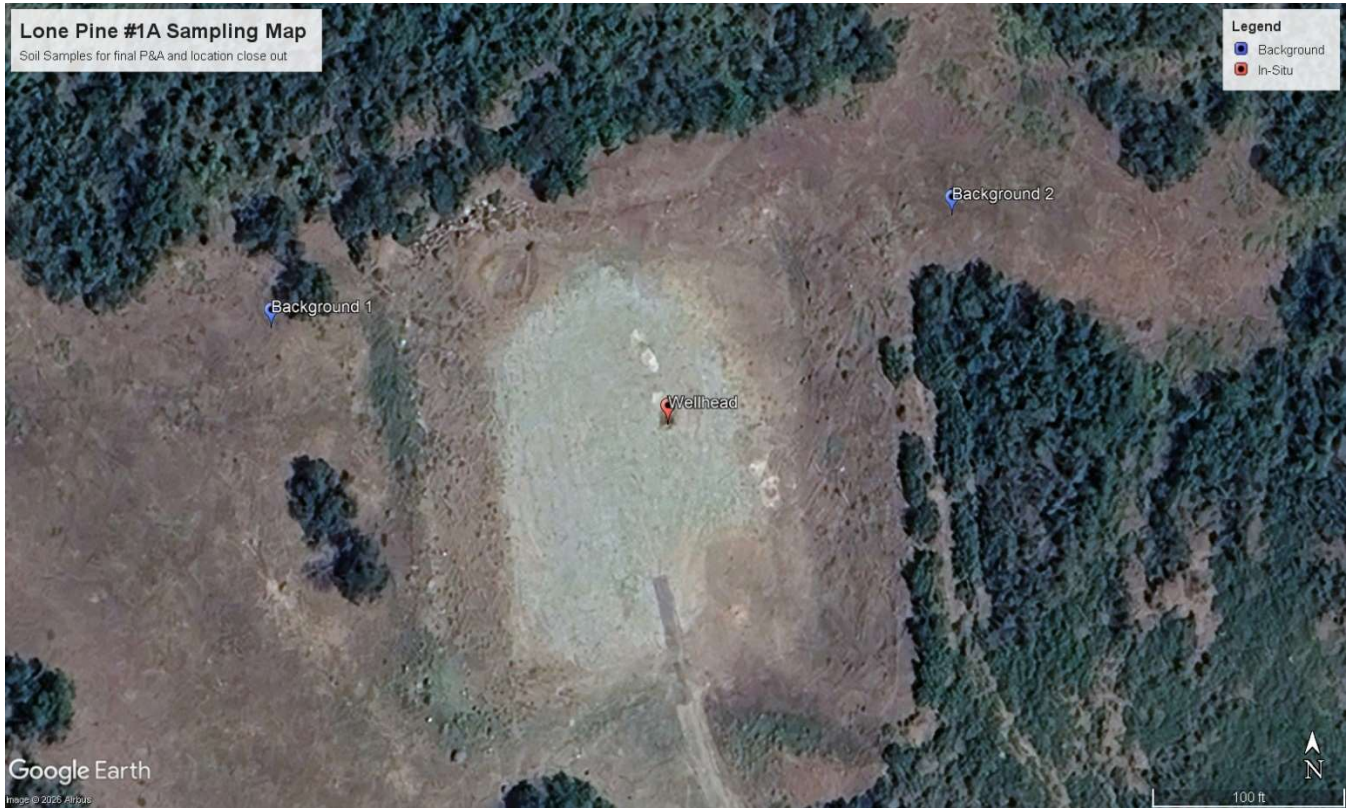
Sample Maps:

In-Situ wellhead sample was taken from the side wall of the excavated cellar prior to cut and cap. The sample was collected at the base of the cut and cap excavation of 36". The well was not connected to a flowline as the well never produced. The remaining side wall inspection indicated no other signs of impact.

Background sample 1 was taken at a depth of 12" below ground level, to be used as a shallow comparison. Background sample 2 was taken at 36" below ground level, to be used as deep comparison for wellhead in-situ.

TAQ Sample Name	Origins Sample Name	Lat	Long
Lone Pine #1A Wellhead	Cone Pine WH	39.98758	-107.50600
Lone Pine #1A Background 1	Cone Pine BG1	38.989772	-107.50671
Lone Pine #1A Background 2	Cone Pine BG2	39.98787	-107.50549
