**Storm Water Management and Erosion control**  
**Location Name: LARAMIE ENERGY LLC CC 0797-05-52 Pad**  
**Location ID: 334774**

**Location Overview: Location is within High  
Priority/Density/Black Bear Habitat areas & in close proximity  
to NSO Habitat area. Location is approximately 250 yards  
from Conn Creek.**

**Section/Township/Range: 5 7S97W**

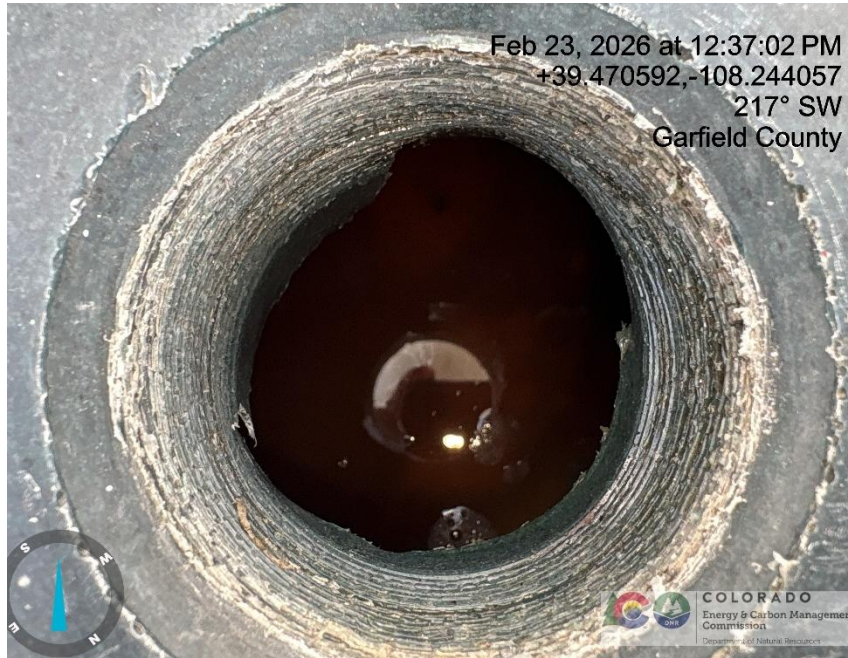
**Photo # 2343 Failure to maintain chemical BMP – Chemical tank containment approximately 3/4 full of fluid/BMP not sufficient to contain possible spill**

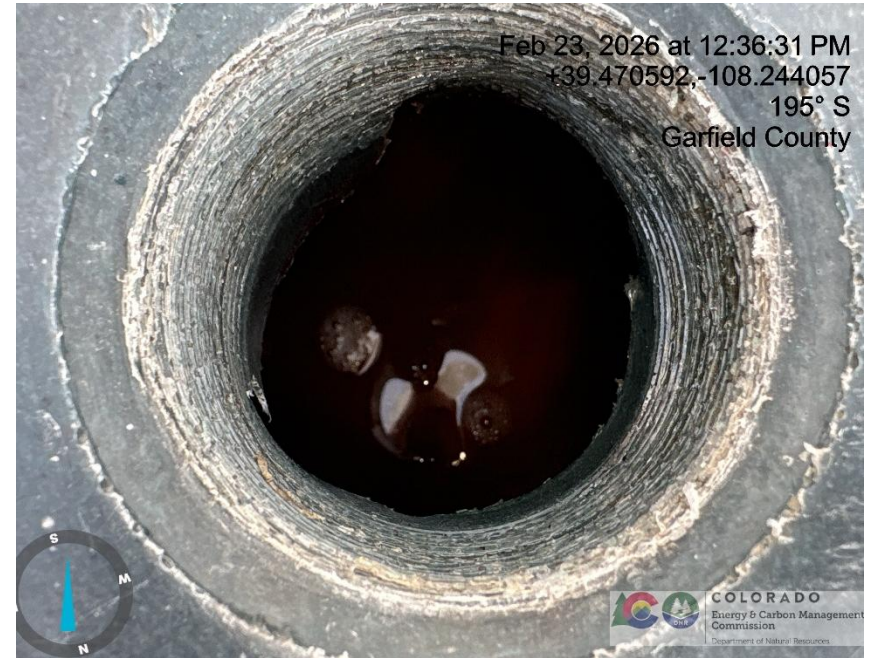
**Photo # 2344 Failure to maintain chemical BMP – Chemical tank containment approximately 3/4 full of fluid/BMP not sufficient to contain possible spill**

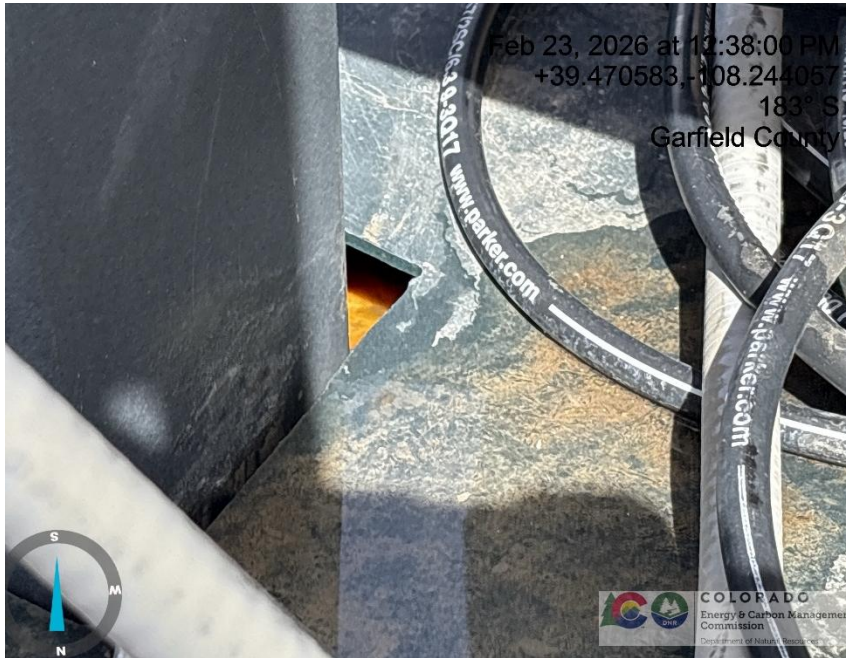
**Photo # 2345 Failure to maintain chemical BMP – Chemical tank containment approximately 3/4 full of fluid/BMP not sufficient to contain possible spill**
