Final Reclamation Inspection

Operator: KERR MCGEE OIL & GAS ONSHORE LP - 47120

Location ID: 309706

Inspection Photos
Location Name: LUCKY L #09-25
Location ID: 309706

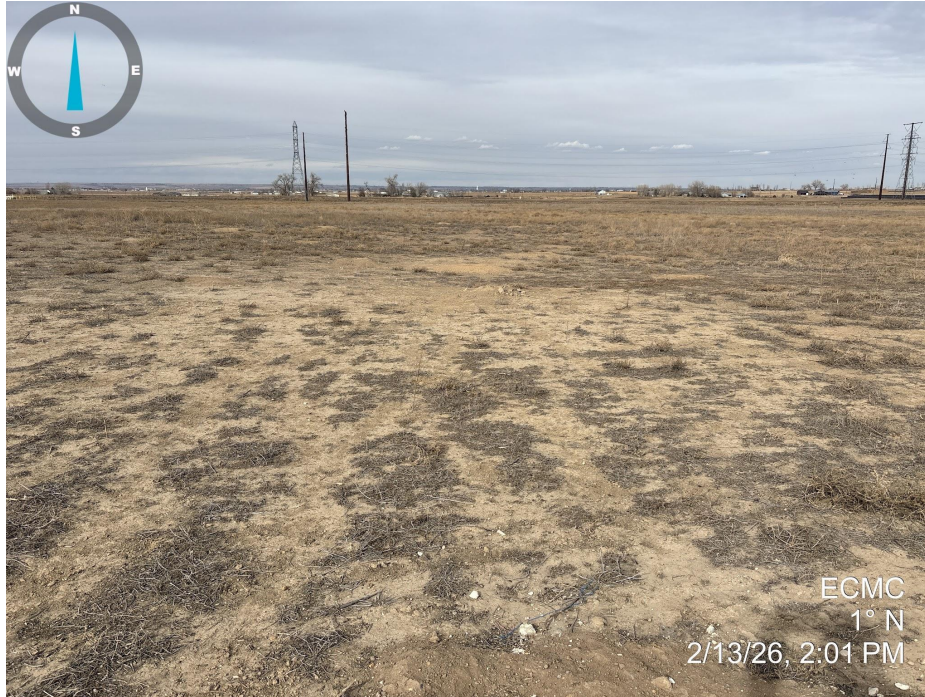
Photo 1. Photo taken of the well location, facing north. Photo illustrates that final reclamation activities appear to have taken place, with evidence of drill row seeding, but vegetation establishment does not meet Rule 1004 standards. Weedy annual vegetation including kochia (*Bassia scoparia*) and russian thistle (*Salsola tragus*) were observed across the location.

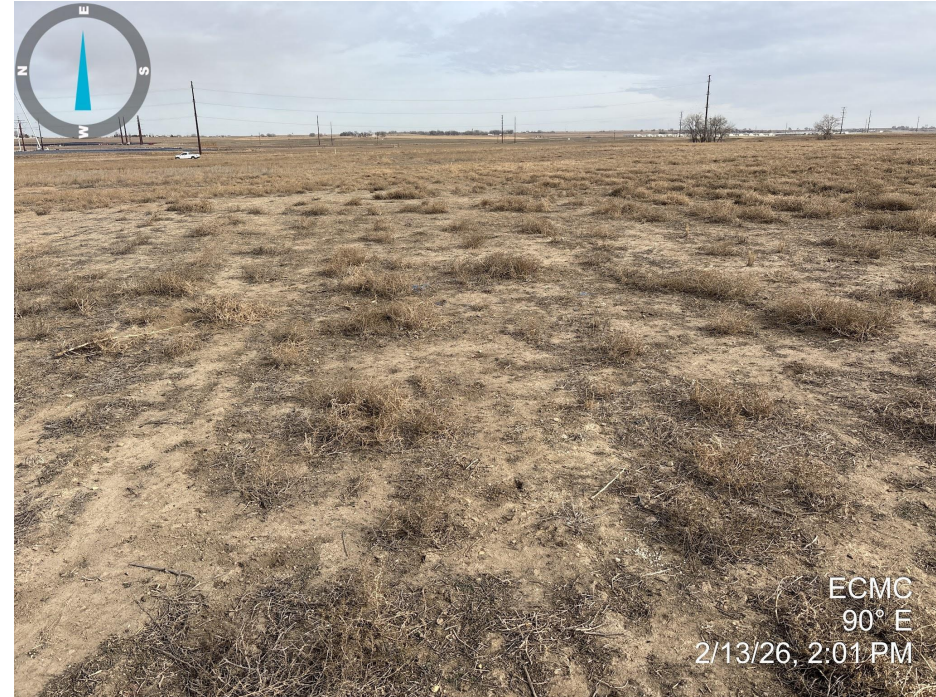
Photo 2. Photo taken of the well location, facing east. See comments under Photo 1.

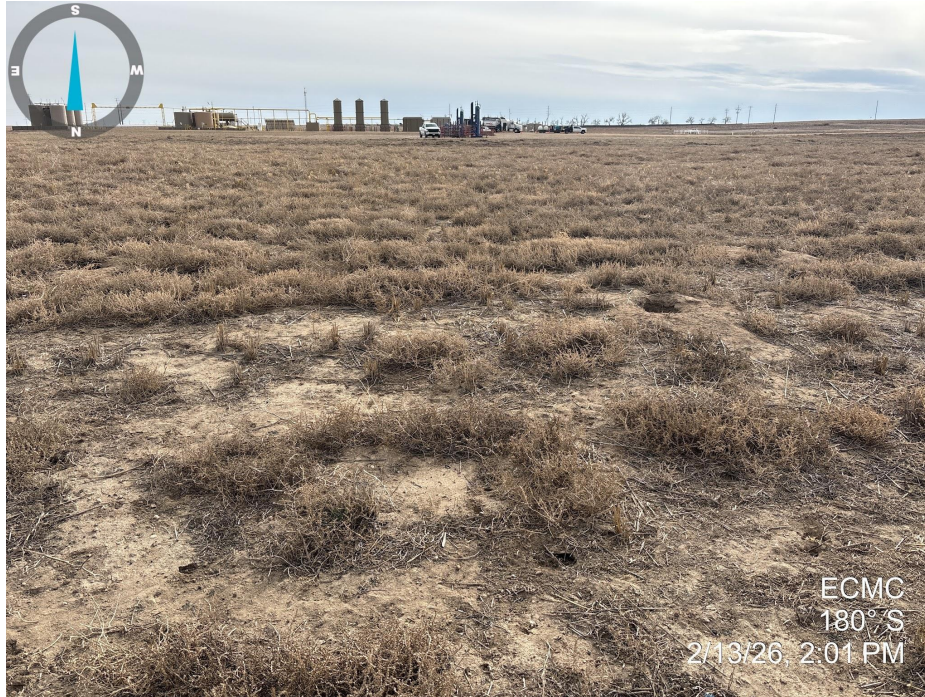
Photo 3. Photo taken of the well location, facing south. See comments under Photo 1.

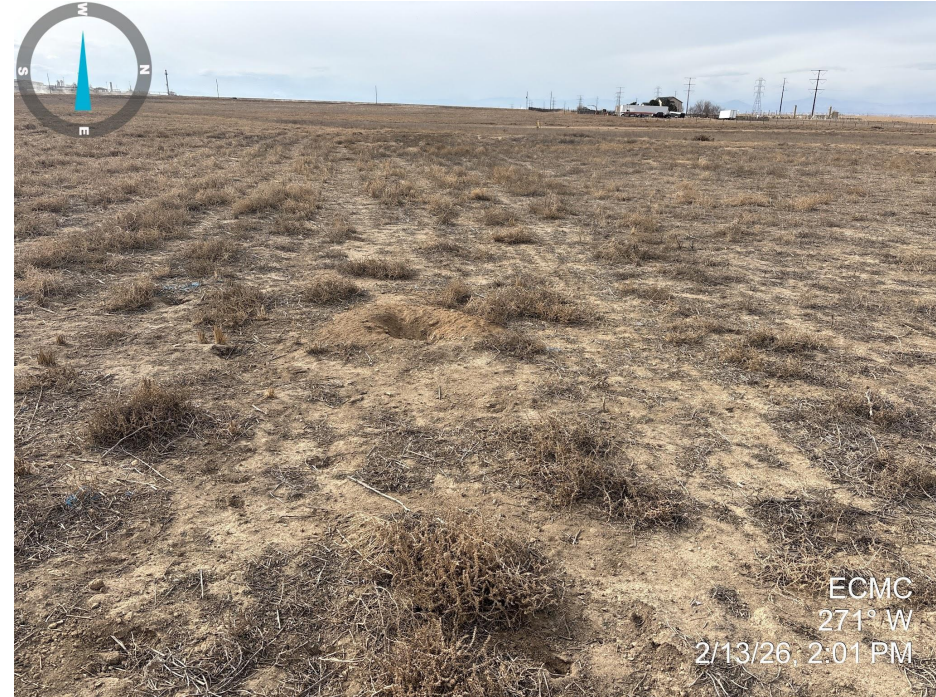
Photo 4. Photo taken of the well location, facing west. See comments under Photo 1.

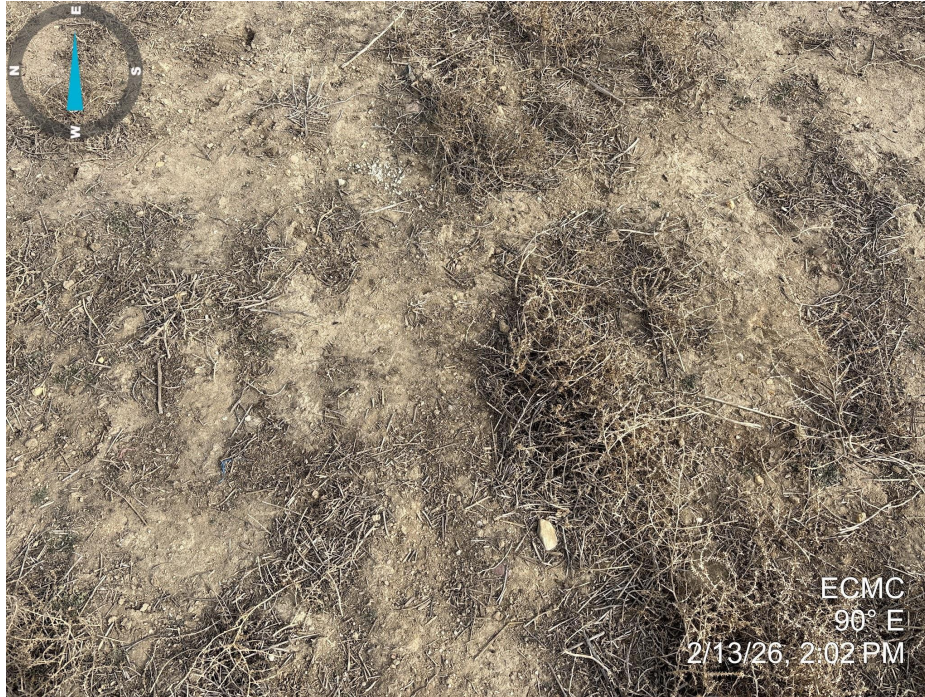
Photo 5. Photo taken of ground cover at the well location. Photo illustrates bare ground and weedy annual vegetation including kochia (*Bassia scoparia*) and russian thistle (*Salsola tragus*).

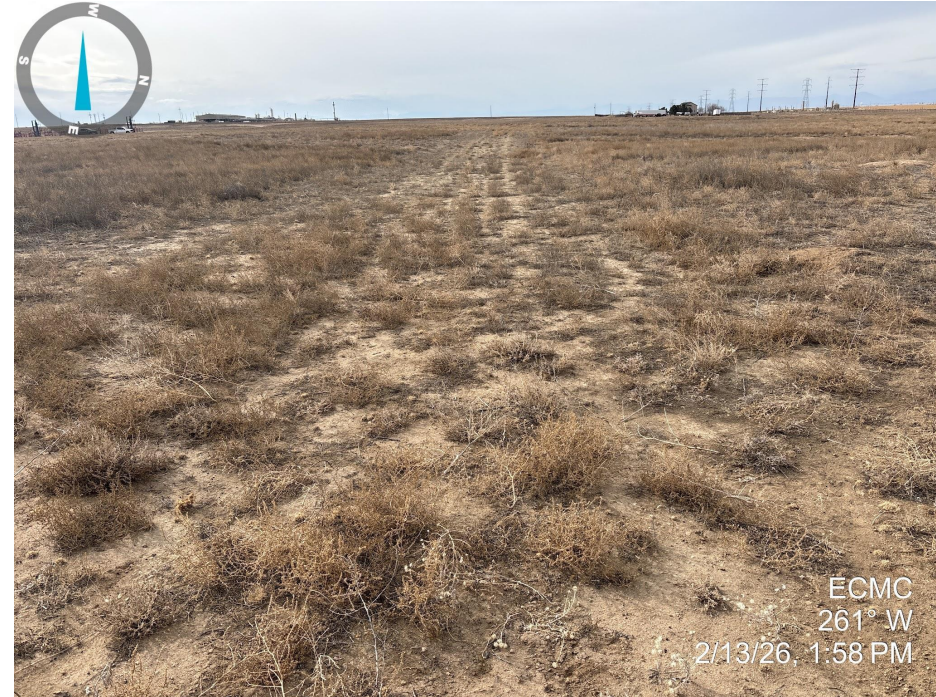
Photo 6. Photo taken of the access road to the location, facing west, towards the location. Photo illustrates that final reclamation activities appear to have taken place, but vegetation has not established to Rule 1004 standards. Weedy annual vegetation including kochia (*Bassia scoparia*) and russian thistle (*Salsola tragus*) were observed along the access road.

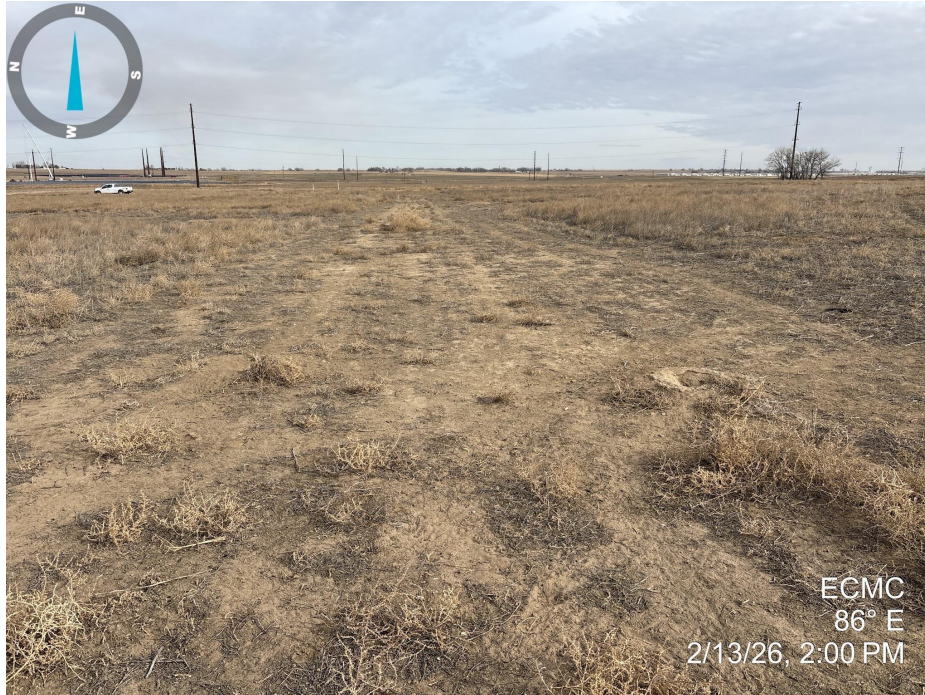
Photo 7. Photo taken of the access road to the location, facing east, away from the location. See comments under Photo 6.

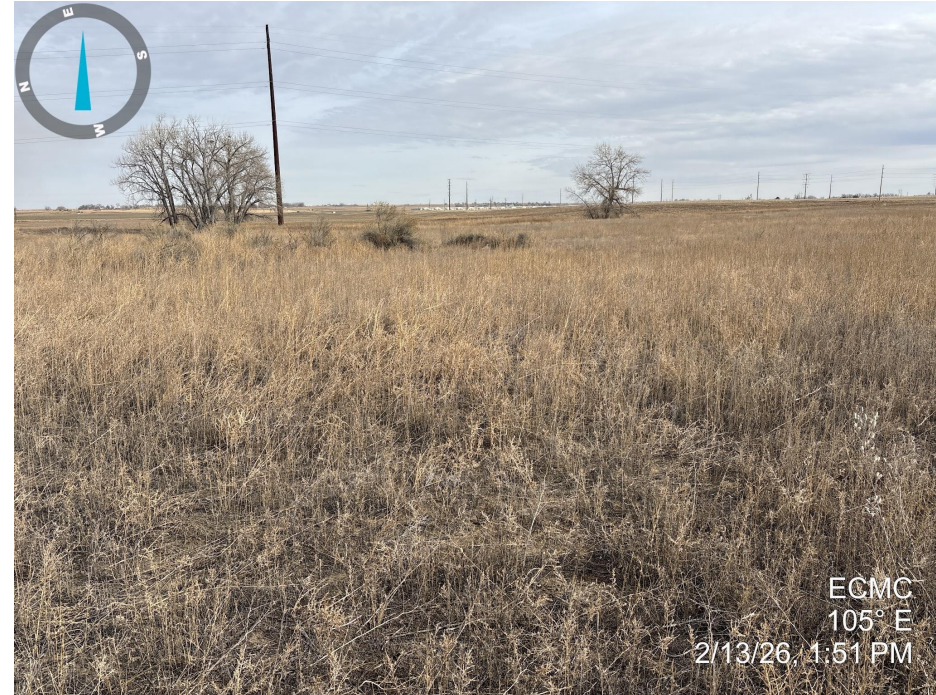
Photo 8. Photo taken of the reference area to the location, southeast of the location, facing east. Photo illustrates perennial grass and weedy annual vegetation.
