# Final Reclamation Inspection

Operator: KERR MCGEE OIL & GAS ONSHORE LP - 47120

Location ID: 327214

Inspection Photos  
Location Name: HSR-STUBBEN #11-26A  
Location ID: 327214

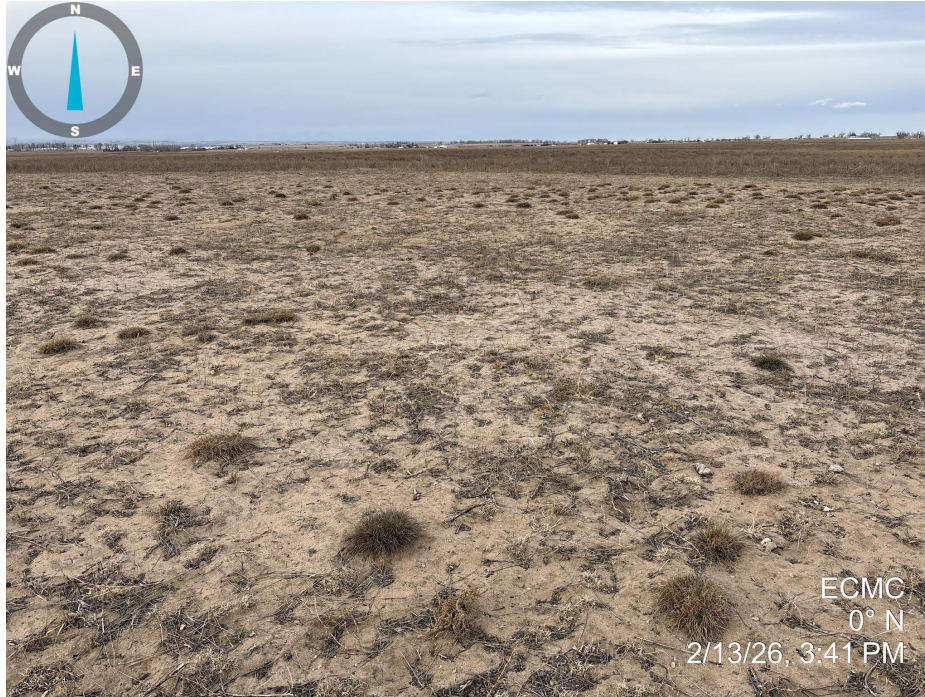
**Photo 1.** Photo taken of the well location, facing north. Photo illustrates that final reclamation activities appear to have taken place, but vegetation establishment does not meet Rule 1004 standards.

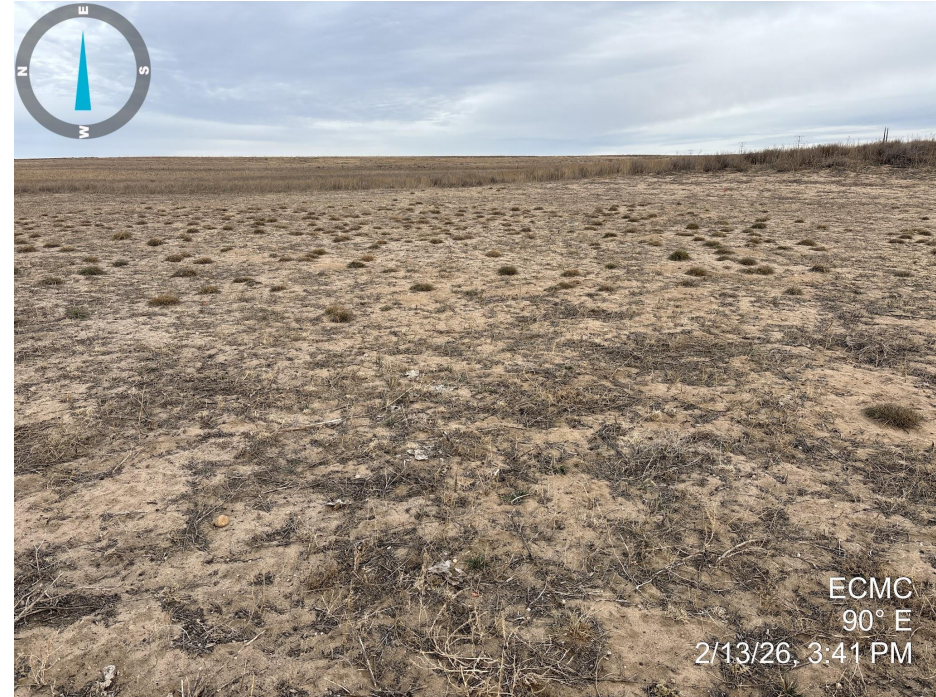
**Photo 2.** Photo taken of the well location, facing east. See comments under Photo 1.

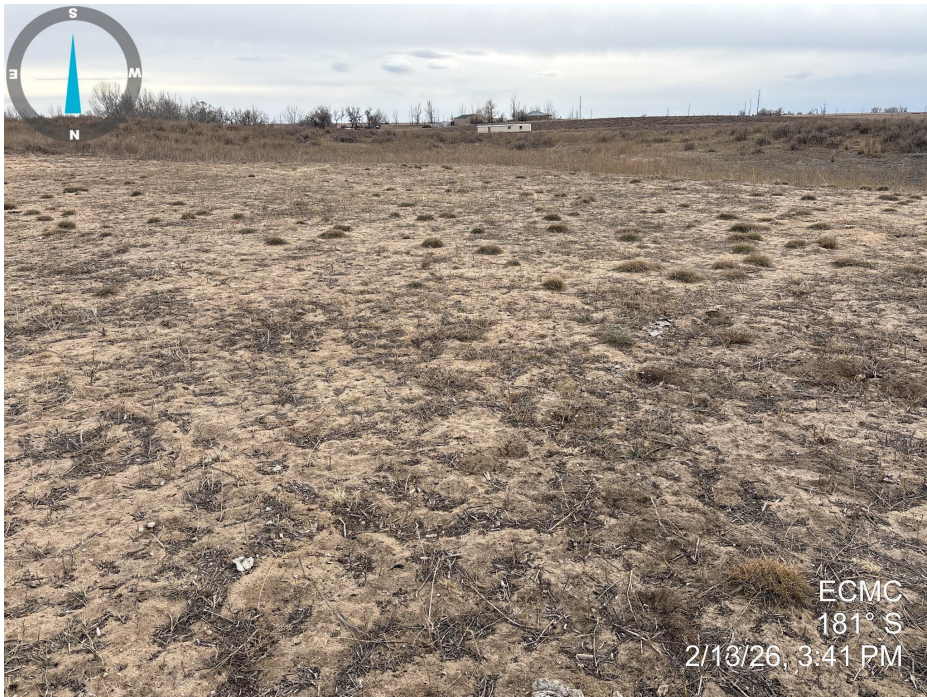
**Photo 3.** Photo taken of the well location, facing south. See comments under Photo 1.

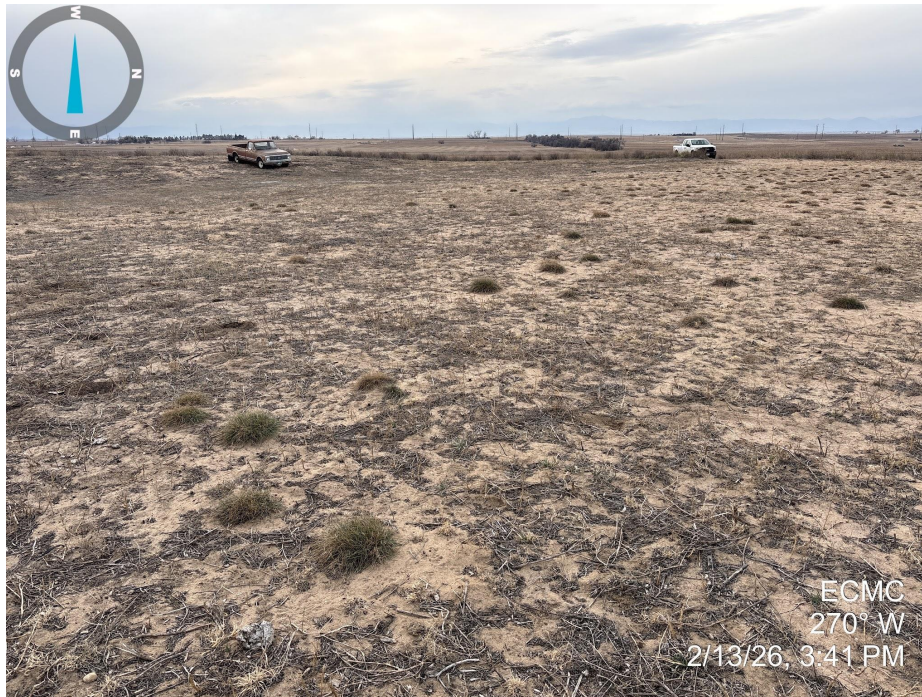
**Photo 4.** Photo taken of the well location, facing west. See comments under Photo 1.

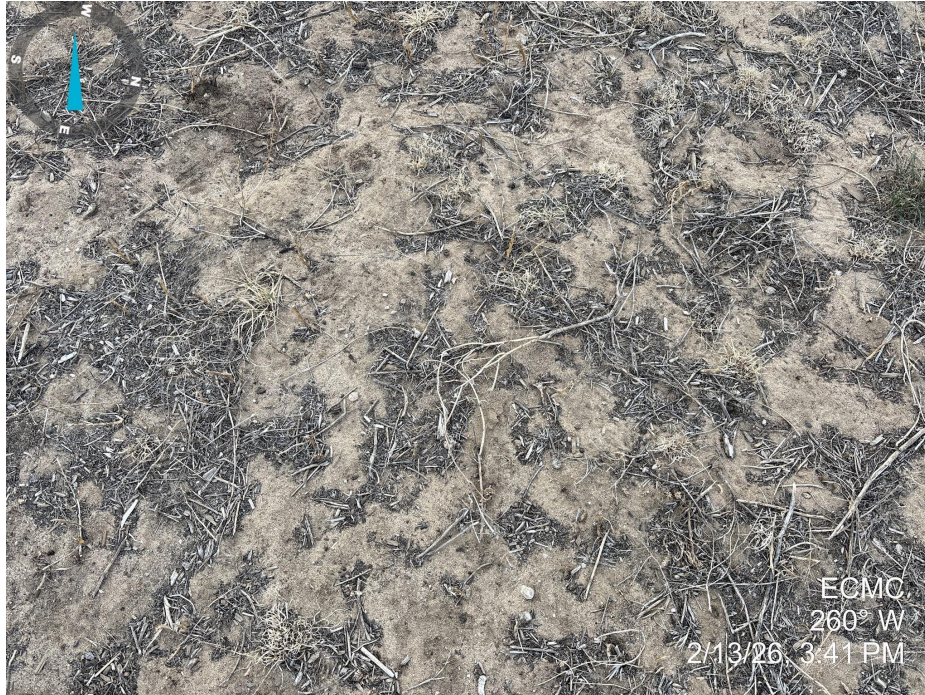
**Photo 5.** Photo taken of ground cover at the well location. Photo illustrates bare ground, mulch, and perennial grass.

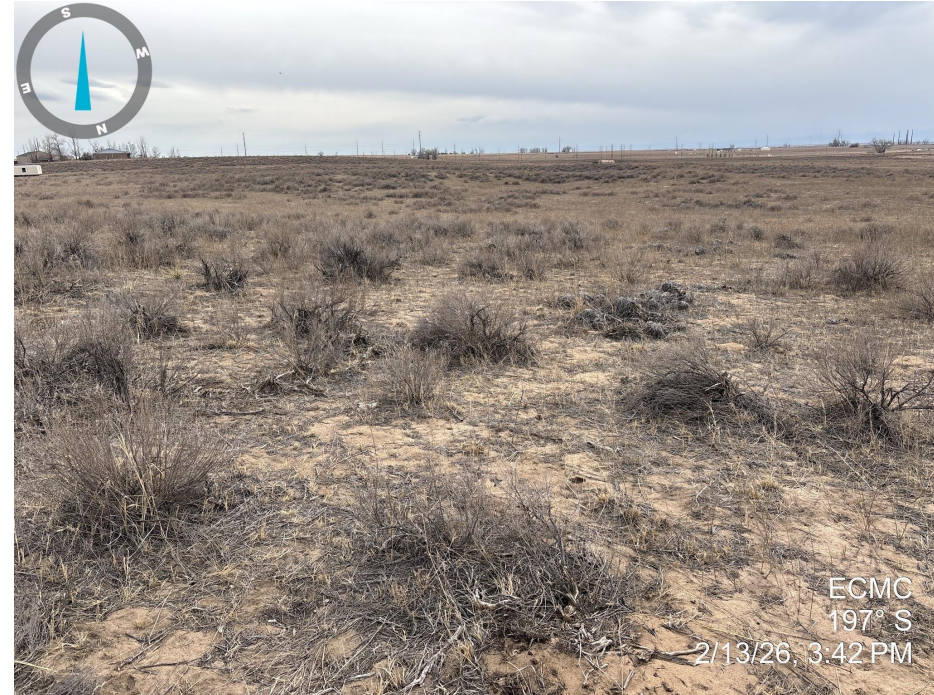
**Photo 6.** Photo taken of the reference area to the location, southwest of the location, facing south. Photo illustrates sand sagebrush and weedy annual vegetation.
