# Final Reclamation Inspection

Operator: KERR MCGEE OIL & GAS ONSHORE LP - 47120

Location ID: 336227

Location Name: HSR-BEIERLE-63N66W/26SESW

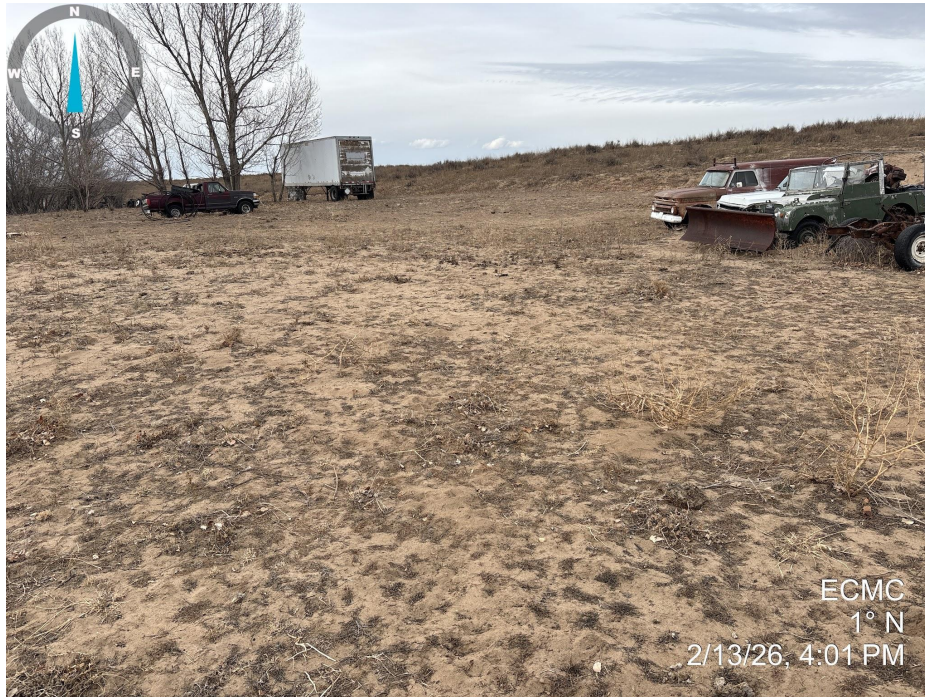
**Photo 1.** Photo taken of the multi-well location, facing north. Photo illustrates that final reclamation activities appear to have taken place, but vegetation establishment does not meet Rule 1004 standards.

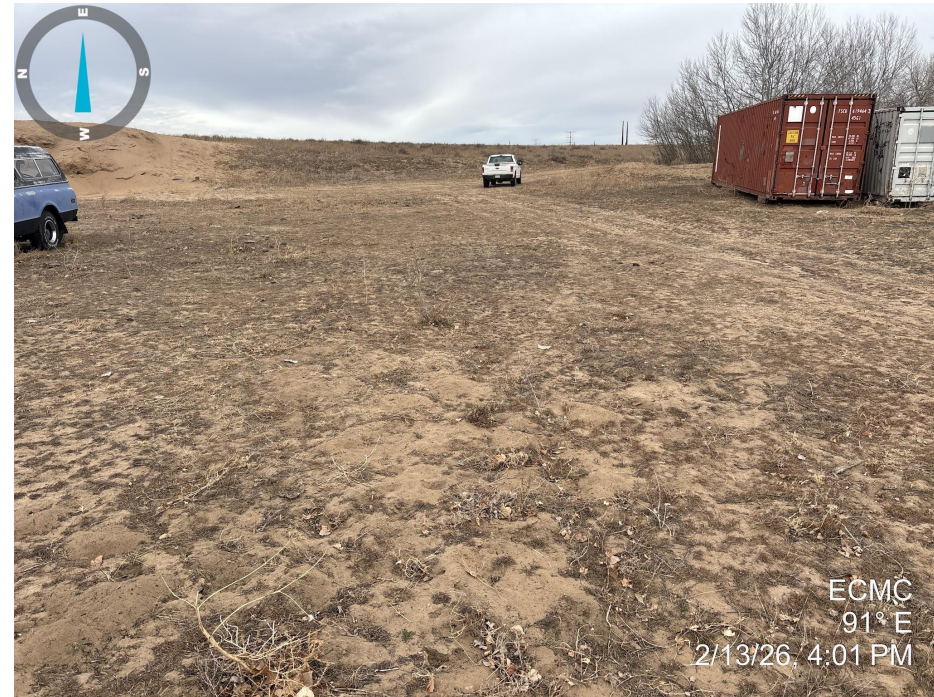
**Photo 2.** Photo taken of the multi-well location, facing east. See comments under Photo 1.

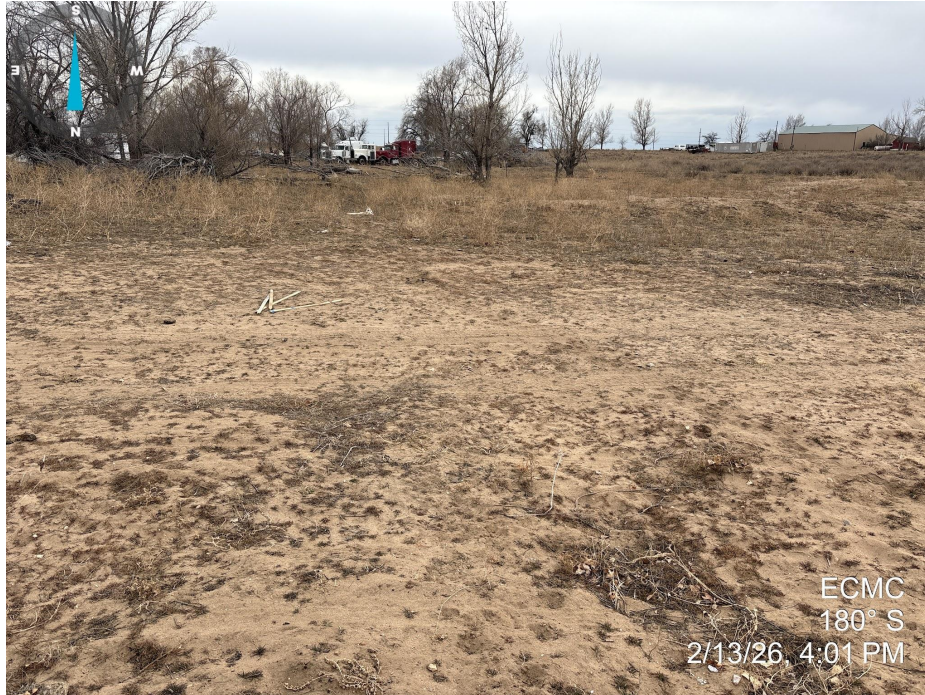
**Photo 3.** Photo taken of the multi-well location, facing south.  
See comments under Photo 1.

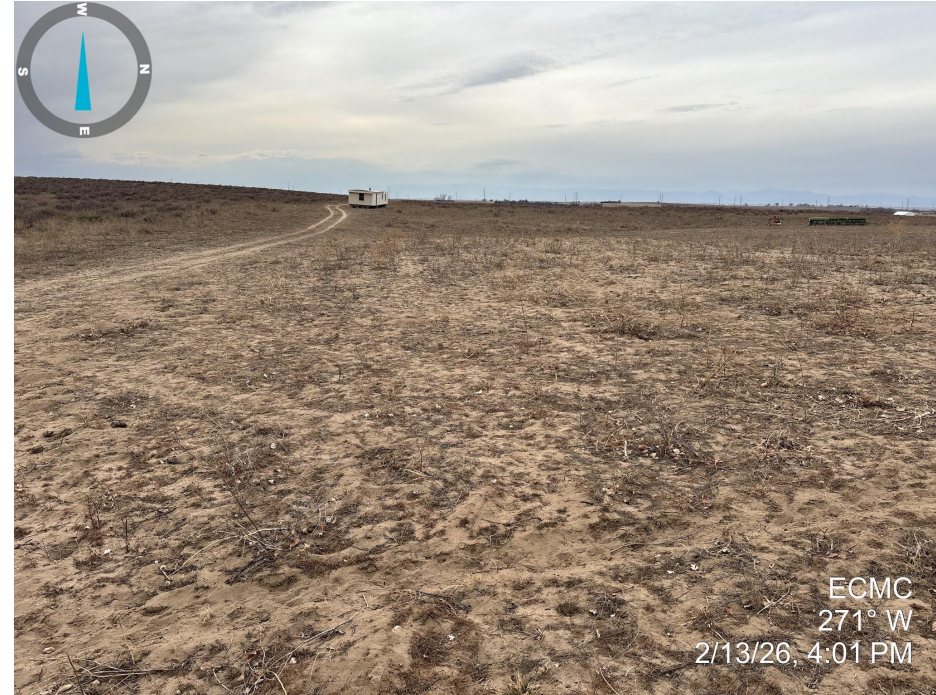
**Photo 4.** Photo taken of the multi-well location, facing west.  
See comments under Photo 1.

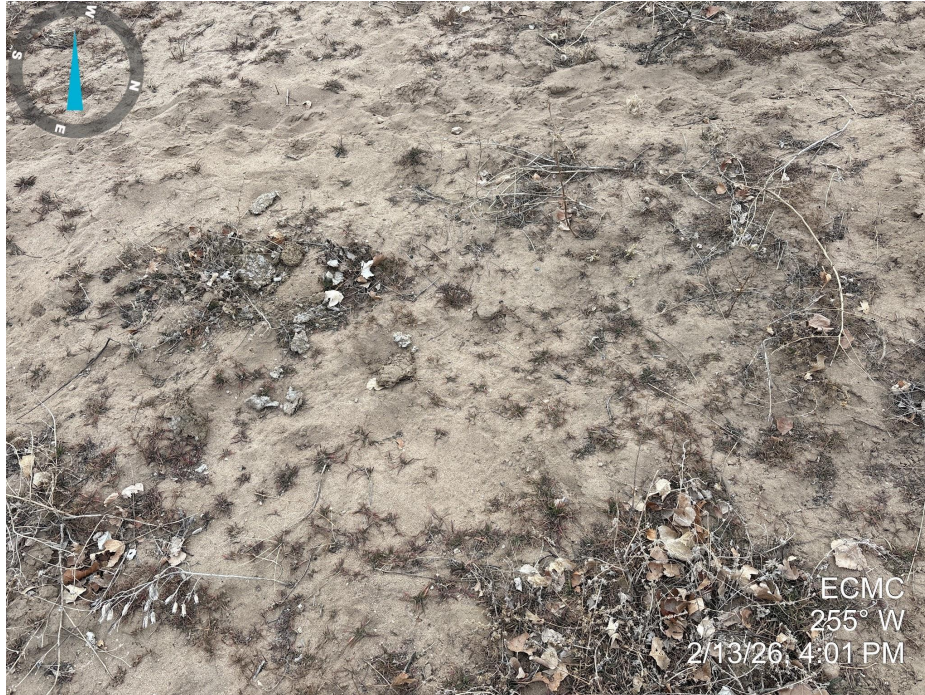
**Photo 5.** Photo taken of ground cover at the well location. Photo illustrates bare ground, perennial grass, and weedy annual vegetation.

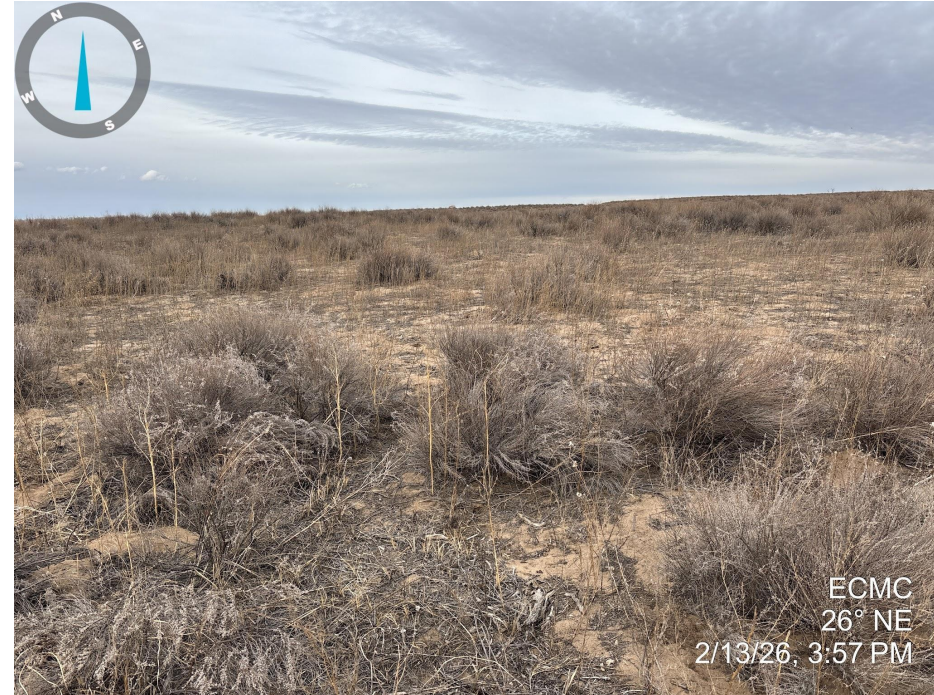
**Photo 6.** Photo taken of the reference area to the location, west of the location, facing northeast. Photo illustrates sand sagebrush, perennial grass and weedy annual vegetation.
