Final Reclamation and Stormwater Inspection

Operator: KP KAUFFMAN COMPANY INC - 46290

Location ID: 319319

Well Name: BBR ABBOTT FARMS #22-34

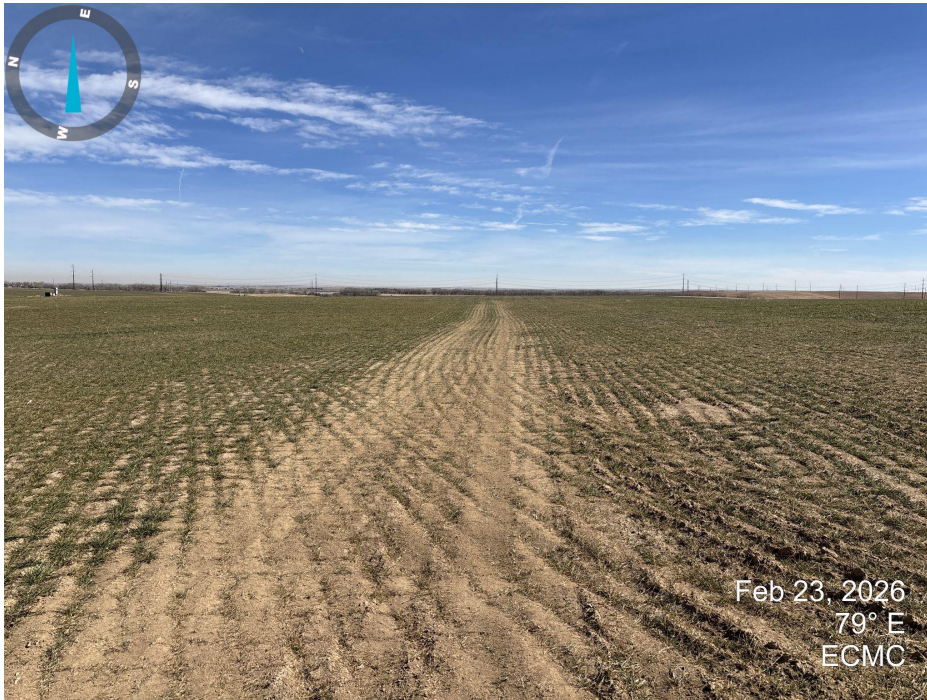
Photo 1. Looking east down access road towards the well location from well API #123-10420. Access road appears to have been planted.

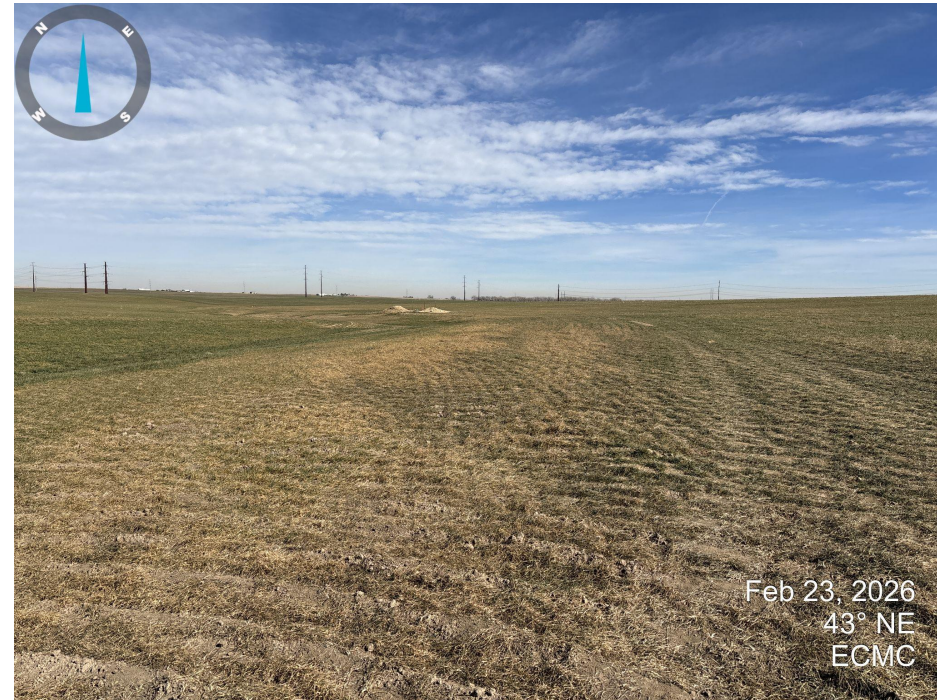
Photo 2. Looking northeast across the well location. Ste area surrounding the well has been planted.

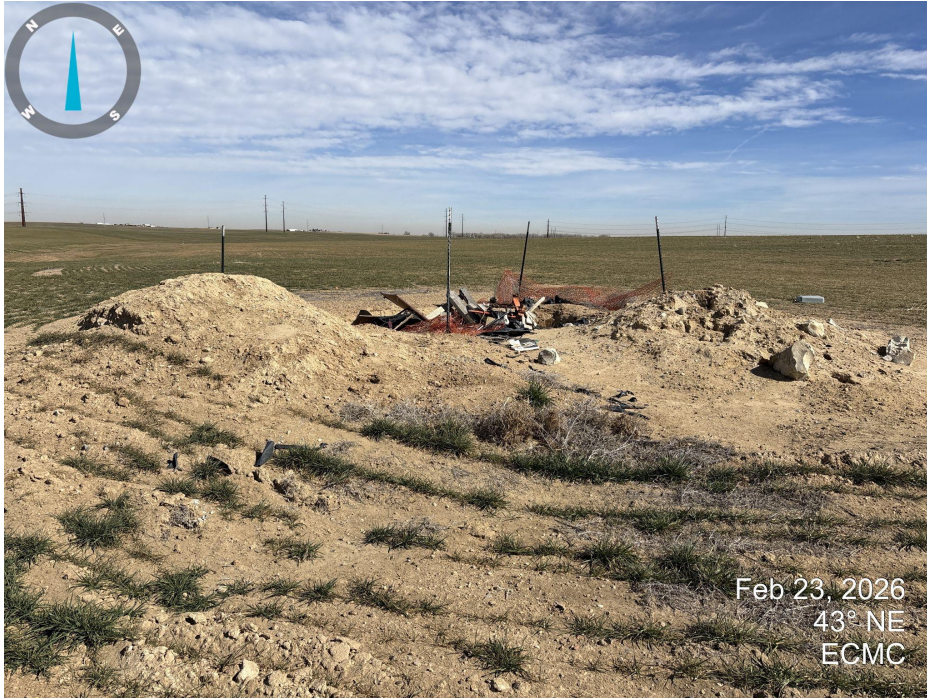
Photo 3. Looking northeast across well location. Soil piles remain on location. Excavation remains on location. Fencing around the excavation is down. The excavation is now filled with trash/debris.

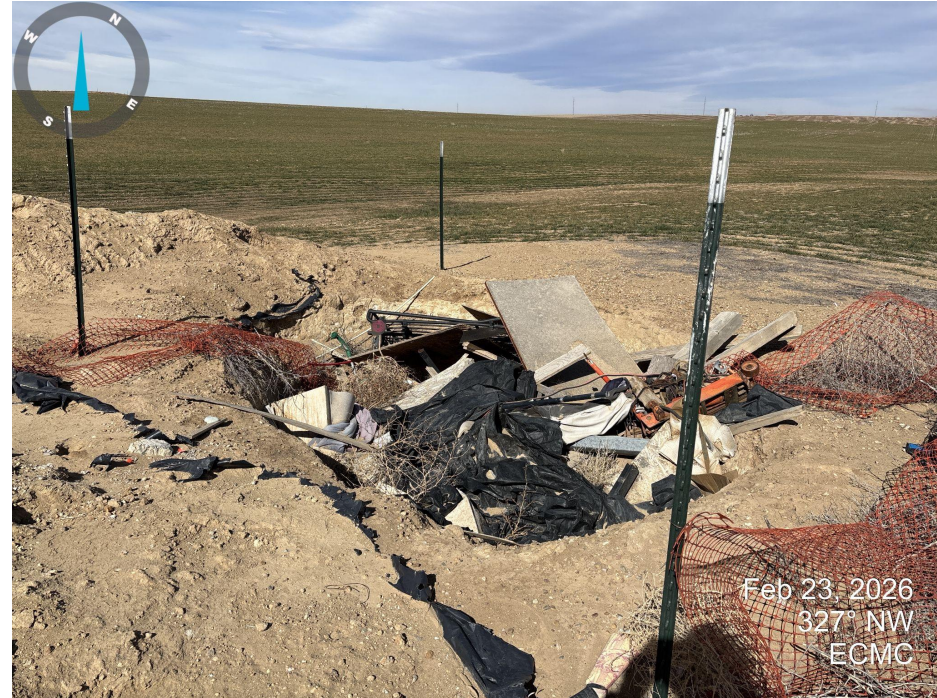
Photo 4. Looking north across the open excavation and wellhead. Trash and debris is present in the open excavation.
