Summit DJ-O Operating, LLC

Spill/Release (Form 19): Site
Documentation and Analytical
Laboratory Results

Form 19 Information Summary	
Site Name	Critter Creek 16" LACT Unit
API #	NA
Location ID	NA
Coordinates	40.916346 / -104.430332
S/T/R	SESE 16/11N/63W
Cause of Release	Equipment Failure
Date of Discovery	1/17/2026
Spill Type	Recent Spill
Land Use	Non-Cropland
Weather Conditions	30 degrees F; WNW wind; 25 mph; Fair
Surface Water	Simpson Creek 3,537 feet NE
Number of Water Wells within a 0.5 Mile Radius	0
Distance to Closest Water Well	4,112 feet W
Approximate Depth to Groundwater	28 feet below ground surface
Distance to Nearest Wetland	Riverine 3,537 feet NE
Sensitive Area / Habitat	Mule Deer Severe Winter Range and Mule Deer Winter Concentration Area
100 Year Floodplain	No
Release in Municipality	No
Fluid Released	Presumed produced fluids
Volume of Release	1bbl to 5bbl
Livestock Present	No
Soil Type(s)	Ascalon fine sandy loam
Notes: <p>On February 18, 2026, H2E directed an excavation at the Critter Creek 16" LACT unit (40.916346, -104.430332) in response to a recent spill. During excavation activities, soil was screened using a photoionization detector (PID) to evaluate the pres

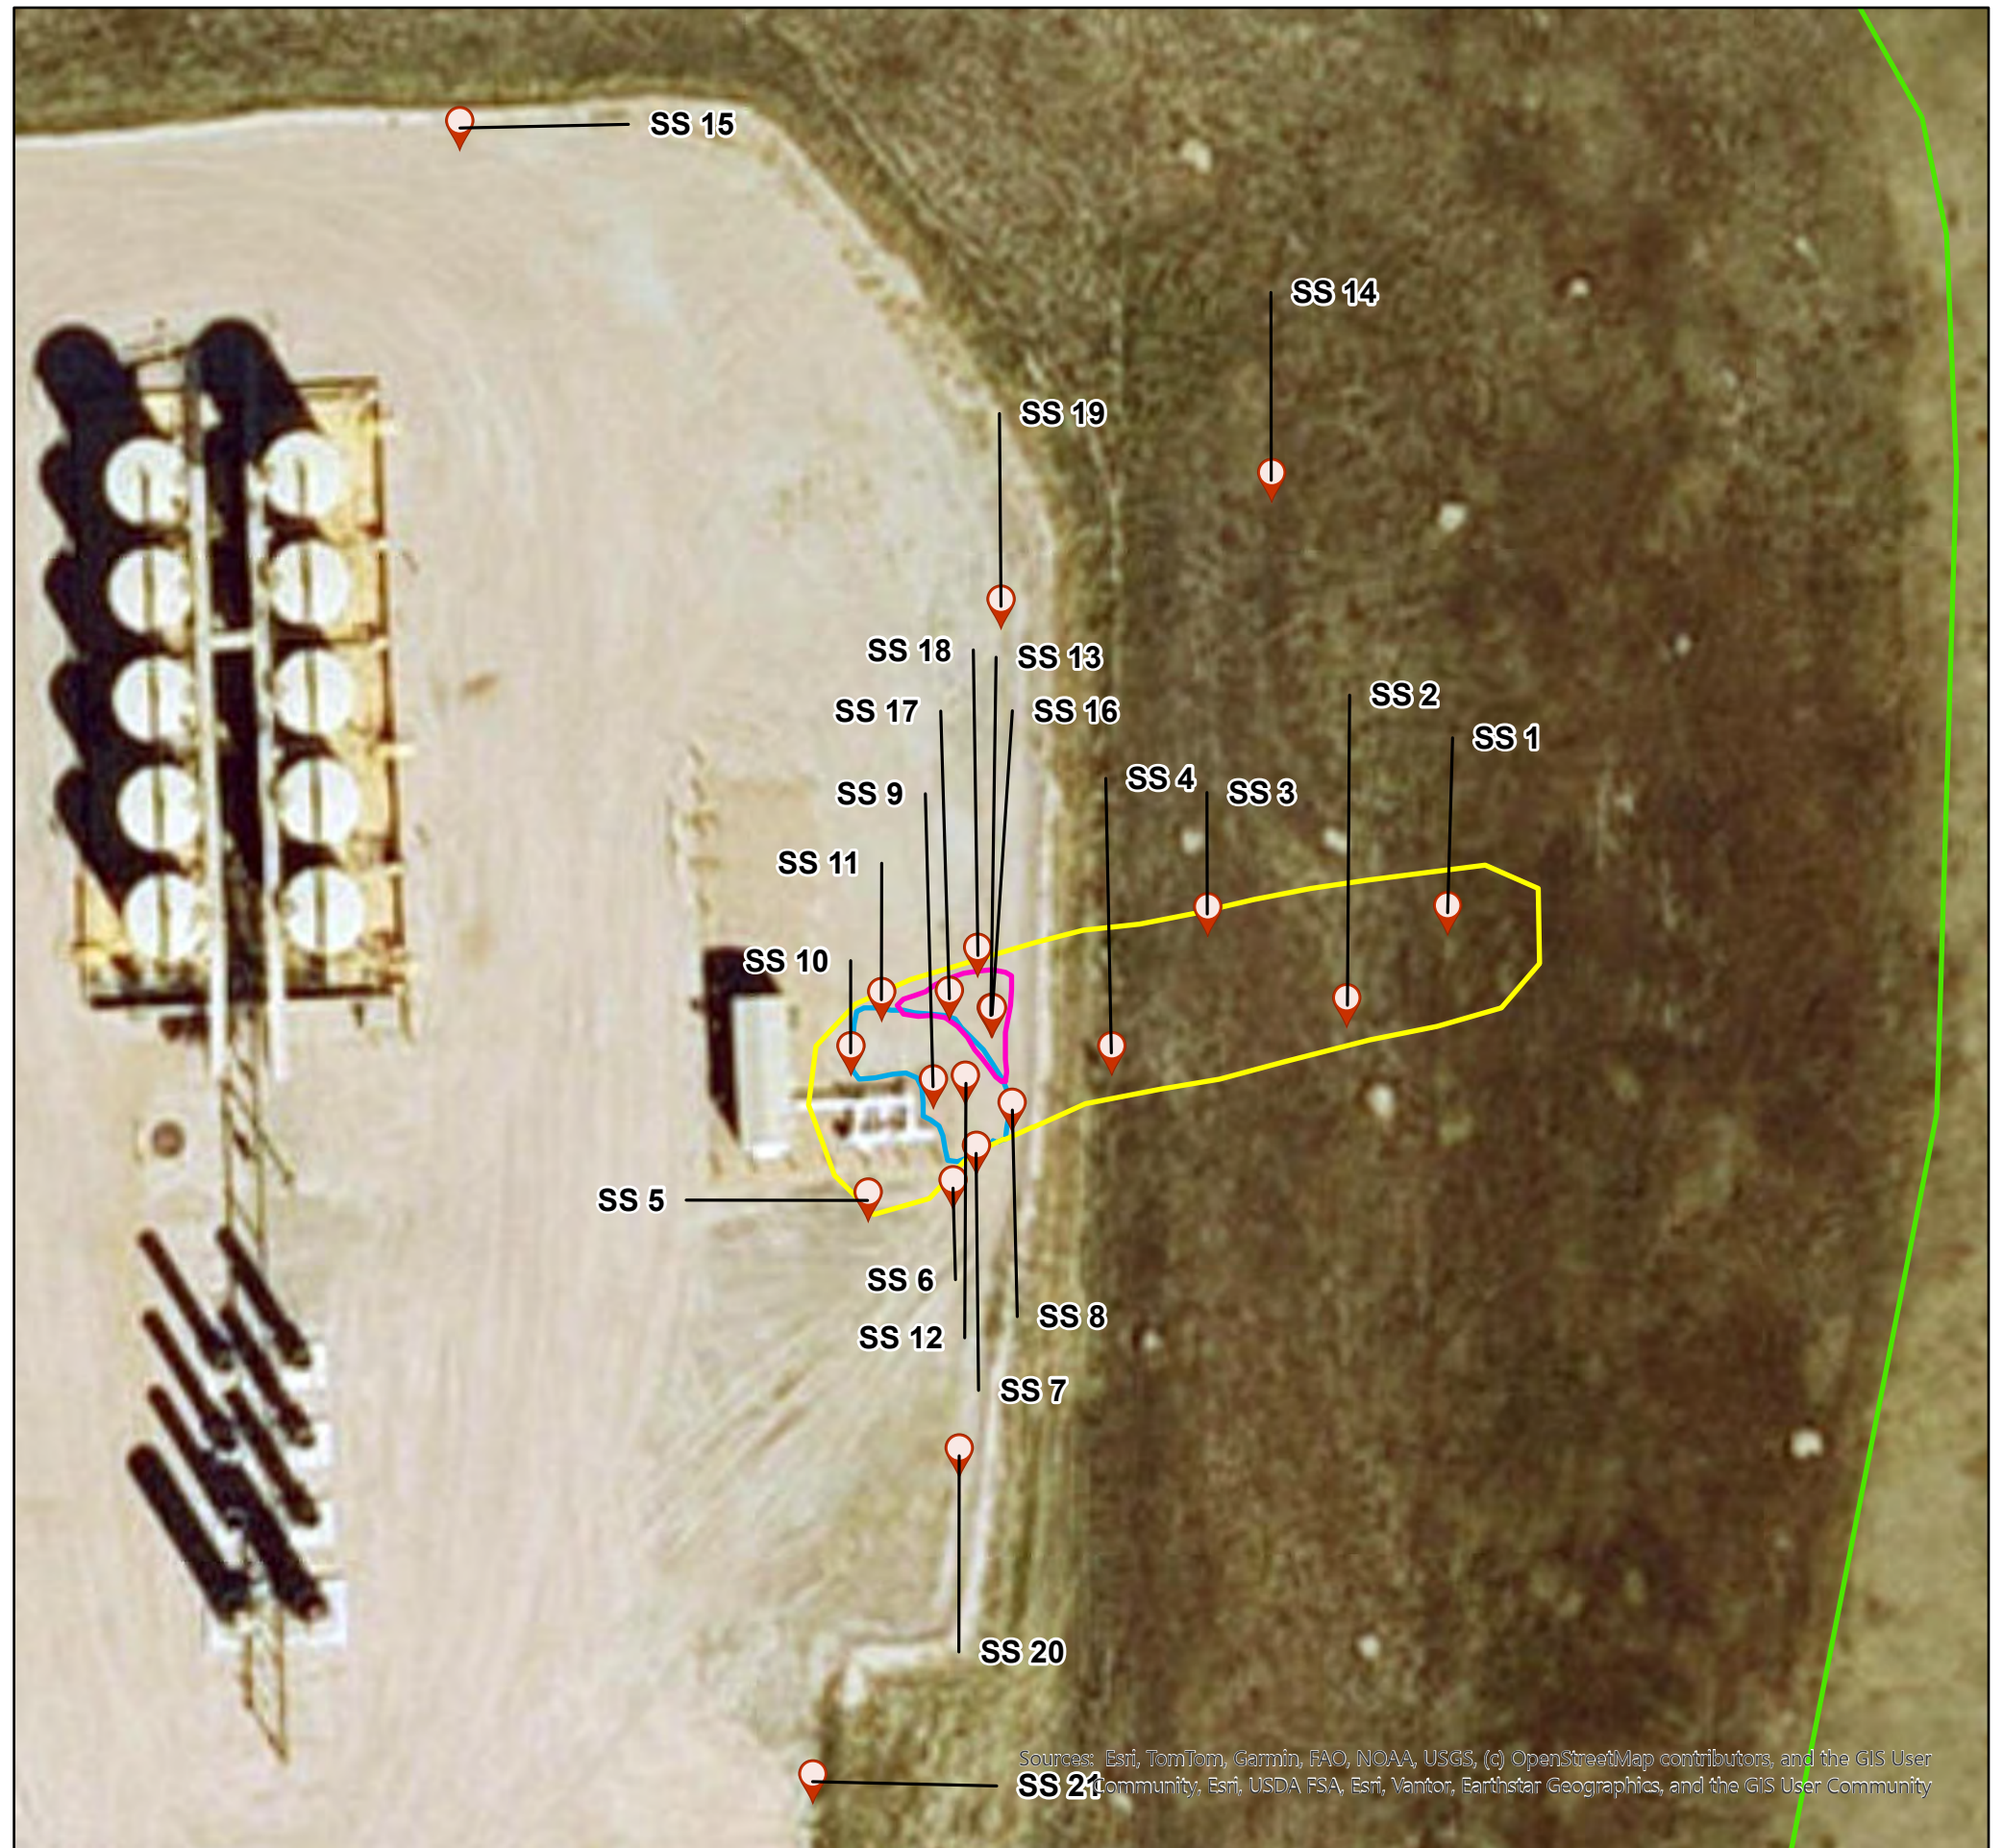
Excavation Area Map

- Soil Sample Location
- Pad Disturbance Boundary
- 2" Excavation Area
- 6" Excavation Area
- 12" Excavation Area

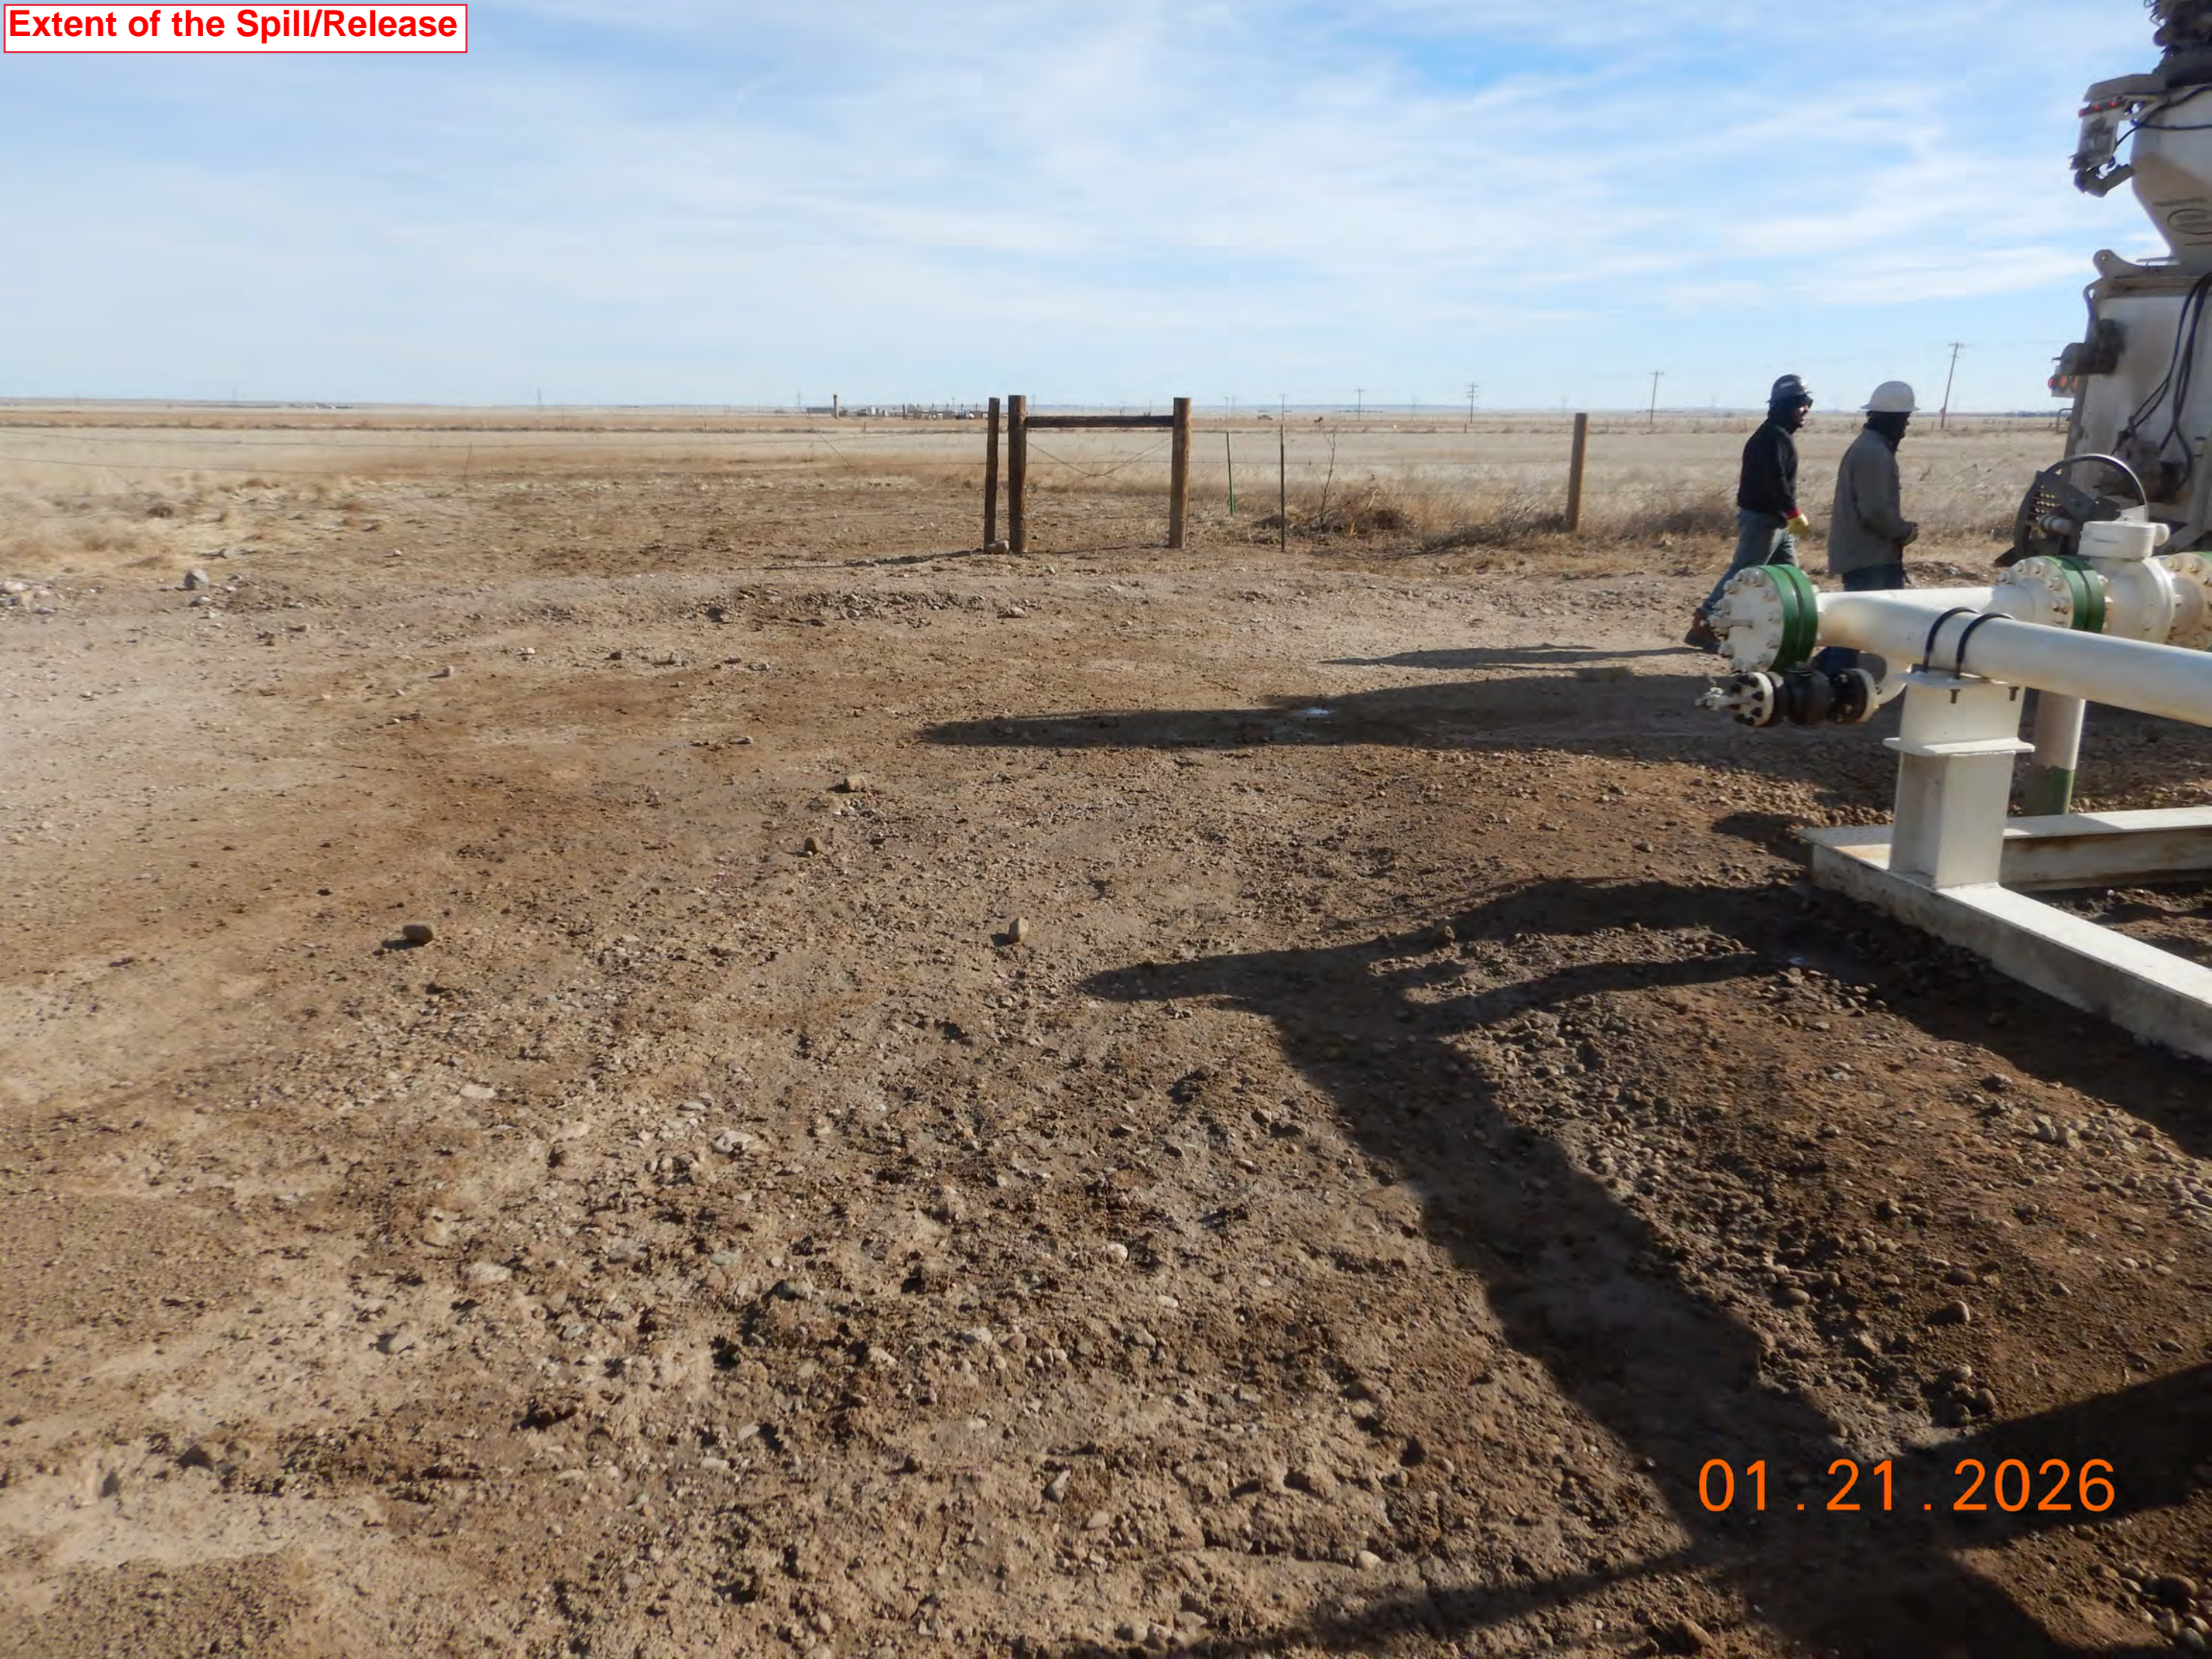
01.21.2026

Source of Spill/Release
3/4" Nipple on LACT Unit 2

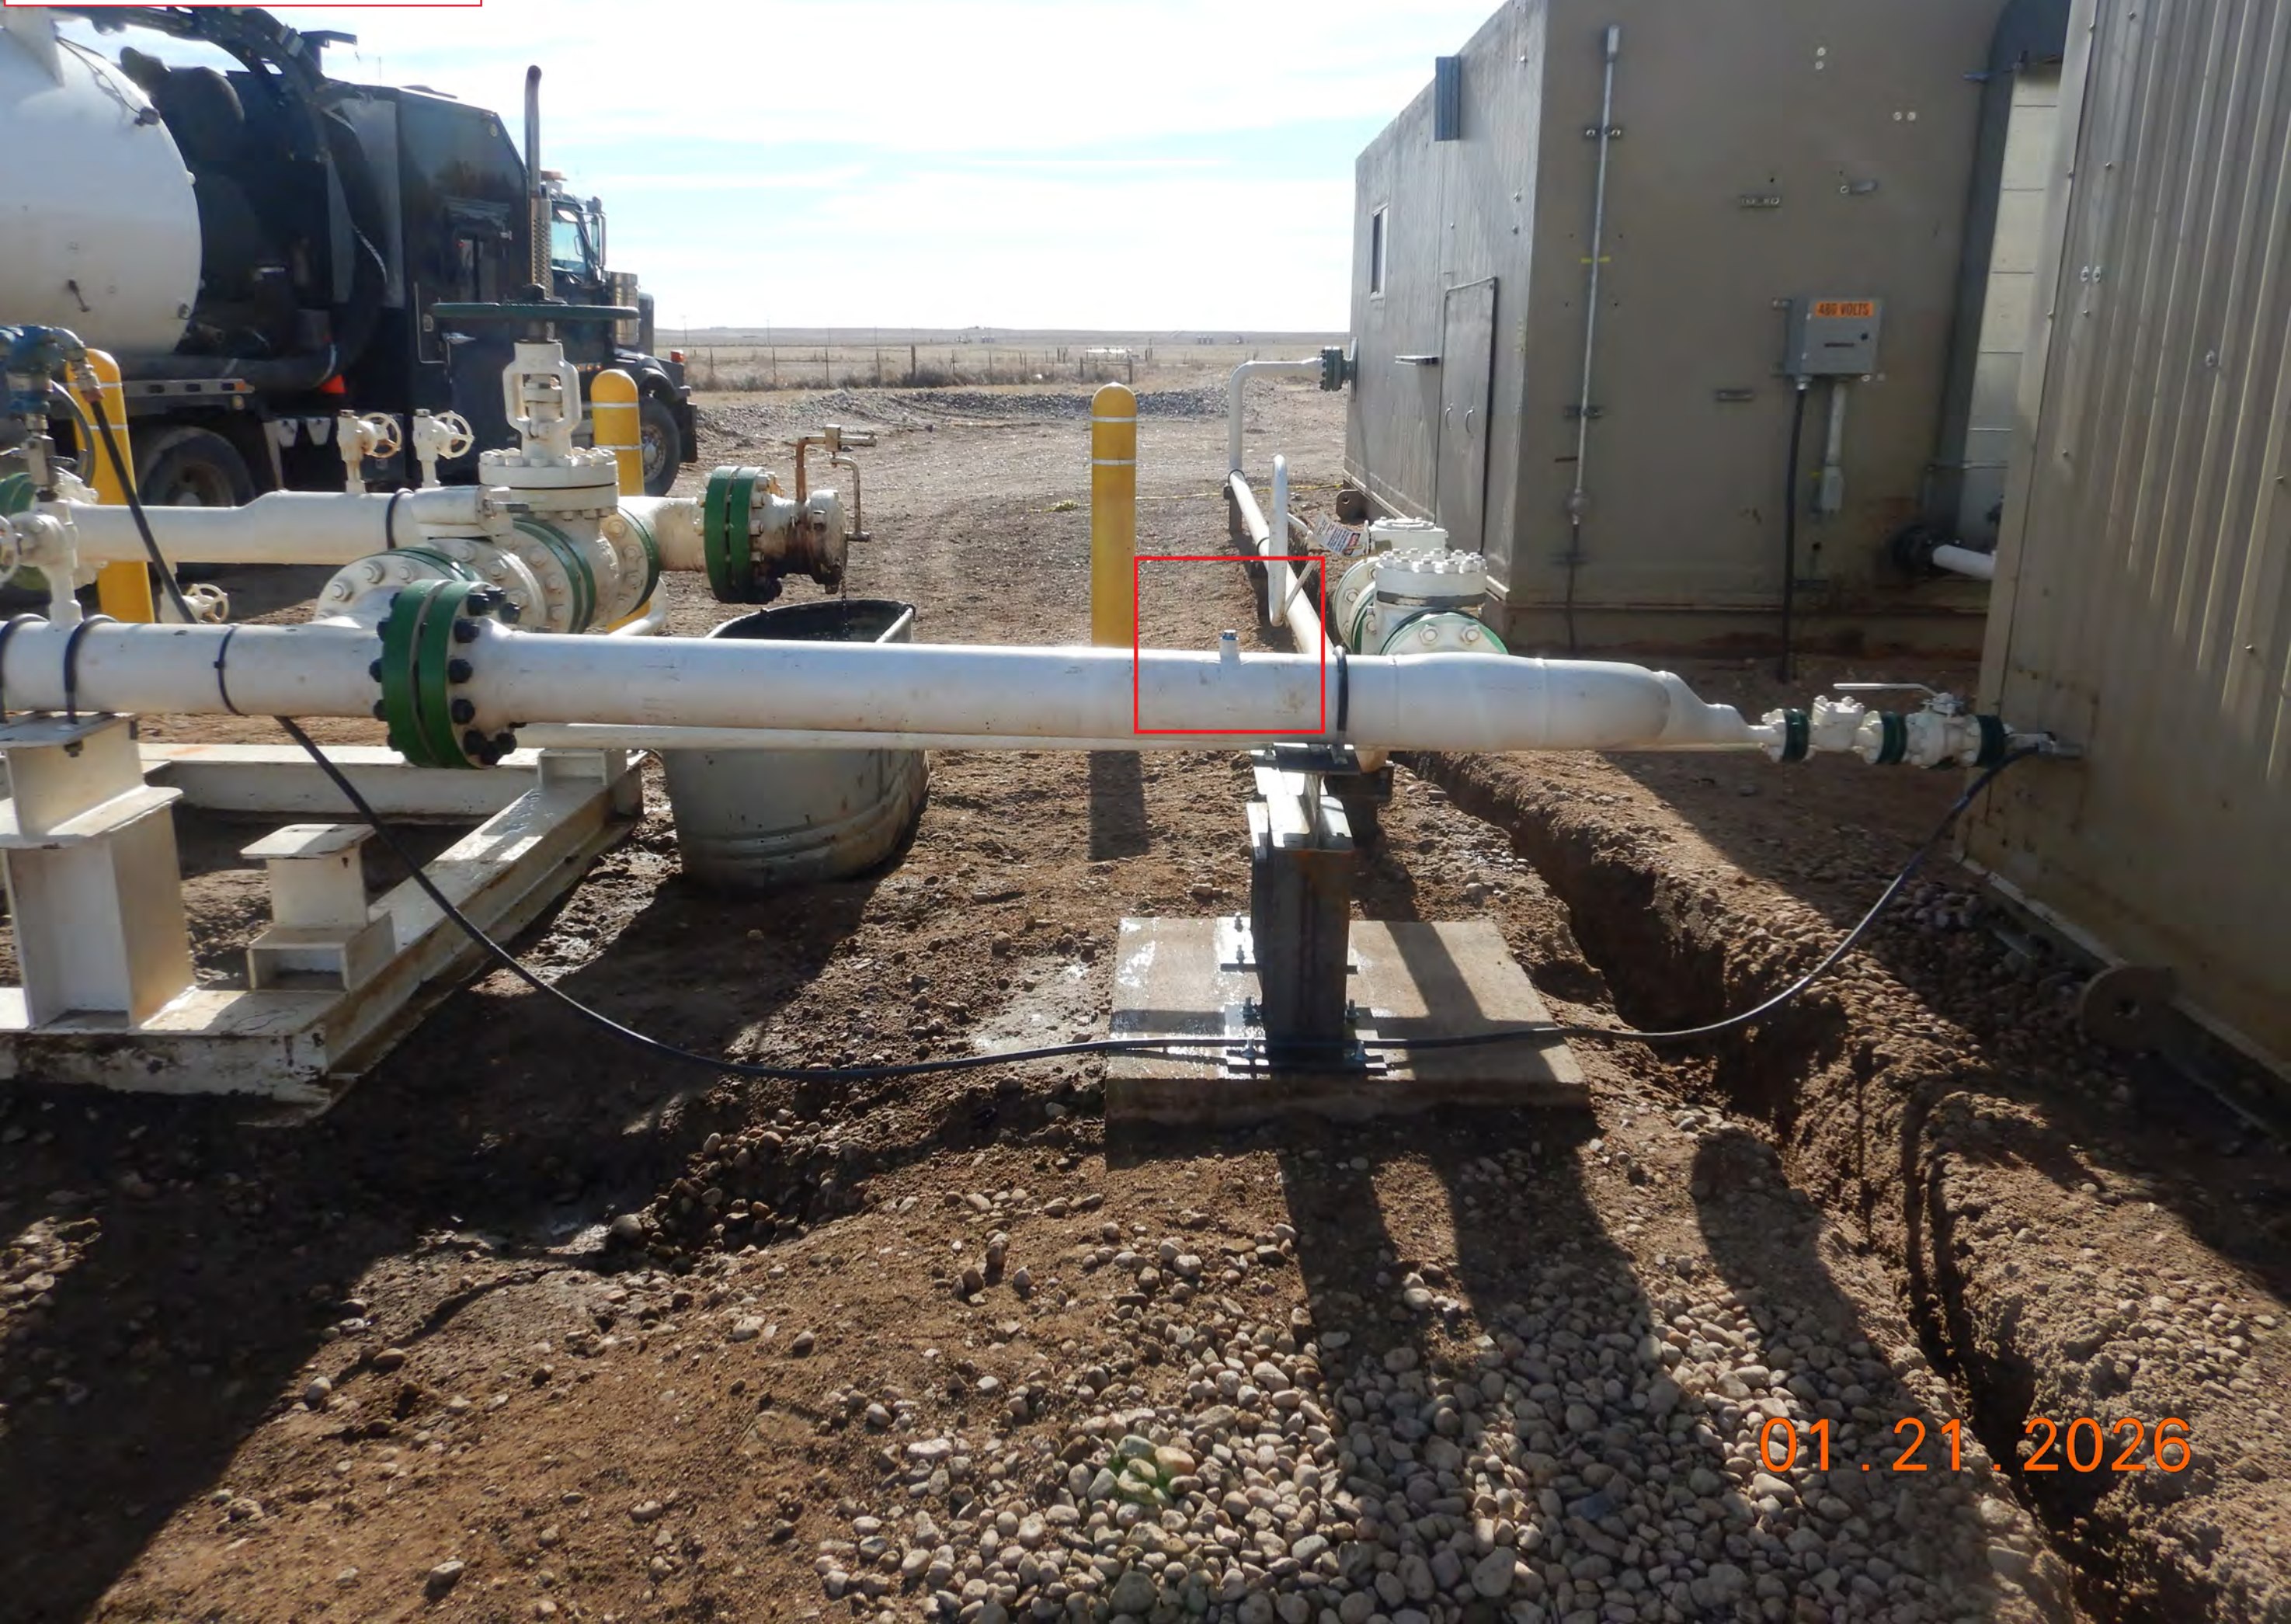
01.21.2026

Initial Cleanup
Hydro-Vac Truck

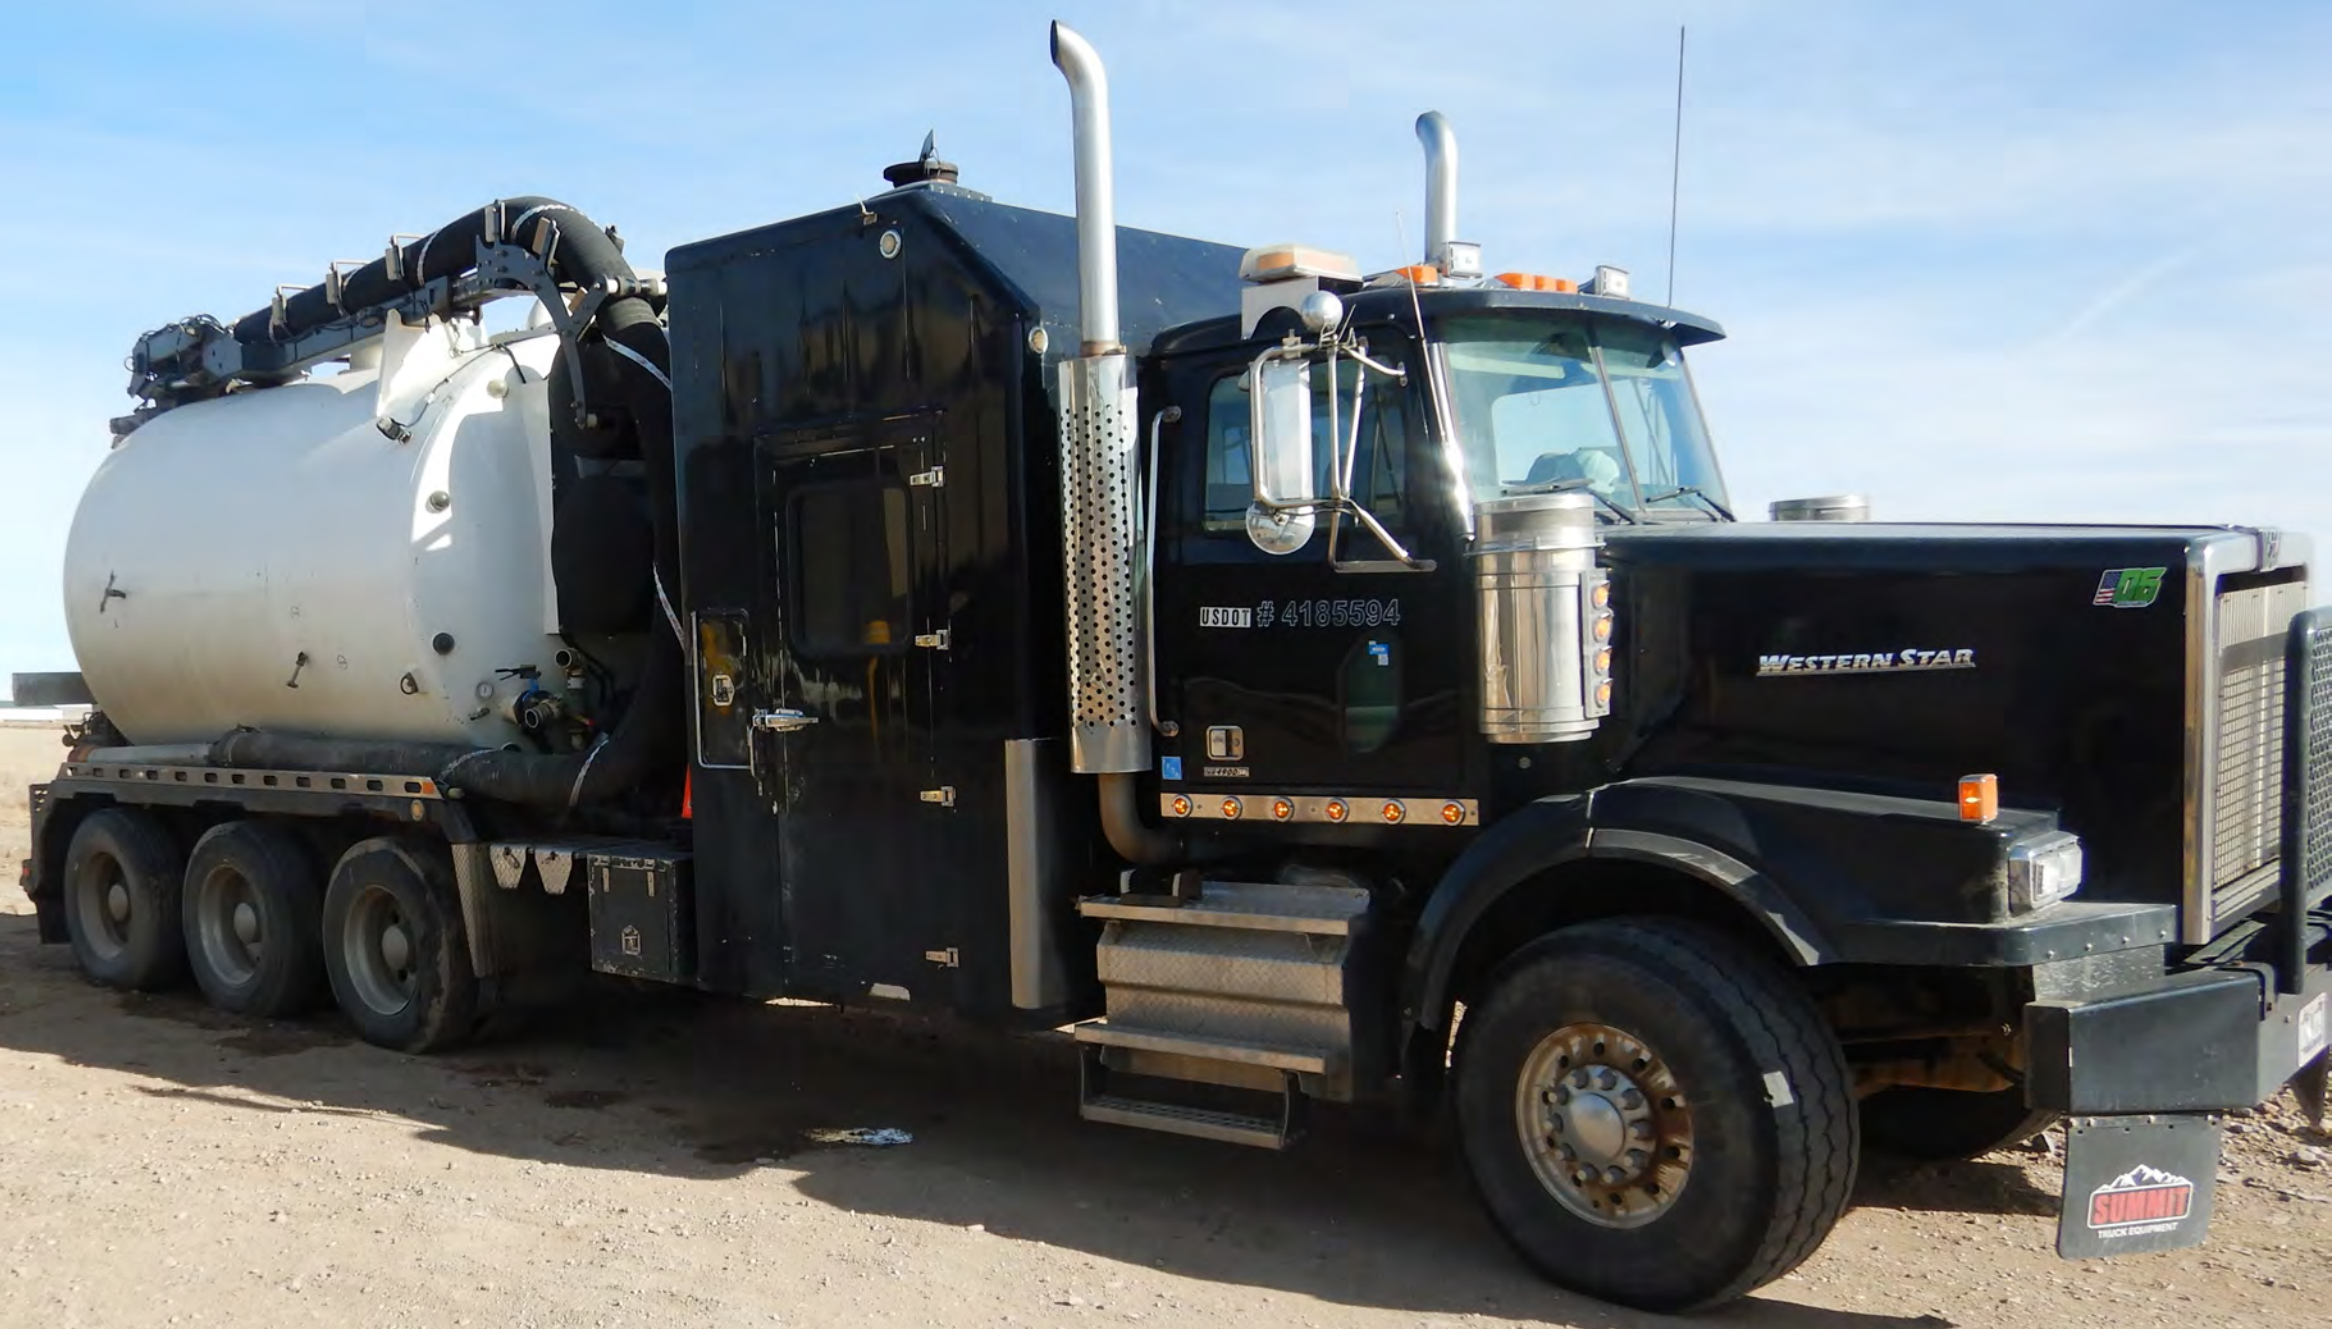
01.21.2026

Cleanup Activity
12" Excavation Area

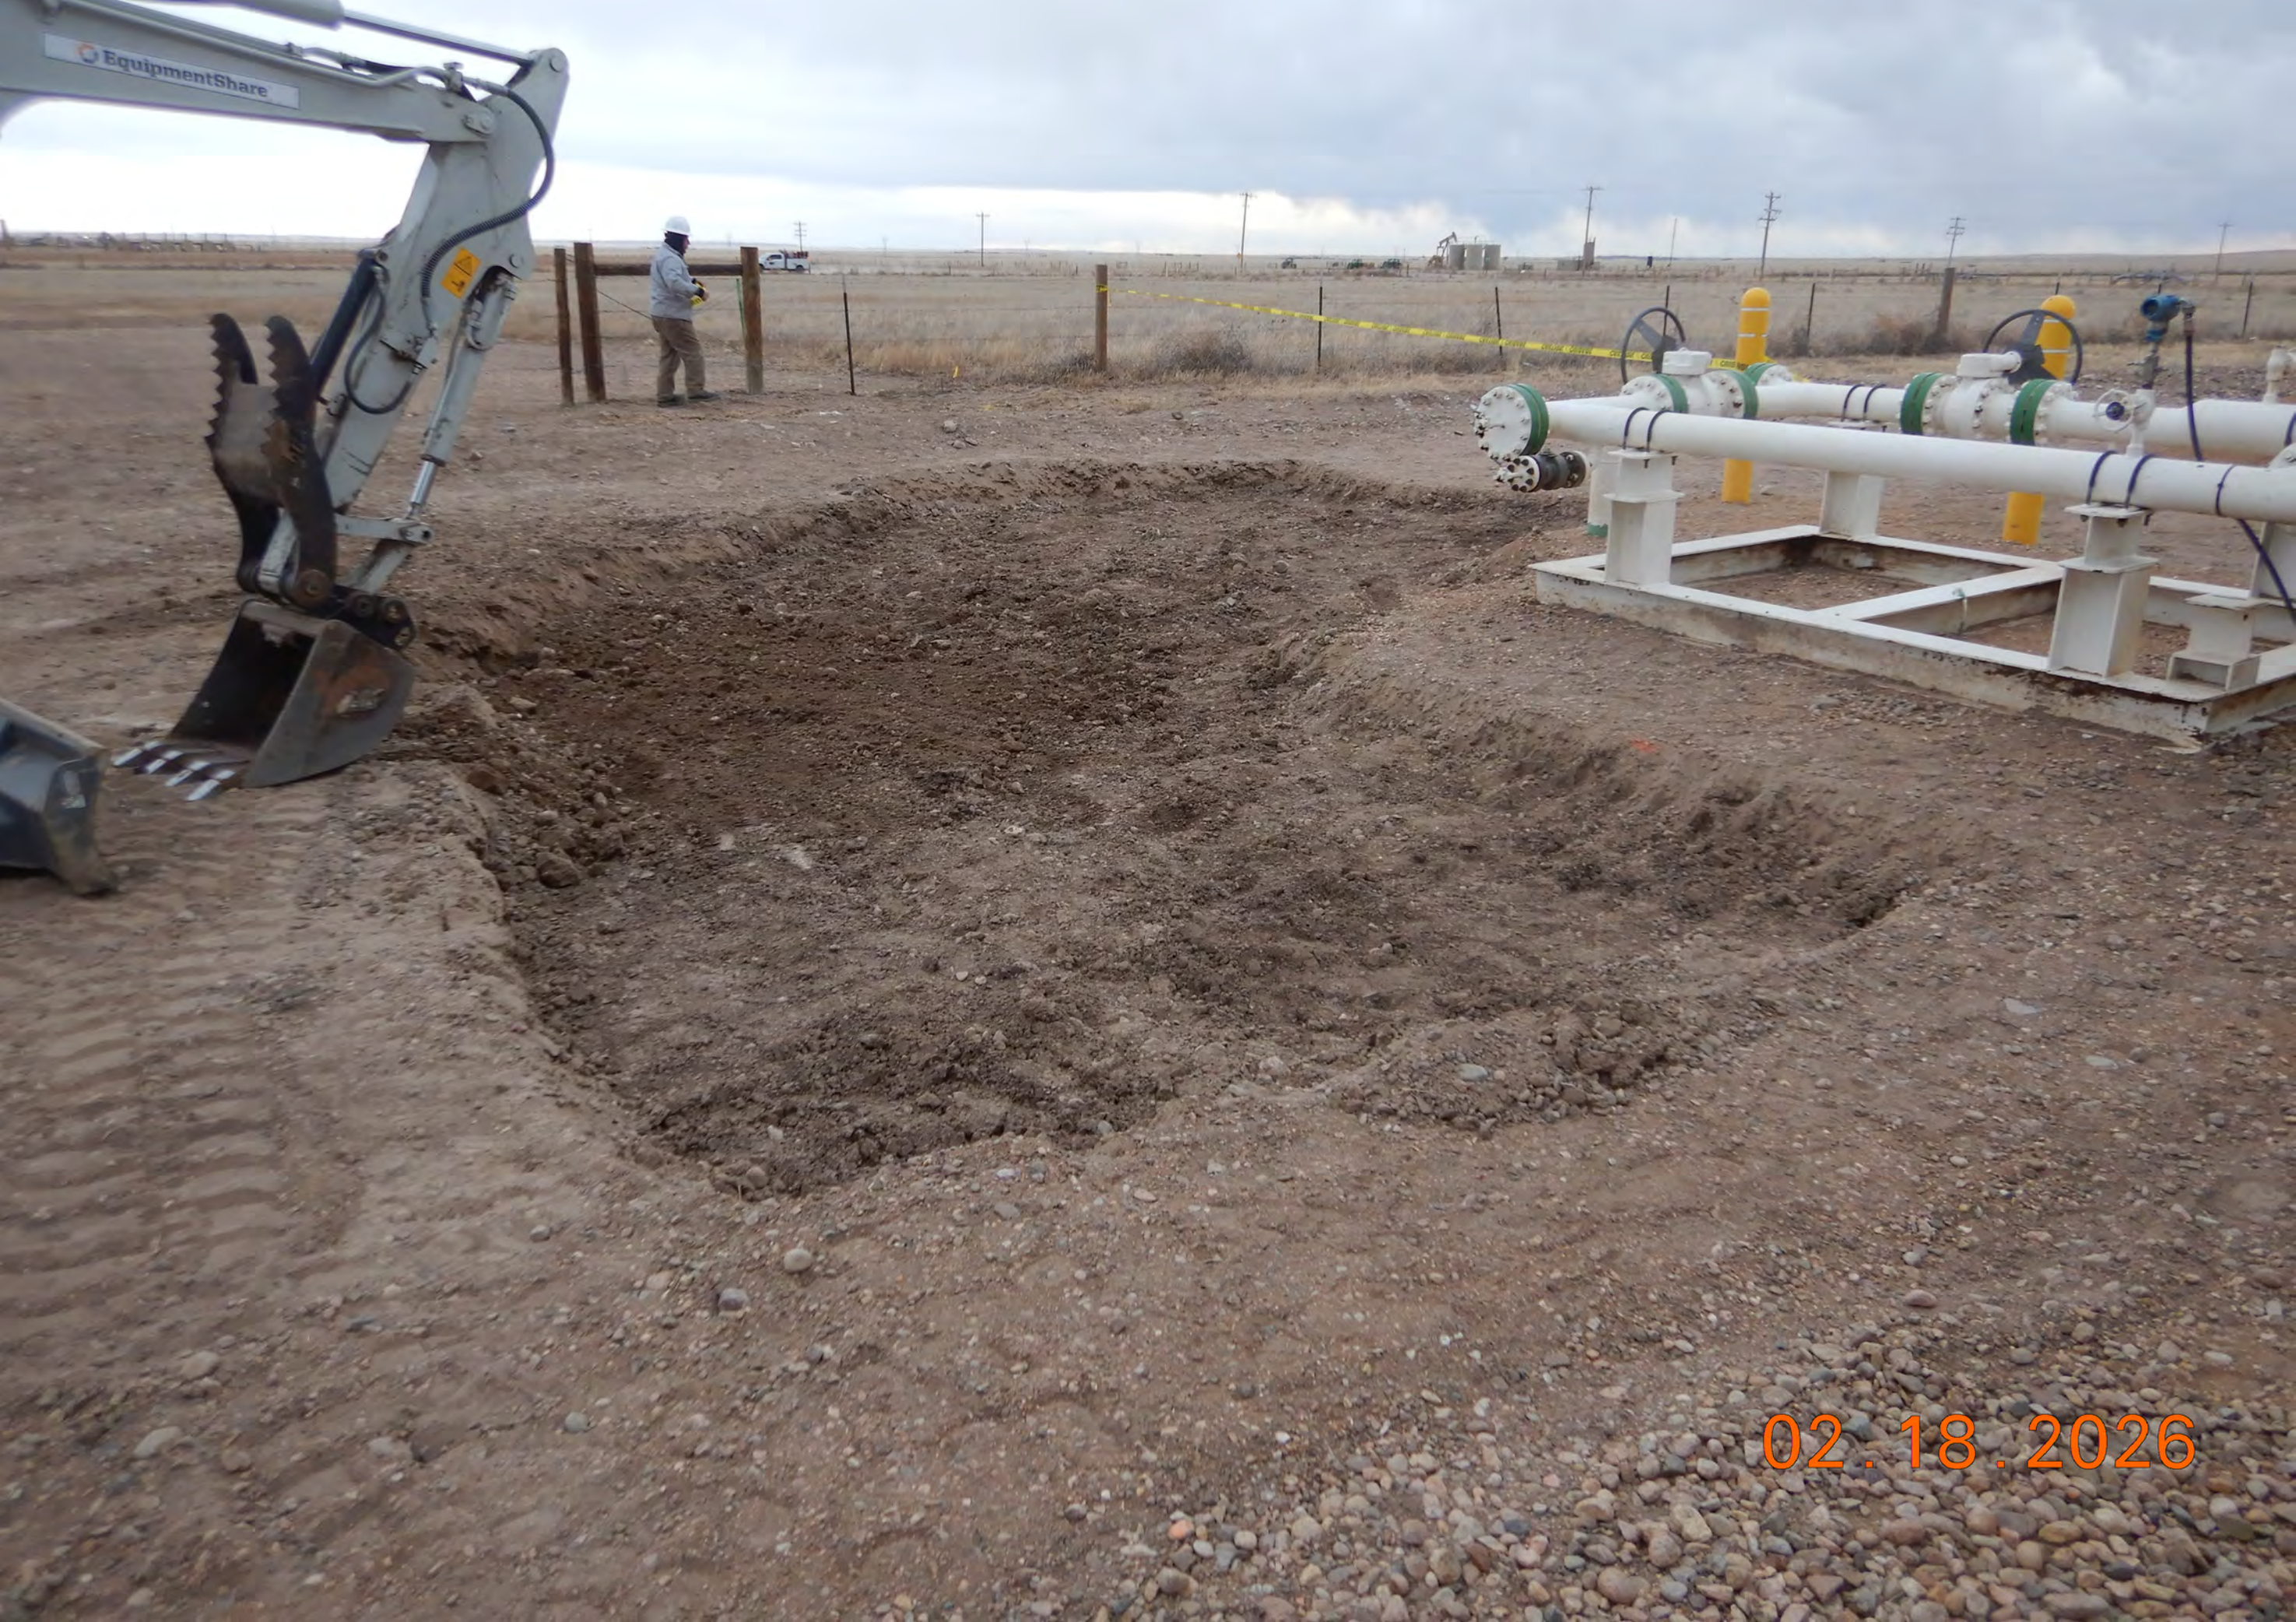
02.18.2026

Cleanup Activity
2" Excavation Area

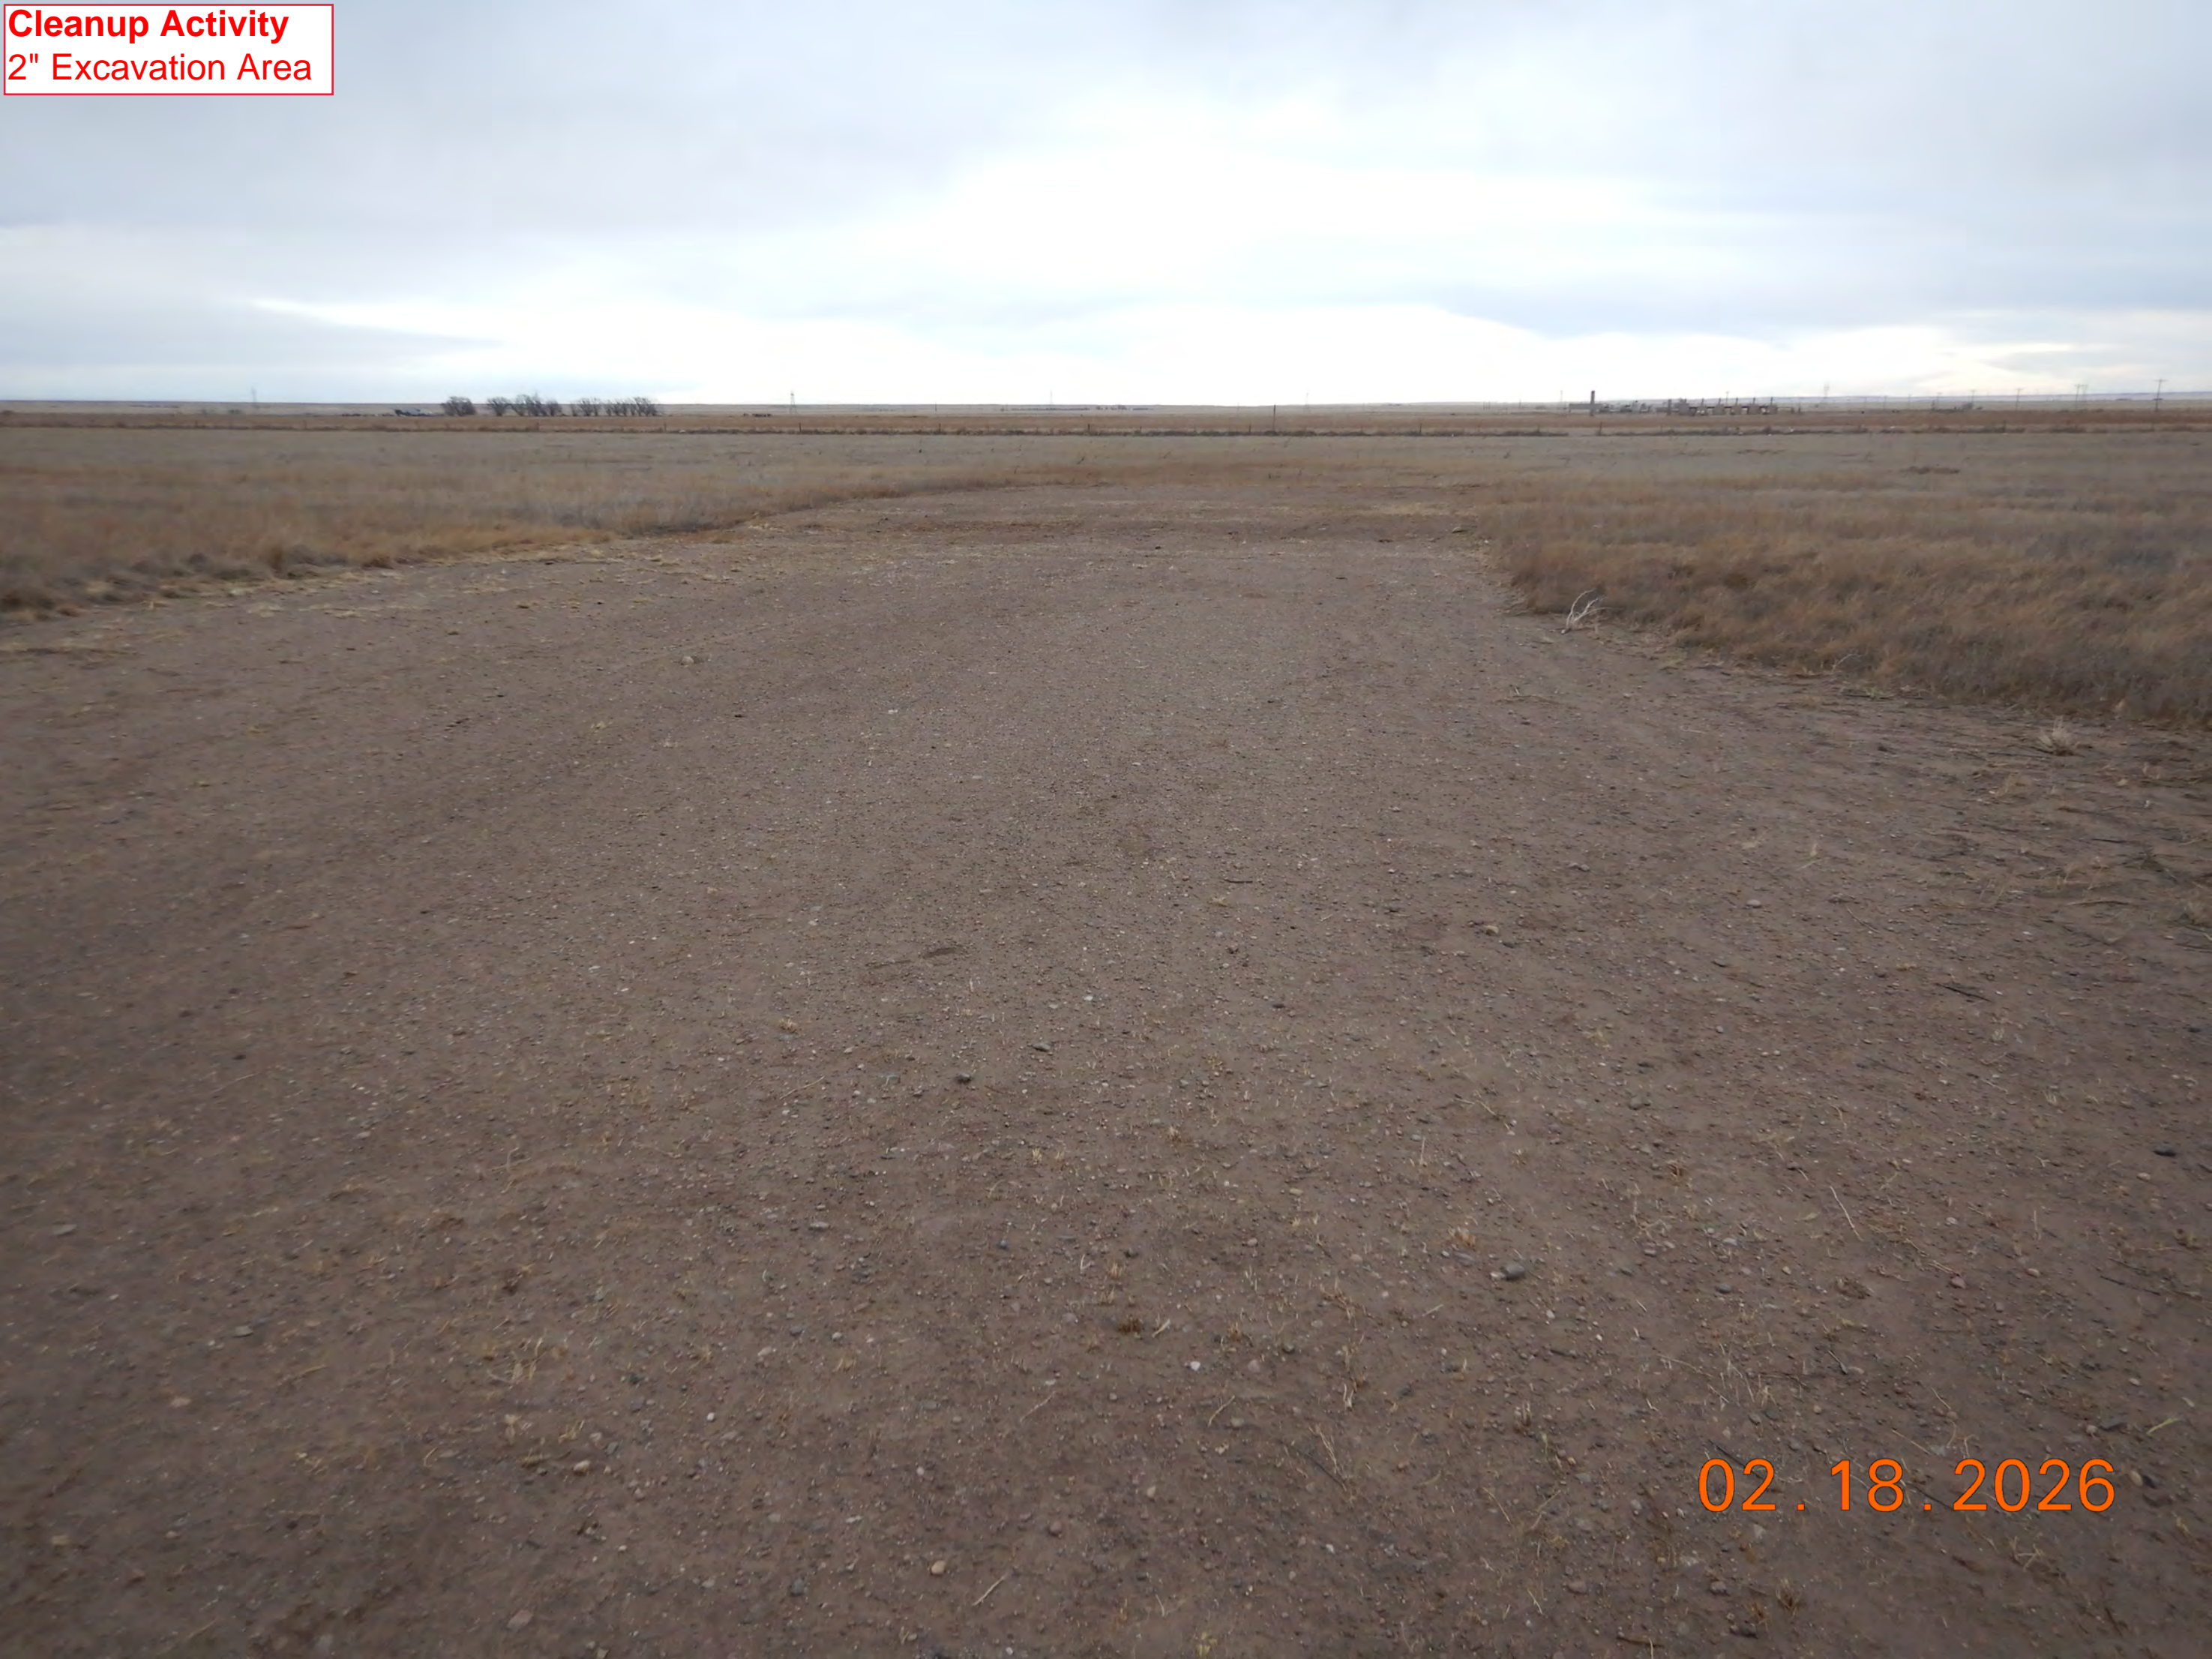
02.18.2026

Cleanup Activity
6" Excavation Area
