INSPECTION PHOTOS

Well: RAMPART 43-33

INSPECTION DOC #: 716302128

Operator: EVERGREEN NATURAL RESOURCES LLC

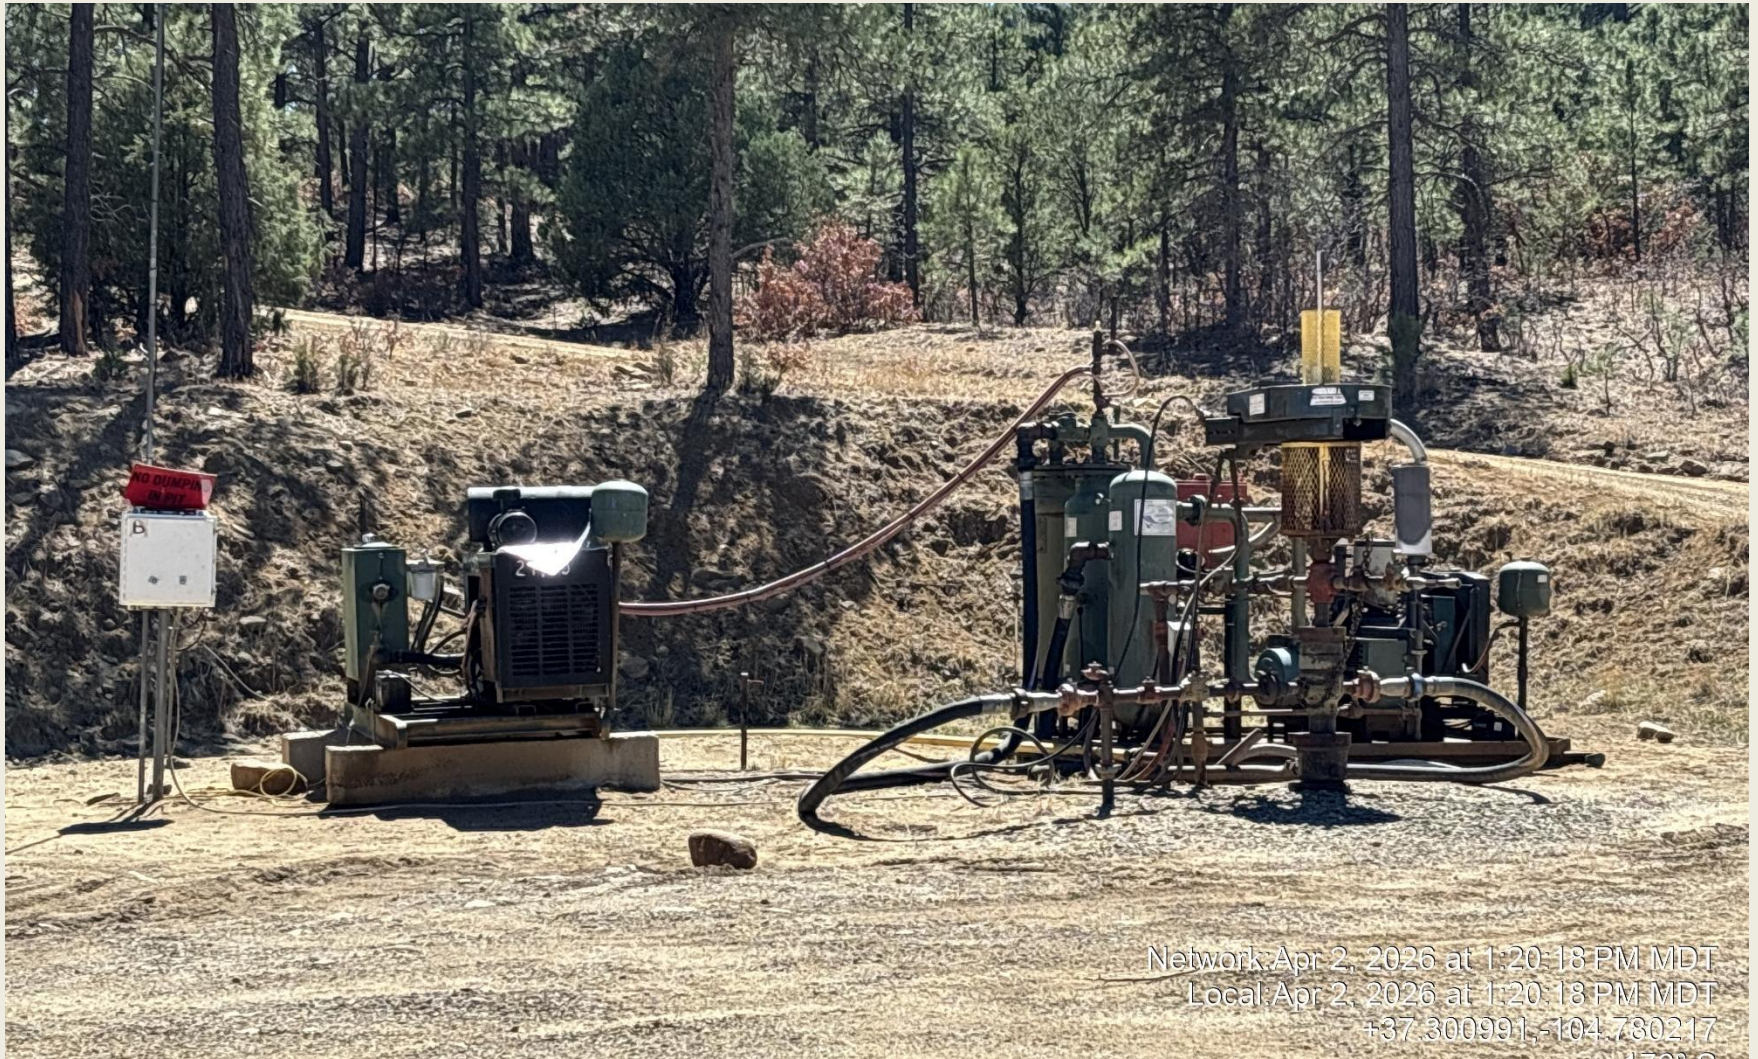
PHOTO 4: TR WELLHEAD AND EQUIPMENT. Vacuum pump observed on well without ECMC approval. Provide ECMC with documentation showing approval of use of vacuum pump. CA DATE 4/17/2026.
