Inspection Photos

Location Name: LARAMIE ENERGY LLC Cascade Creek CC 0697-15-08 Pad

Location # 481743

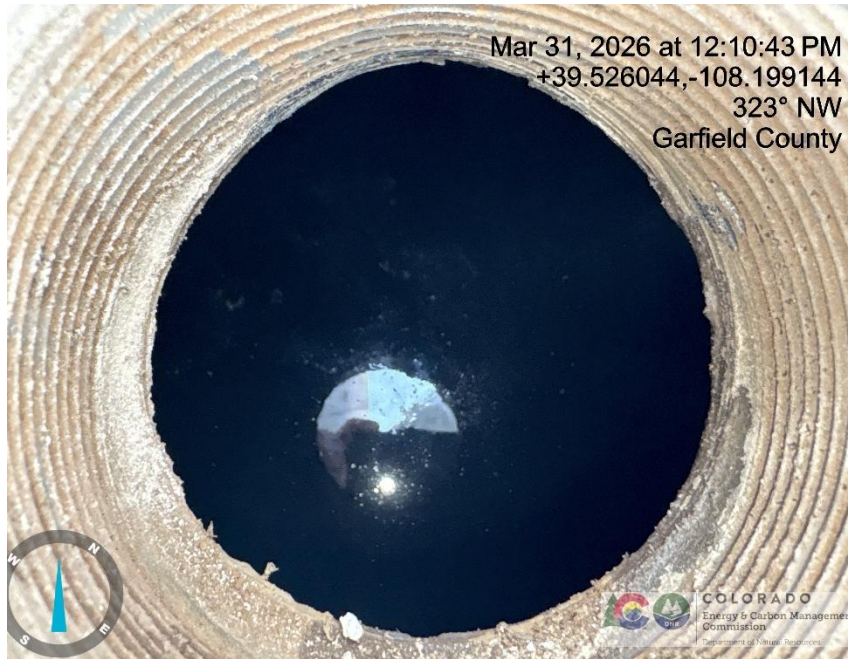
Photo # 4291 Failure to maintain chemical BMP – Chemical tank containment approximately 2/3 full of fluid/BMP insufficient to contain possible spill

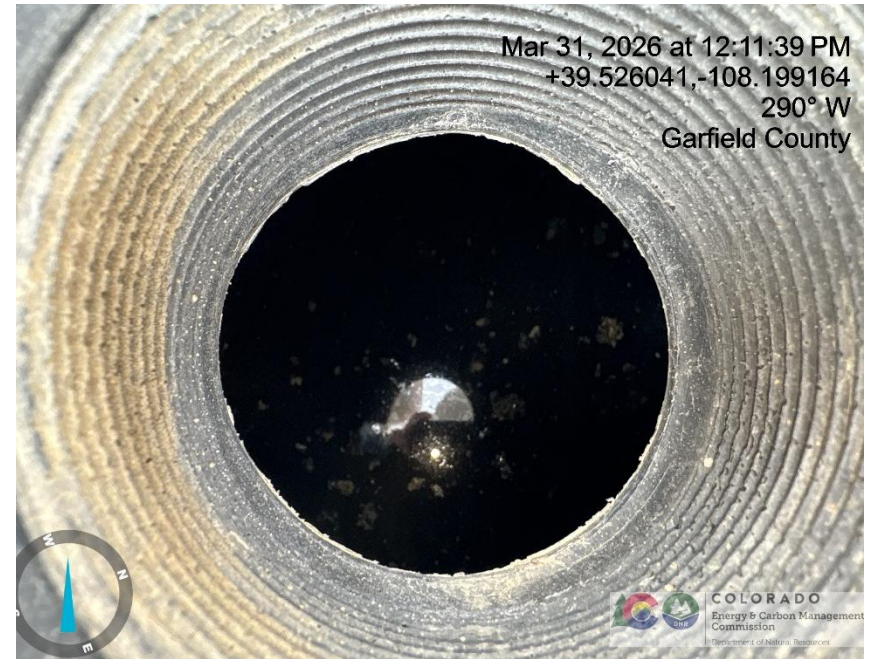
Photo # 4292 Failure to maintain chemical BMP – Chemical tank containment approximately 2/3 full of fluid/BMP insufficient to contain possible spill
