INSPECTION PHOTOS

Well: APACHE CANYON 19-06

API #: 05-071-08824

Operator: OGRIS OPERATING LLC 10758

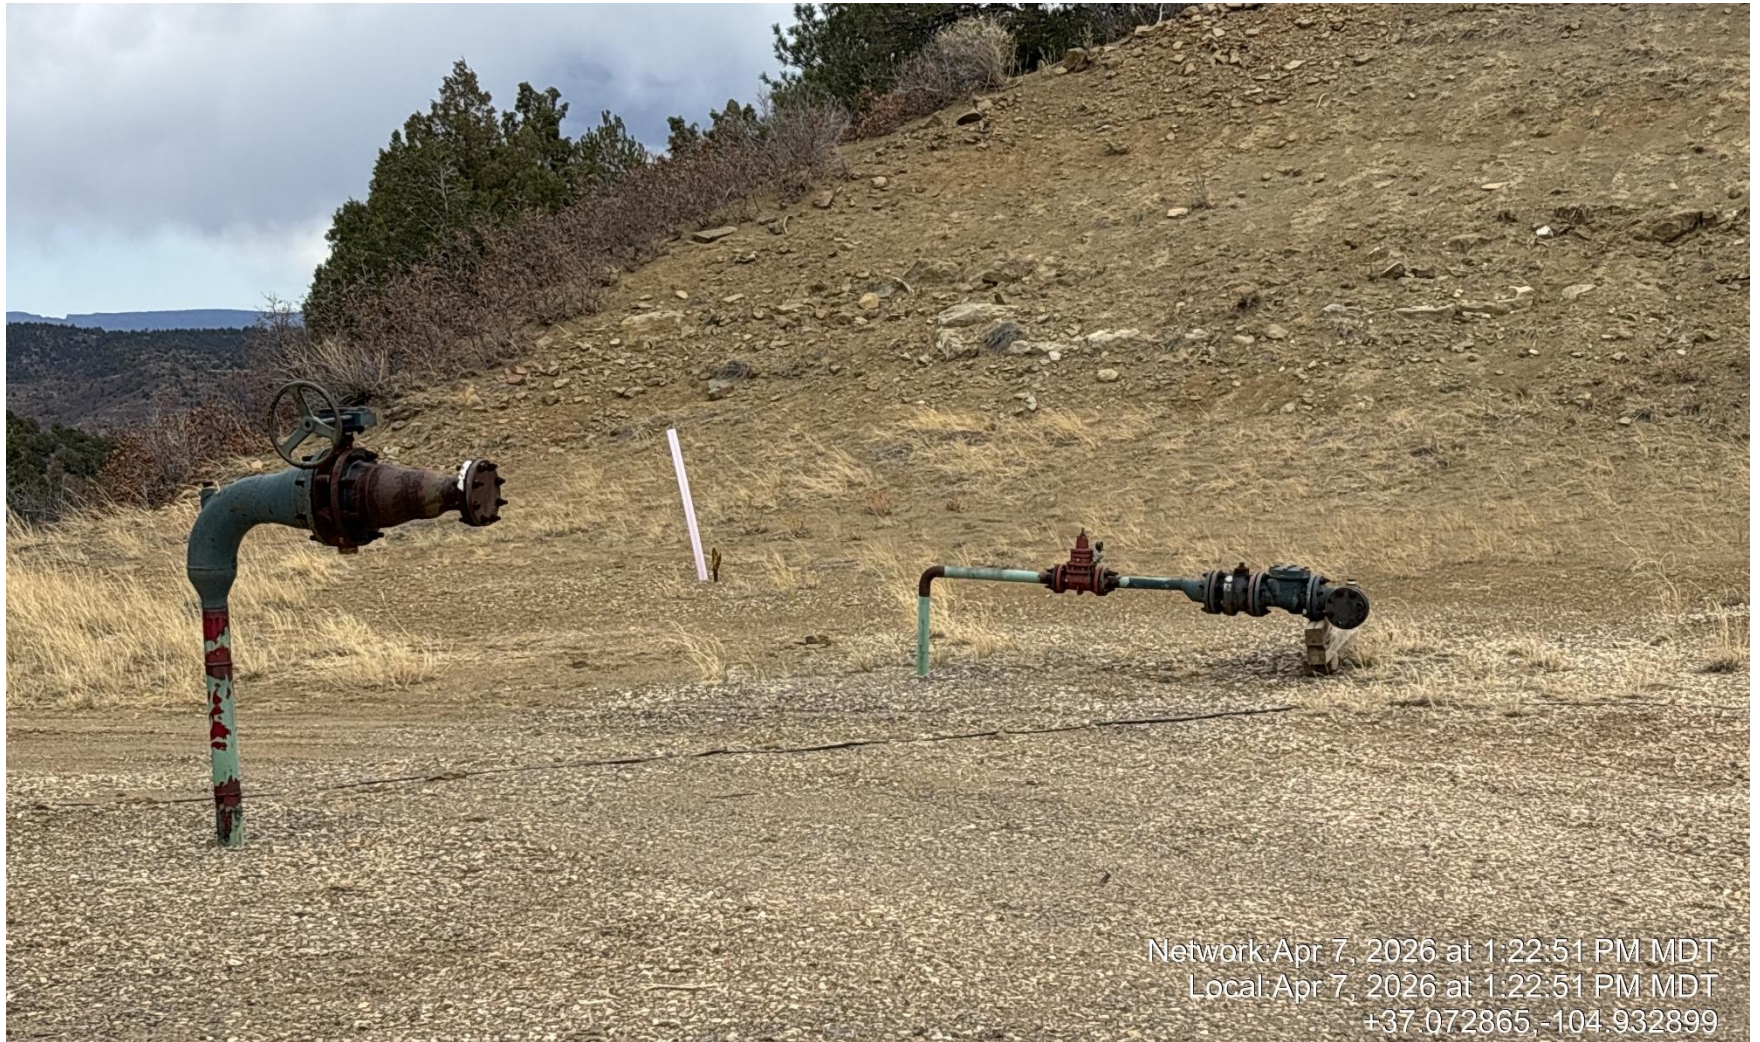
PHOTO 4: WELLHEAD AND EQUIPMENT. Vacuum pump observed on well without ECMC approval. **Provide ECMC with documentation showing approval of use of vacuum pump PER RULE 432. CA DATE 4/23/2026.**
