Final Reclamation and Stormwater Inspection

Location ID: 317827

Well Name: ACCO-TERRA-BODEKER #40

Inspection Document #: 718601566

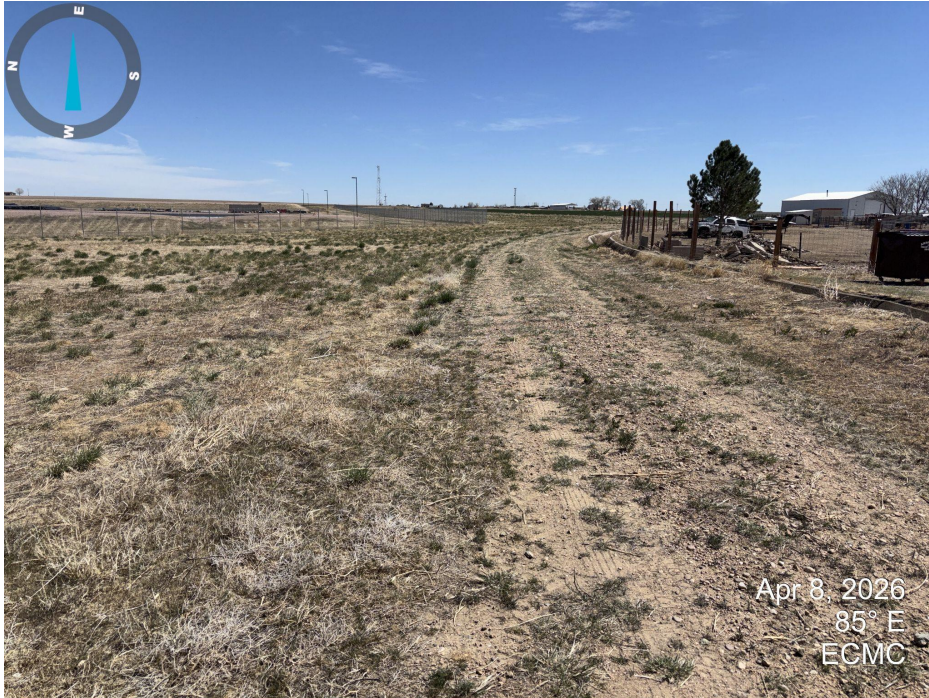
Photo 1. Looking east down the main access road. This access road appears to be preexisting to oil and gas development.

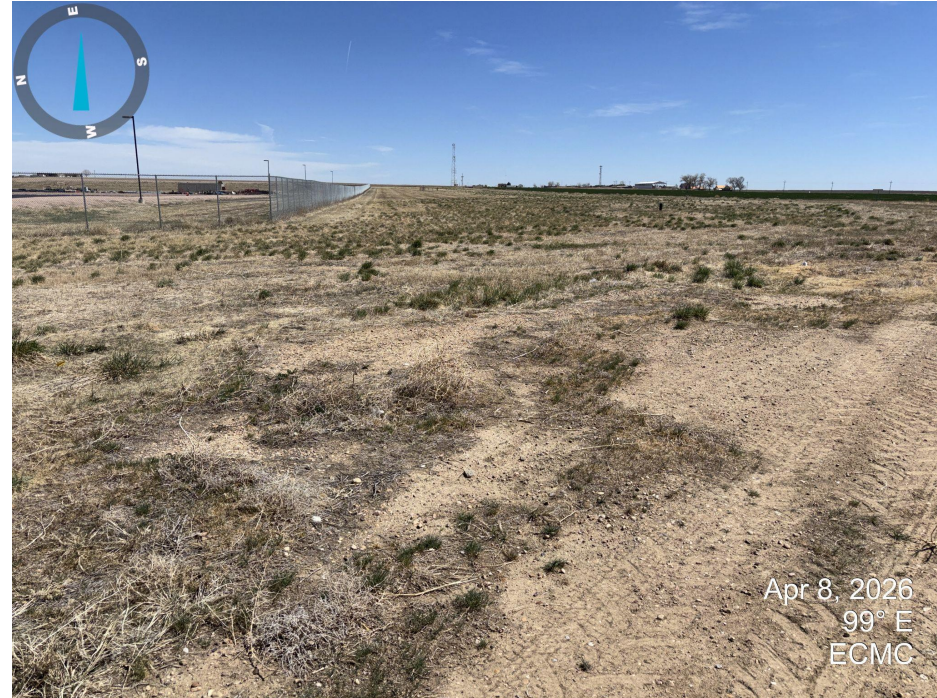
Photo 2. Photo taken approximately 1000 ft west of the well location along the access road at the tank battery location. There is less desirable vegetation establishment on the tank battery area than the surrounding reference area.

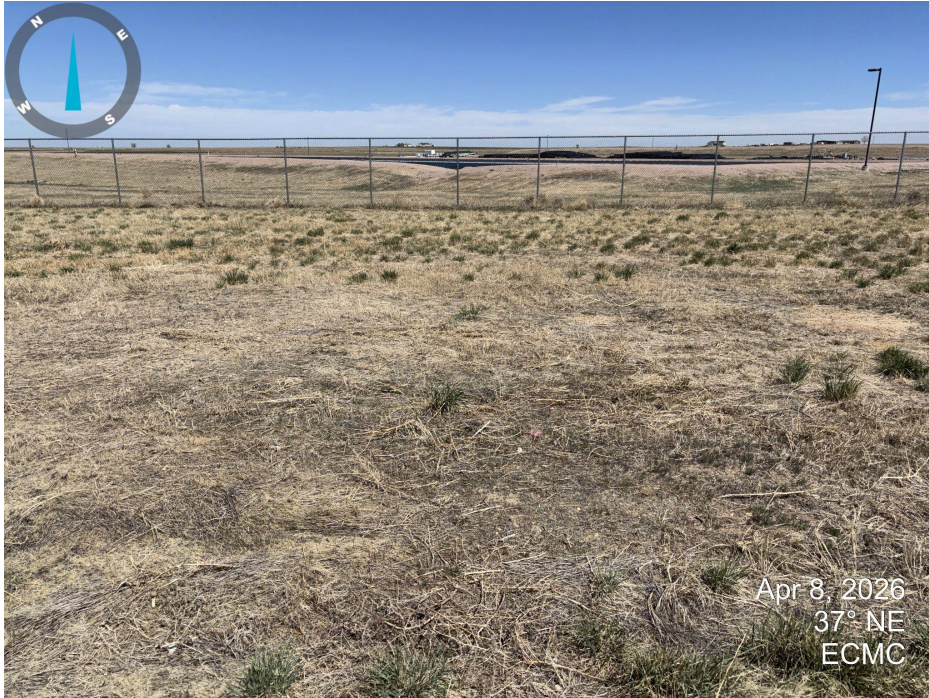
Photo 3. Looking northeast across the tank battery area. See photo 2 comments.

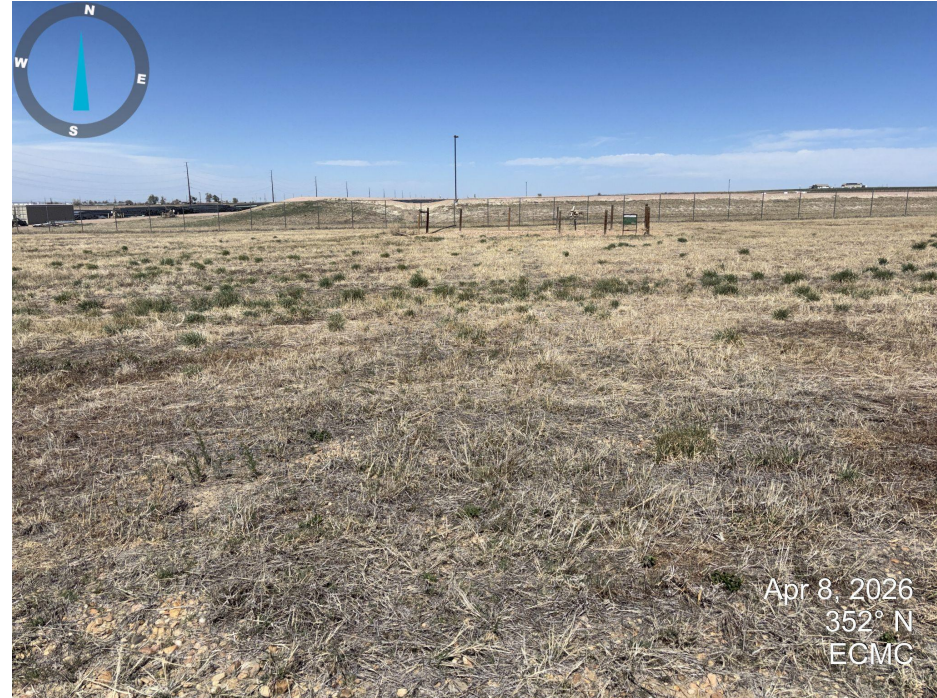
Photo 4. Looking north north down the former access road to the well area. Desirable perennial vegetation is present on the access road.

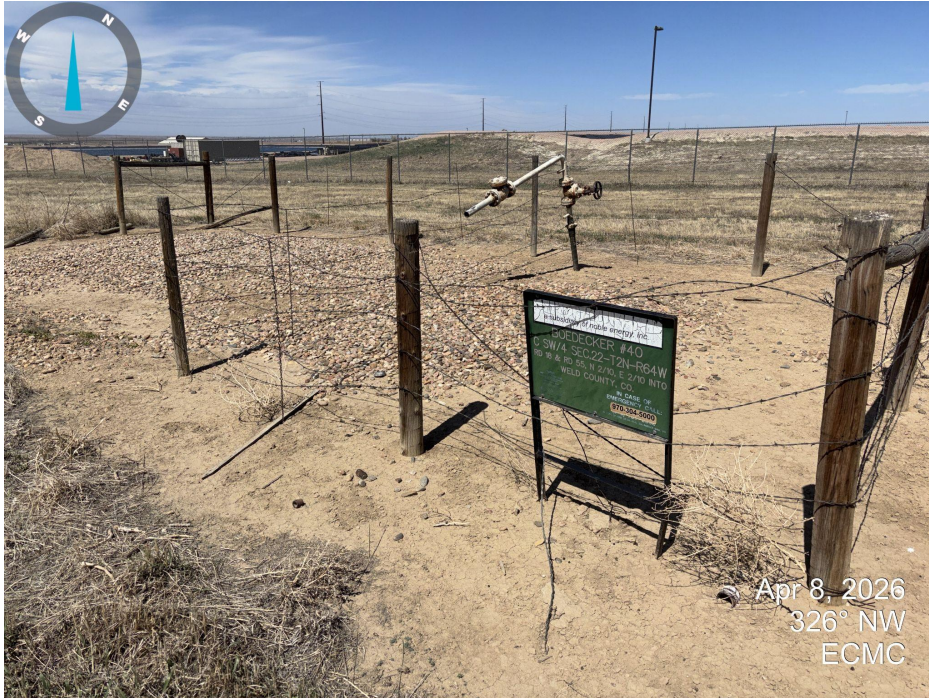
Photo 5. Looking north across the west side of the well location. It appears that production equipment was located in this area. A fence, sign, pipe riser, and heavy gravel remain on location.

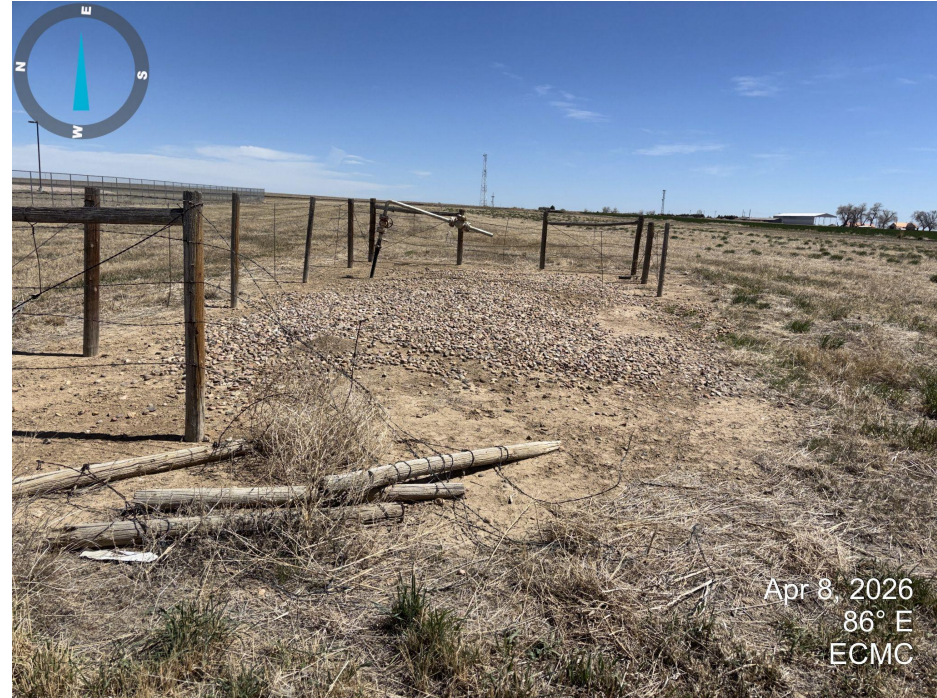
Photo 6. Looking east across the well location. There is desirable perennial vegetation surrounding the remaining equipment. The area within the remaining fence is bare ground or gravel.

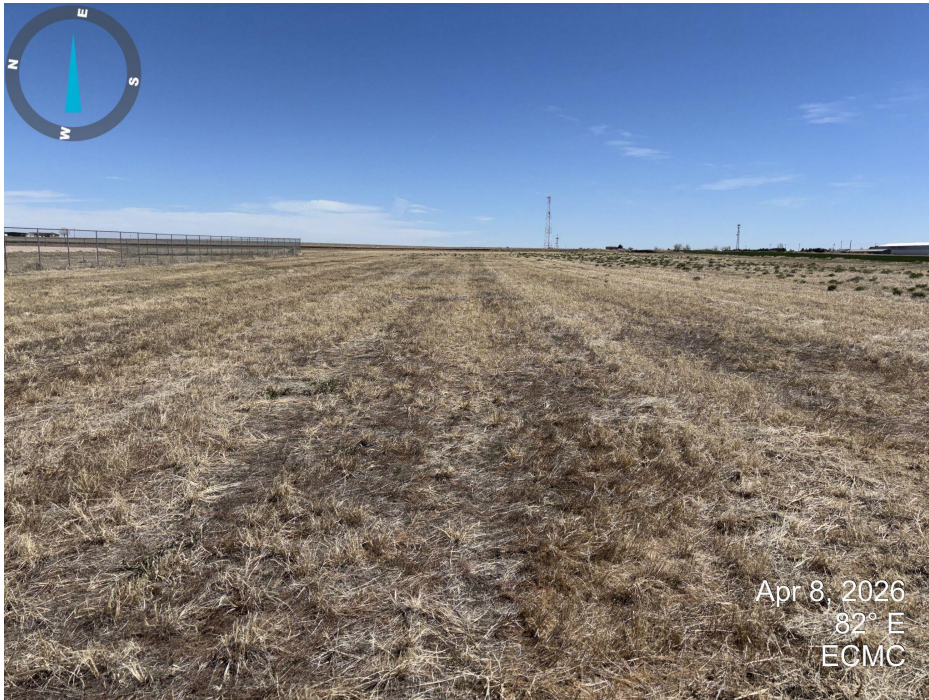
Photo 7. Reference vegetation to the east of the well location.

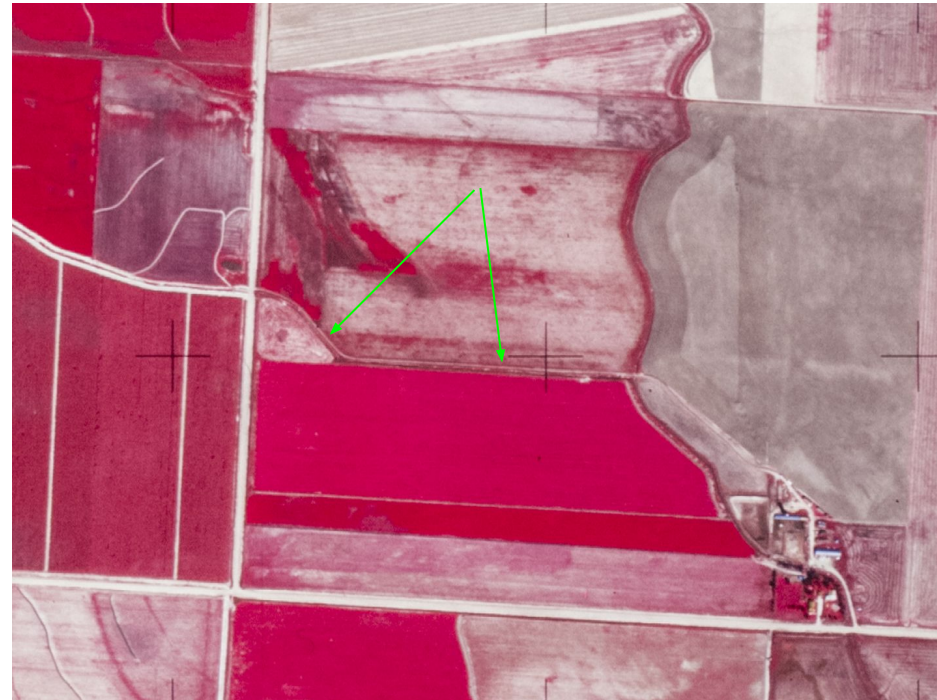
Photo 8. Historical aerial imagery taken 09/1972. The main access road appears to be preexisting to oil and gas development (green arrows).
