# Final Reclamation Inspection

Location ID: 323506

Weld County, CO

Inspection Photos  
Location Name: MUIRHEAD #1-4  
Location ID: 323506

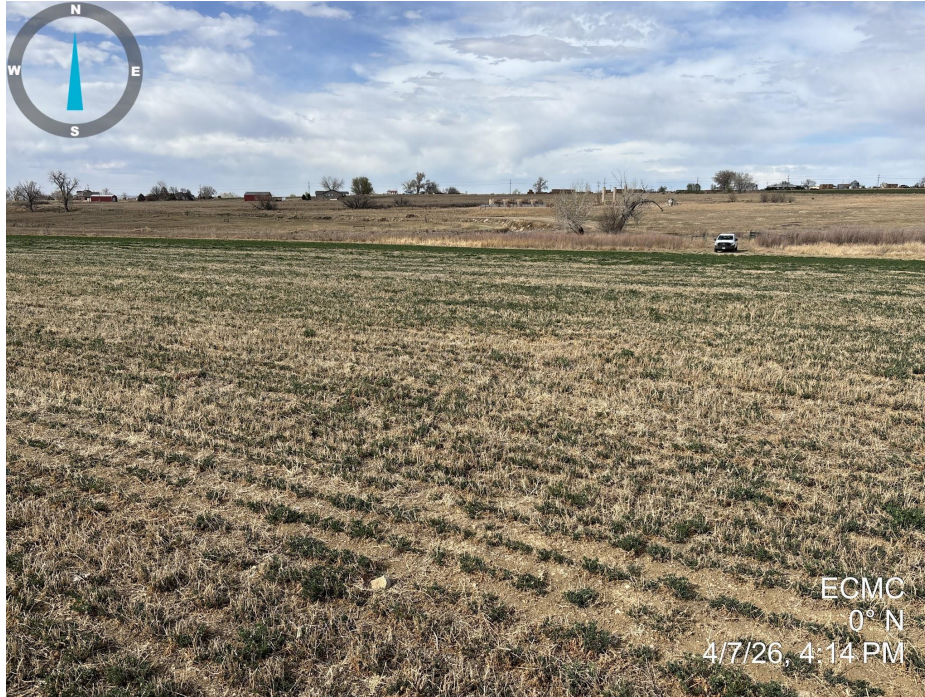
**Photo 1.** Photo taken of the well location, facing north. Photo illustrates that final reclamation activities have taken place and alfalfa and perennial grass vegetation is establishing at the location. However this location does not meet Rule 1004 standards as subsidence was observed at the well site.

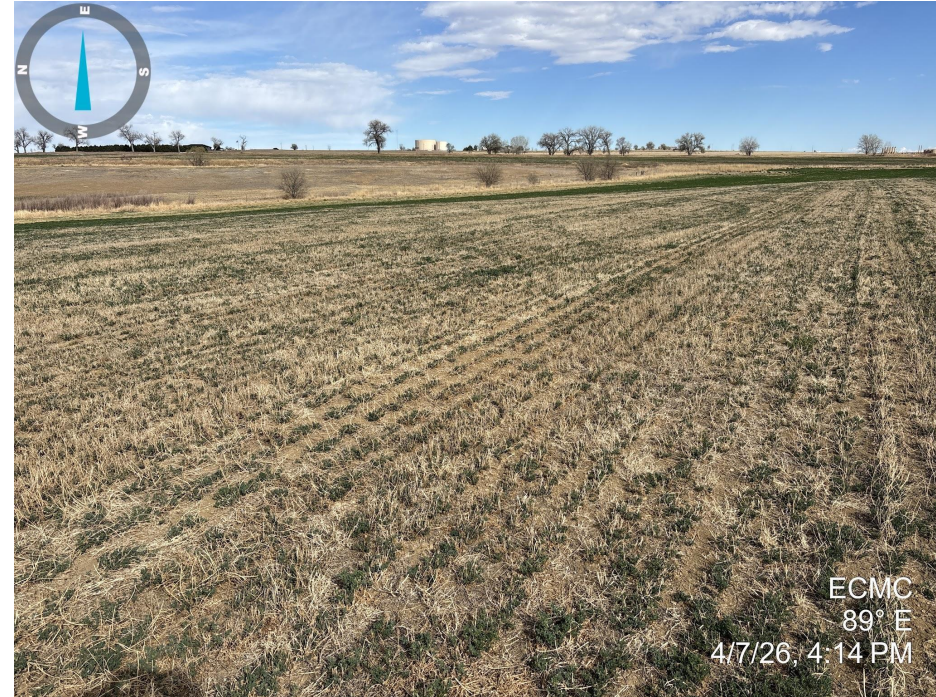
**Photo 2.** Photo taken of the well location, facing east. See comments under Photo 1.

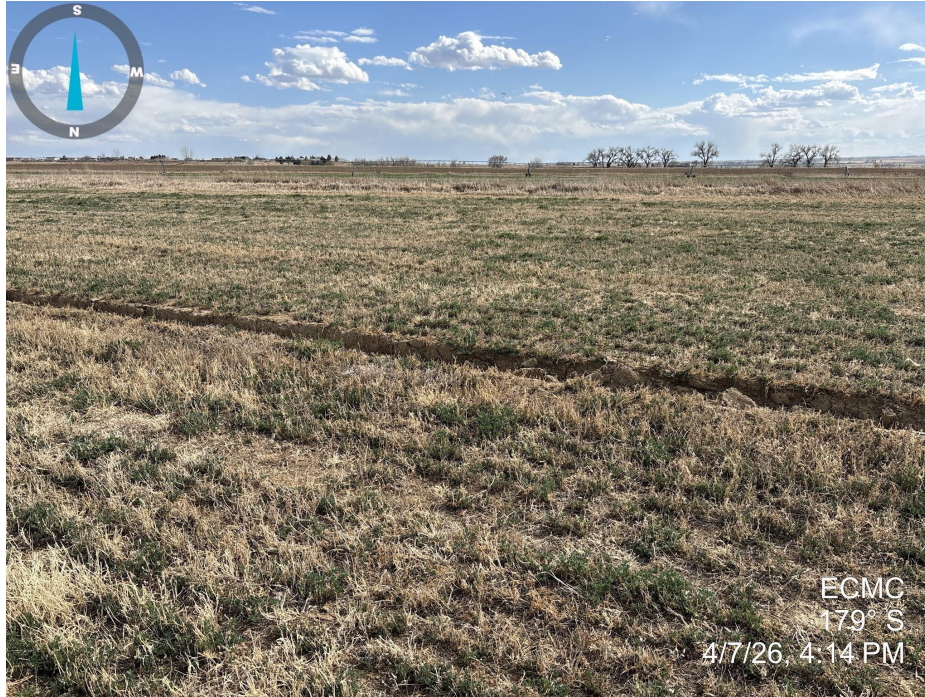
**Photo 3.** Photo taken of the well location, facing south. See comments under Photo 1.

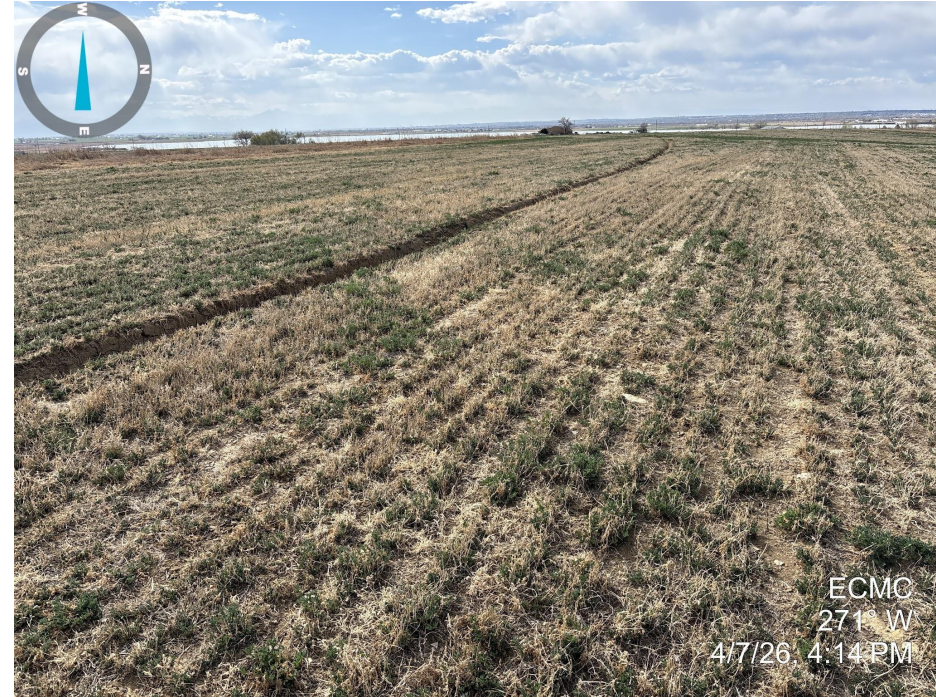
**Photo 4.** Photo taken of the well location, facing west. See comments under Photo 1.

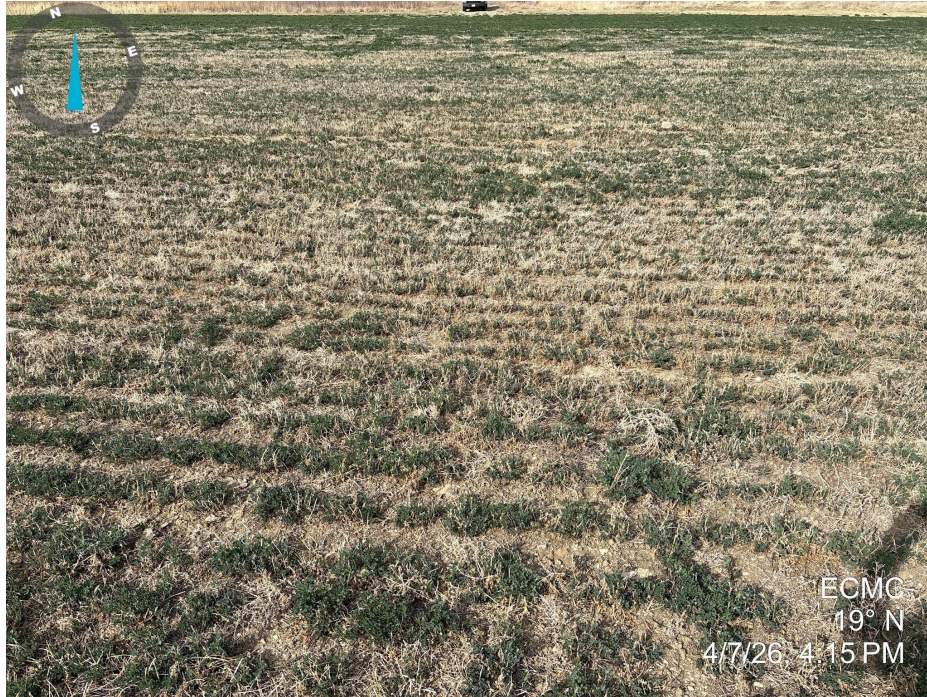
**Photo 5.** Photo taken of the access road to the well location, facing north. Photo illustrates that final reclamation activities have taken place and alfalfa and perennial grass vegetation has established along the access road.

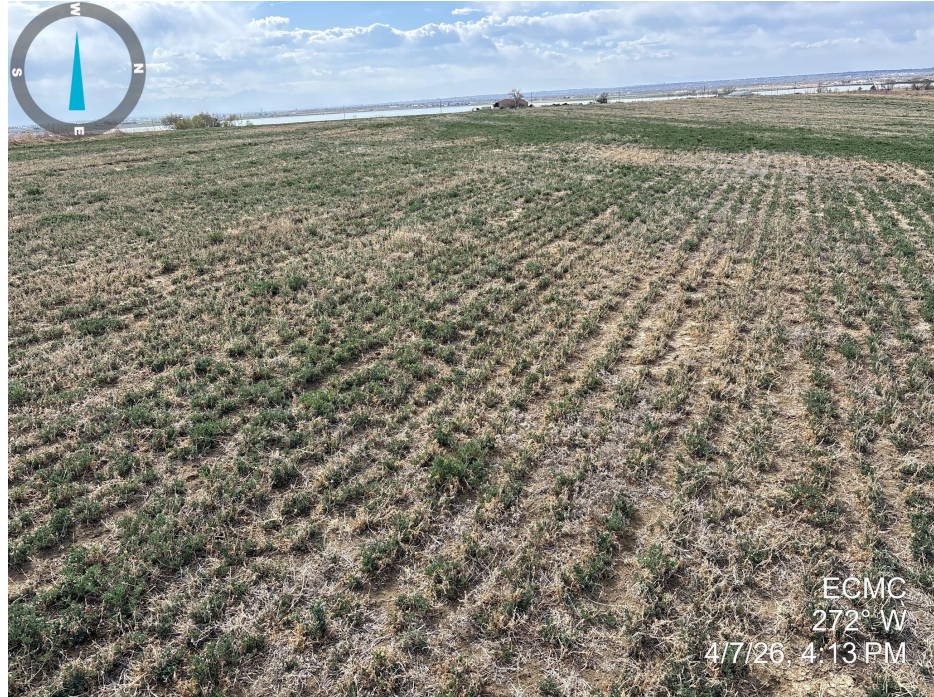
**Photo 6.** Photo taken of the reference area to the location, south of the location, facing south. Photo illustrates perennial grass and alfalfa vegetation.
