ROW Compliance Inspection		Case #: COC 61214 Holder: Maralex Disposal LLC	Project Name: Roan Creek Evaporation Pond
Twn: 8 S Rng: 98 W Sec 36: Qtr: NESE		County: Mesa County State: Colorado	
Inspection Date & Time: 9/27/2018 9:00am			
Inspector: Scott Hall		Office Time:	Total Time:
People/Affiliations at Inspection: COGCC		Steven Arauza	
Existing Conditions? 1.Construction, 2.Operation, 3.Reclamation; Disturbed Area Measurements; Facilities		Site was construction in the 1980's and was used until 2009. Pit has been in noncompliance since 2010 and has not been used since. The site is 285' by 505' and include a 24' x 245' access road and a 100' x 77' site for bioremediation of soils. Facilities include, pit, fence, 300 barrel tank with berm, and leak detection system.	
Conformance with ROW Terms & Conditions? Constructed to Specifications		ROW is not in compliance with the stipulations. ROW expired 8/30/2018.

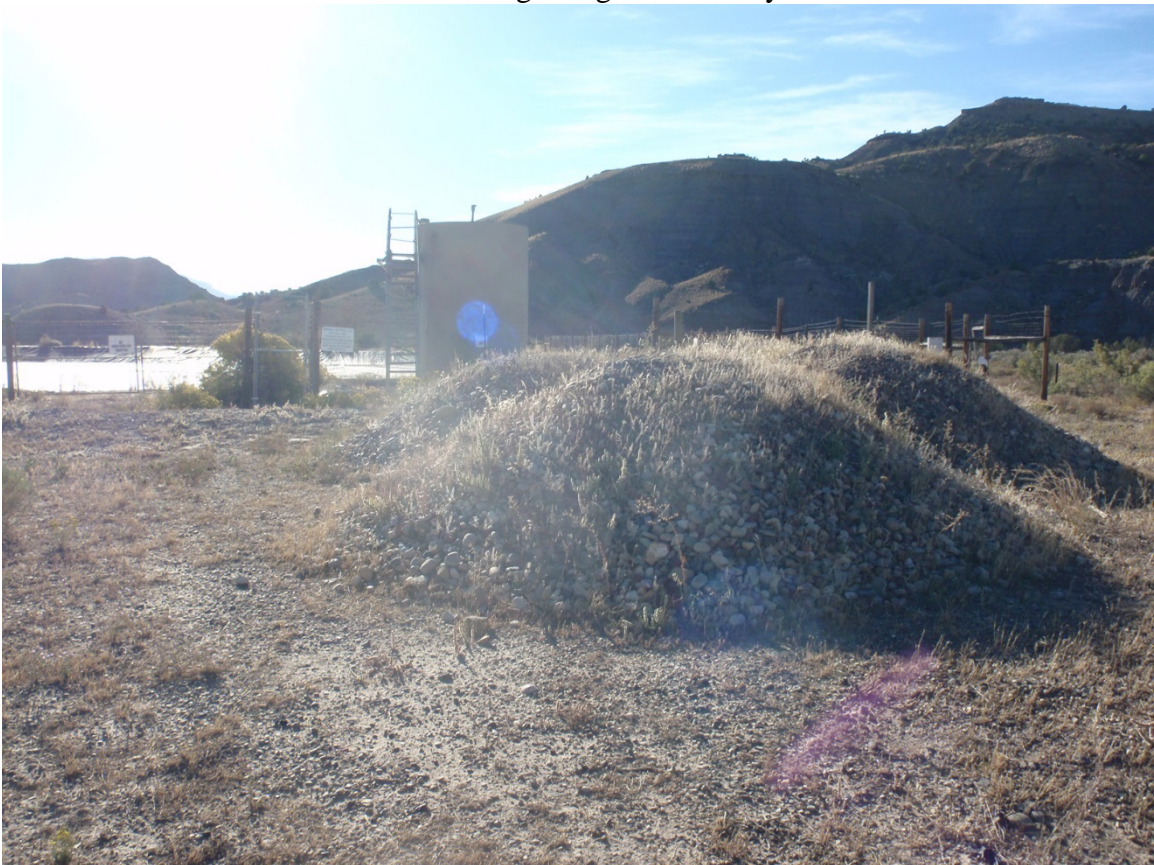
Photo 2. Piles of mixed soil and gravel in the former bio-remediation site that must be removed.

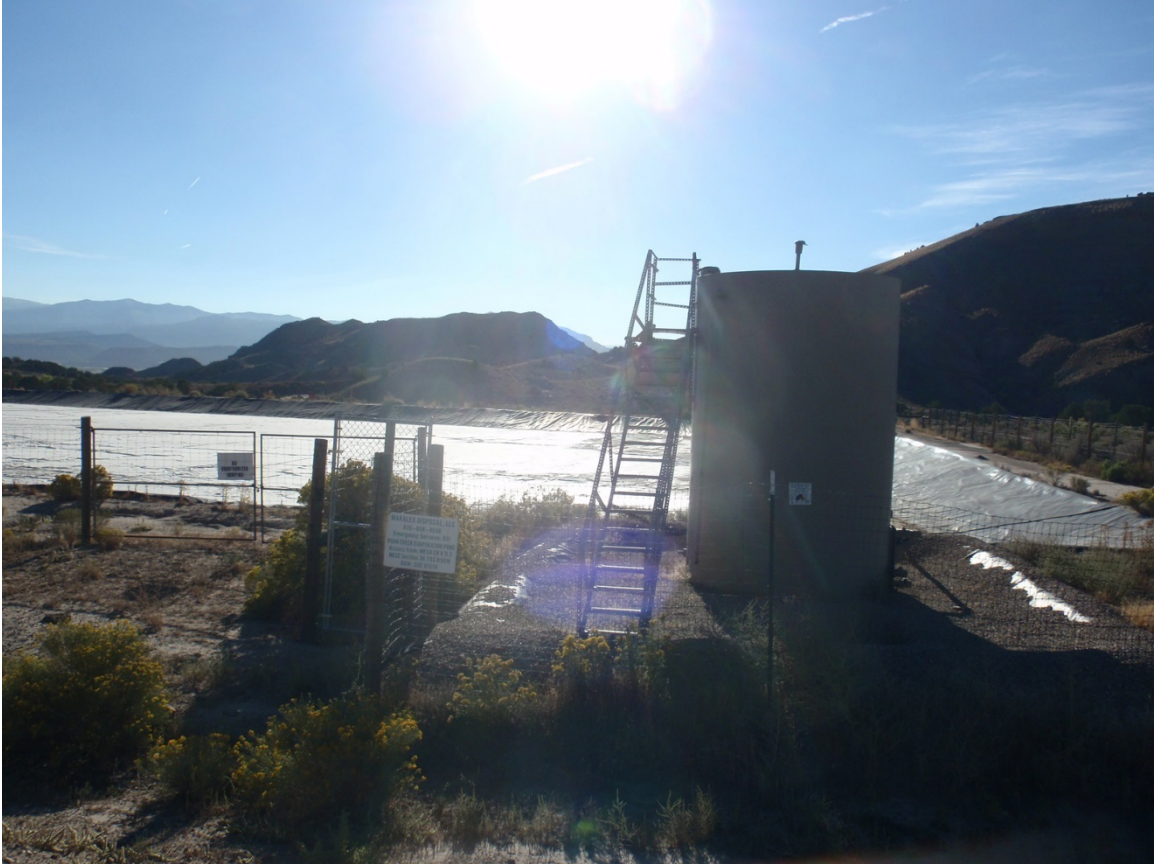
Photo 5. 300 barrel storage tank with shallow berm. Can it hold 115% capacity of liquid?

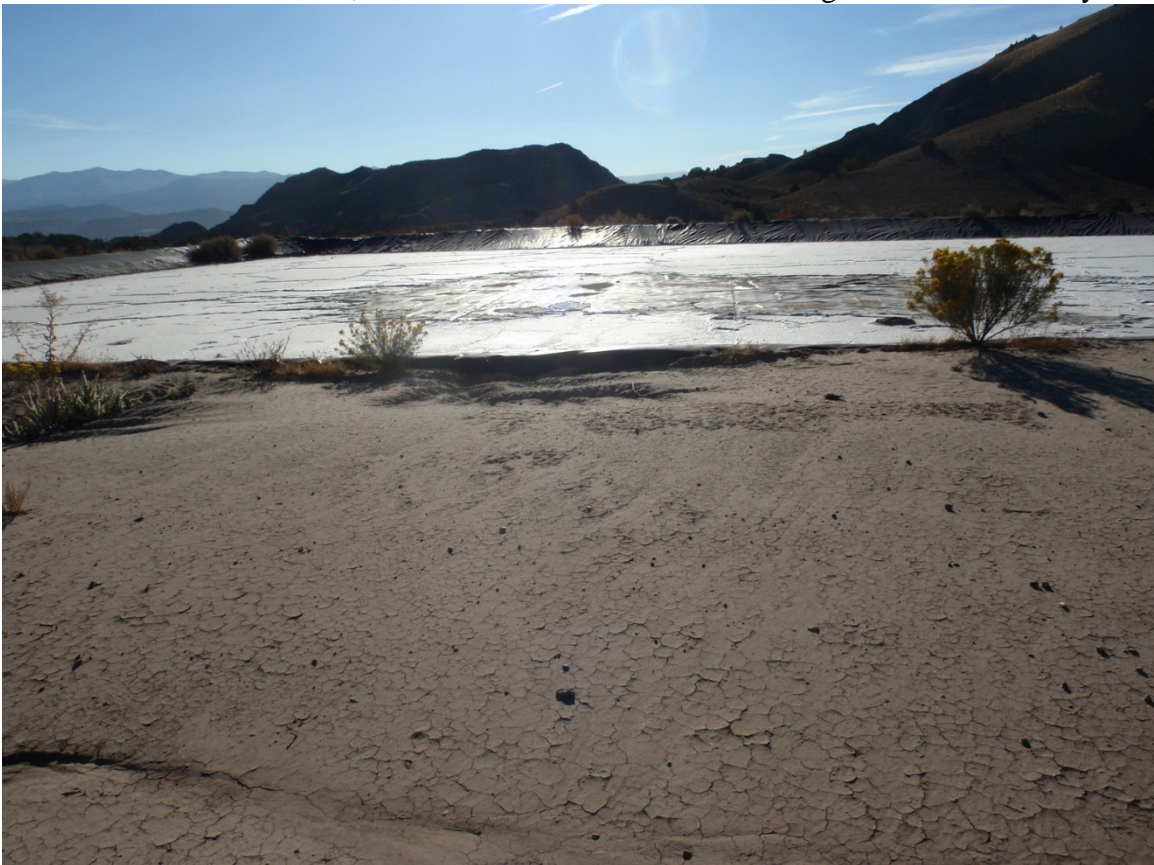
Photo 8. View looking east midway along fence, sheet flow and potential flow under liner.

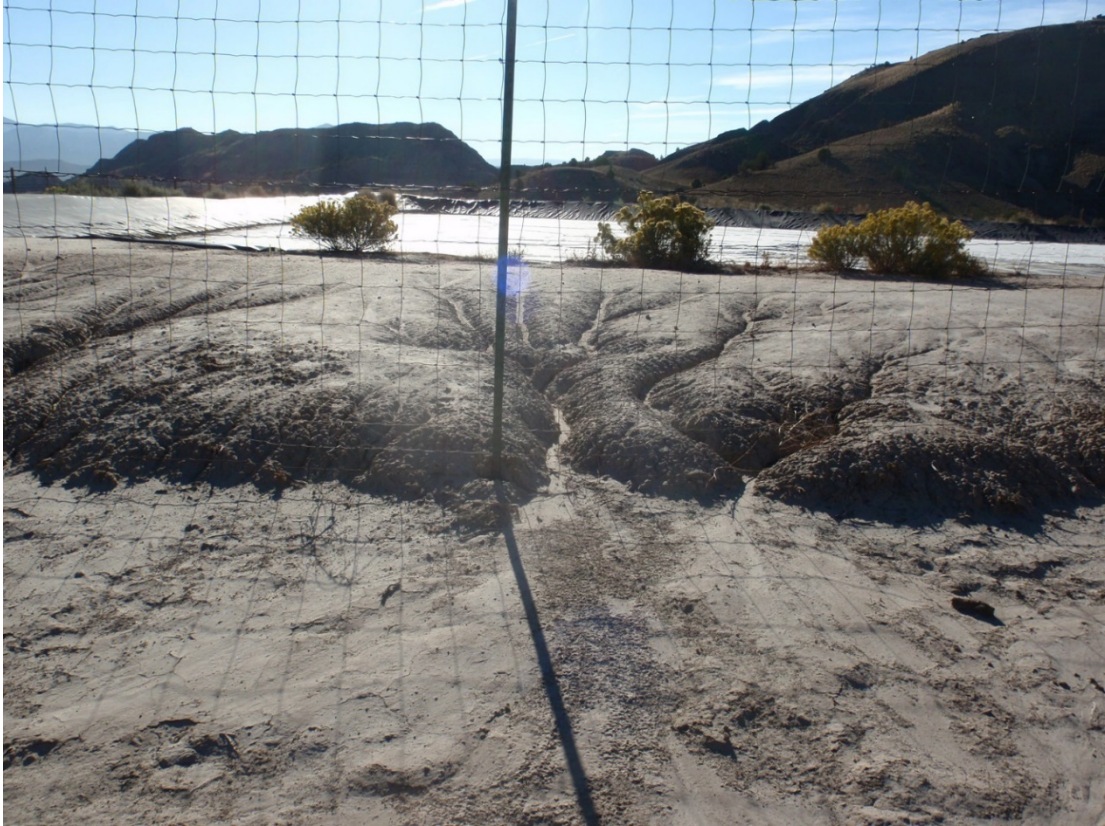
Photo 9. West side of facility berm showing erosional rills

Maintenance Needs?		Berms need to be repaired and protected from erosion. Liner has numerous patches and 70 + holes were seen. Large hole in liner.	
Photos & Maps		See Attached	
Other Comments and Additional Actions Necessary: The ROW has expired and will not be renewed. The holder must submit a plan detail the removal of all facilities, and the reclamation and restoration of the site. This should include the testing and disposal of soils, contouring and reseeding of site. A joint inspection must be scheduled with BLM and Maralex to discuss the requirements for an acceptable termination and rehabilitation plan.			
DRAFT February 27, 2009 - Perry		Next Inspection date:

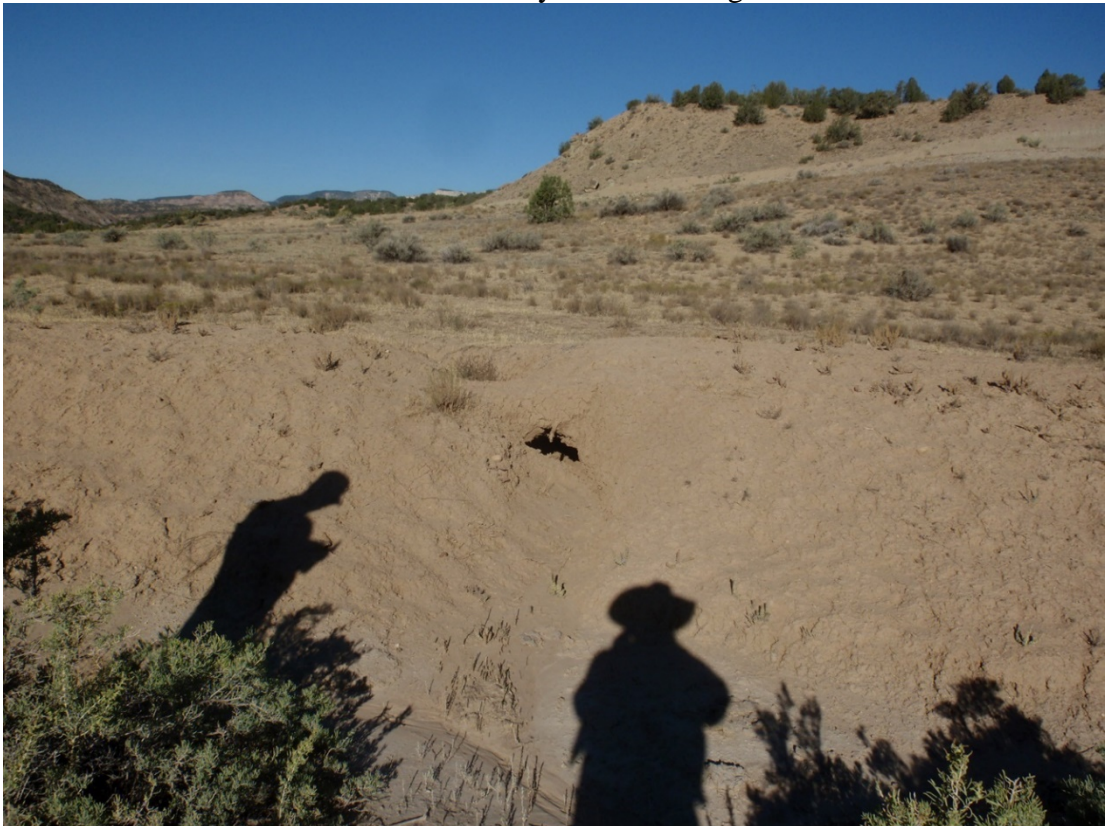
Photo 10. Looking west from facility, erosion issue on bank of storm water channel.

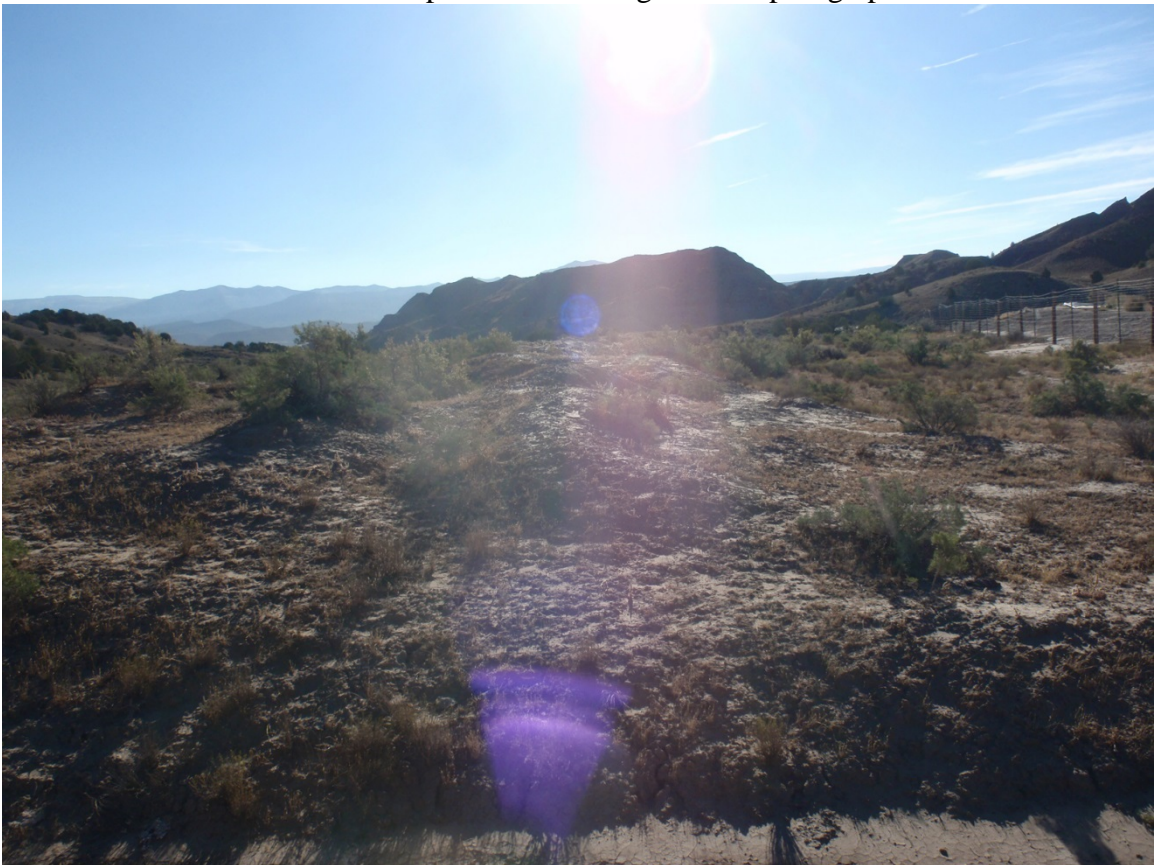
All operations within ROW?		There is a berm and drainage feature on the NE side that may be outside the limits of the ROW	
Topsoil? Salvage & Replacement		Approximately 1500 cu yd of material is stockpiled on the NE side of the location. Does not appear to be viable topsoil.	
Seeding?		No evidence of seeding, no vegetation on berms to slow erosion	
Interim Reclamation? Vegetation Types & Success		Most or the berms around the pond show erosional damage, rills, head cutting, soil movement, possibly undercutting the liner.	
Final Reclamation? Recontoured to Original Contour. Vegetation Types & Success.		Not completed	
Noxious Weeds?		Halogeton, Kochia,	
Water Management? Drainage Structures, Ditches, Culverts, Rip-Rap		Drainage feature on NW side channel water around site. Berms are eroding because there is no vegetation to hold soil in place.	
Site Stability? Erosion & Runoff Controlled, Sediment Traps		The berm on the SE side has eroded past the fence and shows lots of erosion. Soils are moving off location.

Photo 12. Stockpile of material ~1500 cu yards. Enough material for reclamation?

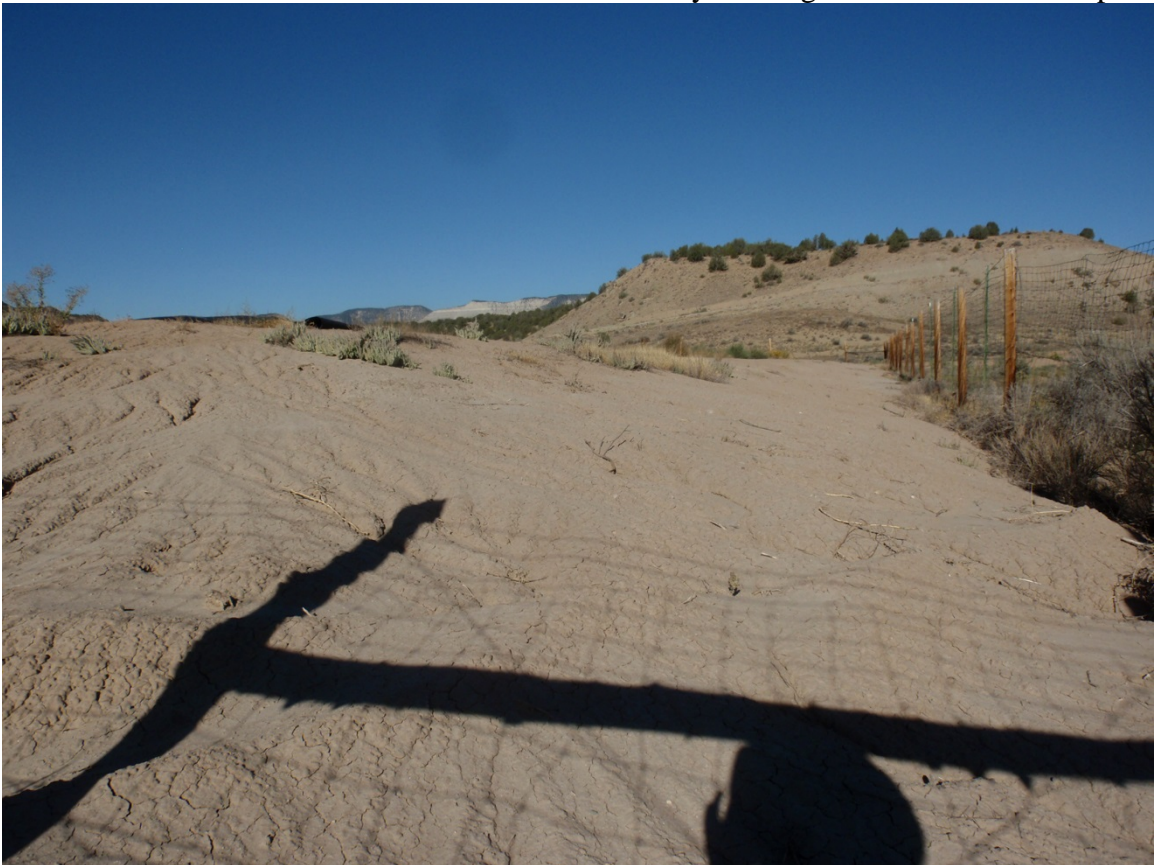
Photo 16. Northeast corner of facility looking west. Erosion occurring along entire berm.

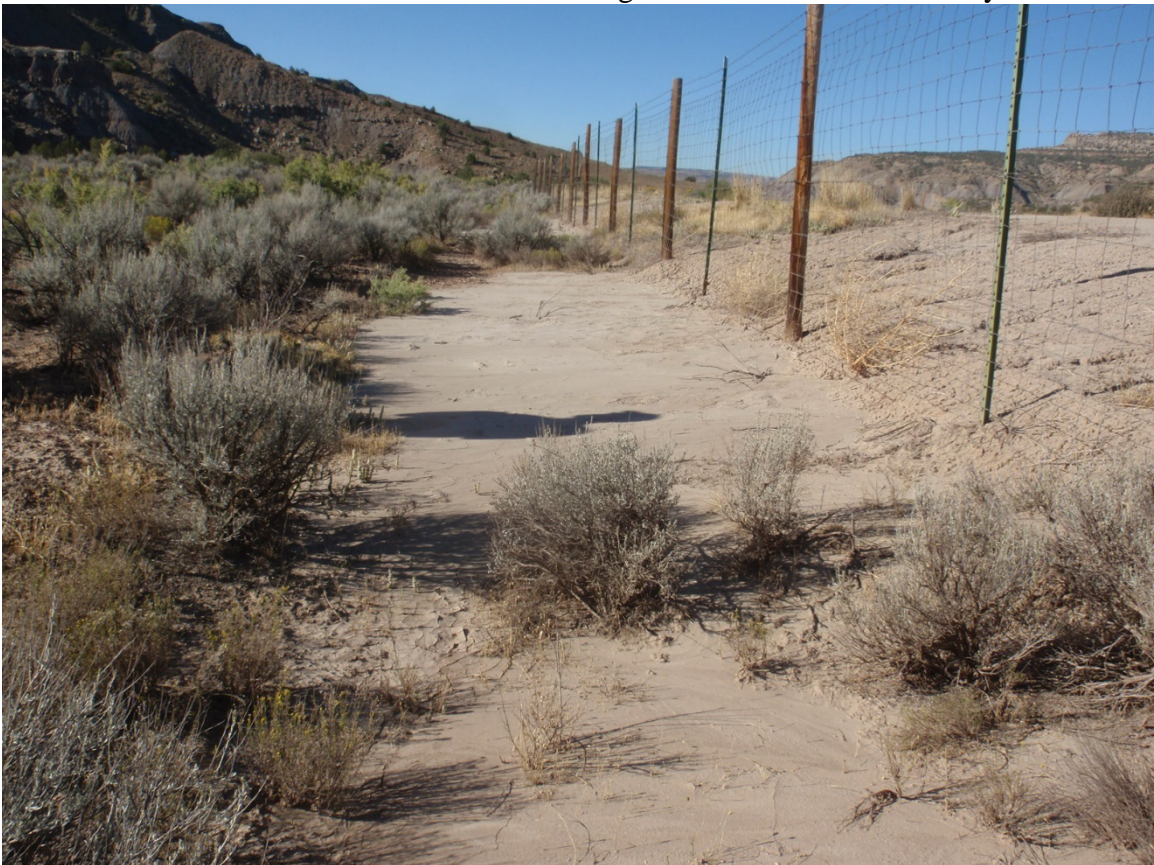
Photo 22. Erosion and offsite soil migration on east side of facility.

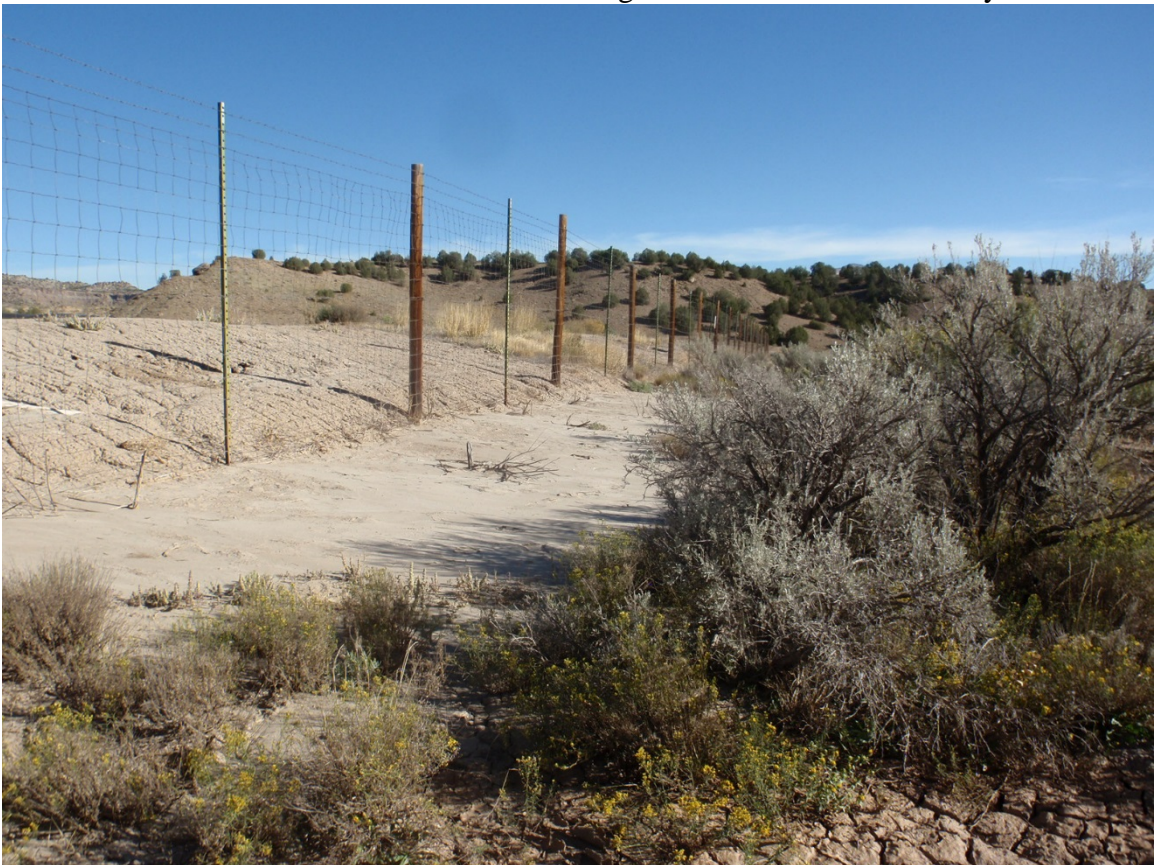
Photo 24. Erosion and offsite soil migration on east side of facility.

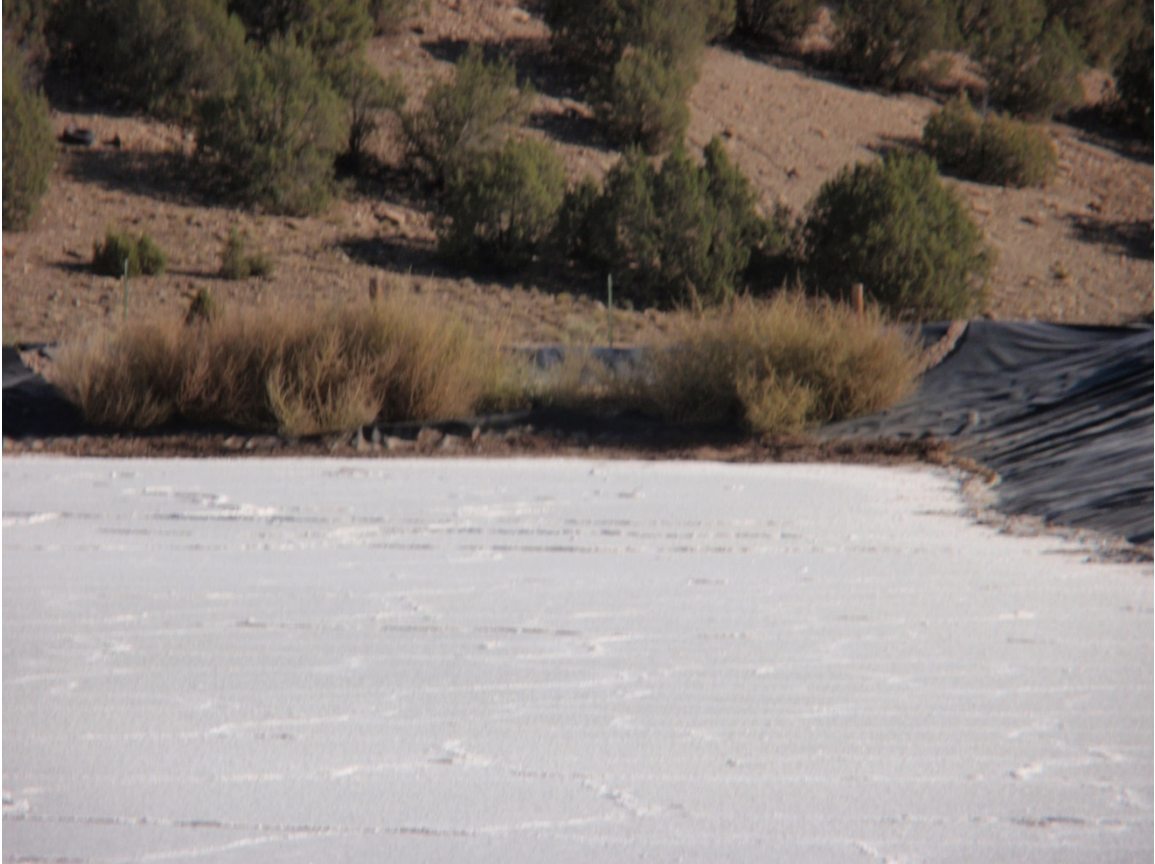
Photo 25. View of facility looking north, accumulation of salts and soils in pit. Liner torn.

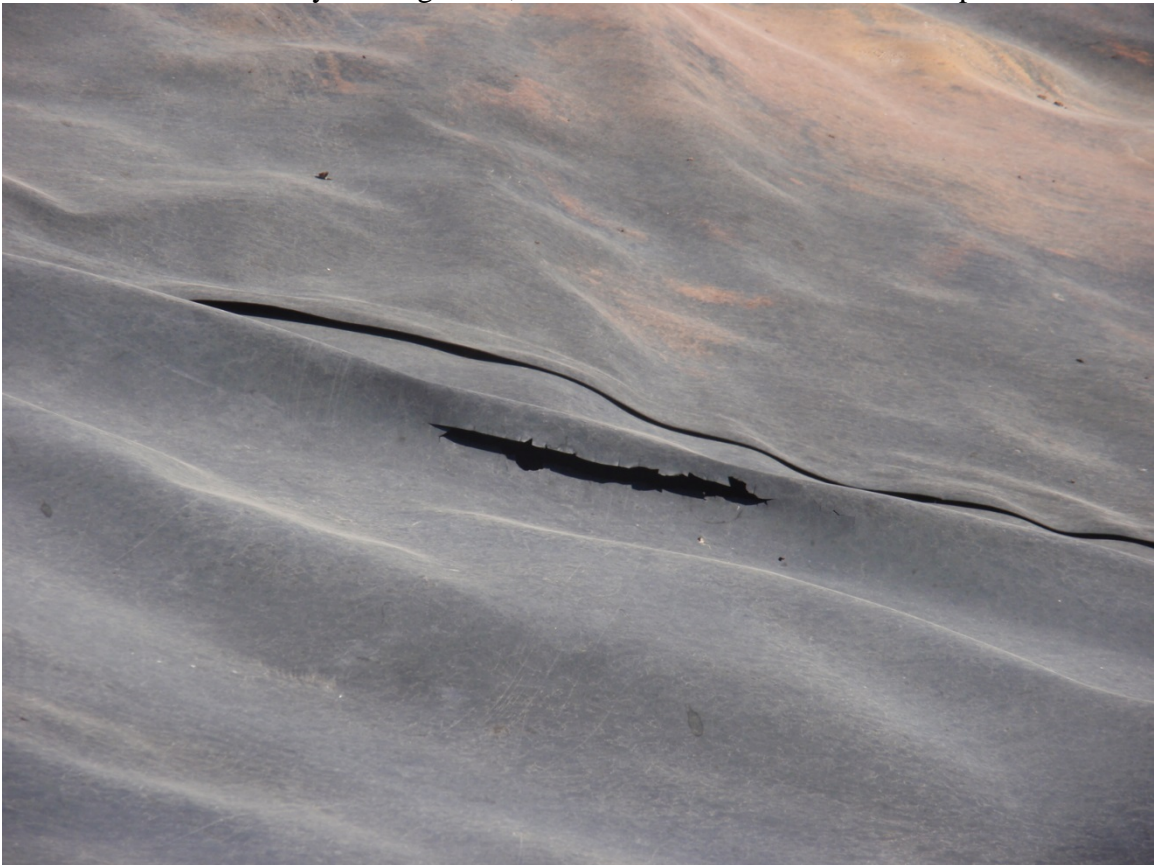
Photo 26. Visible tear in liner on south side of pit.

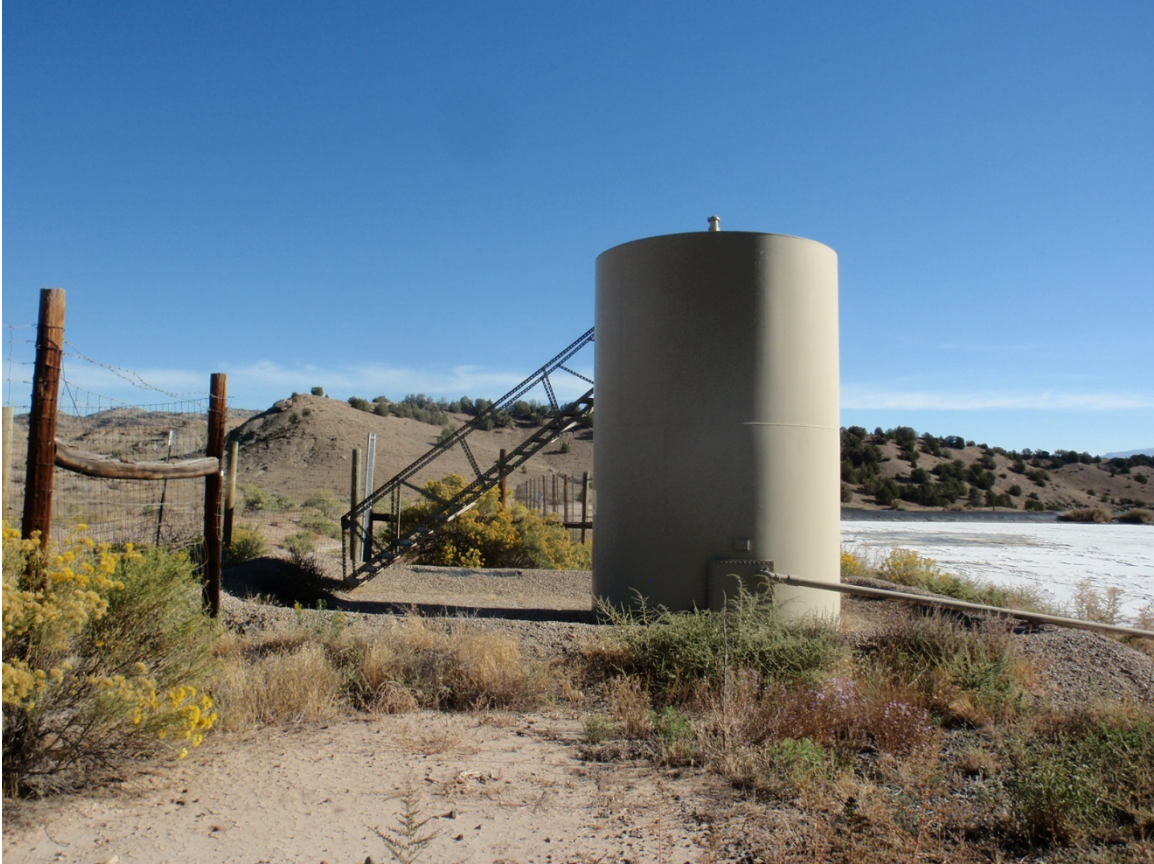
Photo 27. 300 barrel tank and shallow containment berm

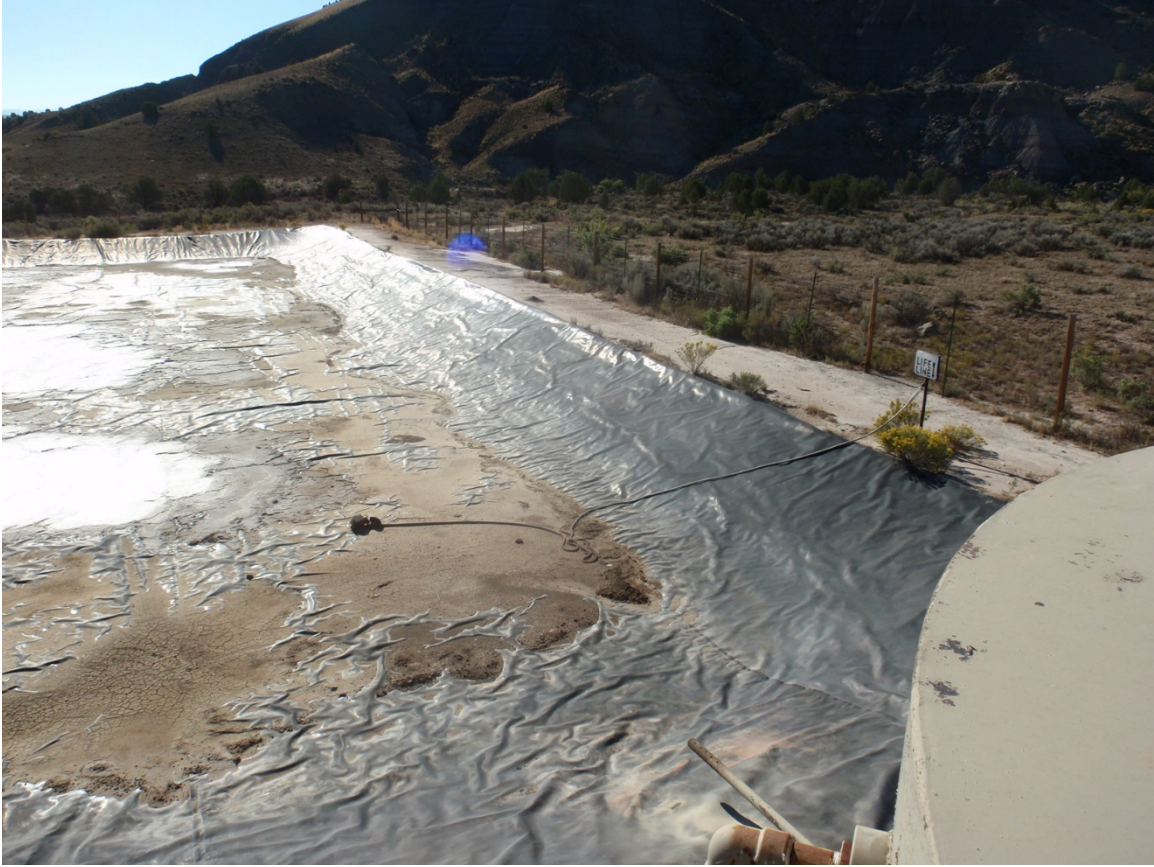
Photo 31. View of south side of pit, soil and salt accumulation in pit.

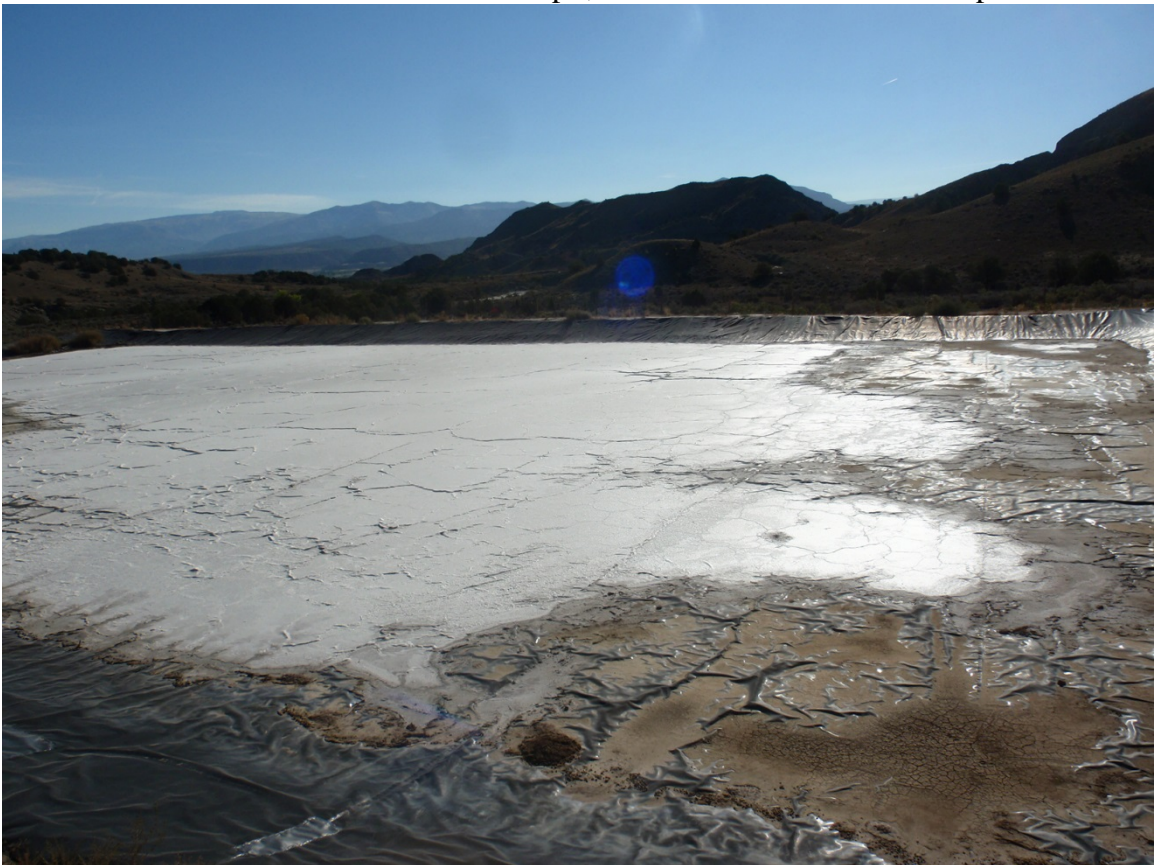
Photo 32. View of central part of pit, soil and salt accumulation in pit.

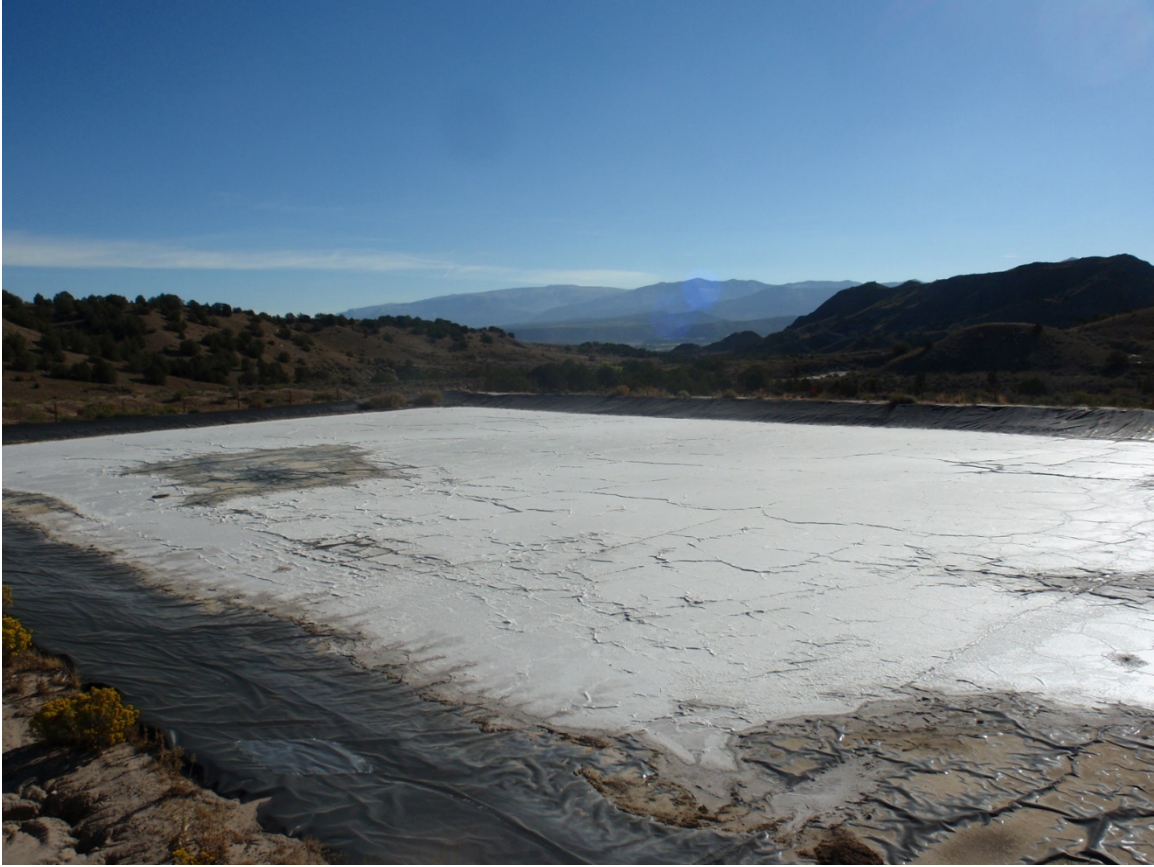
Photo 33. View of central part of pit, soil and salt accumulation in pit.

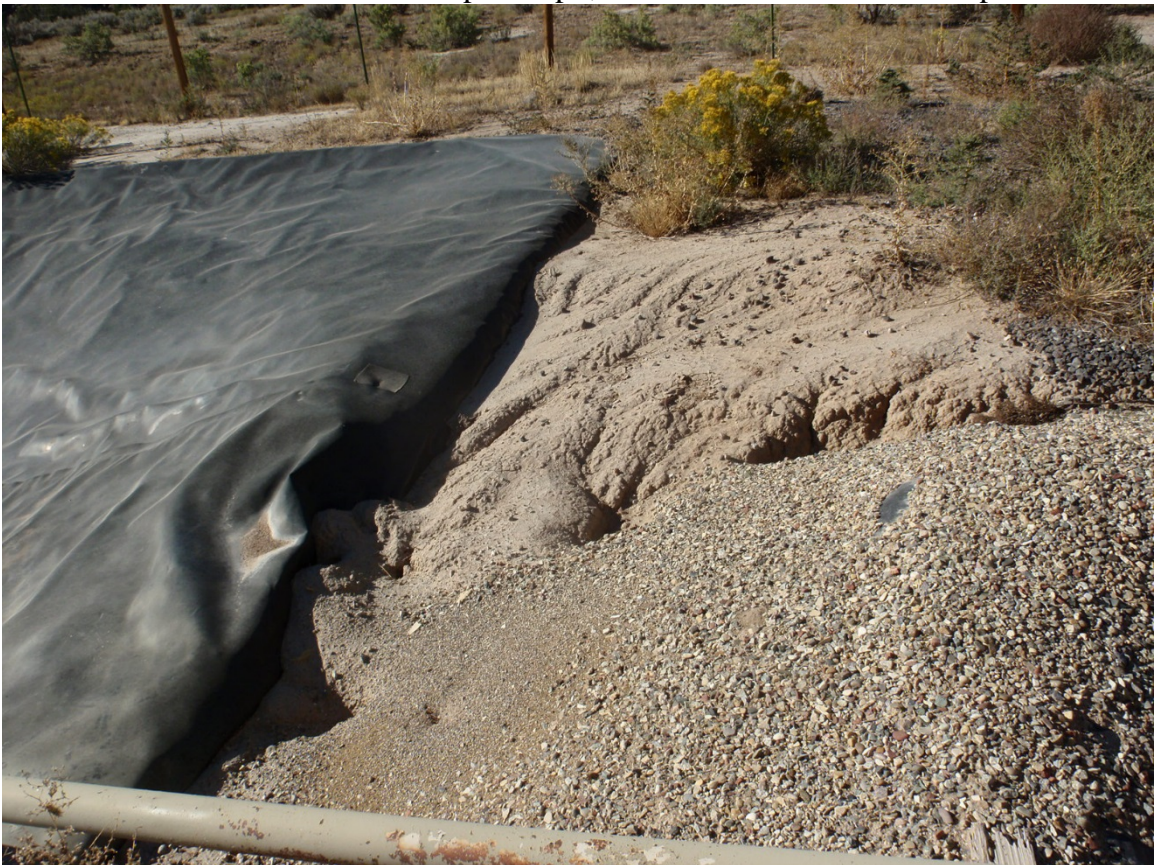
Photo 34. Erosion next to 300 bbl tank soils migrating under pit liner.

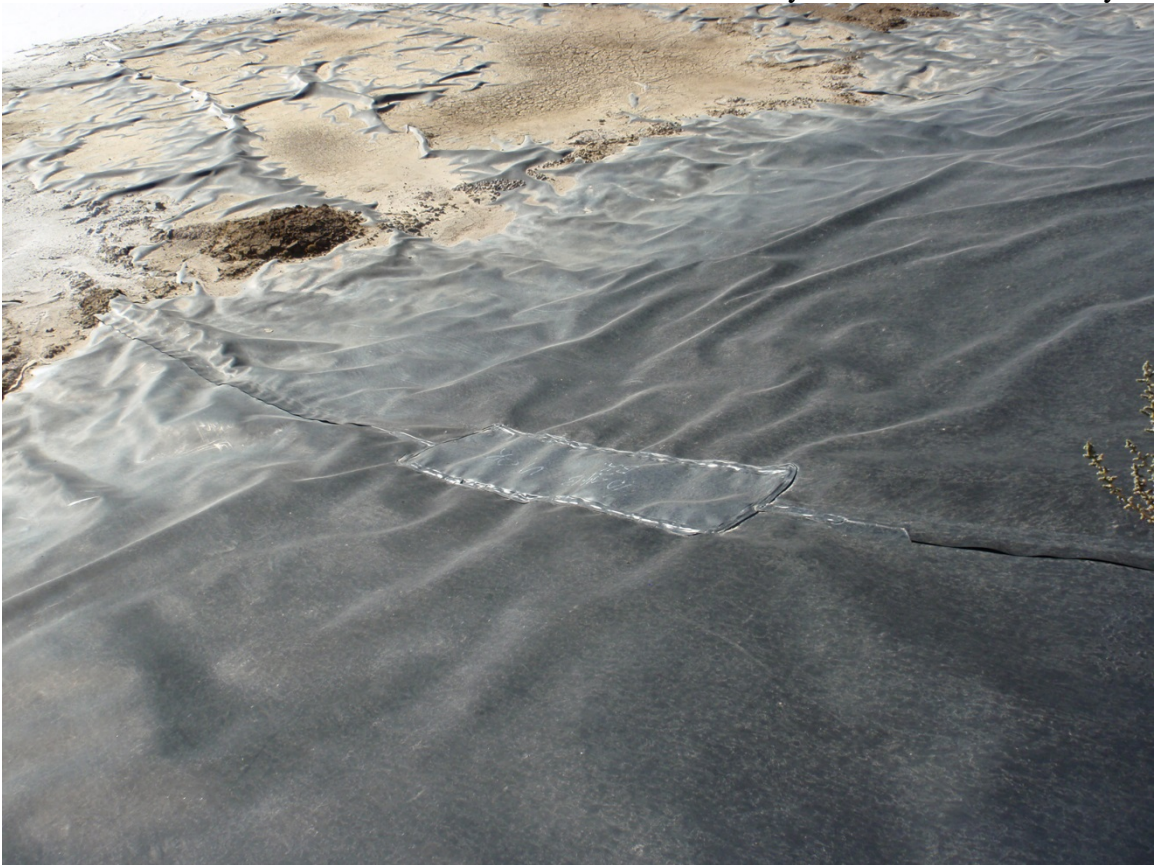
Photo 36. Older patch in liner on west site of pit.

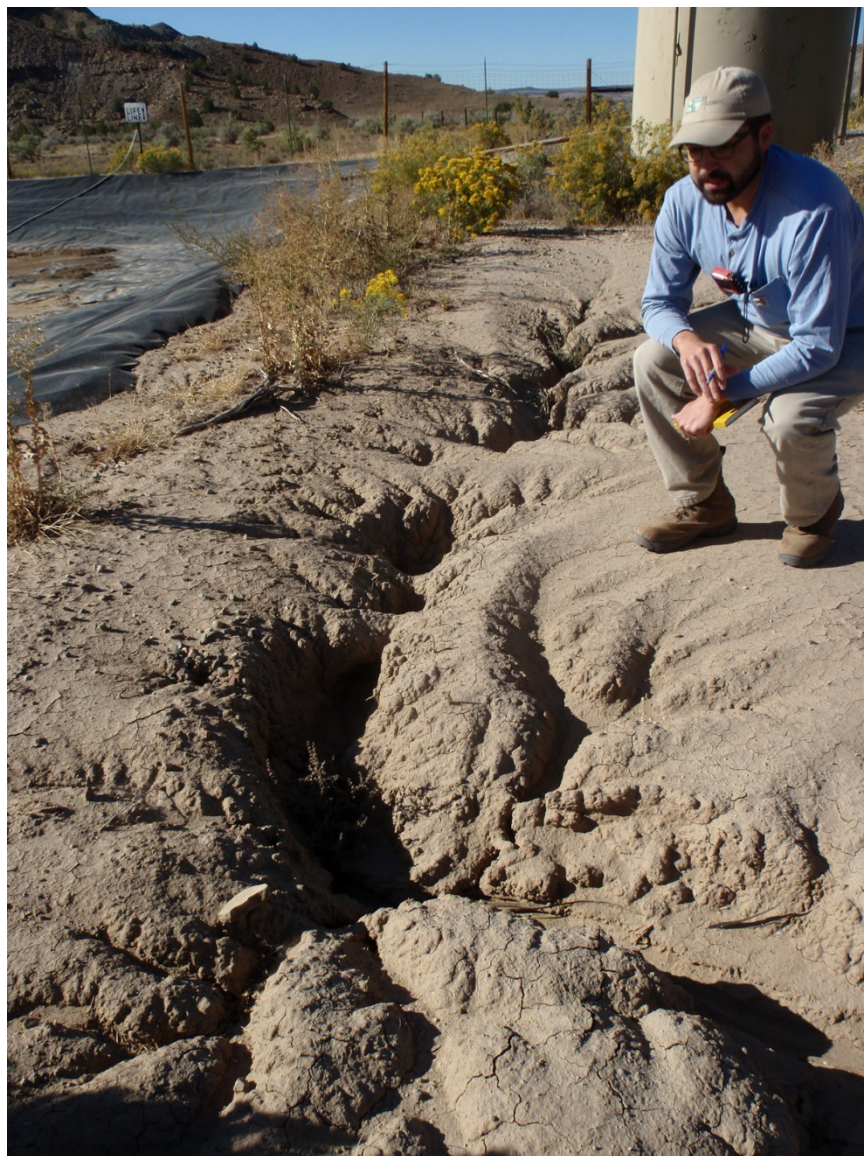
Photo 40. Erosion on berm on west side of pit

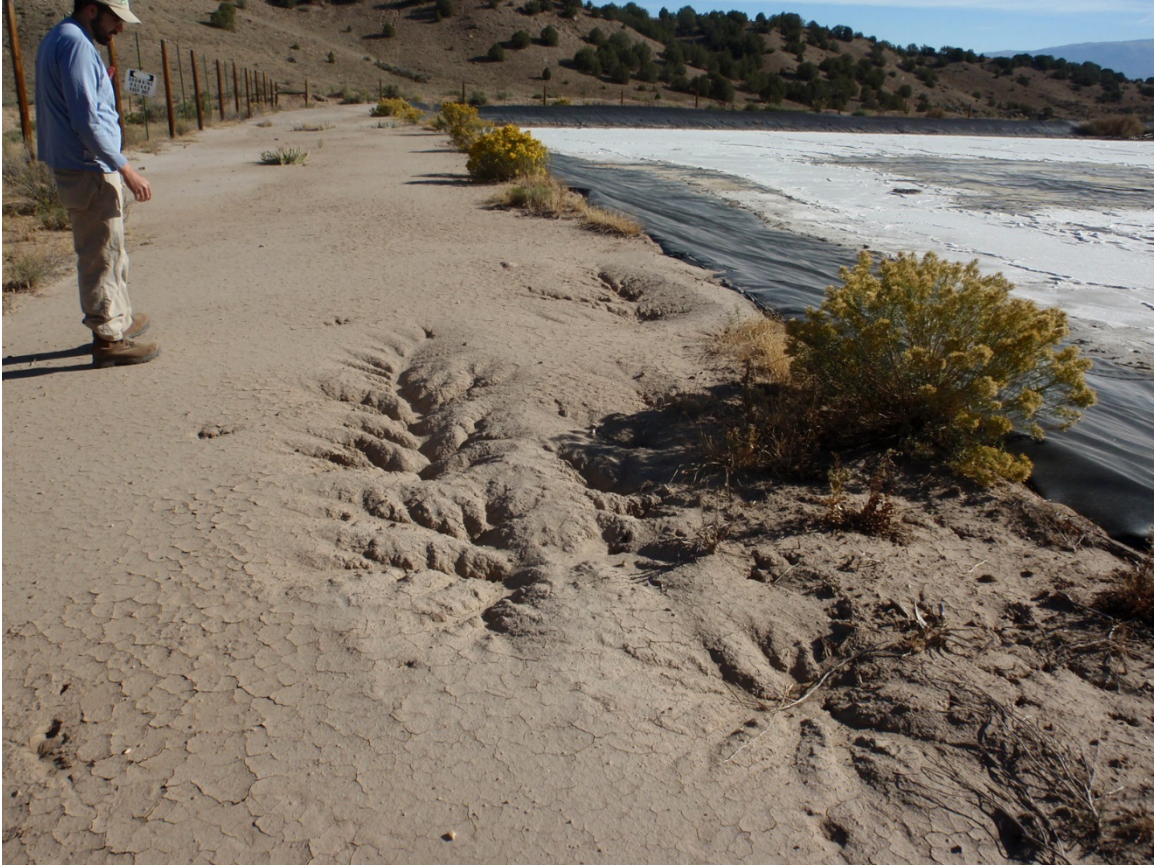
Photo 41. Erosion on berm on west side of pit

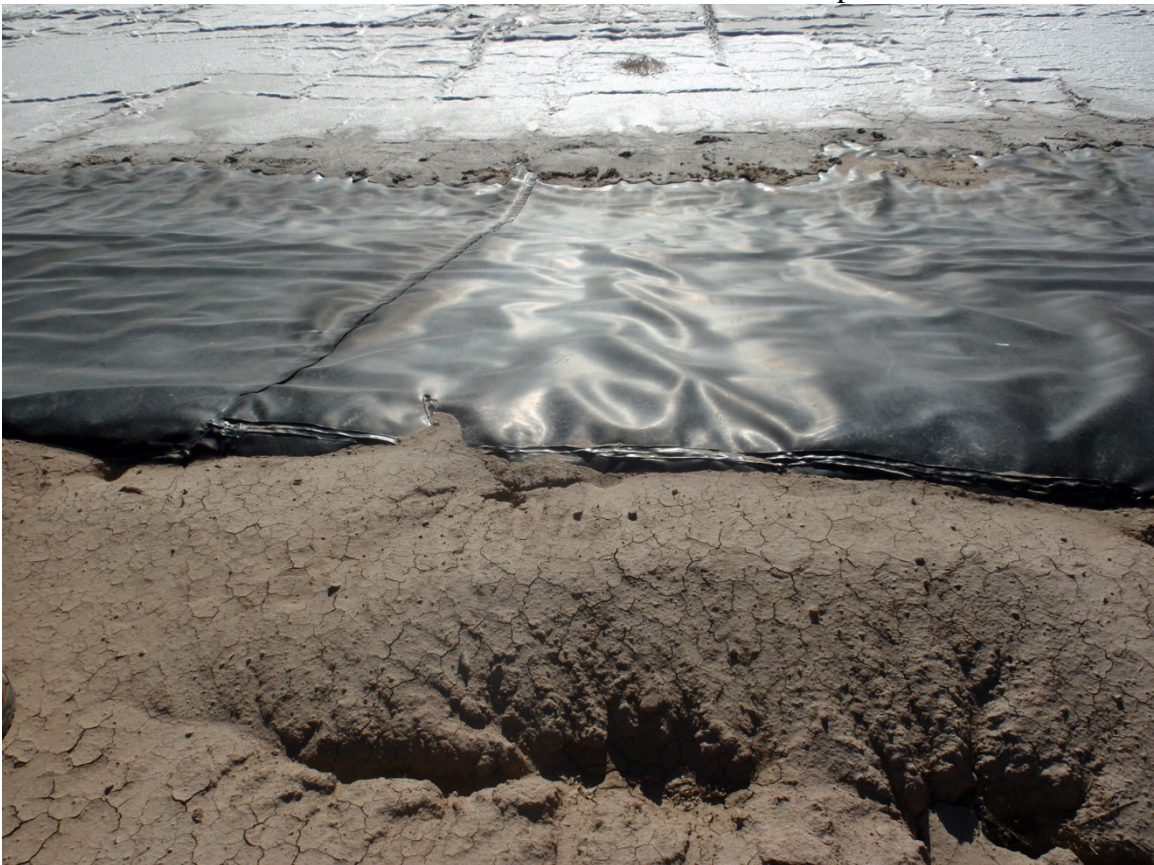
Photo 42. Erosion on berm on west side of pit

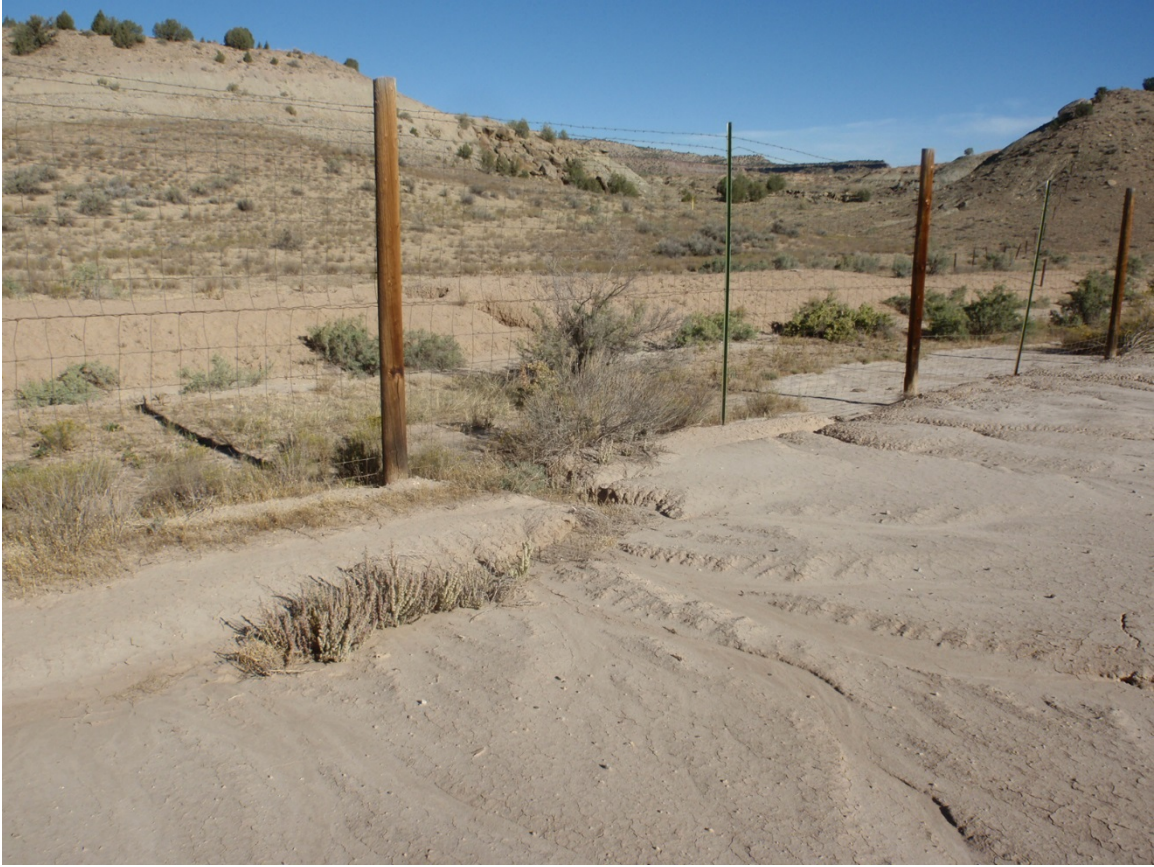
Photo 45. Erosion on berm on west side of pit, soil migrating offsite.

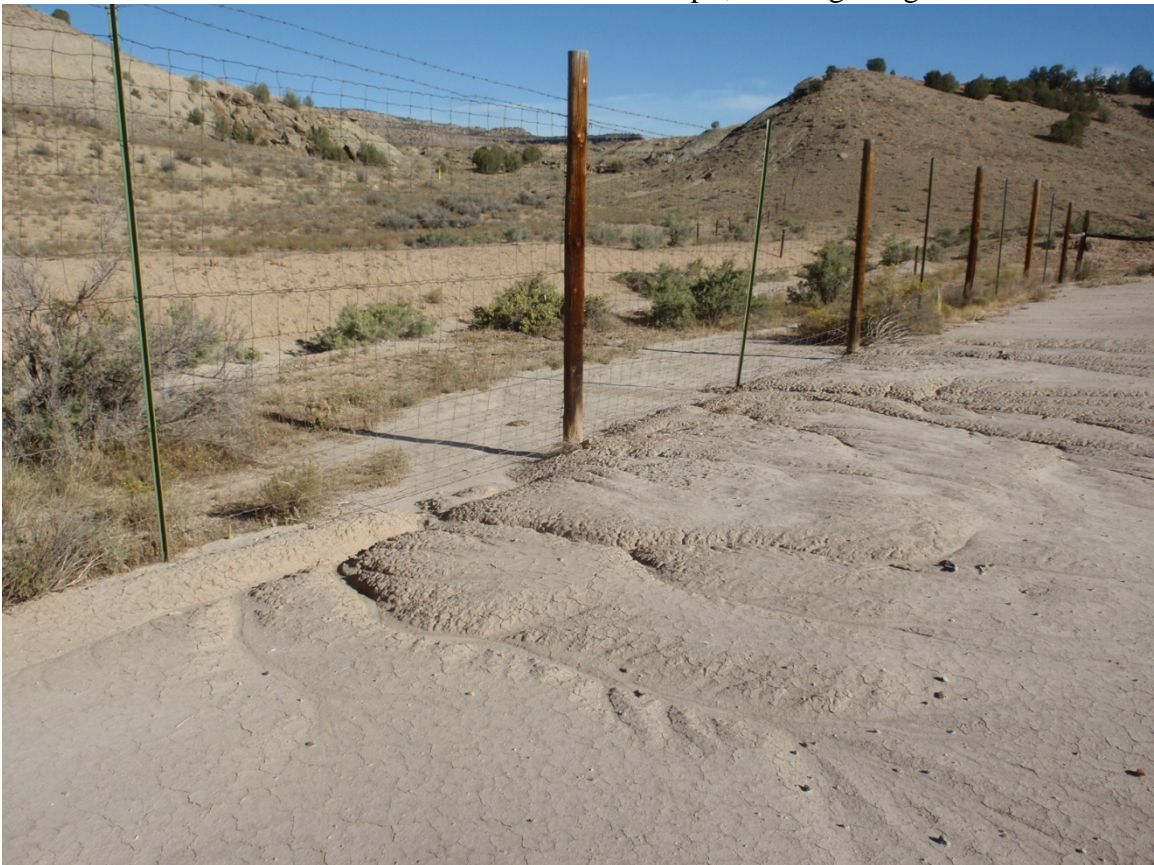
Photo 46. Erosion on berm on west side of pit, soil migrating offsite.
