ROW Compliance Inspection		Case #: COC 61214 Holder: Maralex Disposal LLC	Project Name: Roan Creek Evaporation Pond
Twn: 8 S Rng: 98 W Sec 36: Qtr: NESE		County: Mesa County State: Colorado	
Inspection Date & Time: 9/27/2018 9:00am			
Inspector: Scott Hall		Office Time:	Total Time:
People/Affiliations at Inspection: COGCC		Steven Arauza	
Existing Conditions? 1.Construction, 2.Operation, 3.Reclamation; Disturbed Area Measurements; Facilities		Site was construction in the 1980's and was used until 2009. Pit has been in noncompliance since 2010 and has not been used since. The site is 285' by 505' and include a 24' x 245' access road and a 100' x 77' site for bioremediation of soils. Facilities include, pit, fence, 300 barrel tank with berm, and leak detection system.	
Conformance with ROW Terms & Conditions? Constructed to Specifications		ROW is not in compliance with the stipulations. ROW expired 8/30/2018.

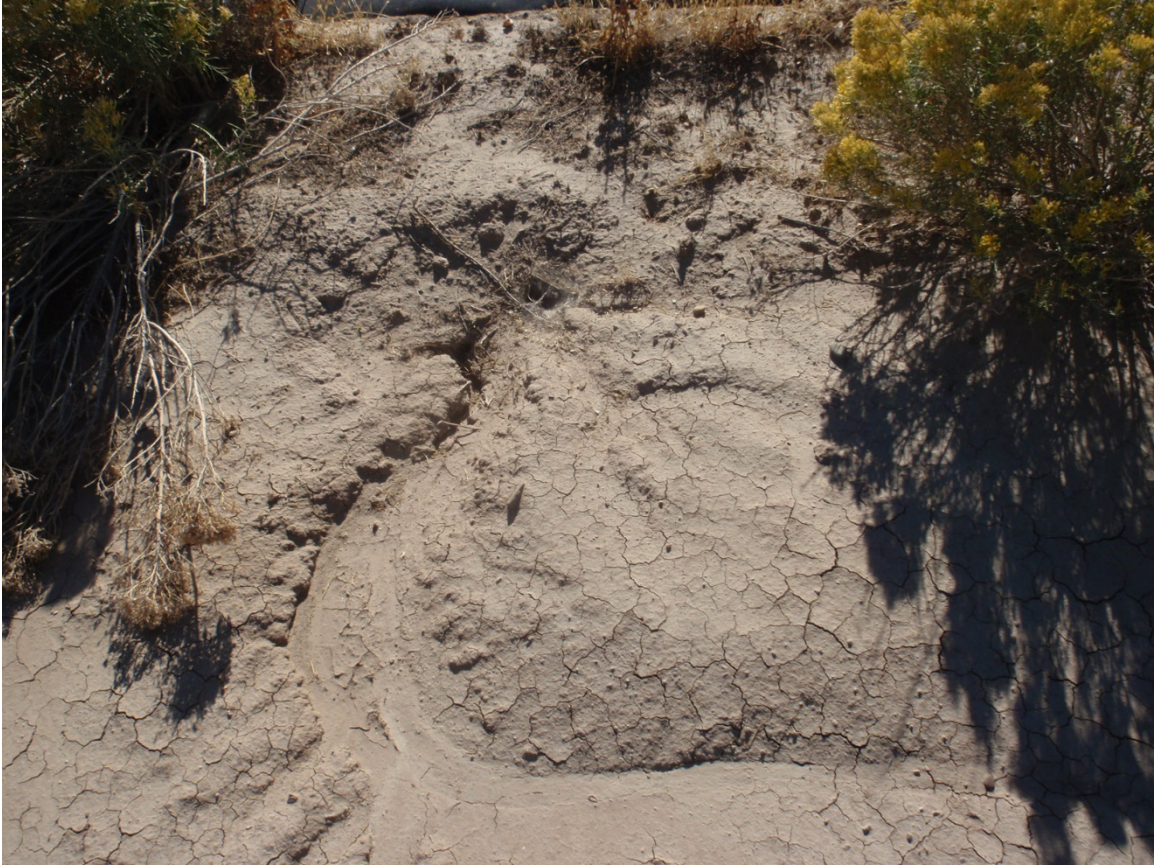
Photo 47. Erosional rill at northwest corner of pit soil migrating under liner.

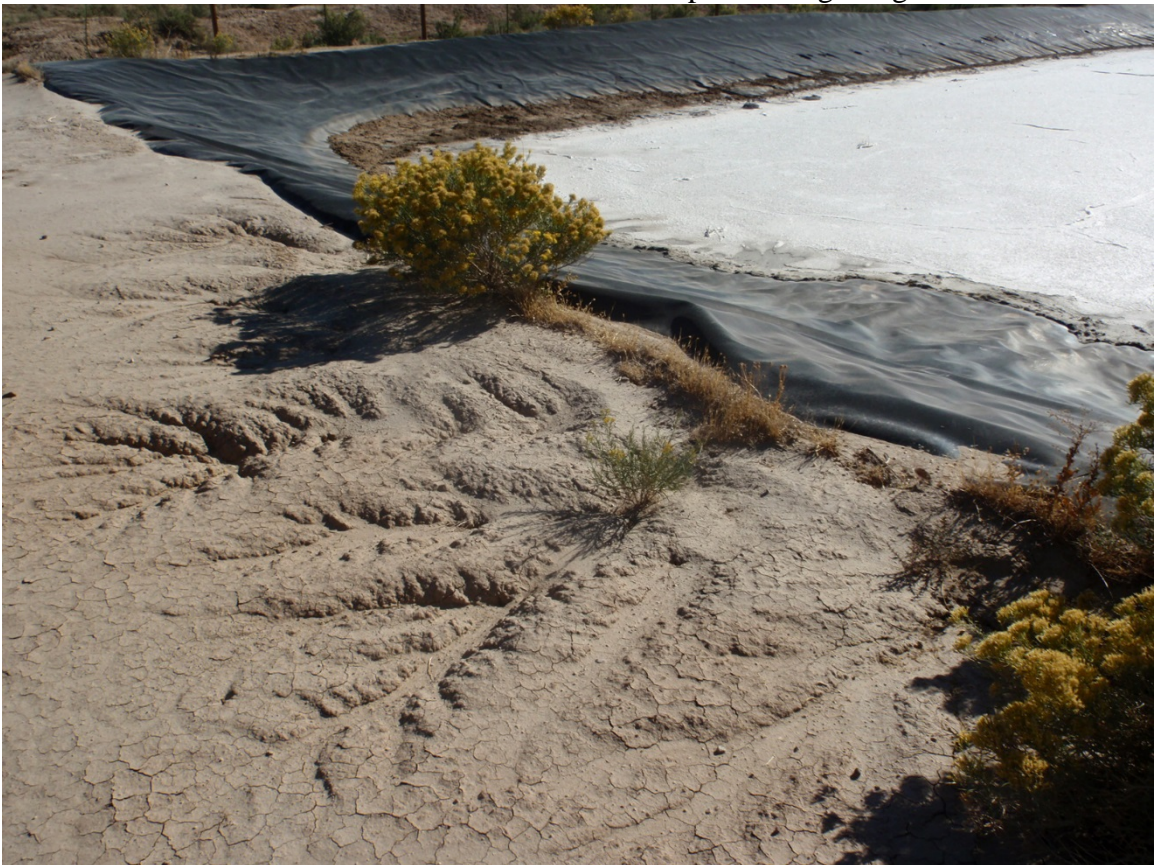
Photo 48. Erosional rill at northwest corner of pit soil migrating under liner

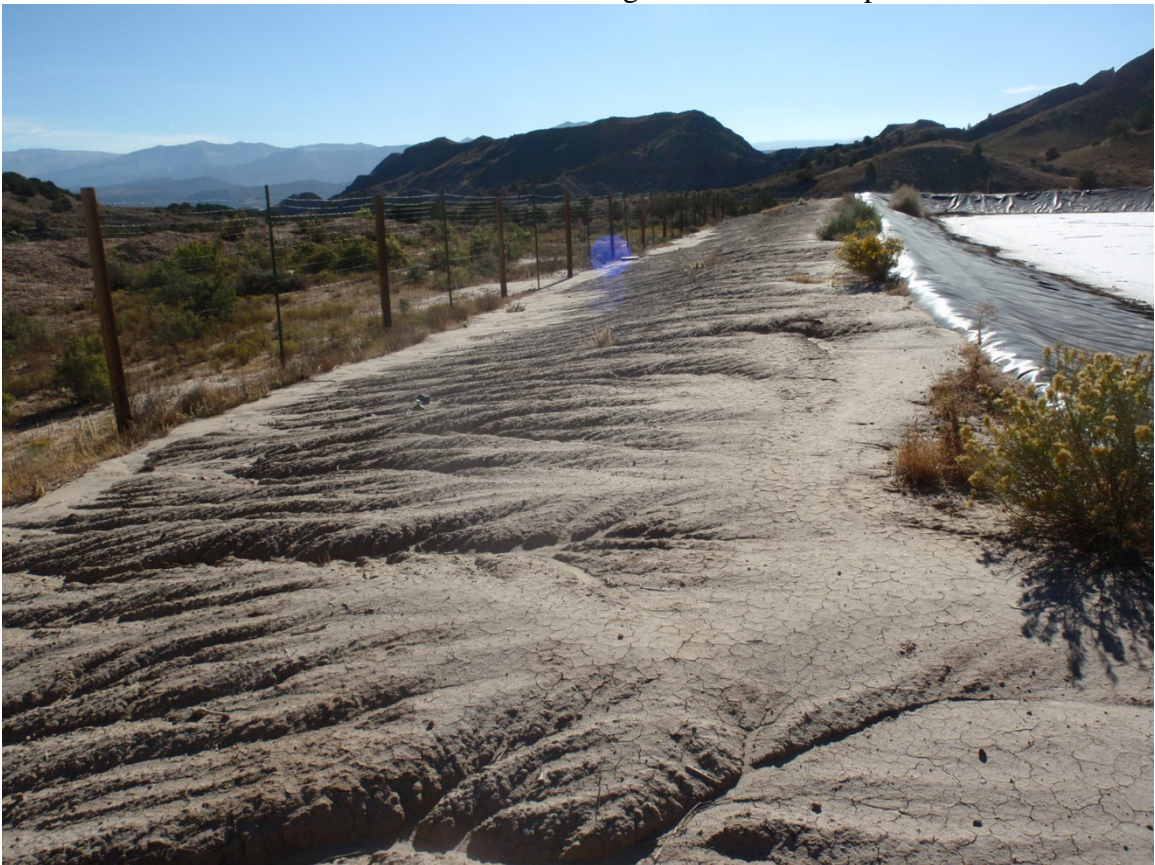
Photo 52. Erosional rills along the north side of pit.

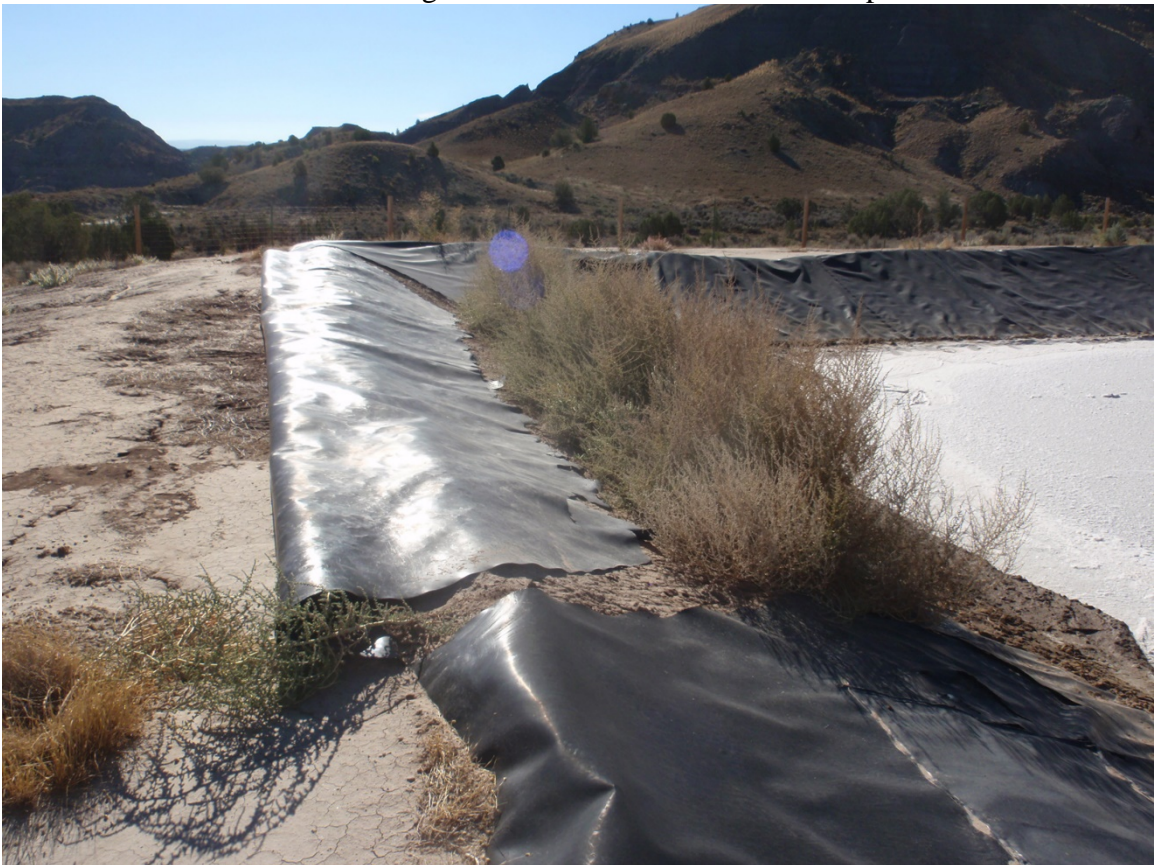
Photo 85. Large tear in liner at northeast side of pit

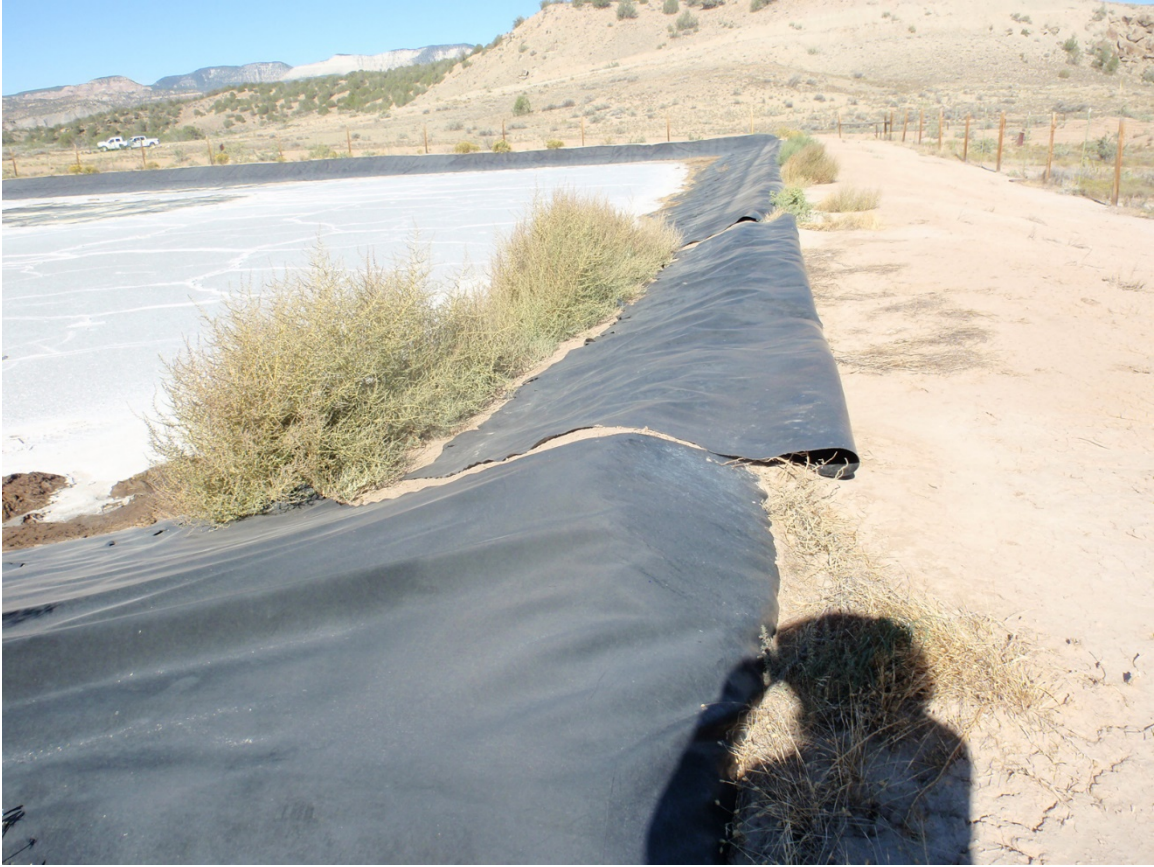
Photo 86. Large tear in liner at northeast side of pit

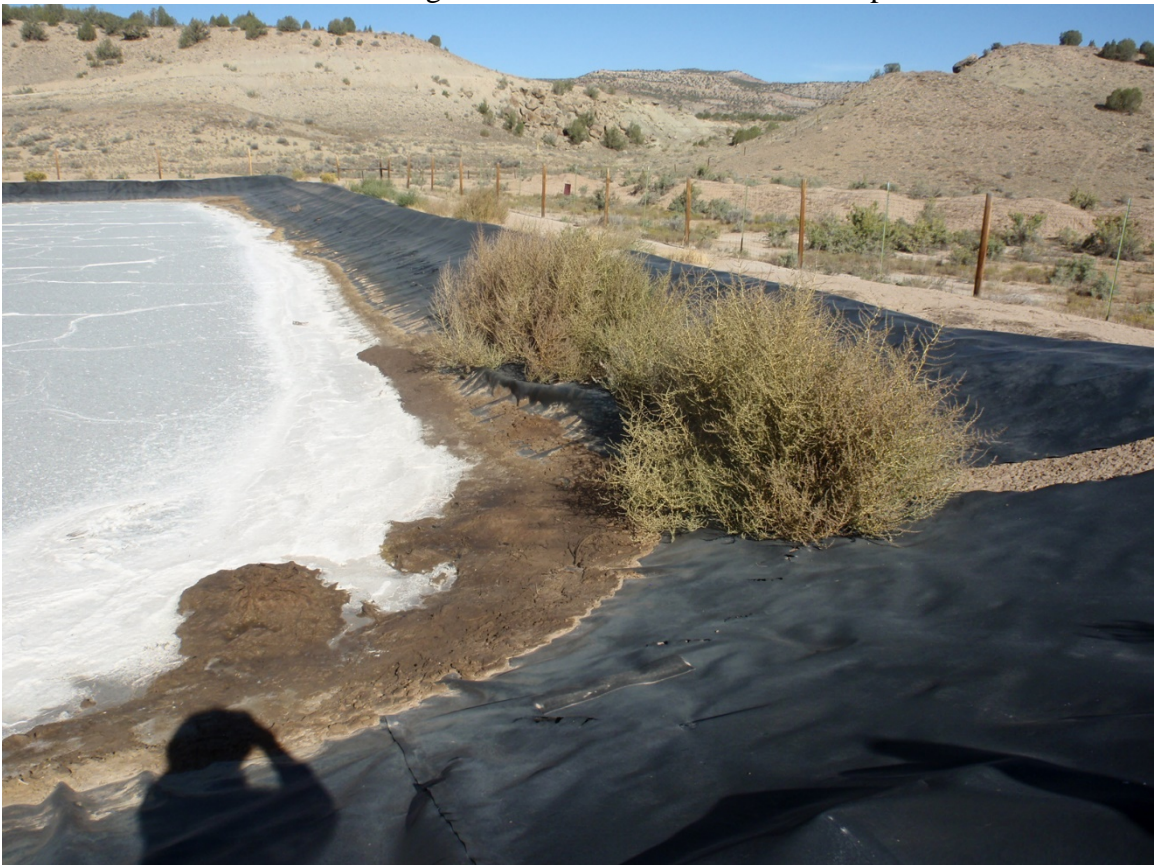
Photo 87. Large tear in liner at northeast side of pit

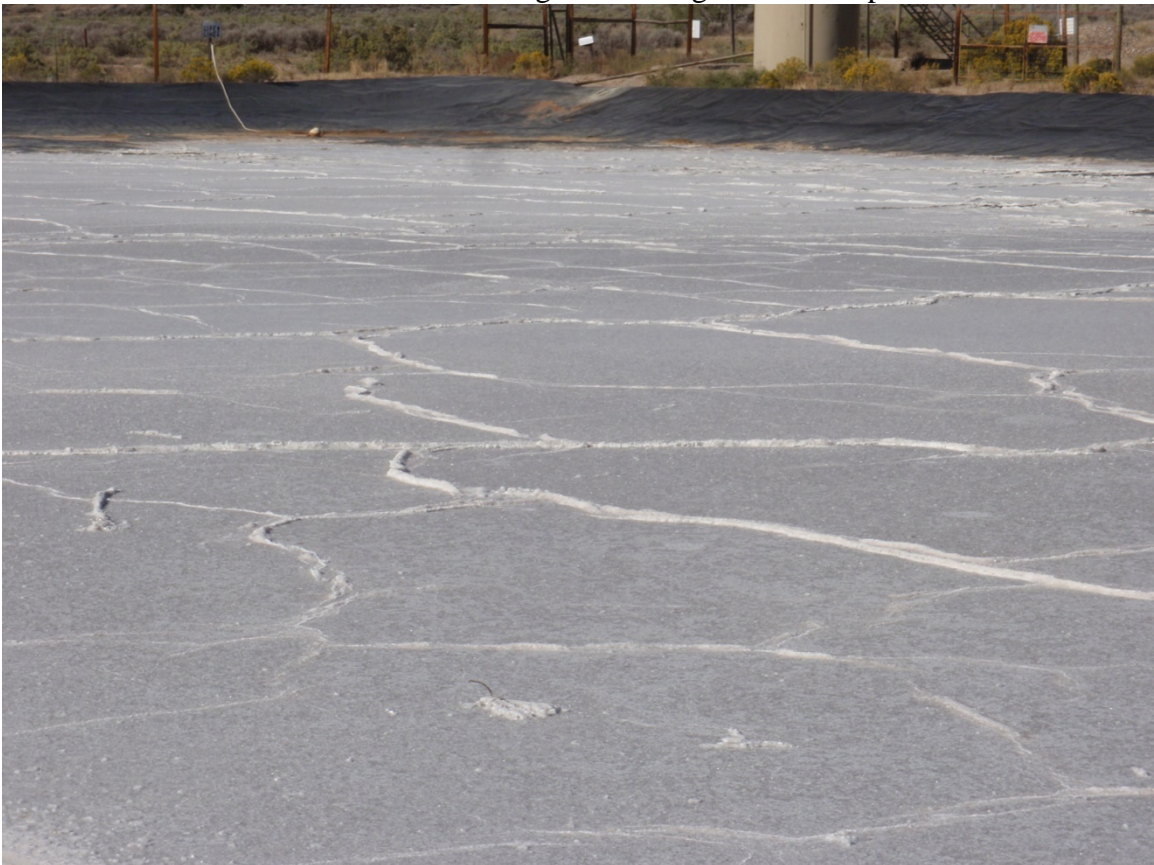
Photo 93. Accumulation of salts in pit

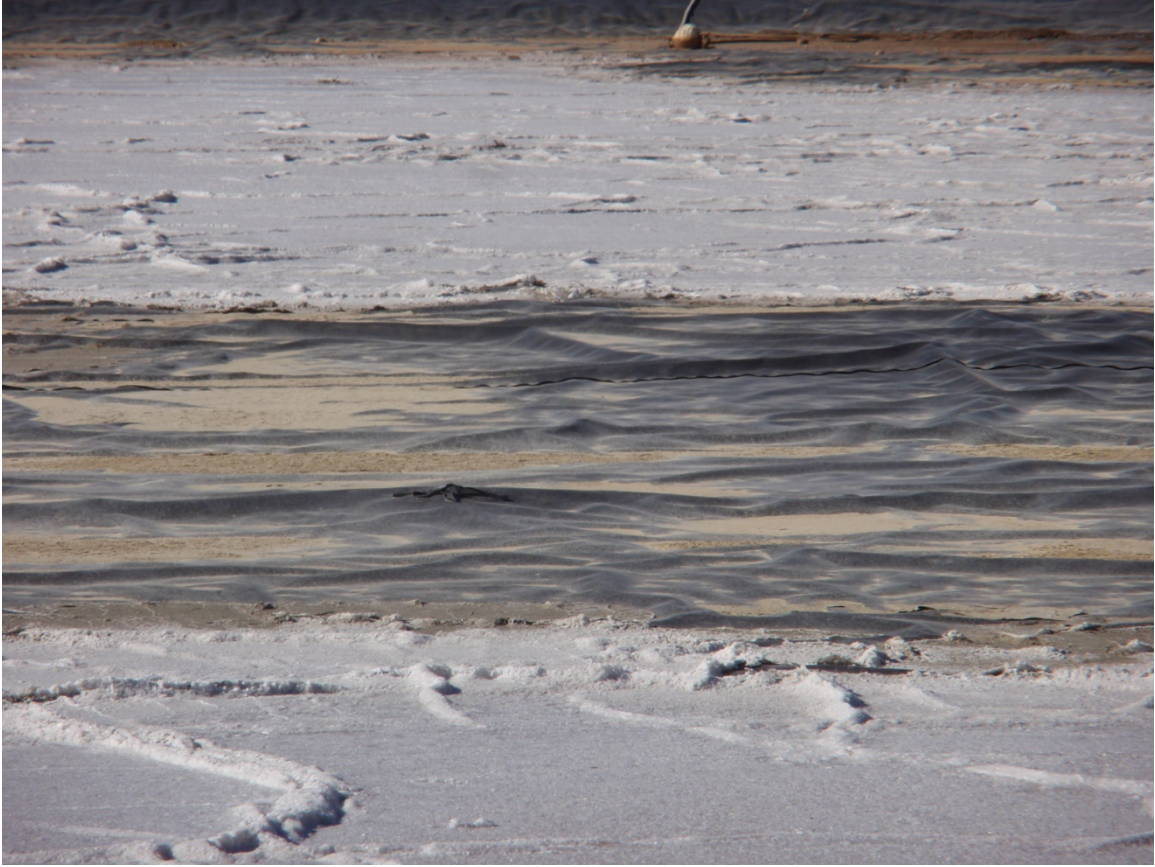
Photo 102. Accumulation of sediment and salt in middle of pit.

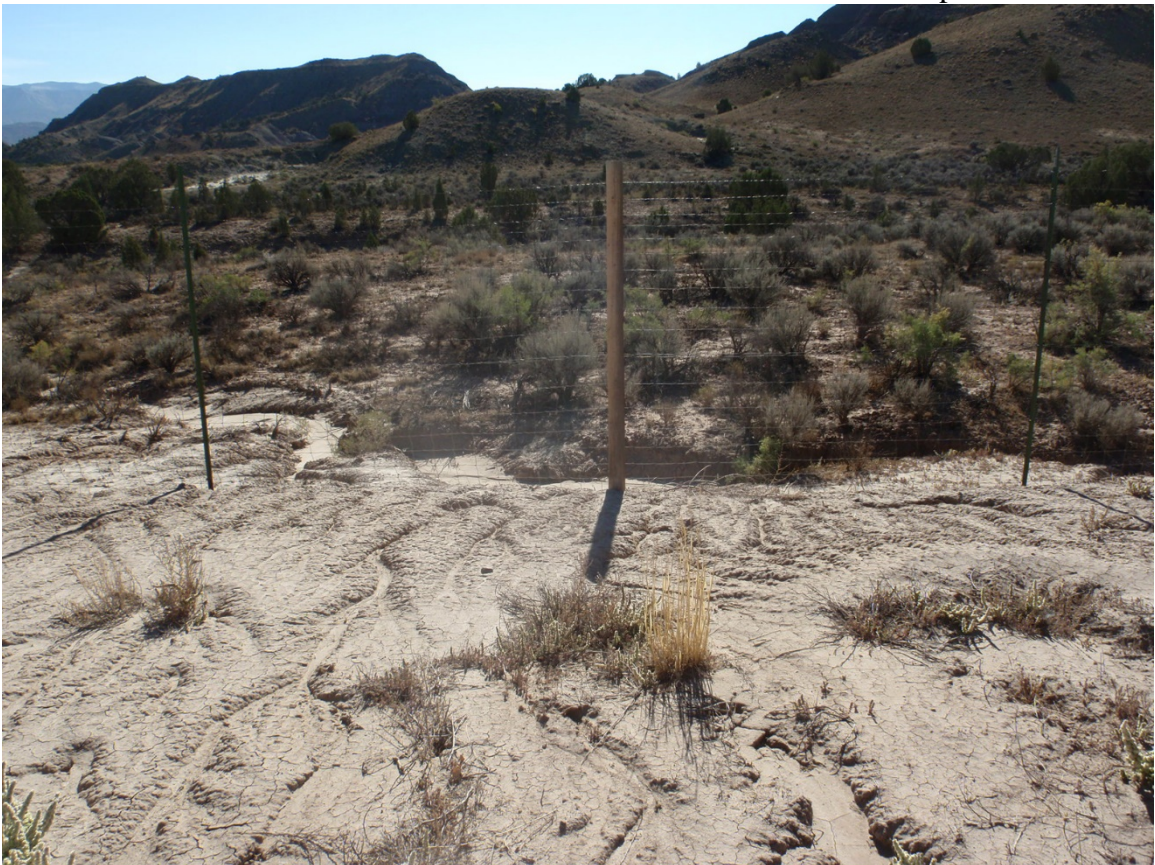
Photo 103. Erosion an soil migrating on east side of pit.

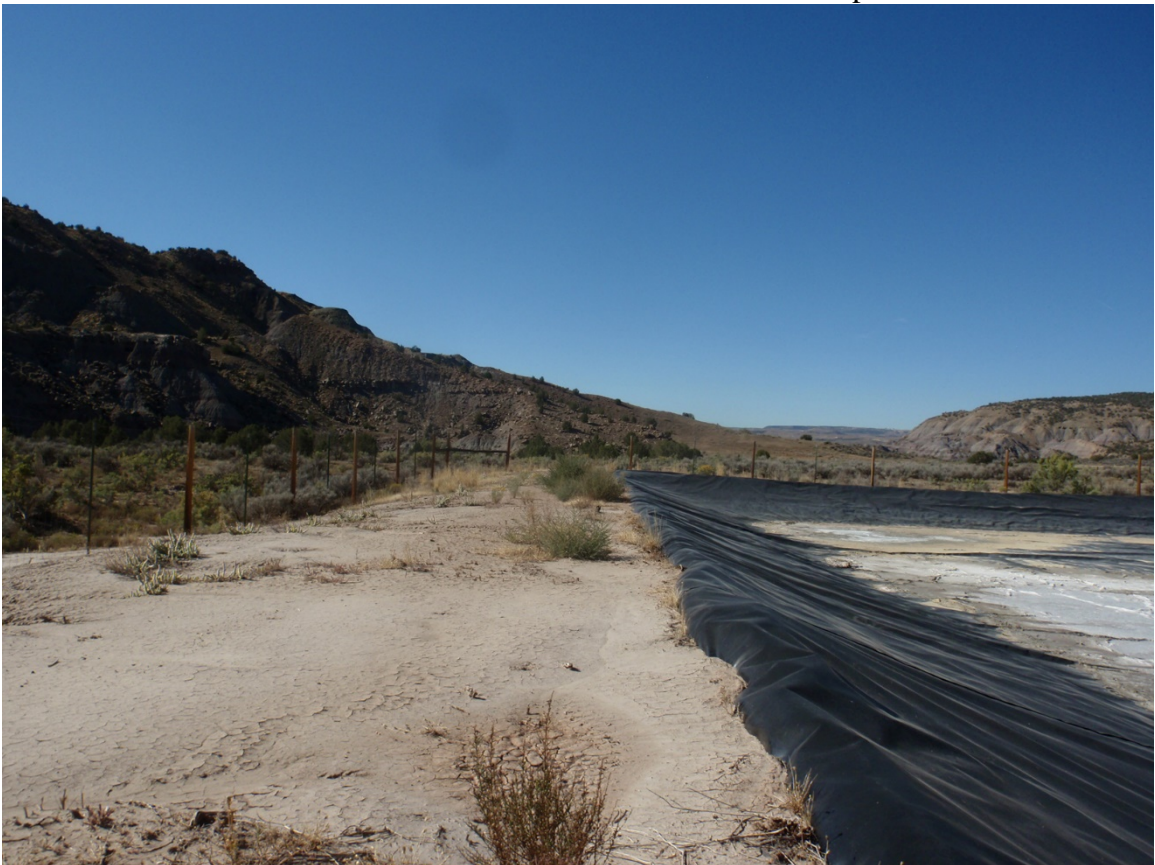
Photo 105. View along east side of pit looking south

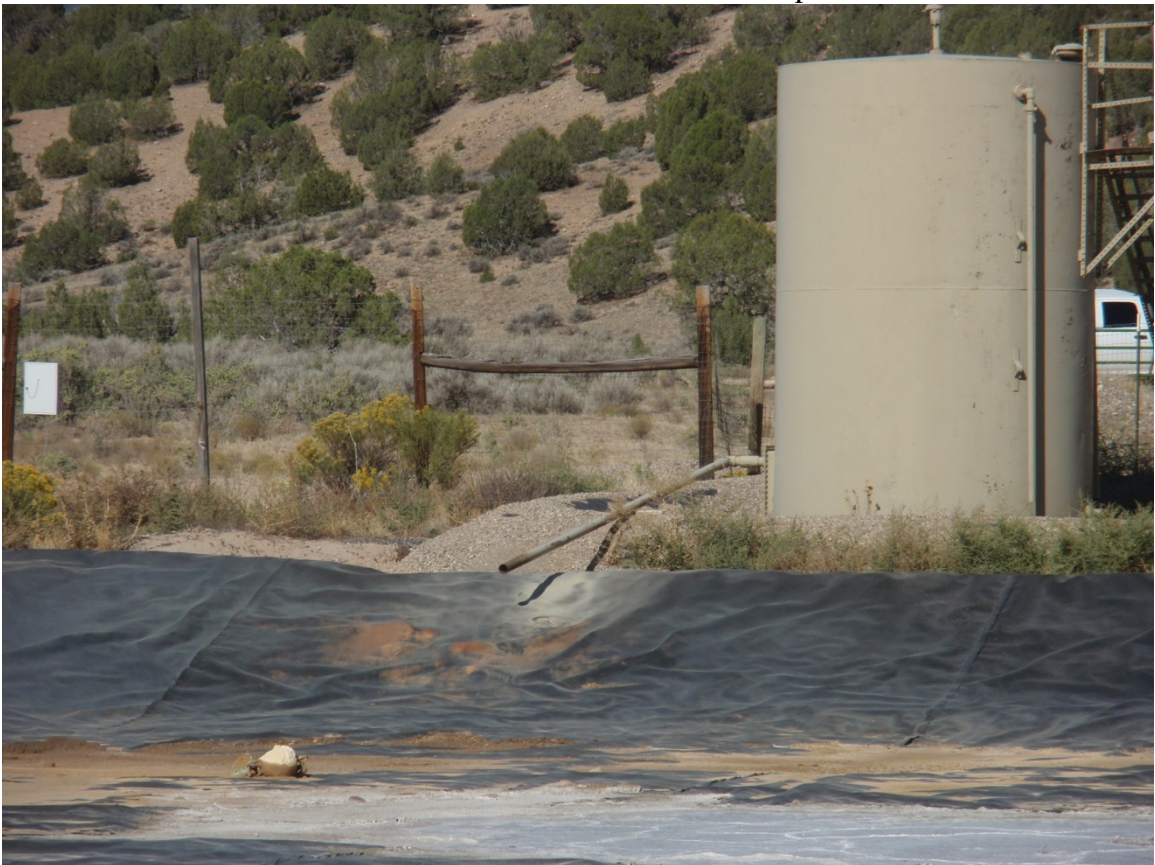
Photo 109. Erosion issue on berm next to 300 bbl tank

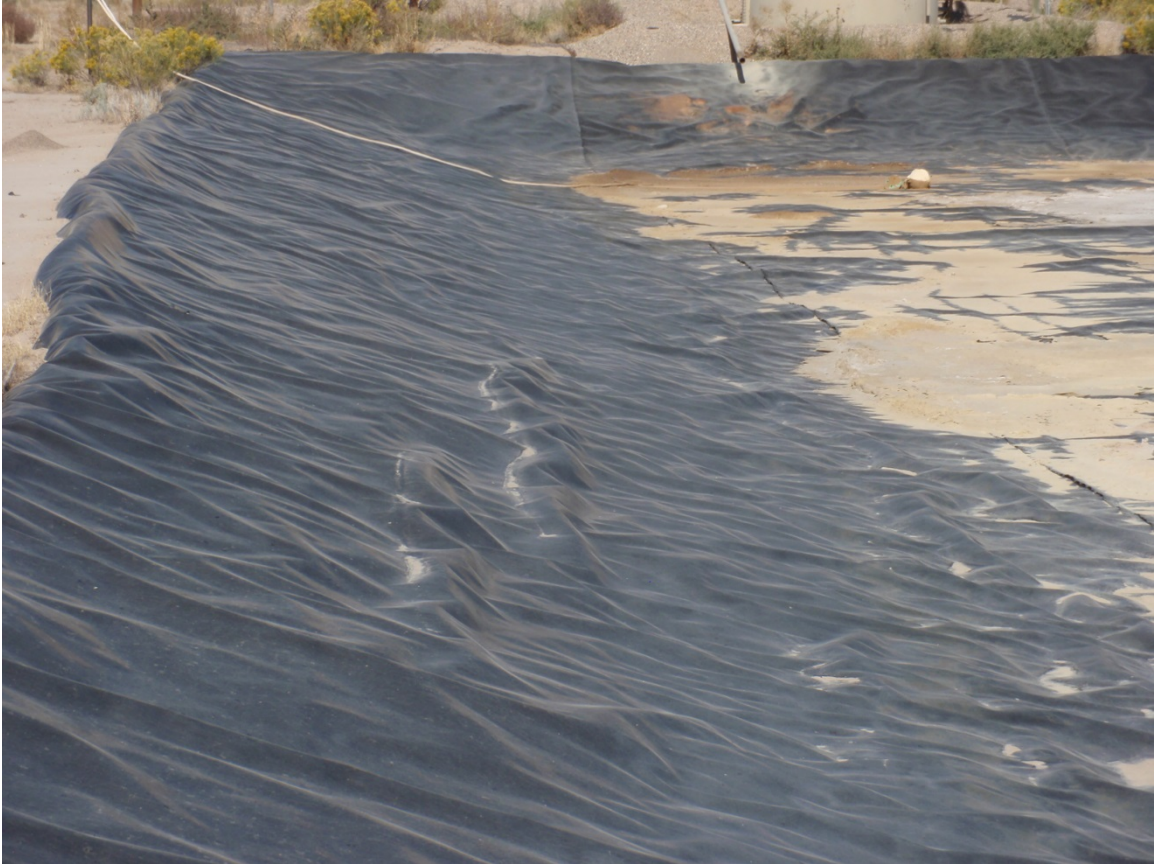
Photo 110. View of liner on south side of pit looking west. Two small rills under liner?

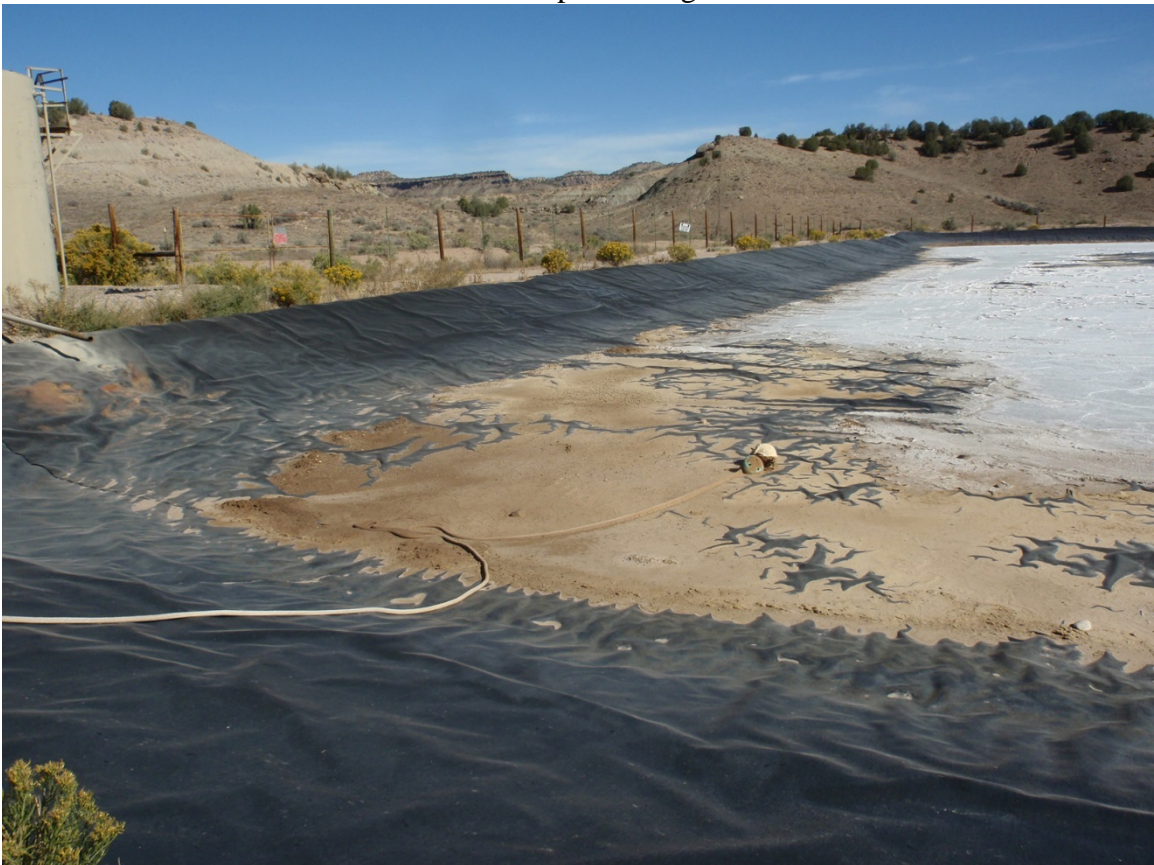
Photo 111. Accumulation of sediment in southwest corner of pit.

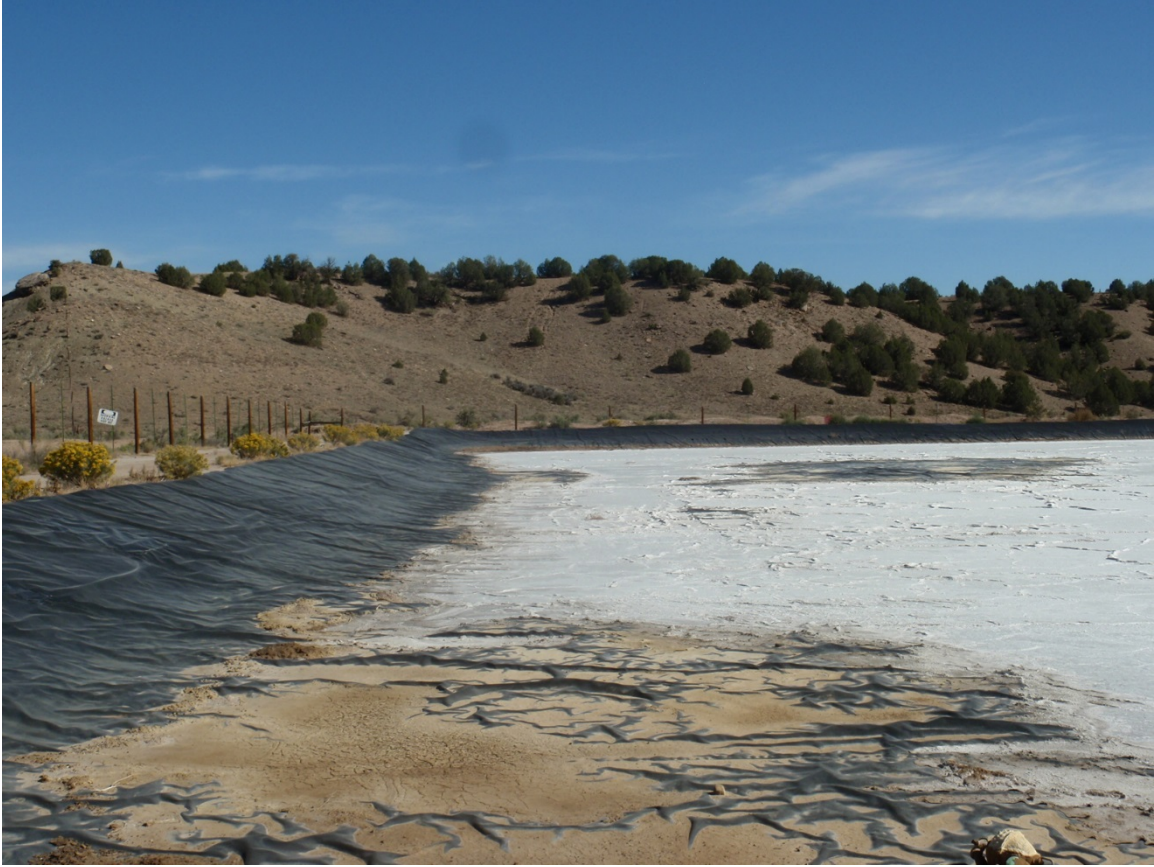
Photo 112. Accumulation of sediment in southwest corner of pit.

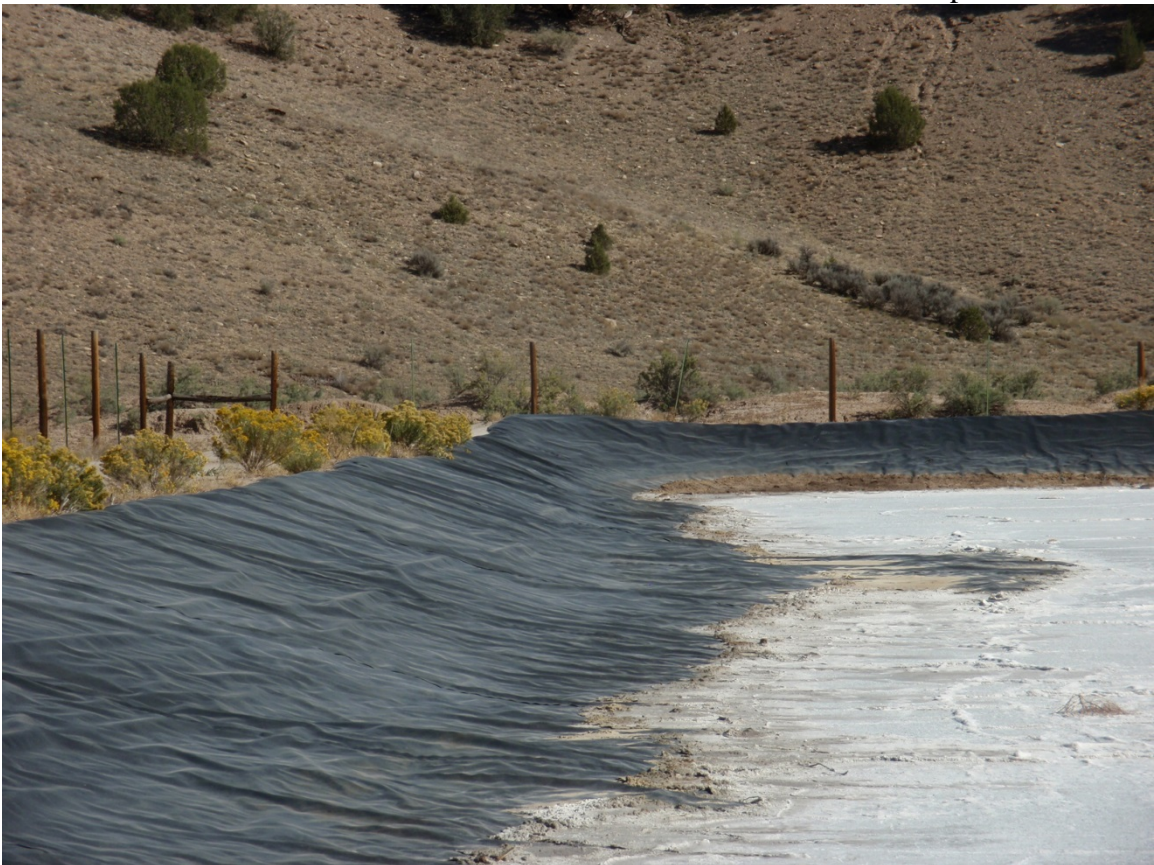
Photo 113. Accumulation of sediment in west side of pit.
