**Gadeco LLC**  
**Hiawatha State 2-36**  
**Loc ID: 313297**

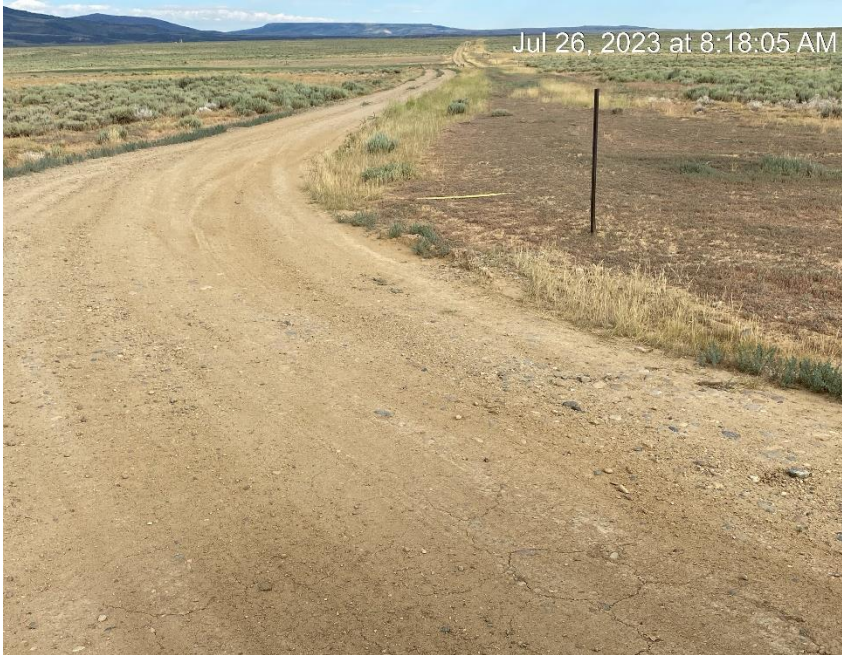
**Lease road**

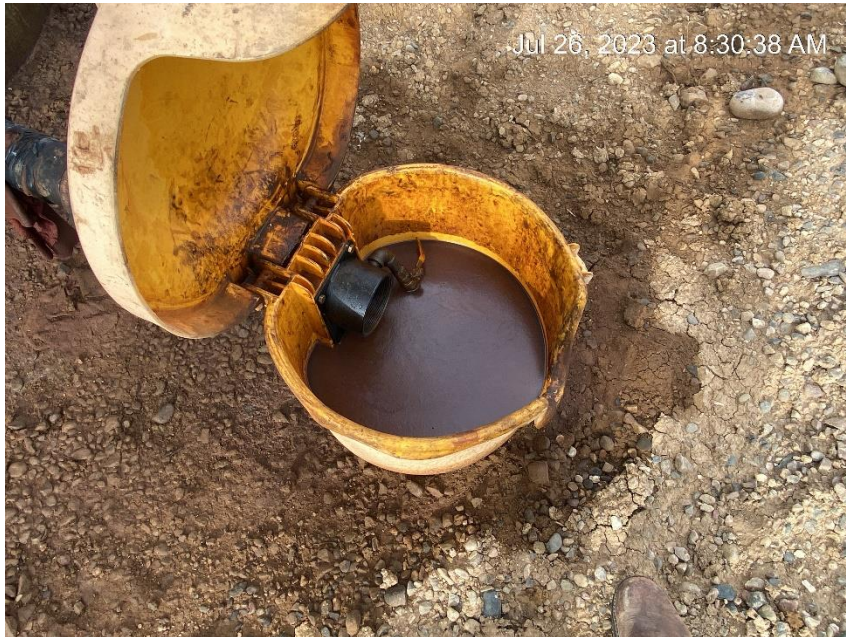
**Open end loadline and full of oil**
