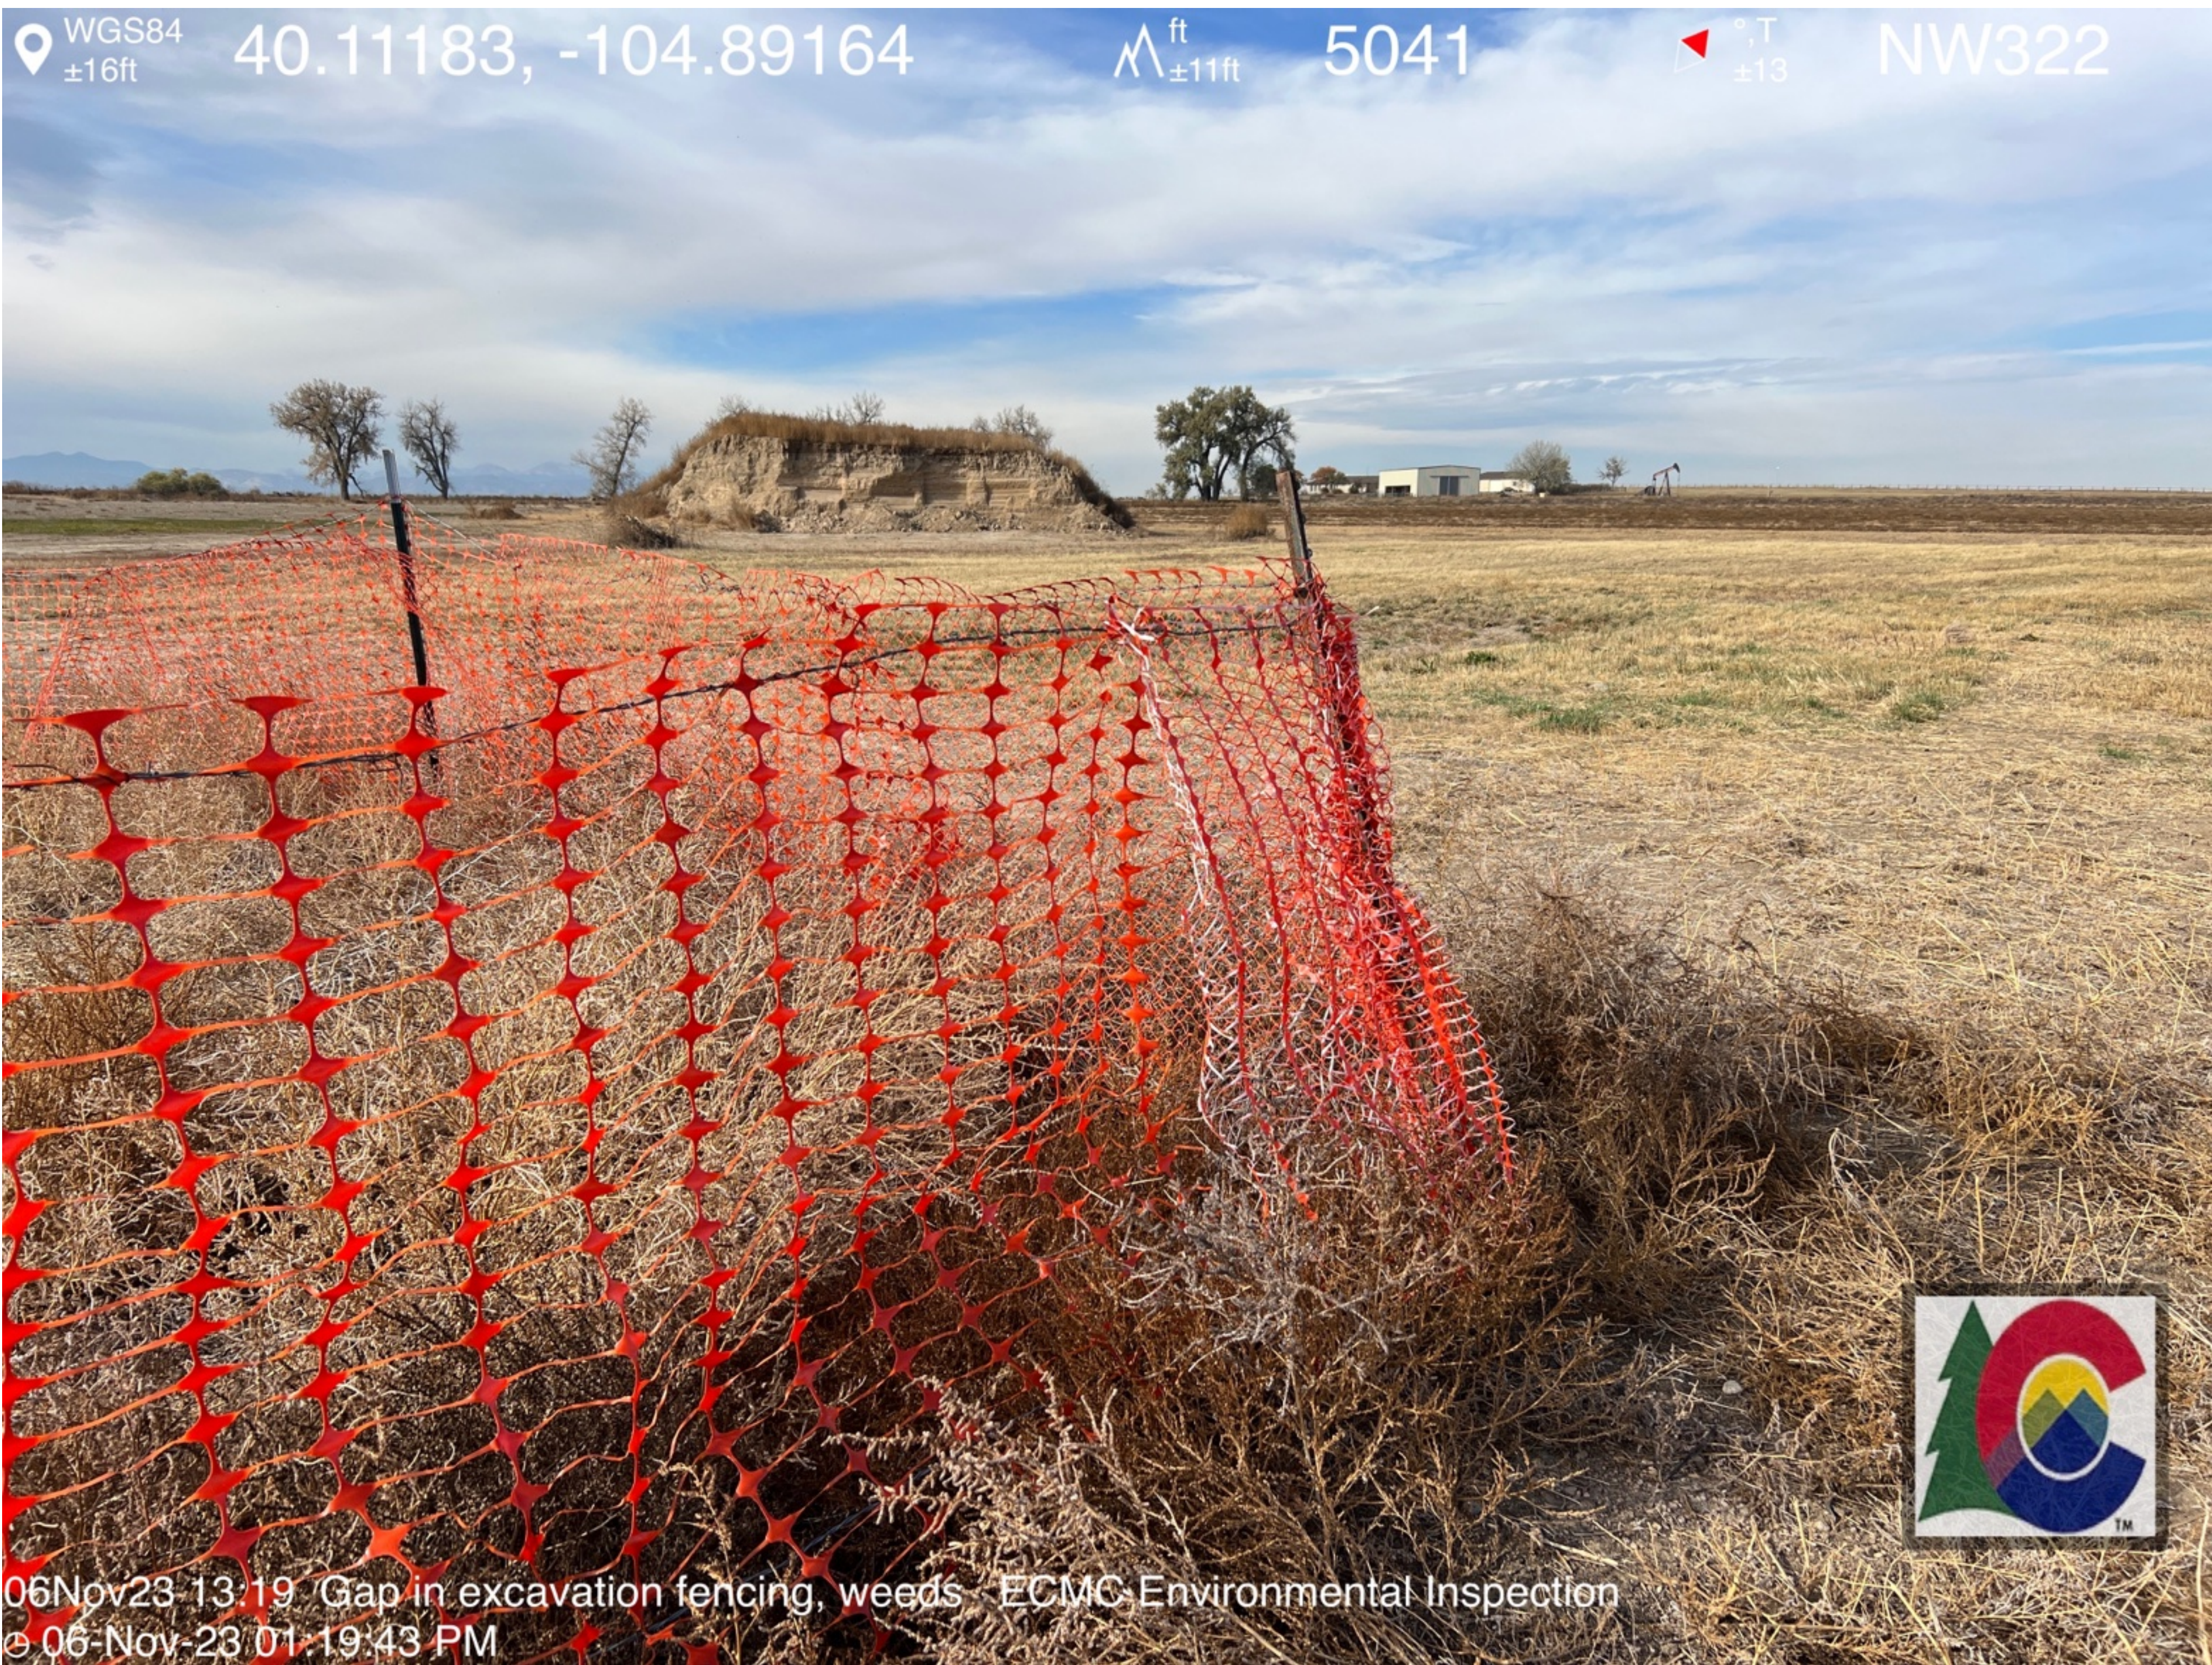
06Nov23 13:19 Gap in excavation fencing, weeds - ECMC Environmental Inspection
© 06-Nov-23 01:19:43 PM

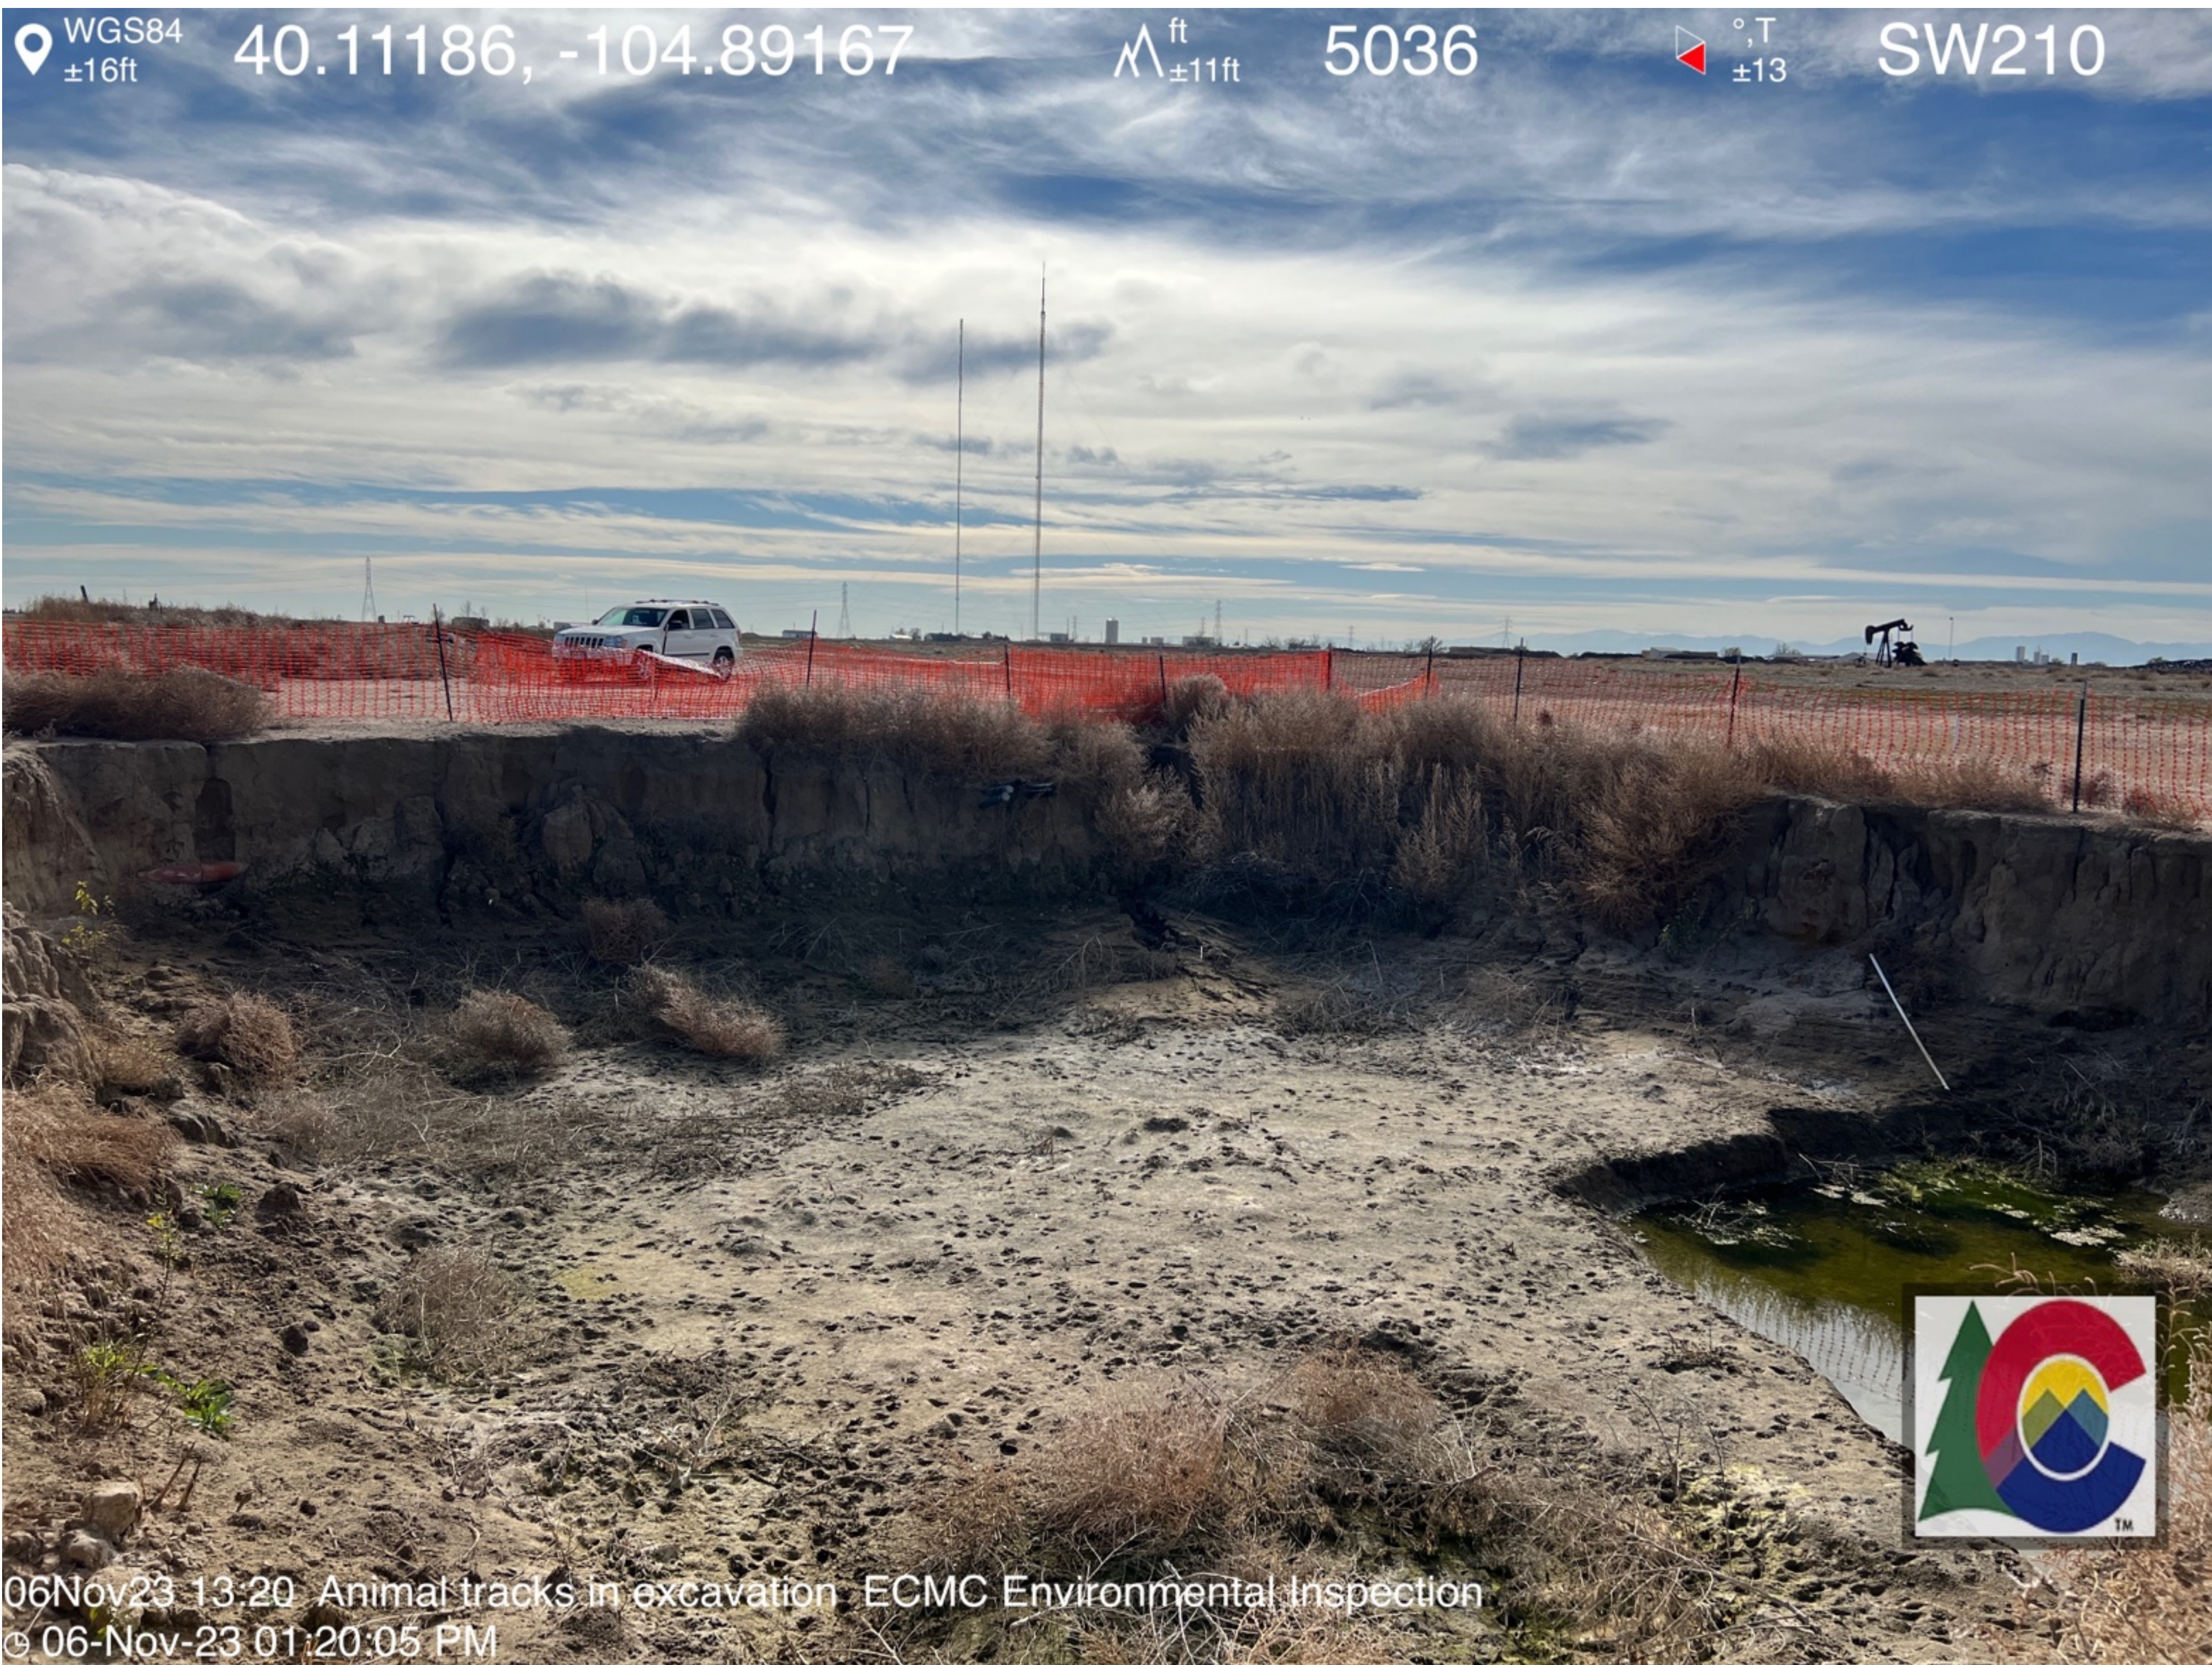
06Nov23 13:20 Animal tracks in excavation ECMC Environmental Inspection
© 06-Nov-23 01:20:05 PM

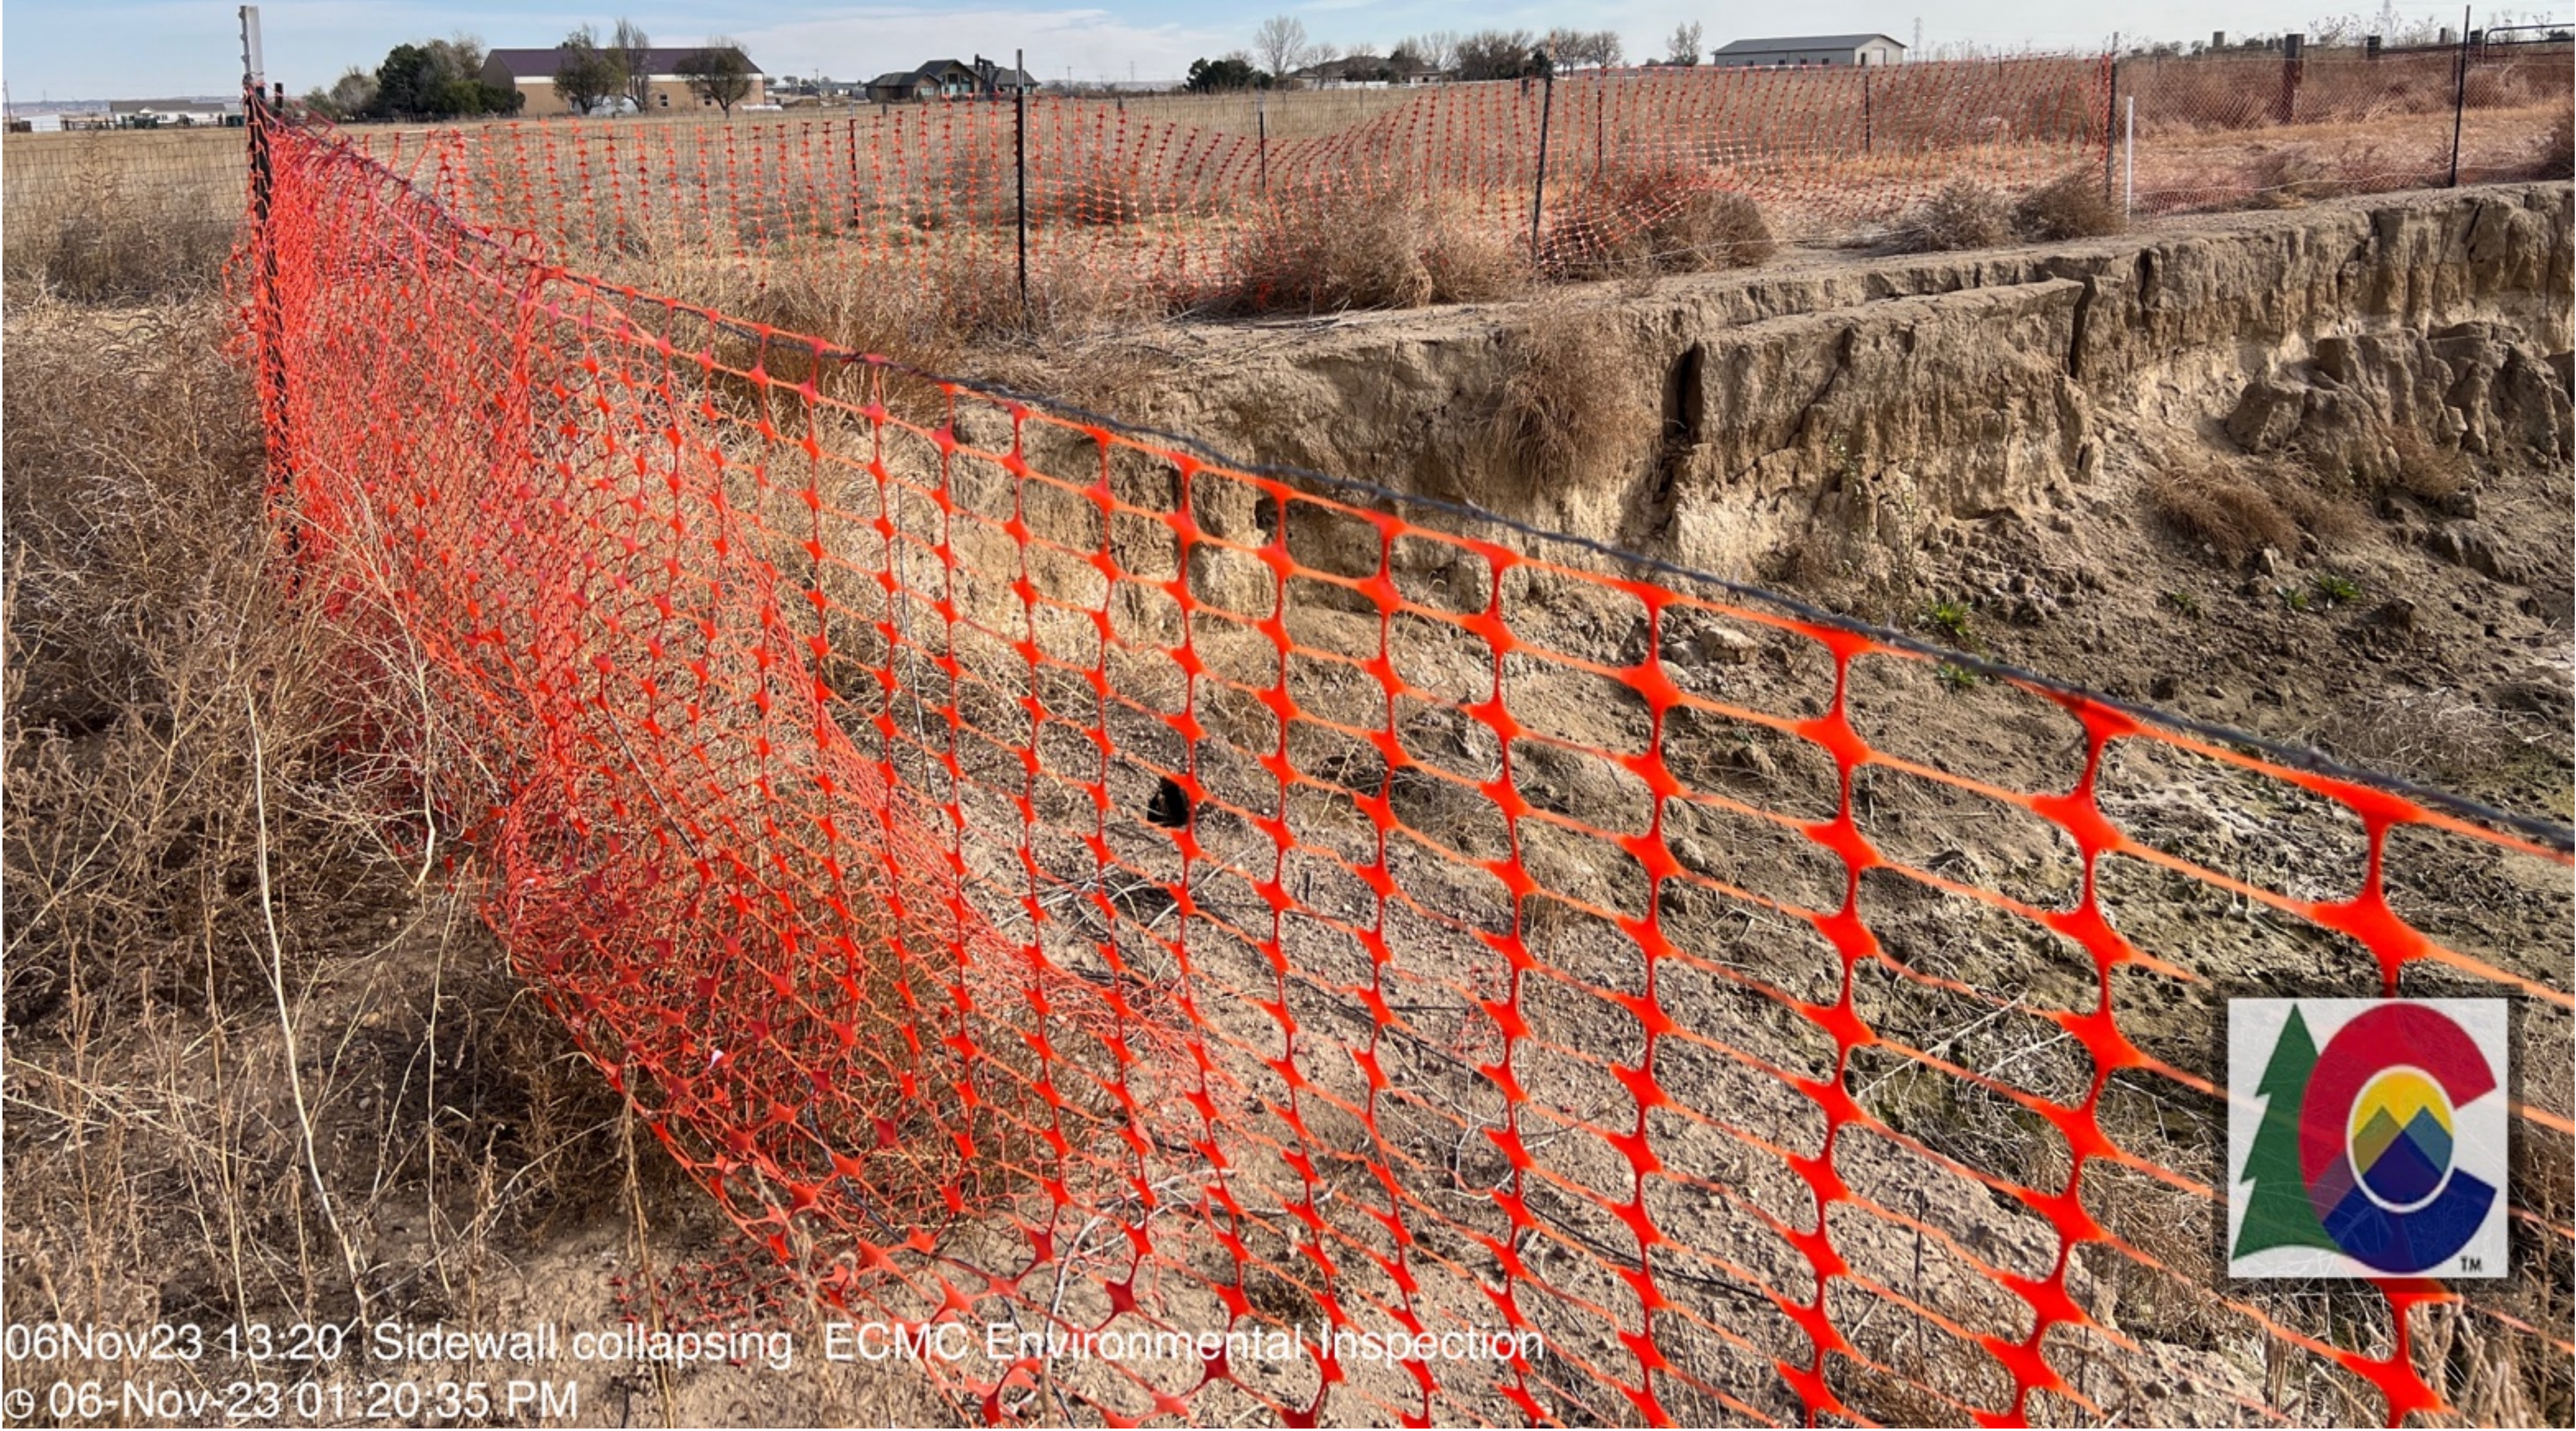
06Nov23 13:20 Sidewall collapsing ECMC Environmental Inspection
© 06-Nov-23 01:20:35 PM

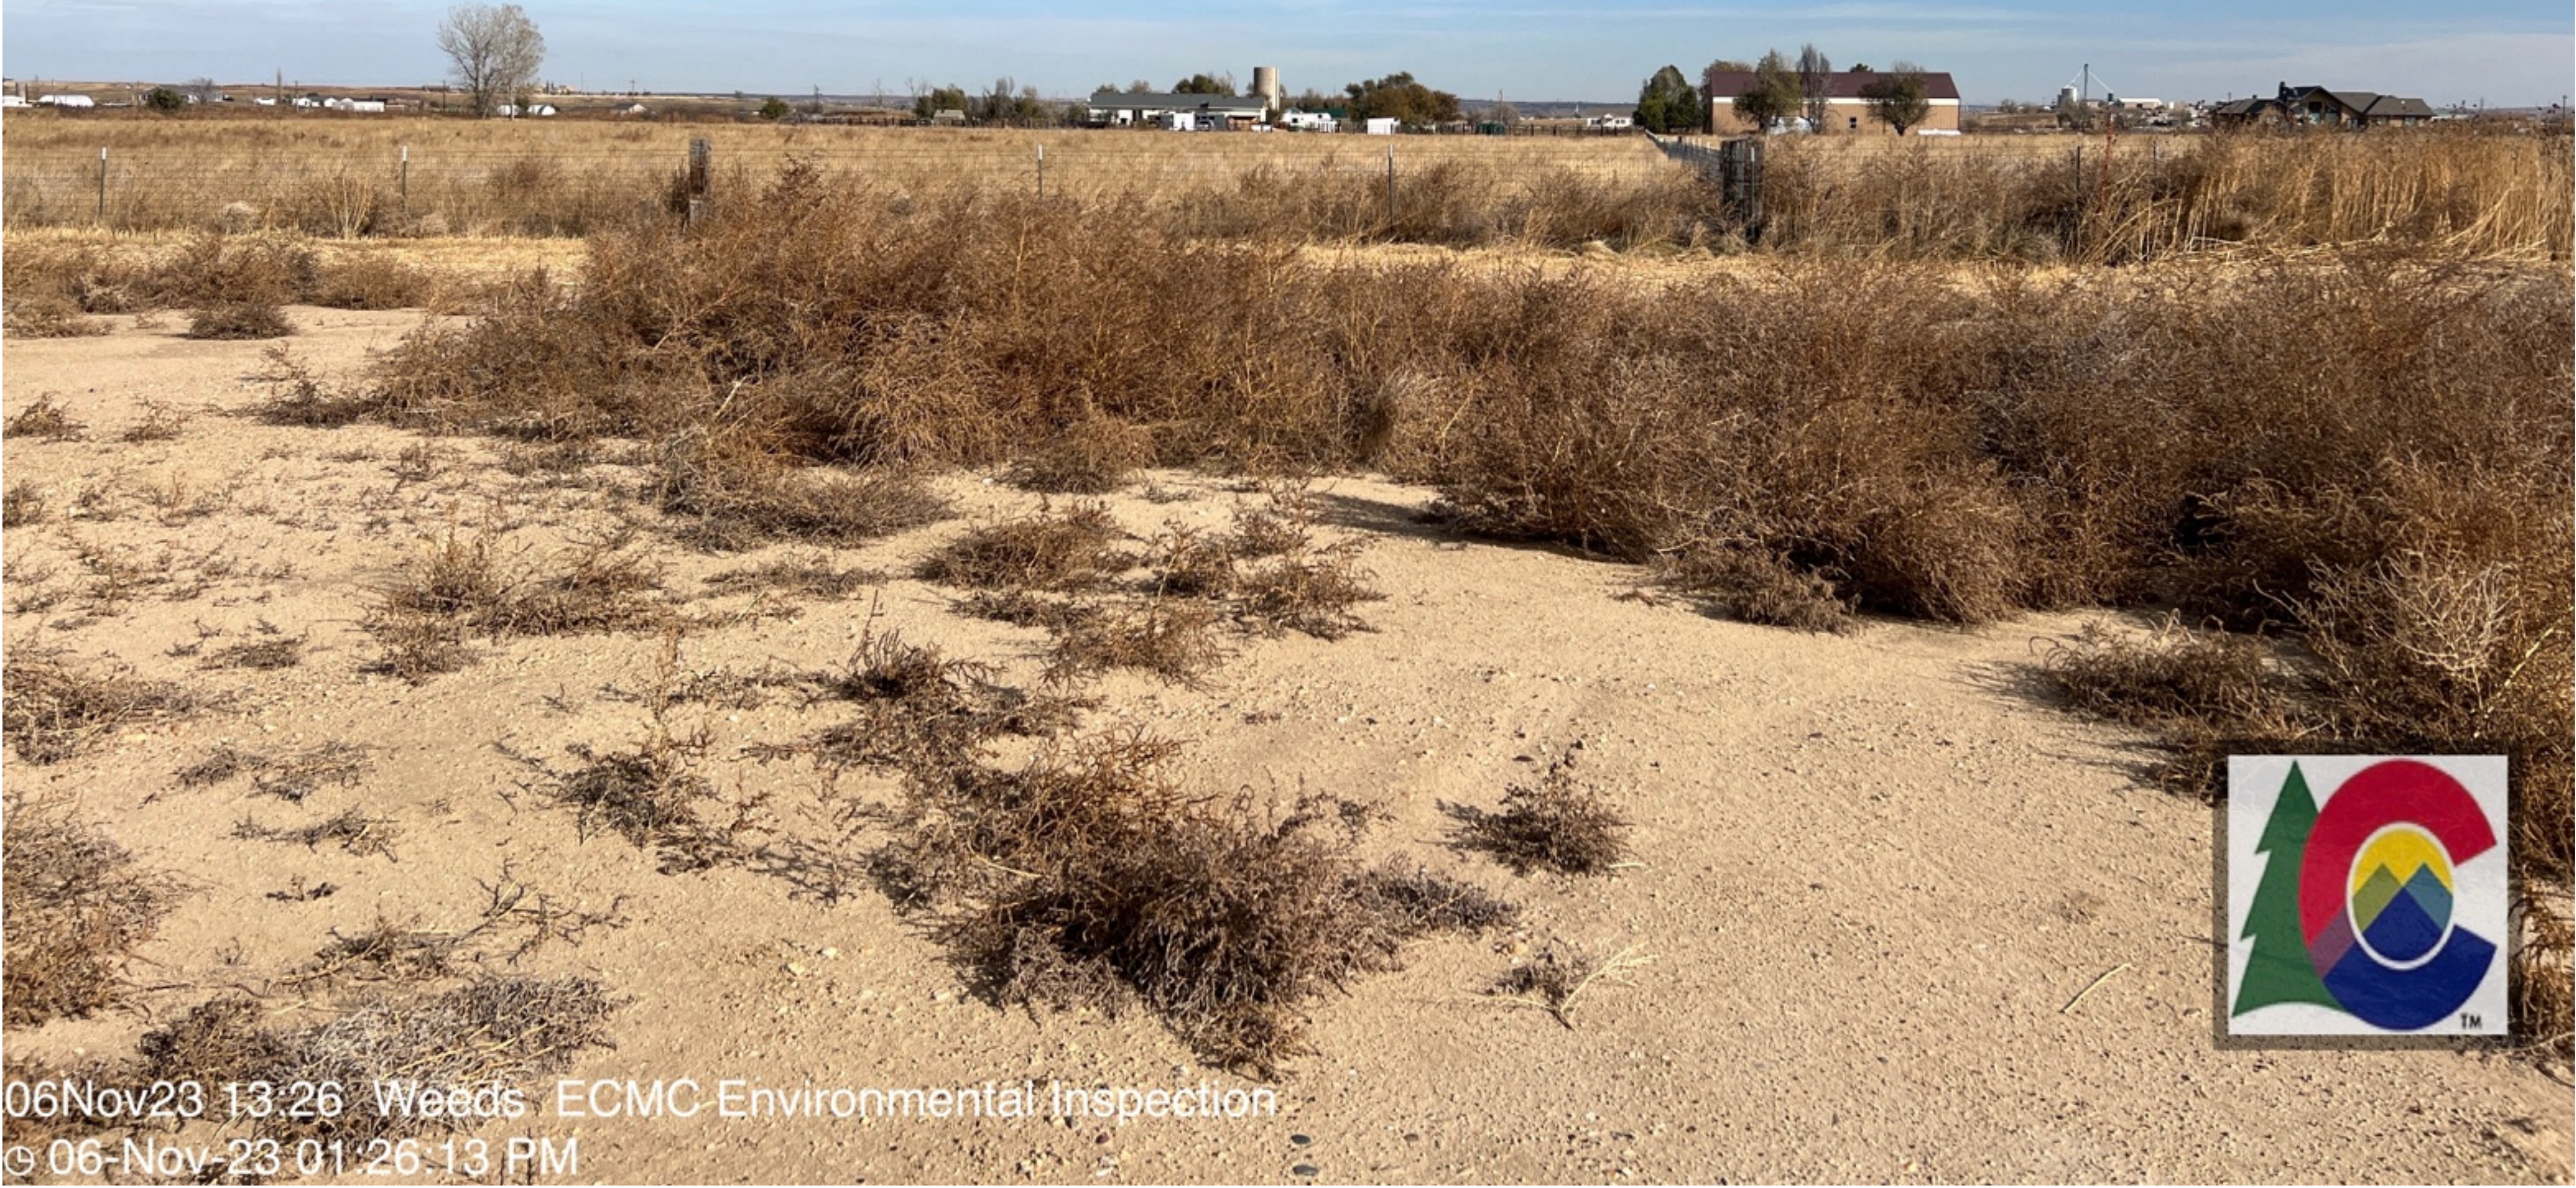
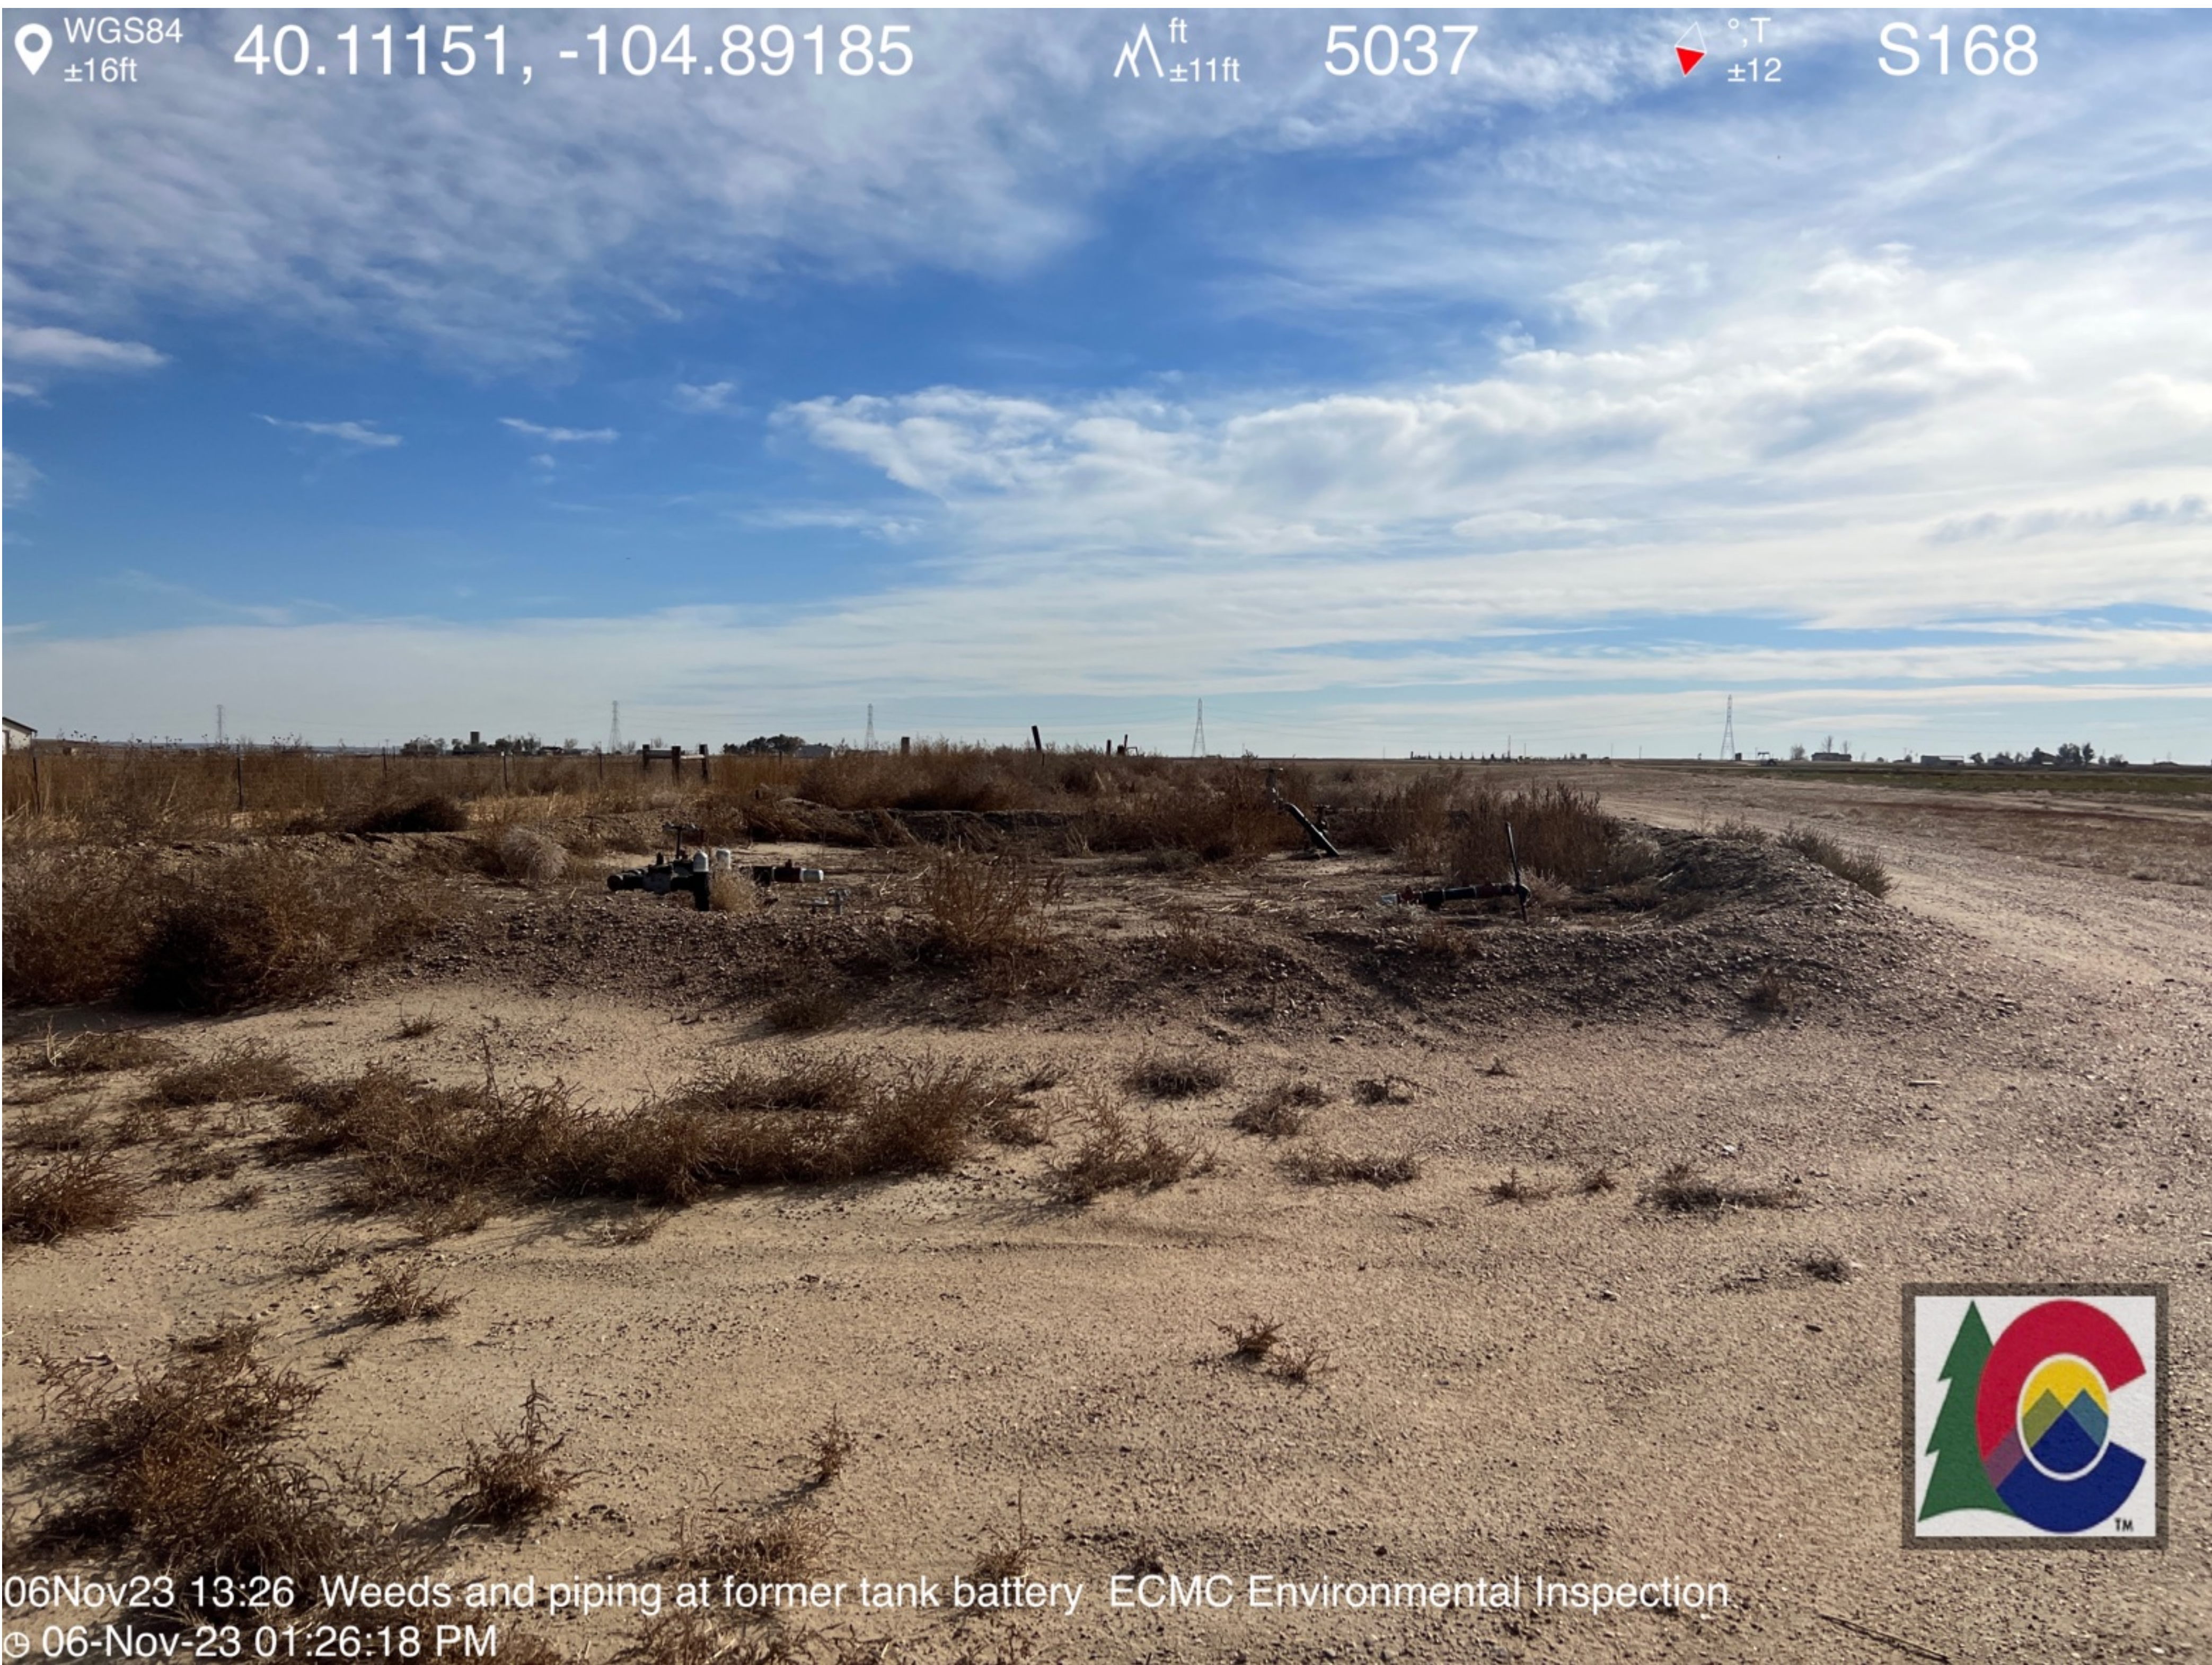
06Nov23 13:25 Gulley in excavation causing sidewall collapse -ECMC Environmental Inspection
© 06-Nov-23 01:25:46 PM
