06Nov23 08:37 ECMC Environmental Inspection
© 06-Nov-23 08:37:11 AM

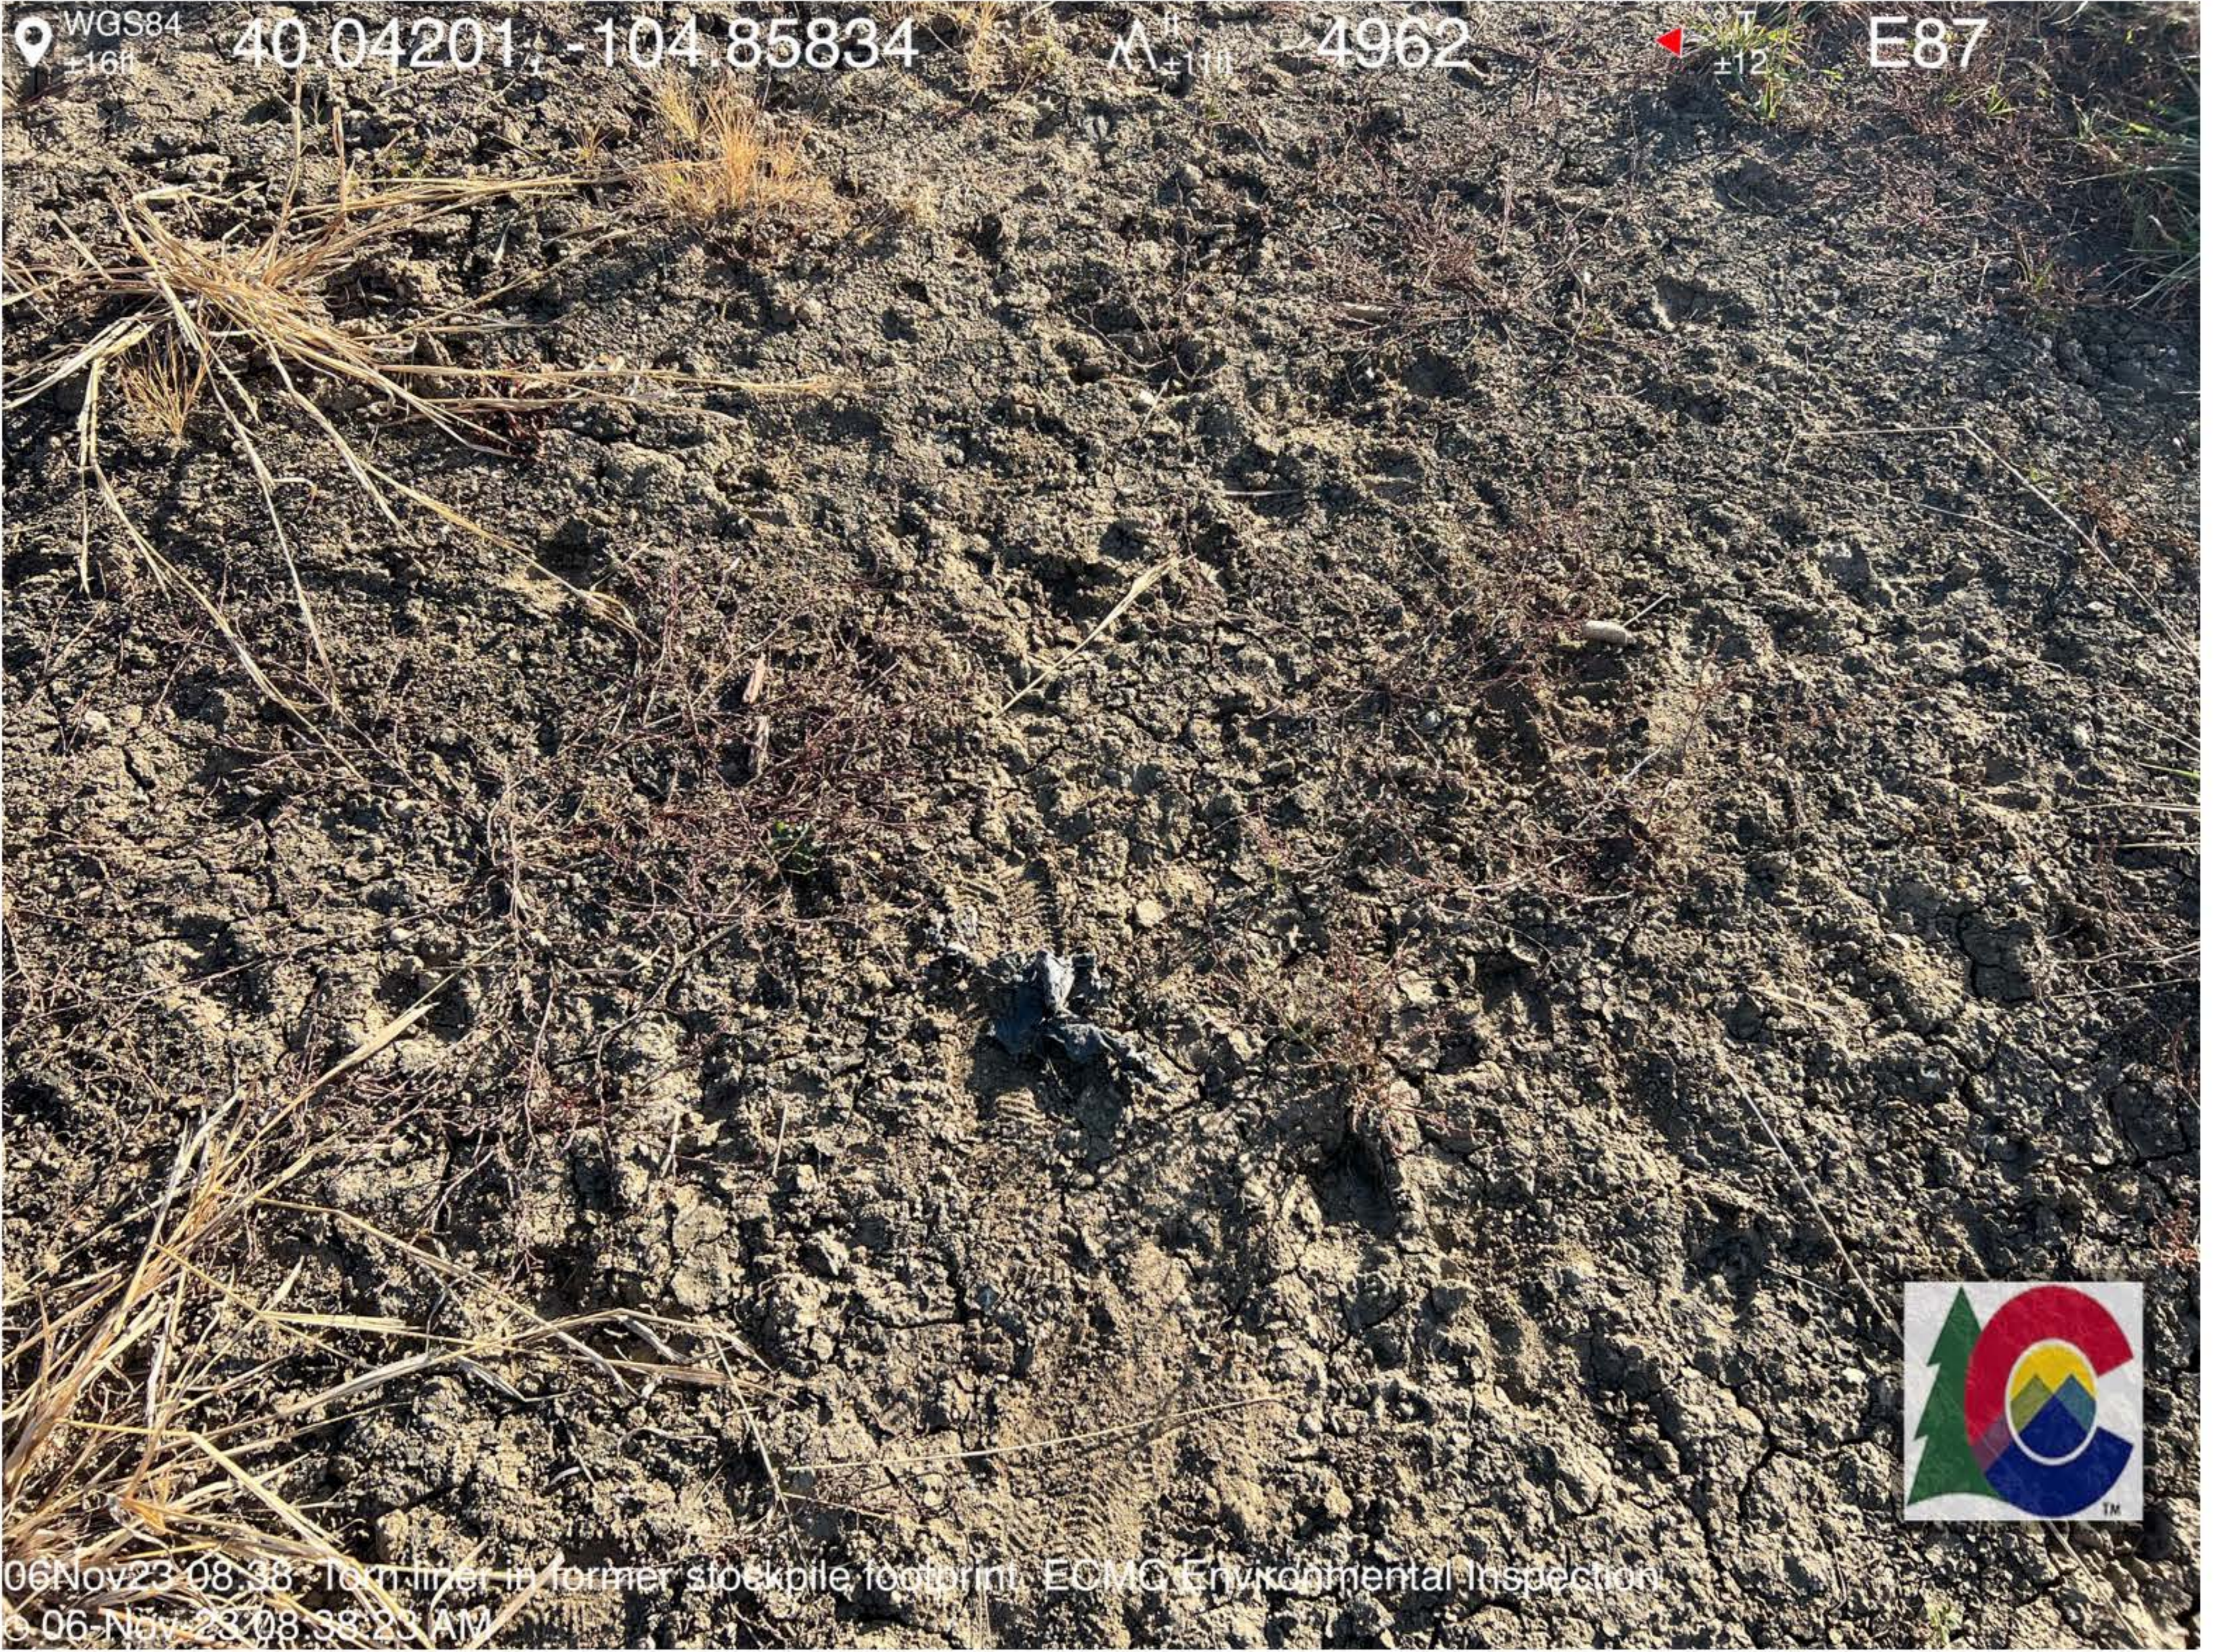
06 Nov 23 08:38 AM - Term limit in former stockpile footprint. ECMC Environmental Inspection
© 06 Nov 23 08:38:23 AM

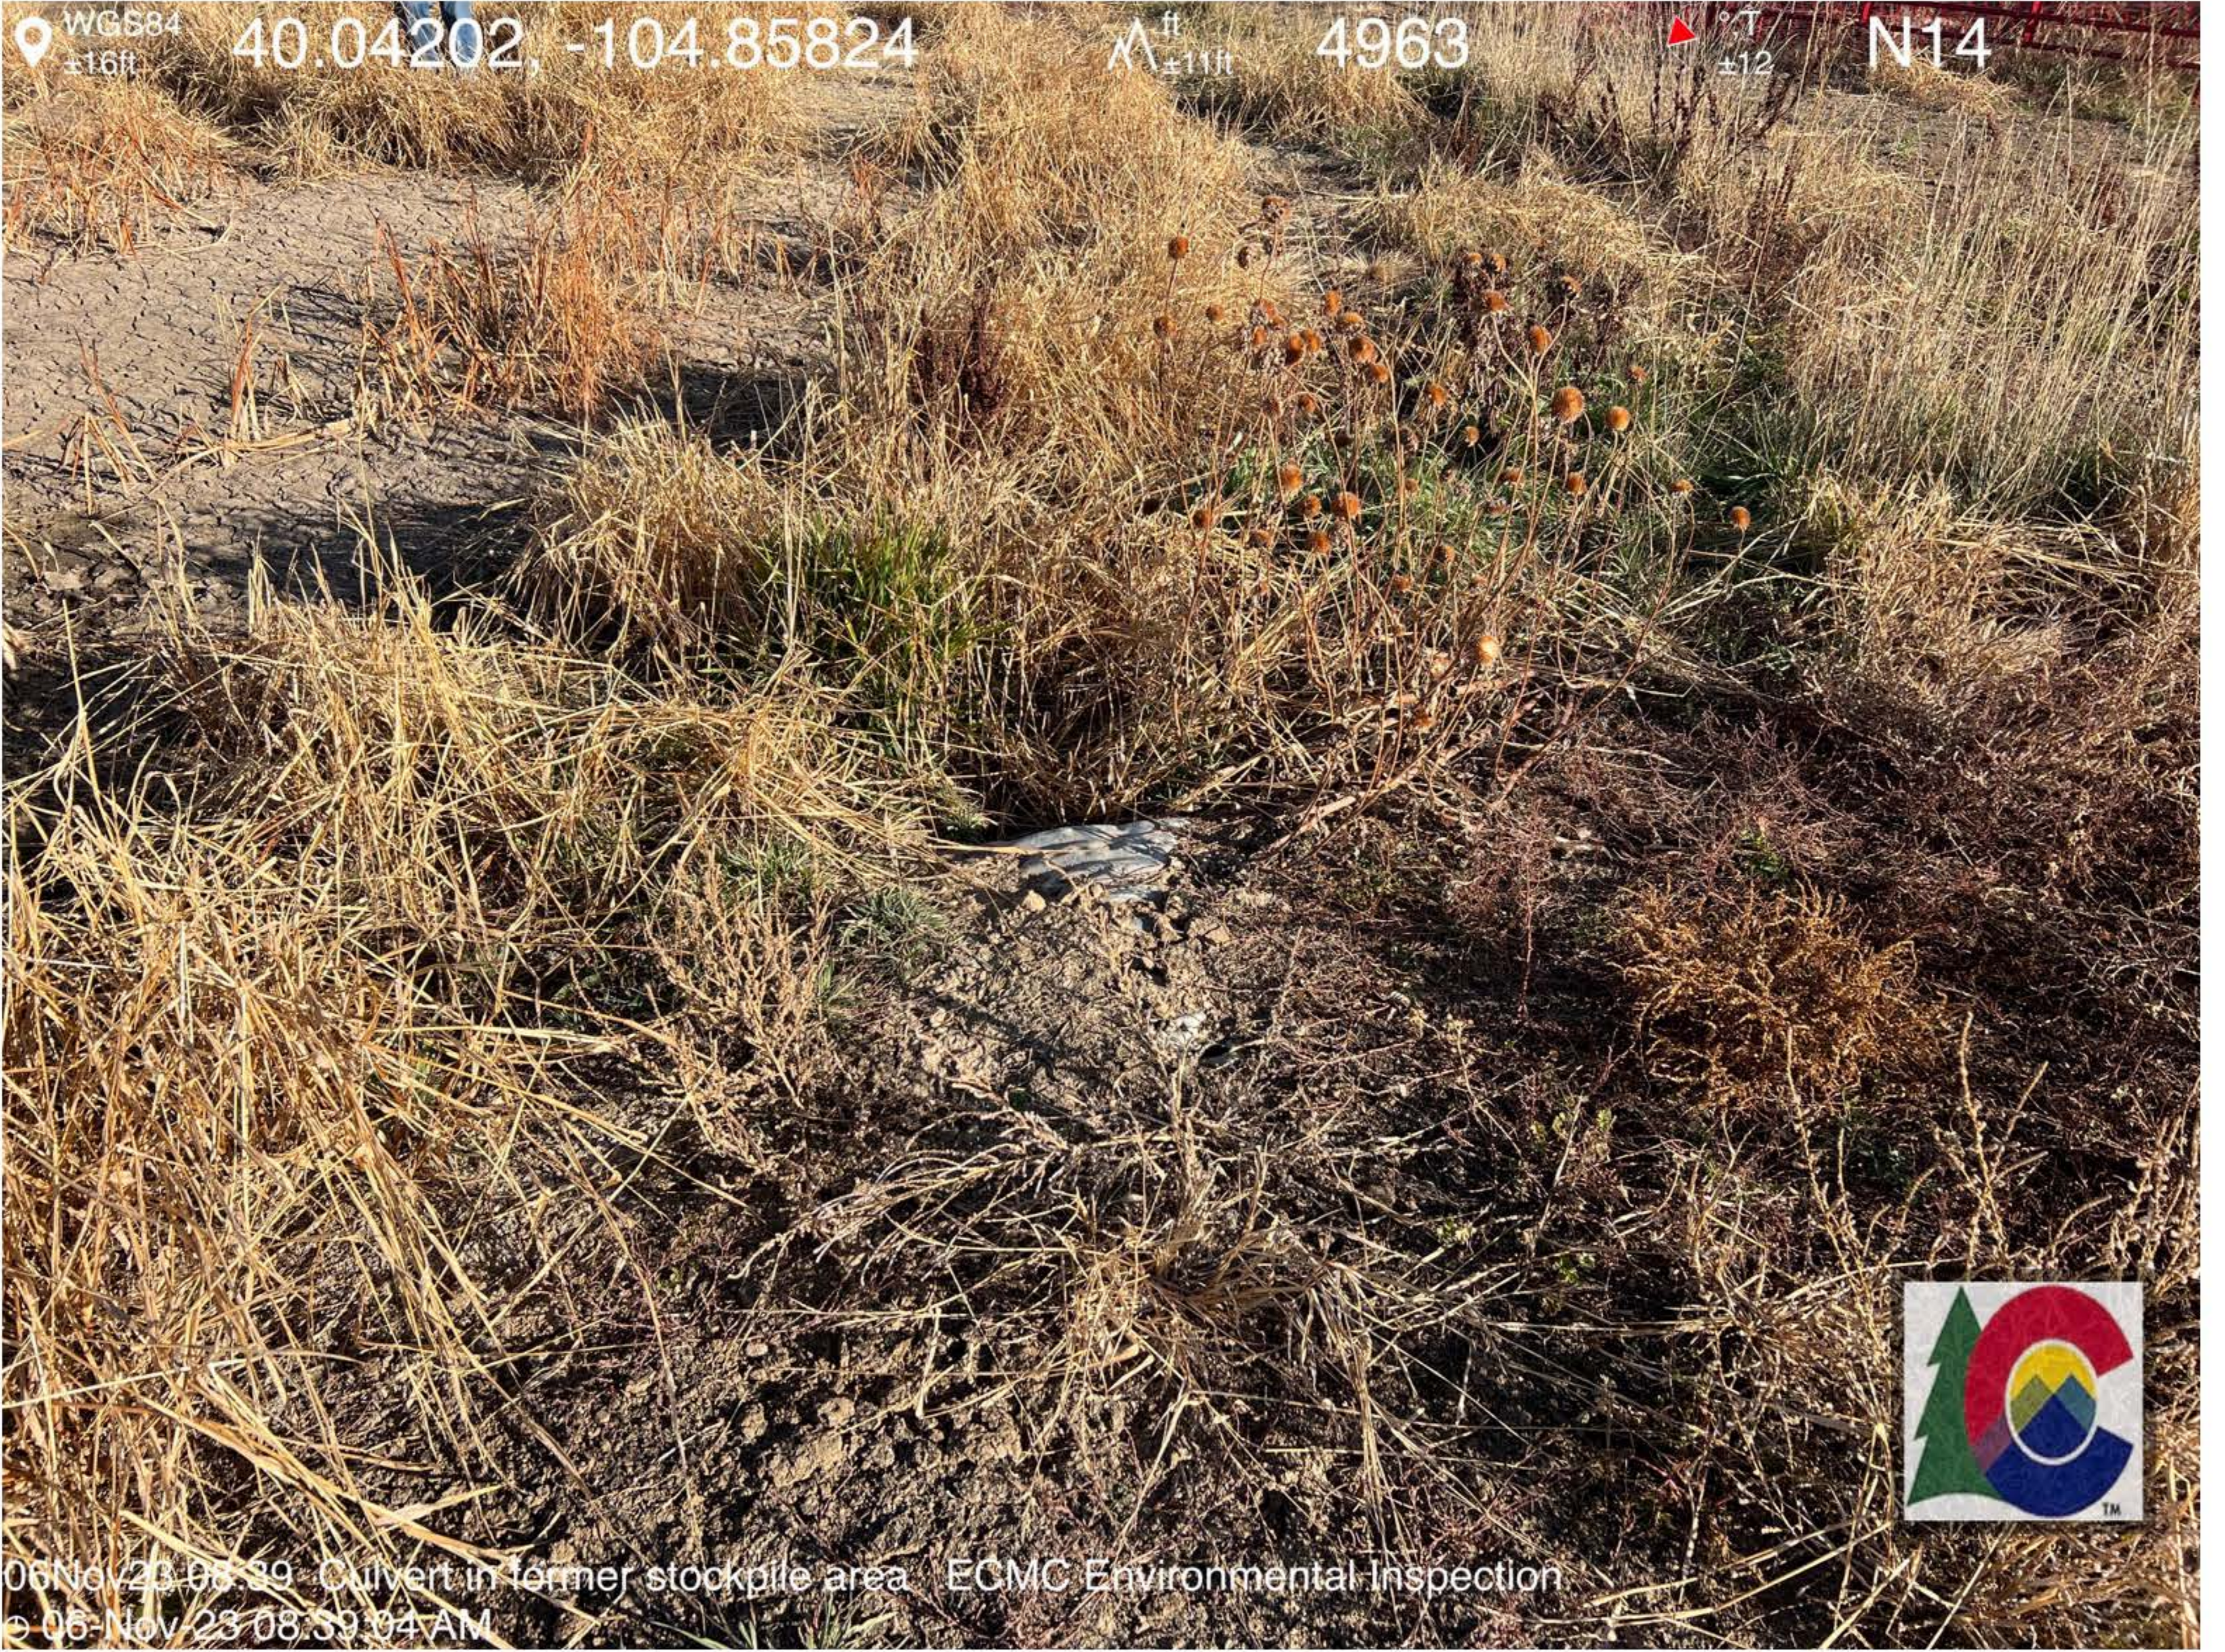
06 Nov 23 08:59 Culvert in former stockpile area ECMC Environmental Inspection
© 06 Nov 23 08:59:04 AM

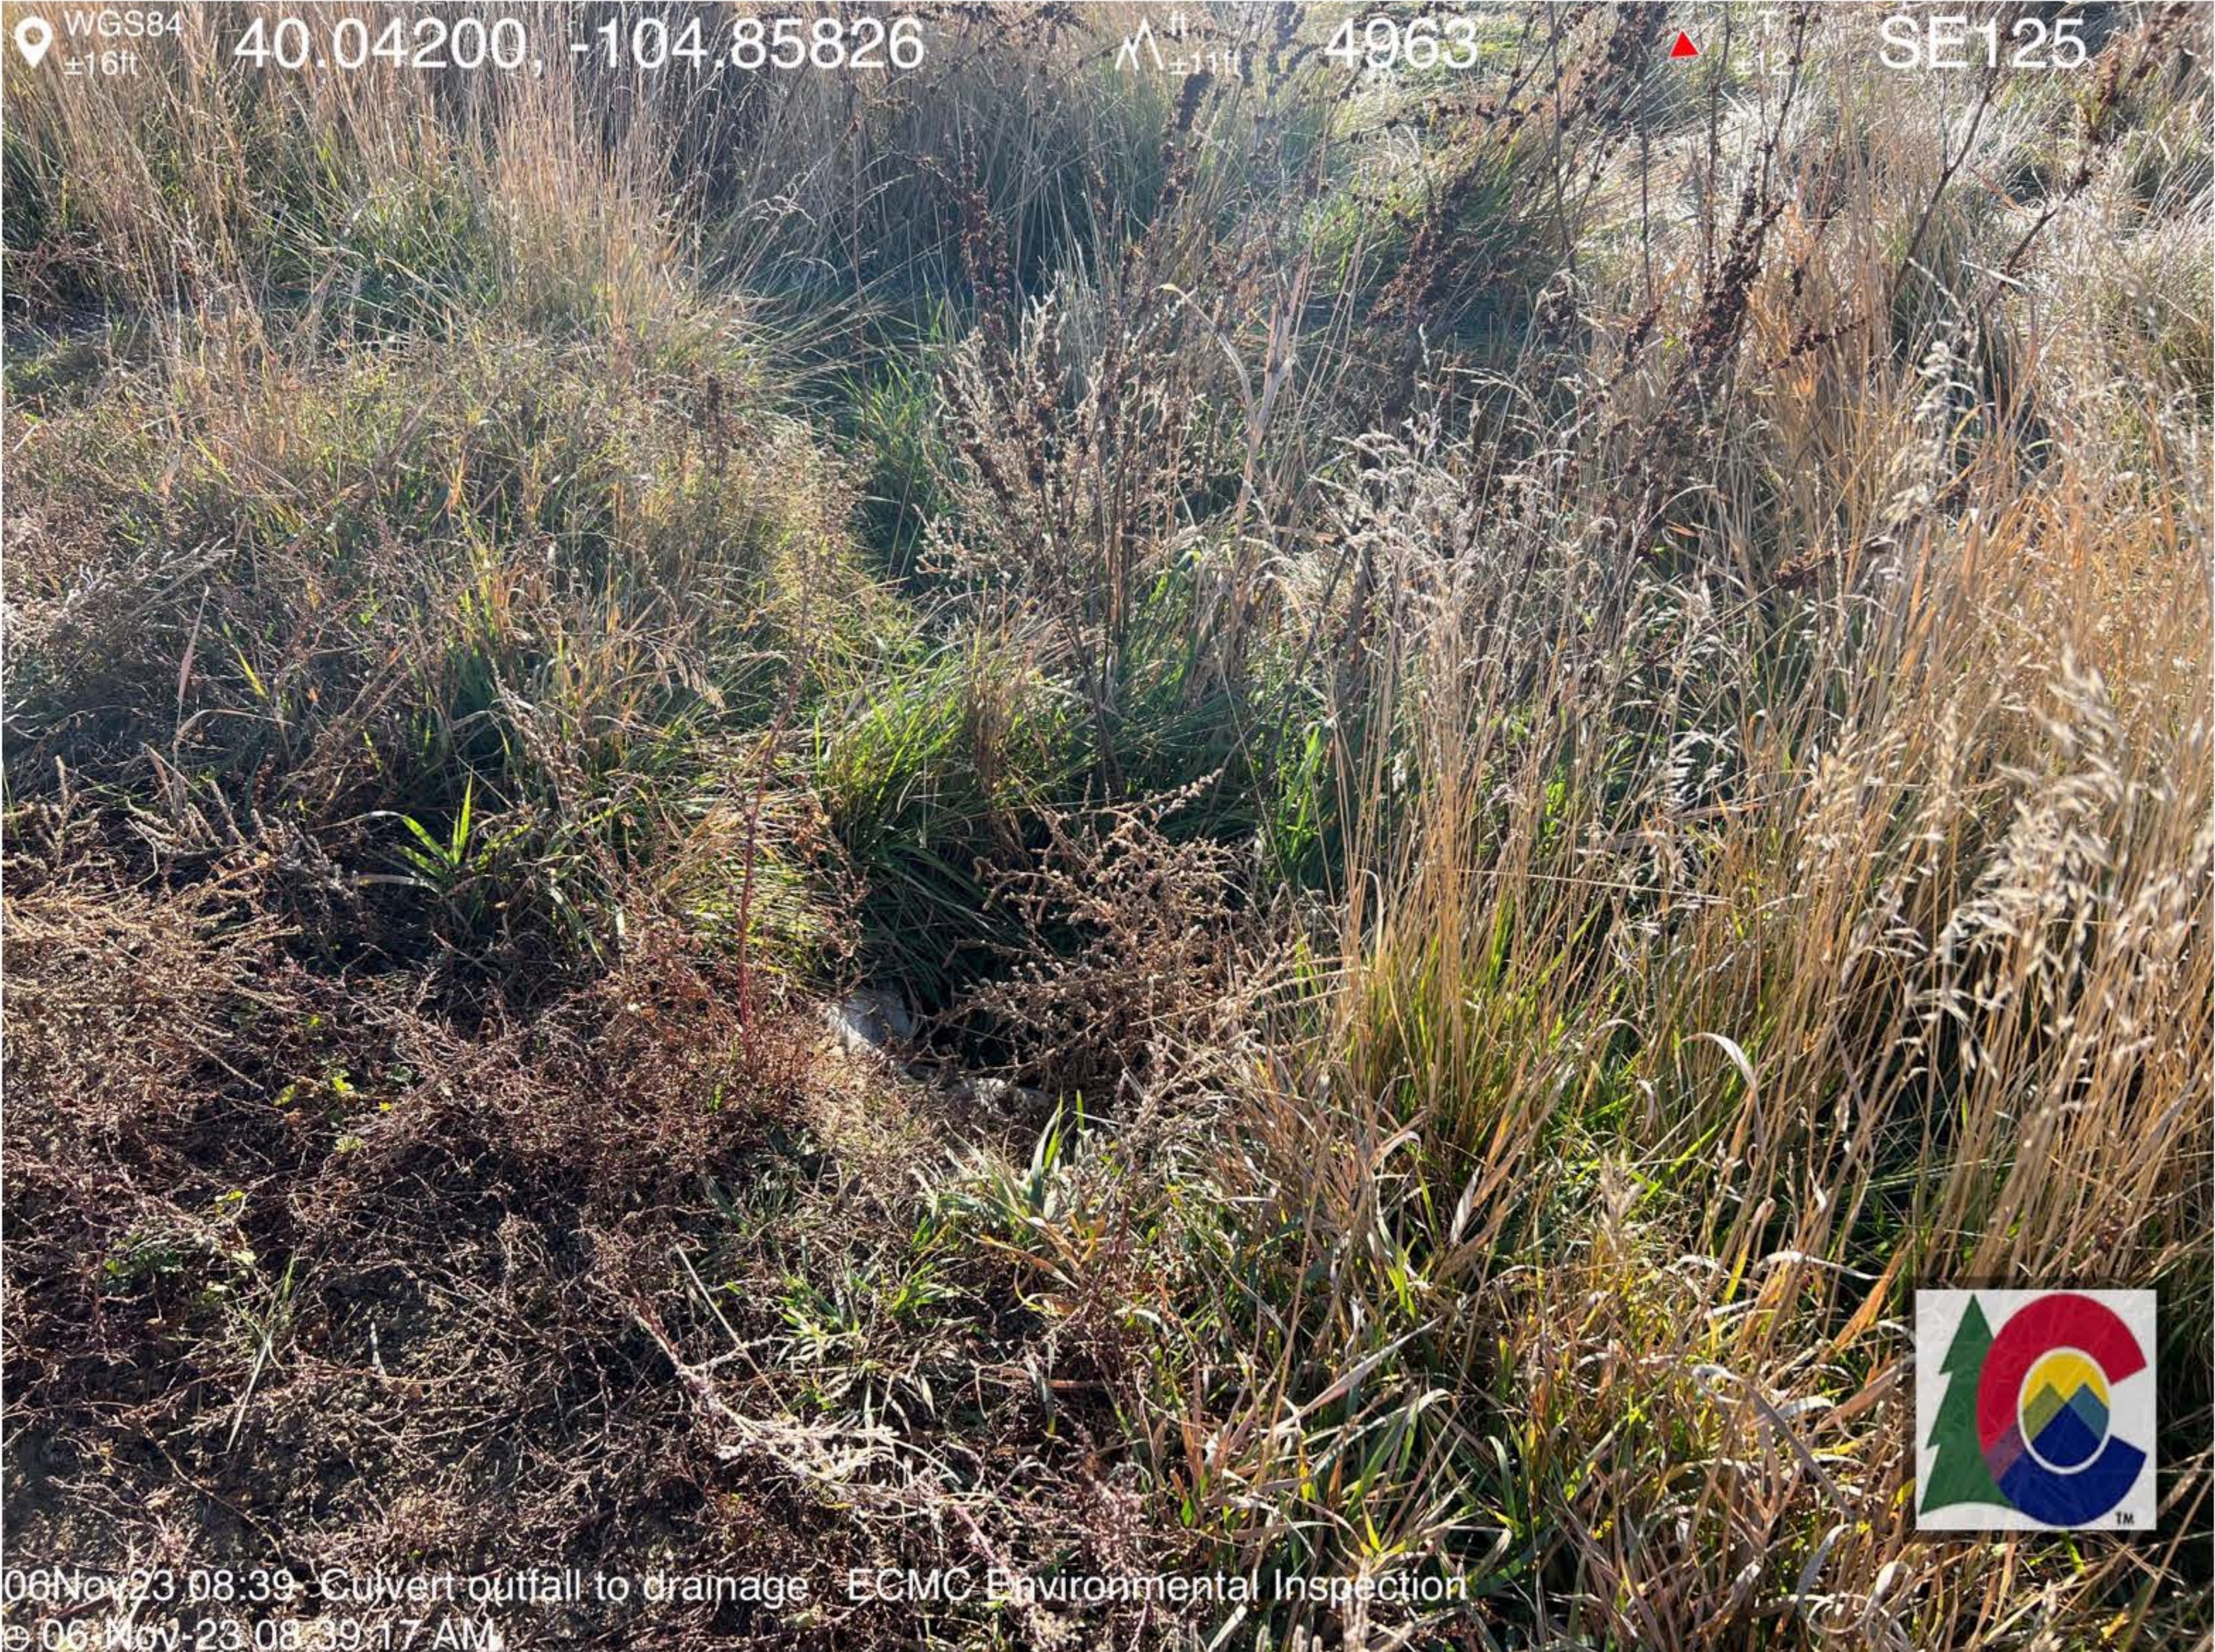
06 Nov 23 08:39 - Culvert outfall to drainage - ECMC Environmental Inspection
e 06 Nov 23 08:39:17 AM

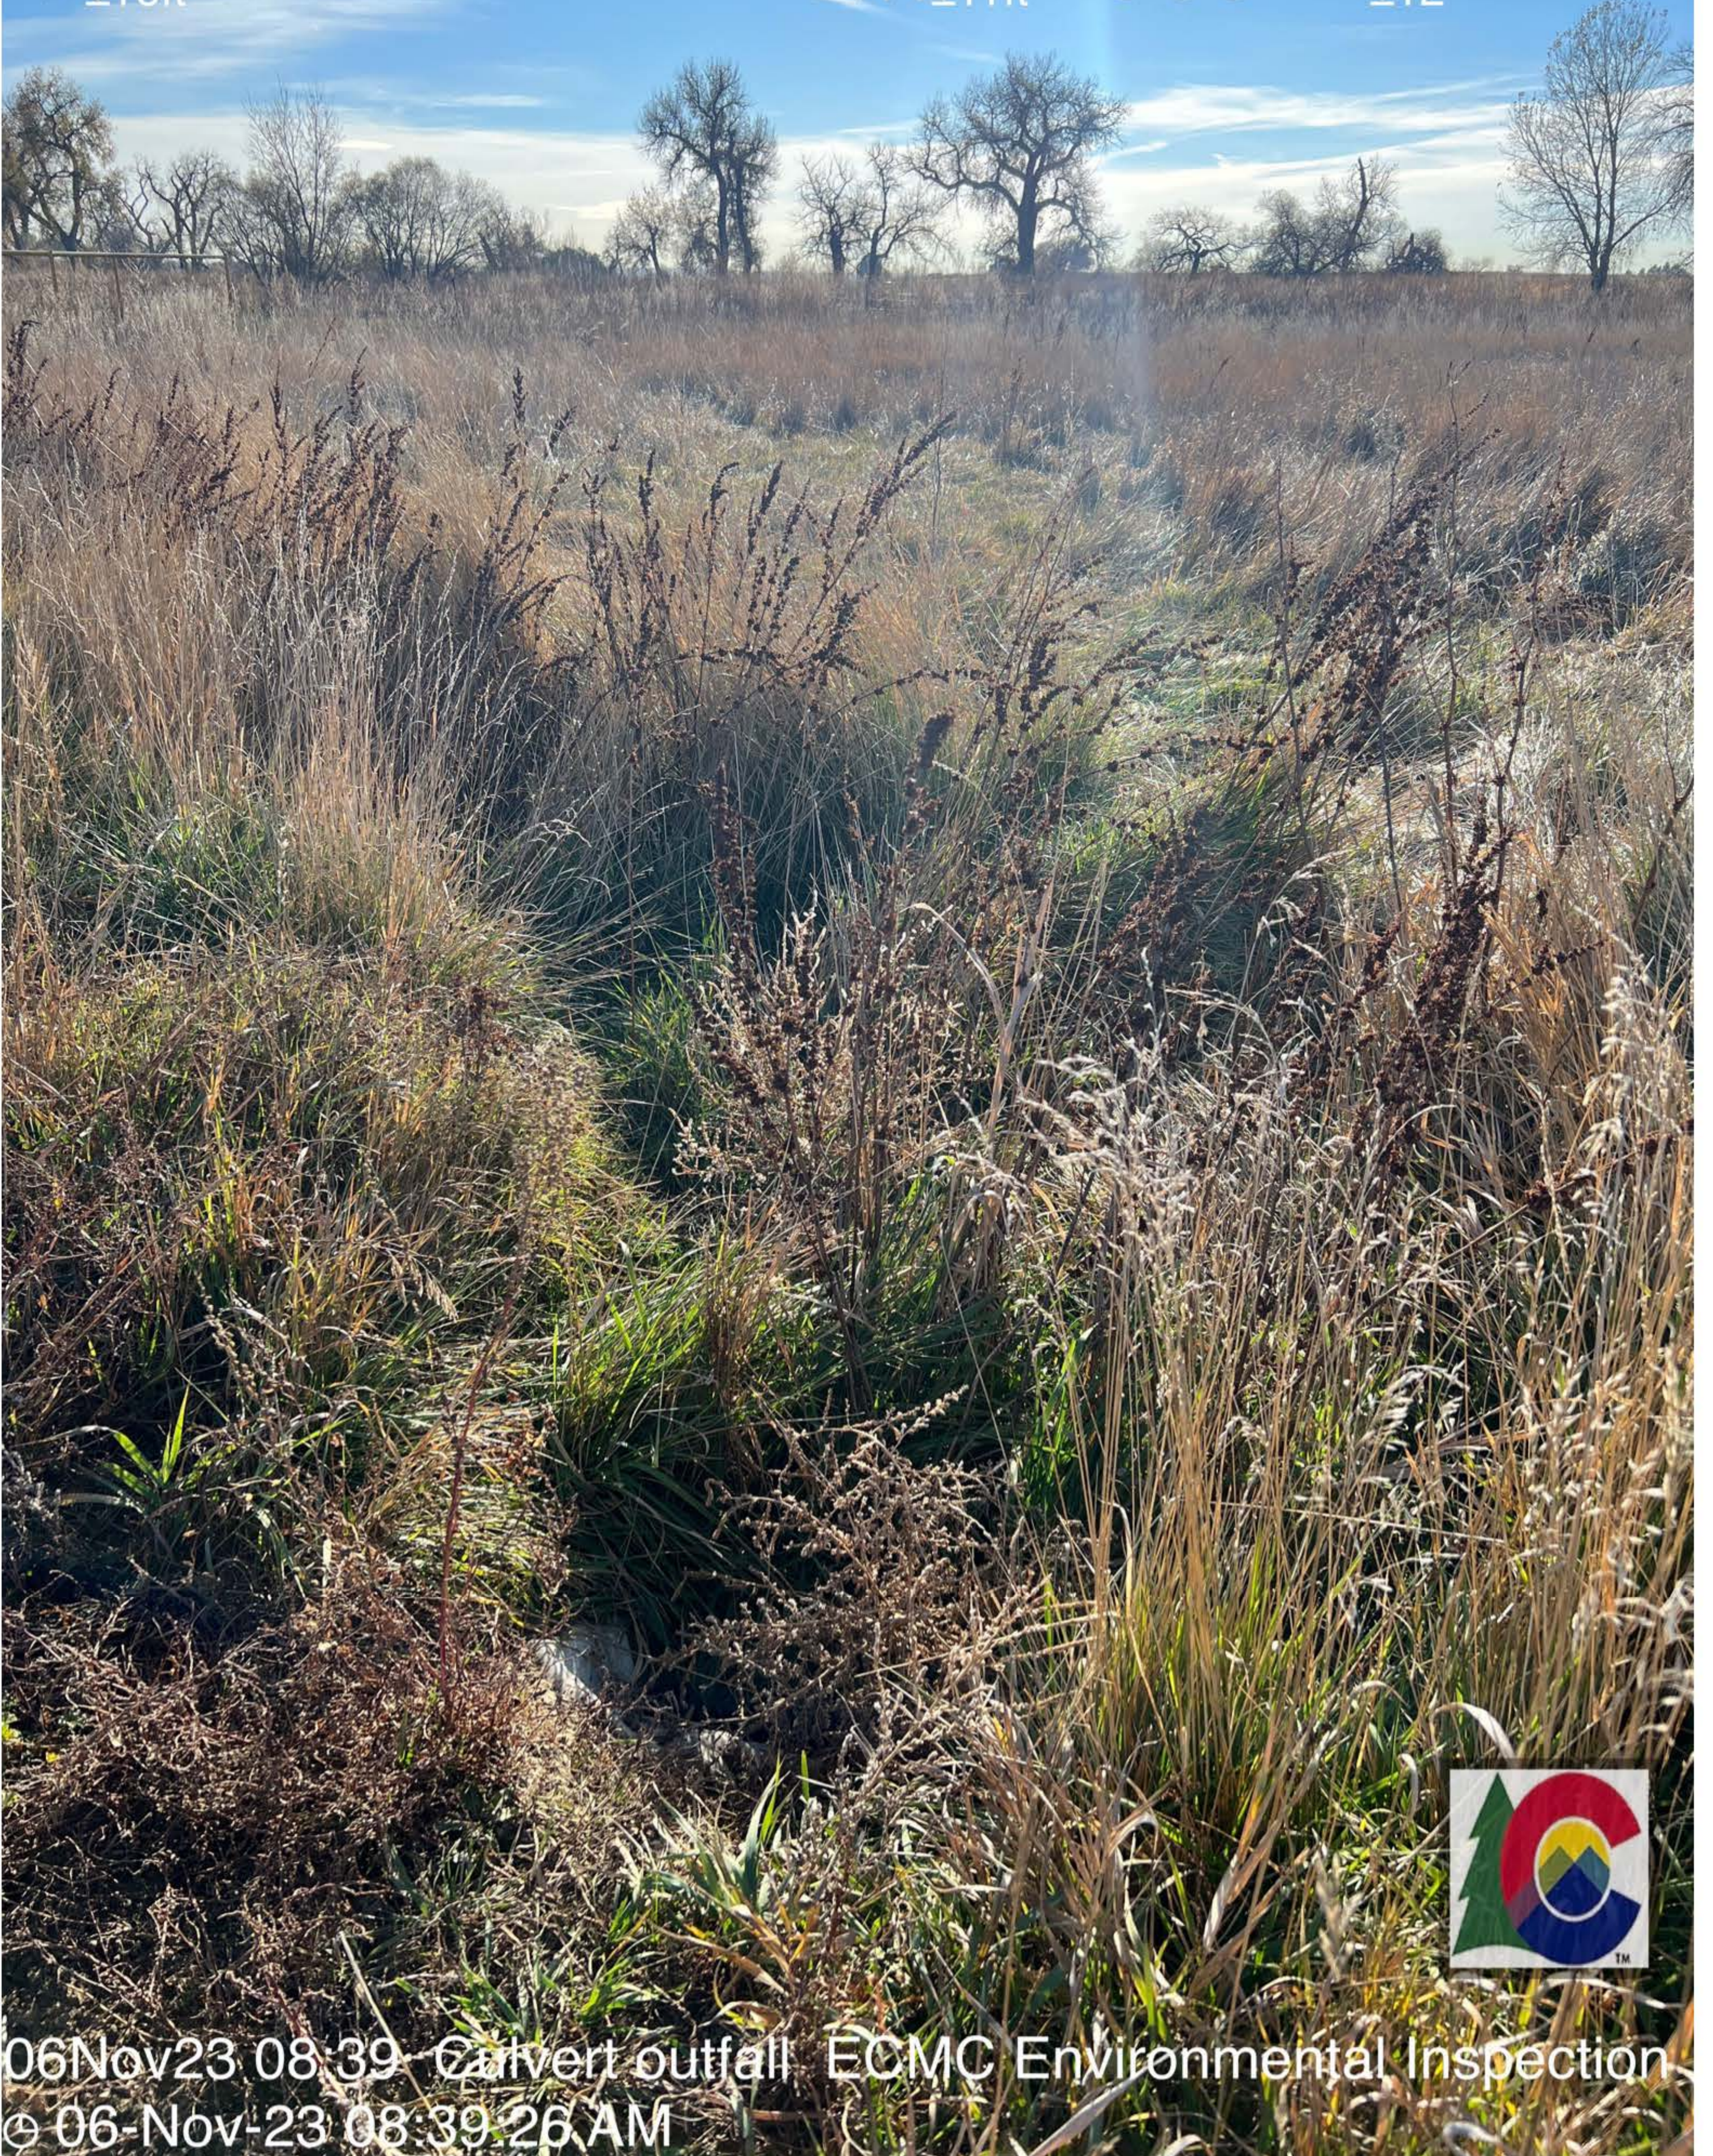
06Nov23 08:39 - Conduit outfall ECMC Environmental Inspection
© 06-Nov-23 08:39:26 AM

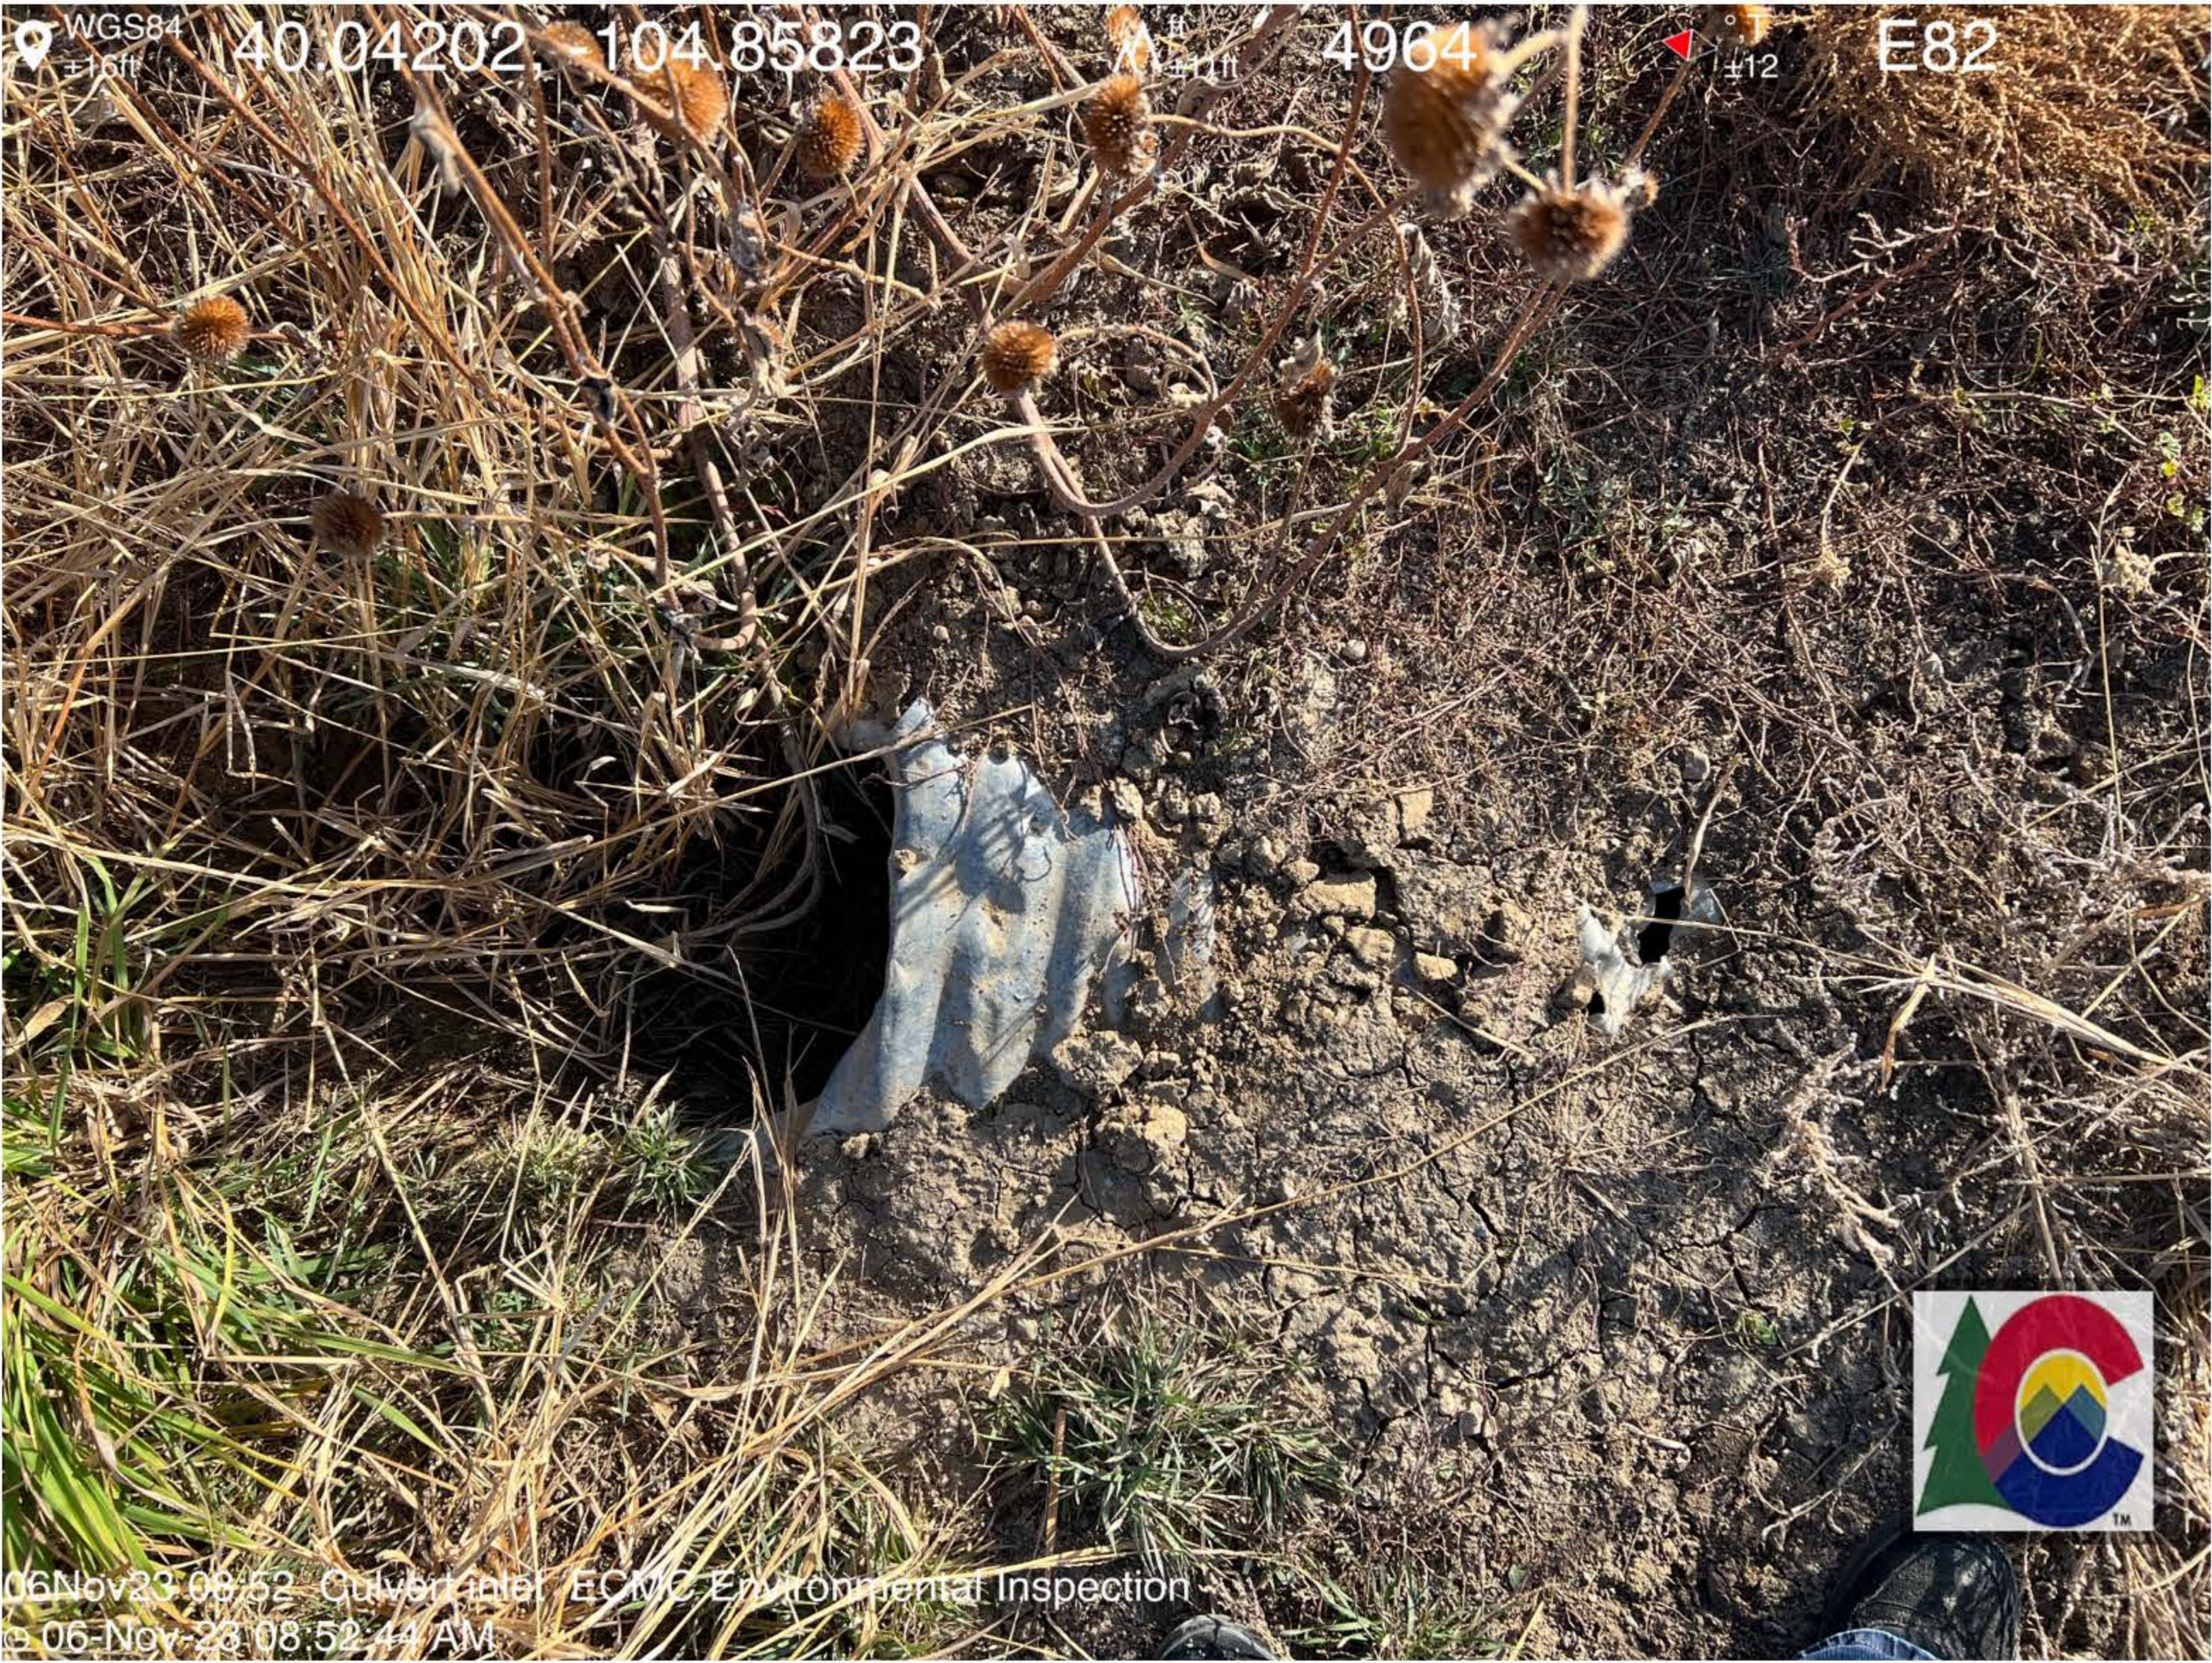
06Nov23 08:52 Culvert inlet ECMC Environmental Inspection
e 06-Nov-23 08:52:44 AM

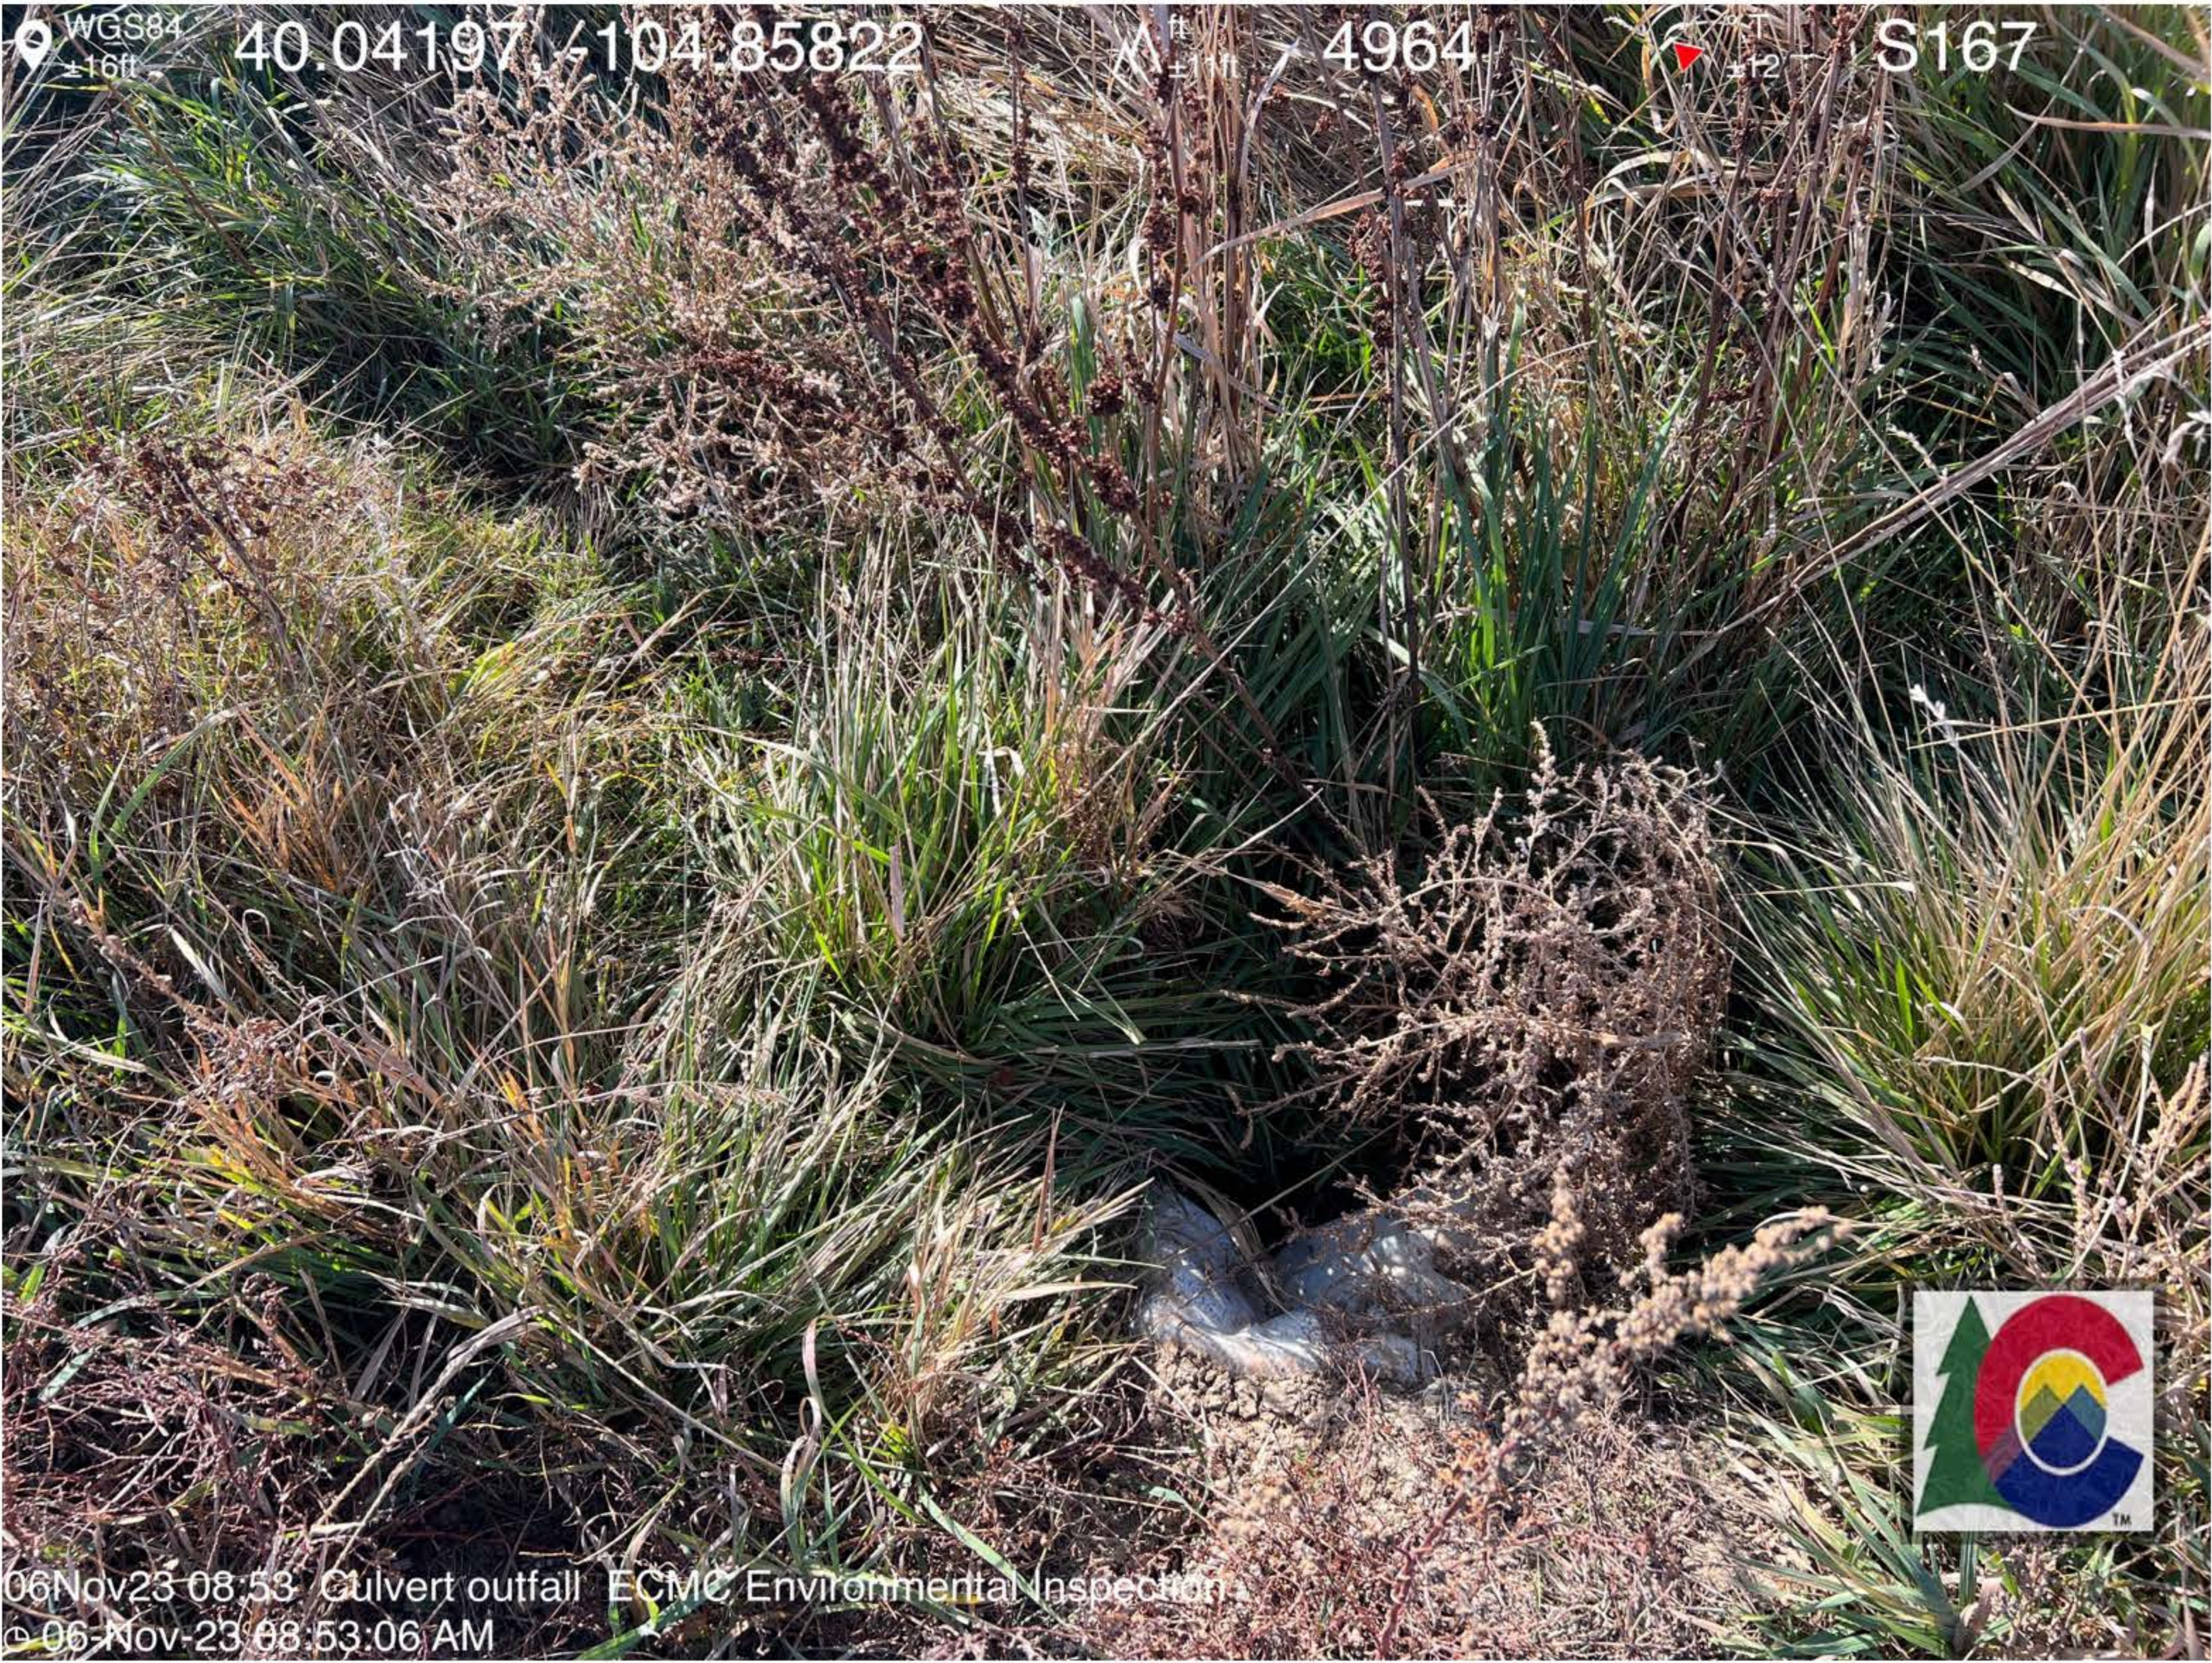
06Nov23 08:53 Culvert outfall ECMC Environmental Inspection
© 06-Nov-23 08:53:06 AM
