06Nov23 08:37 ECMC Environmental Inspection
© 06-Nov-23 08:37:11 AM

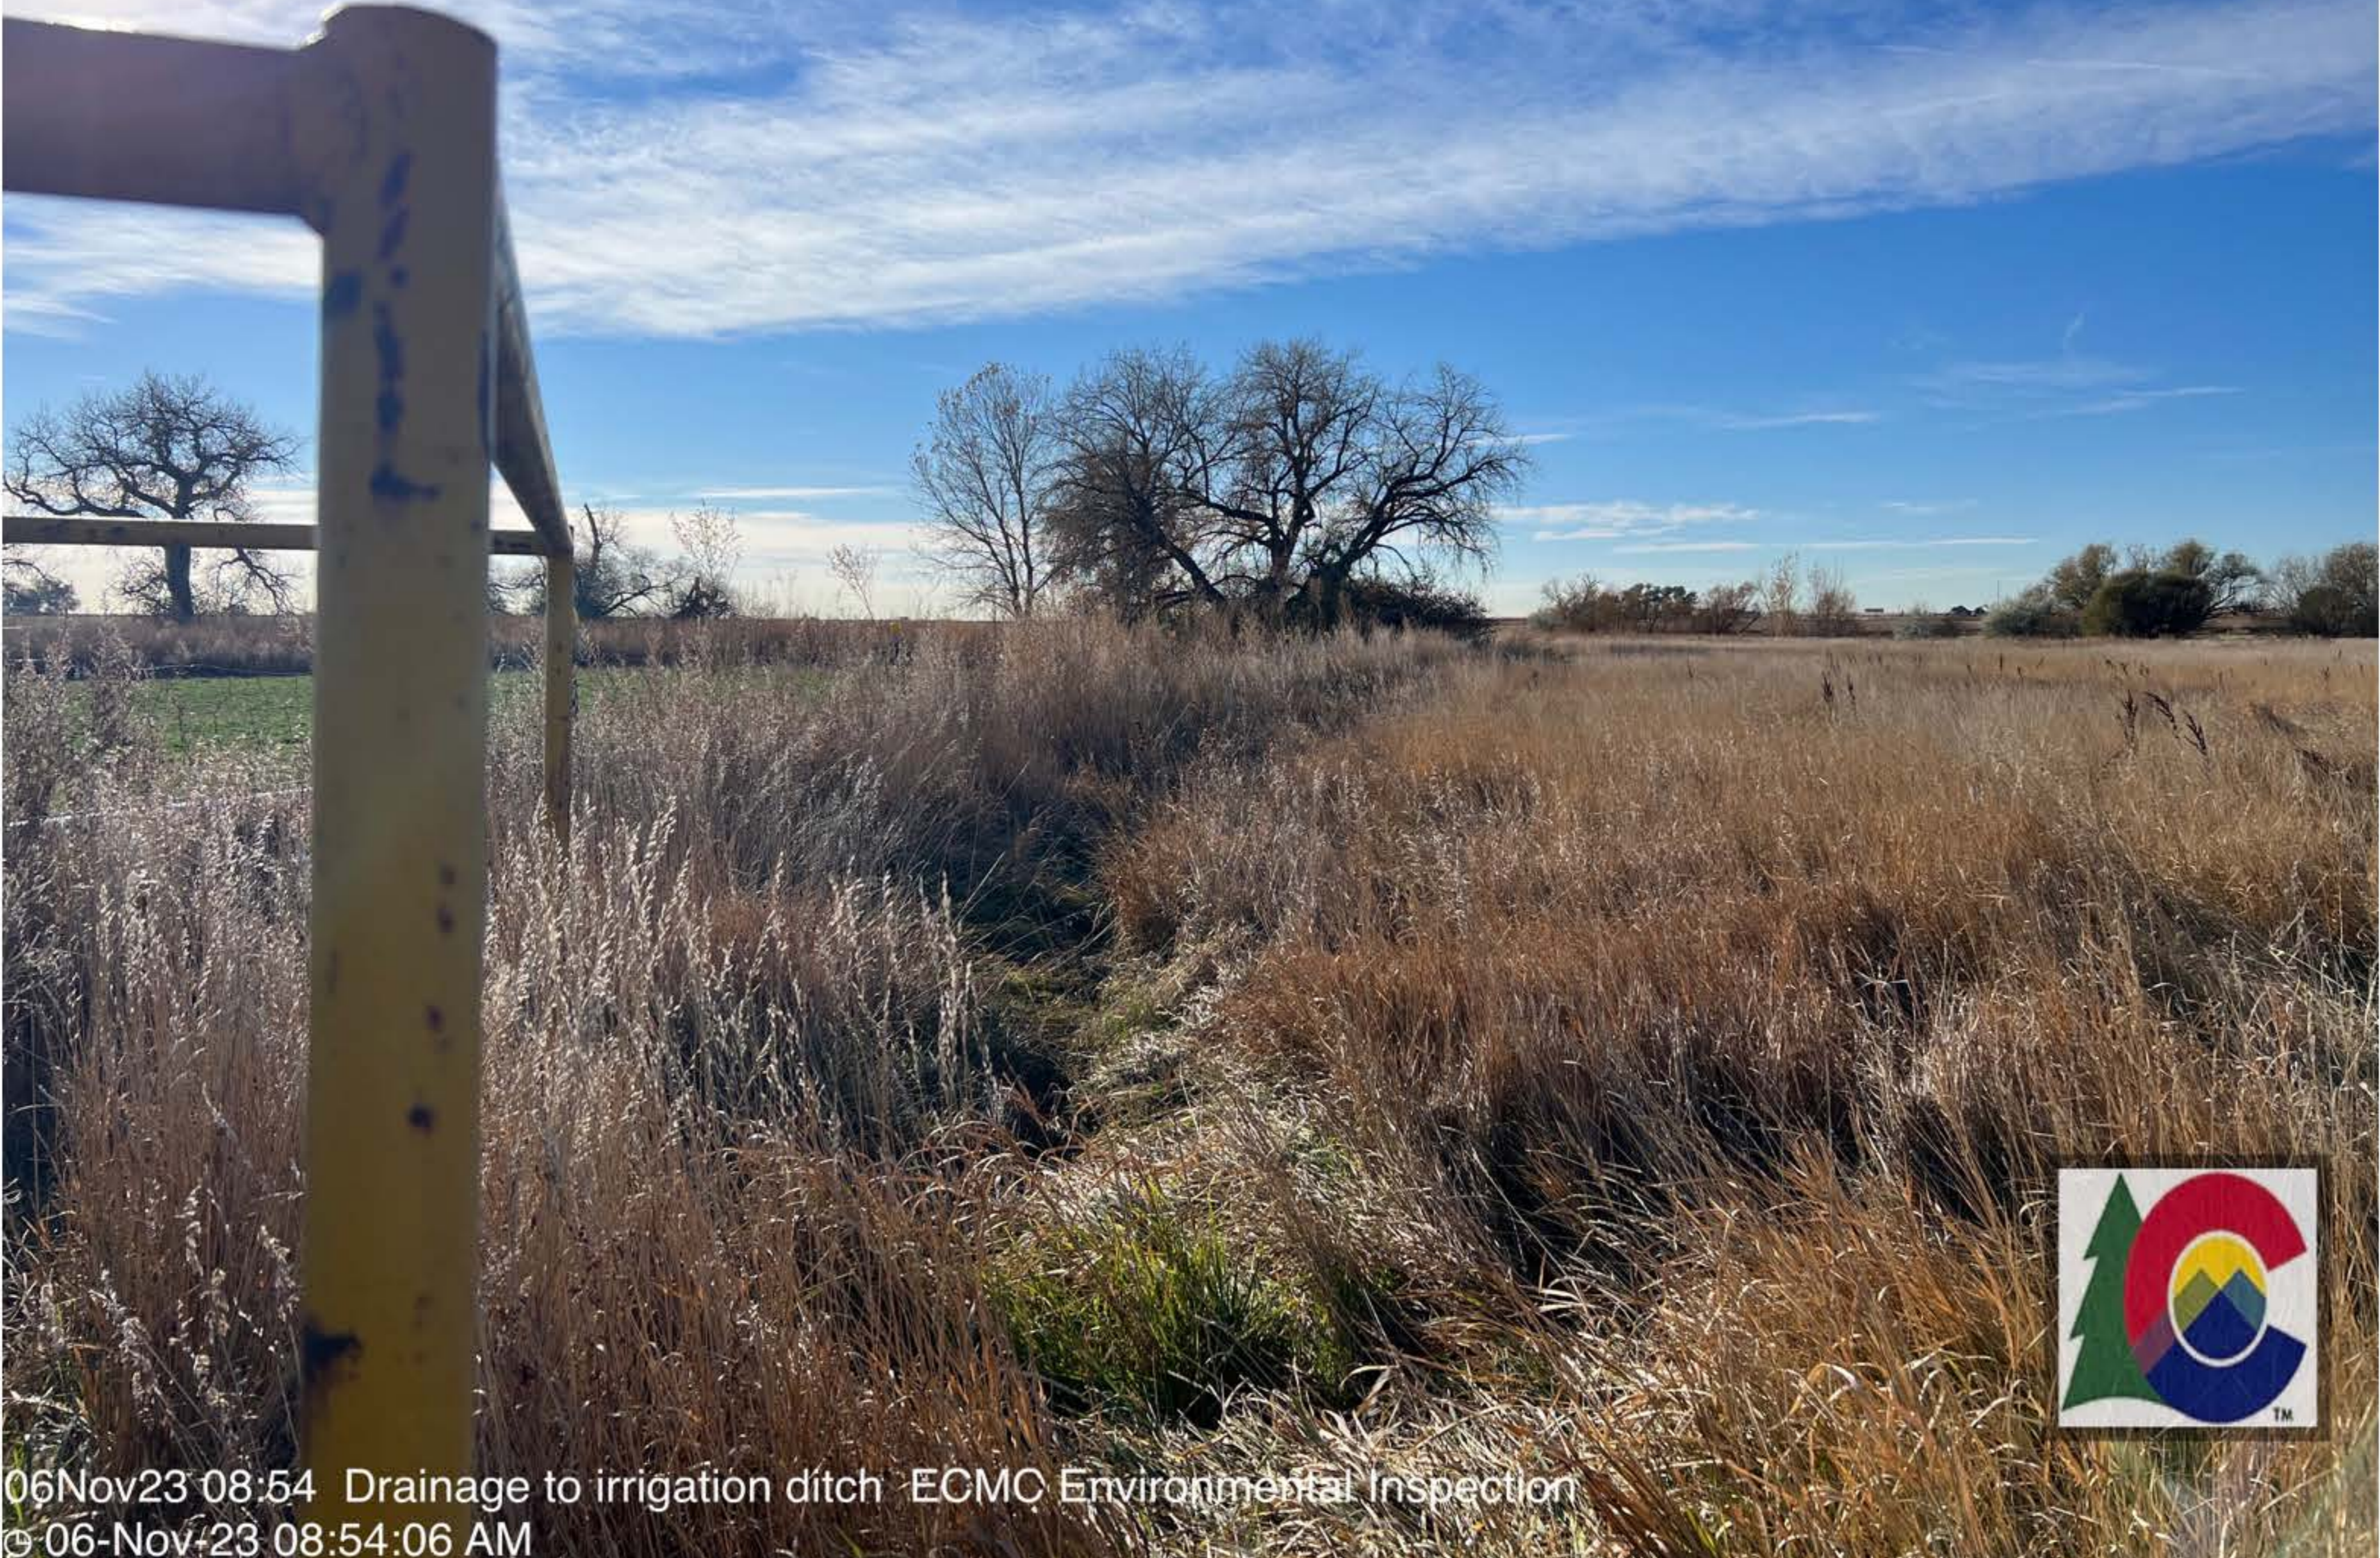
06Nov23 08:54 Drainage to irrigation ditch -ECMC Environmental Inspection
© 06-Nov-23 08:54:06 AM

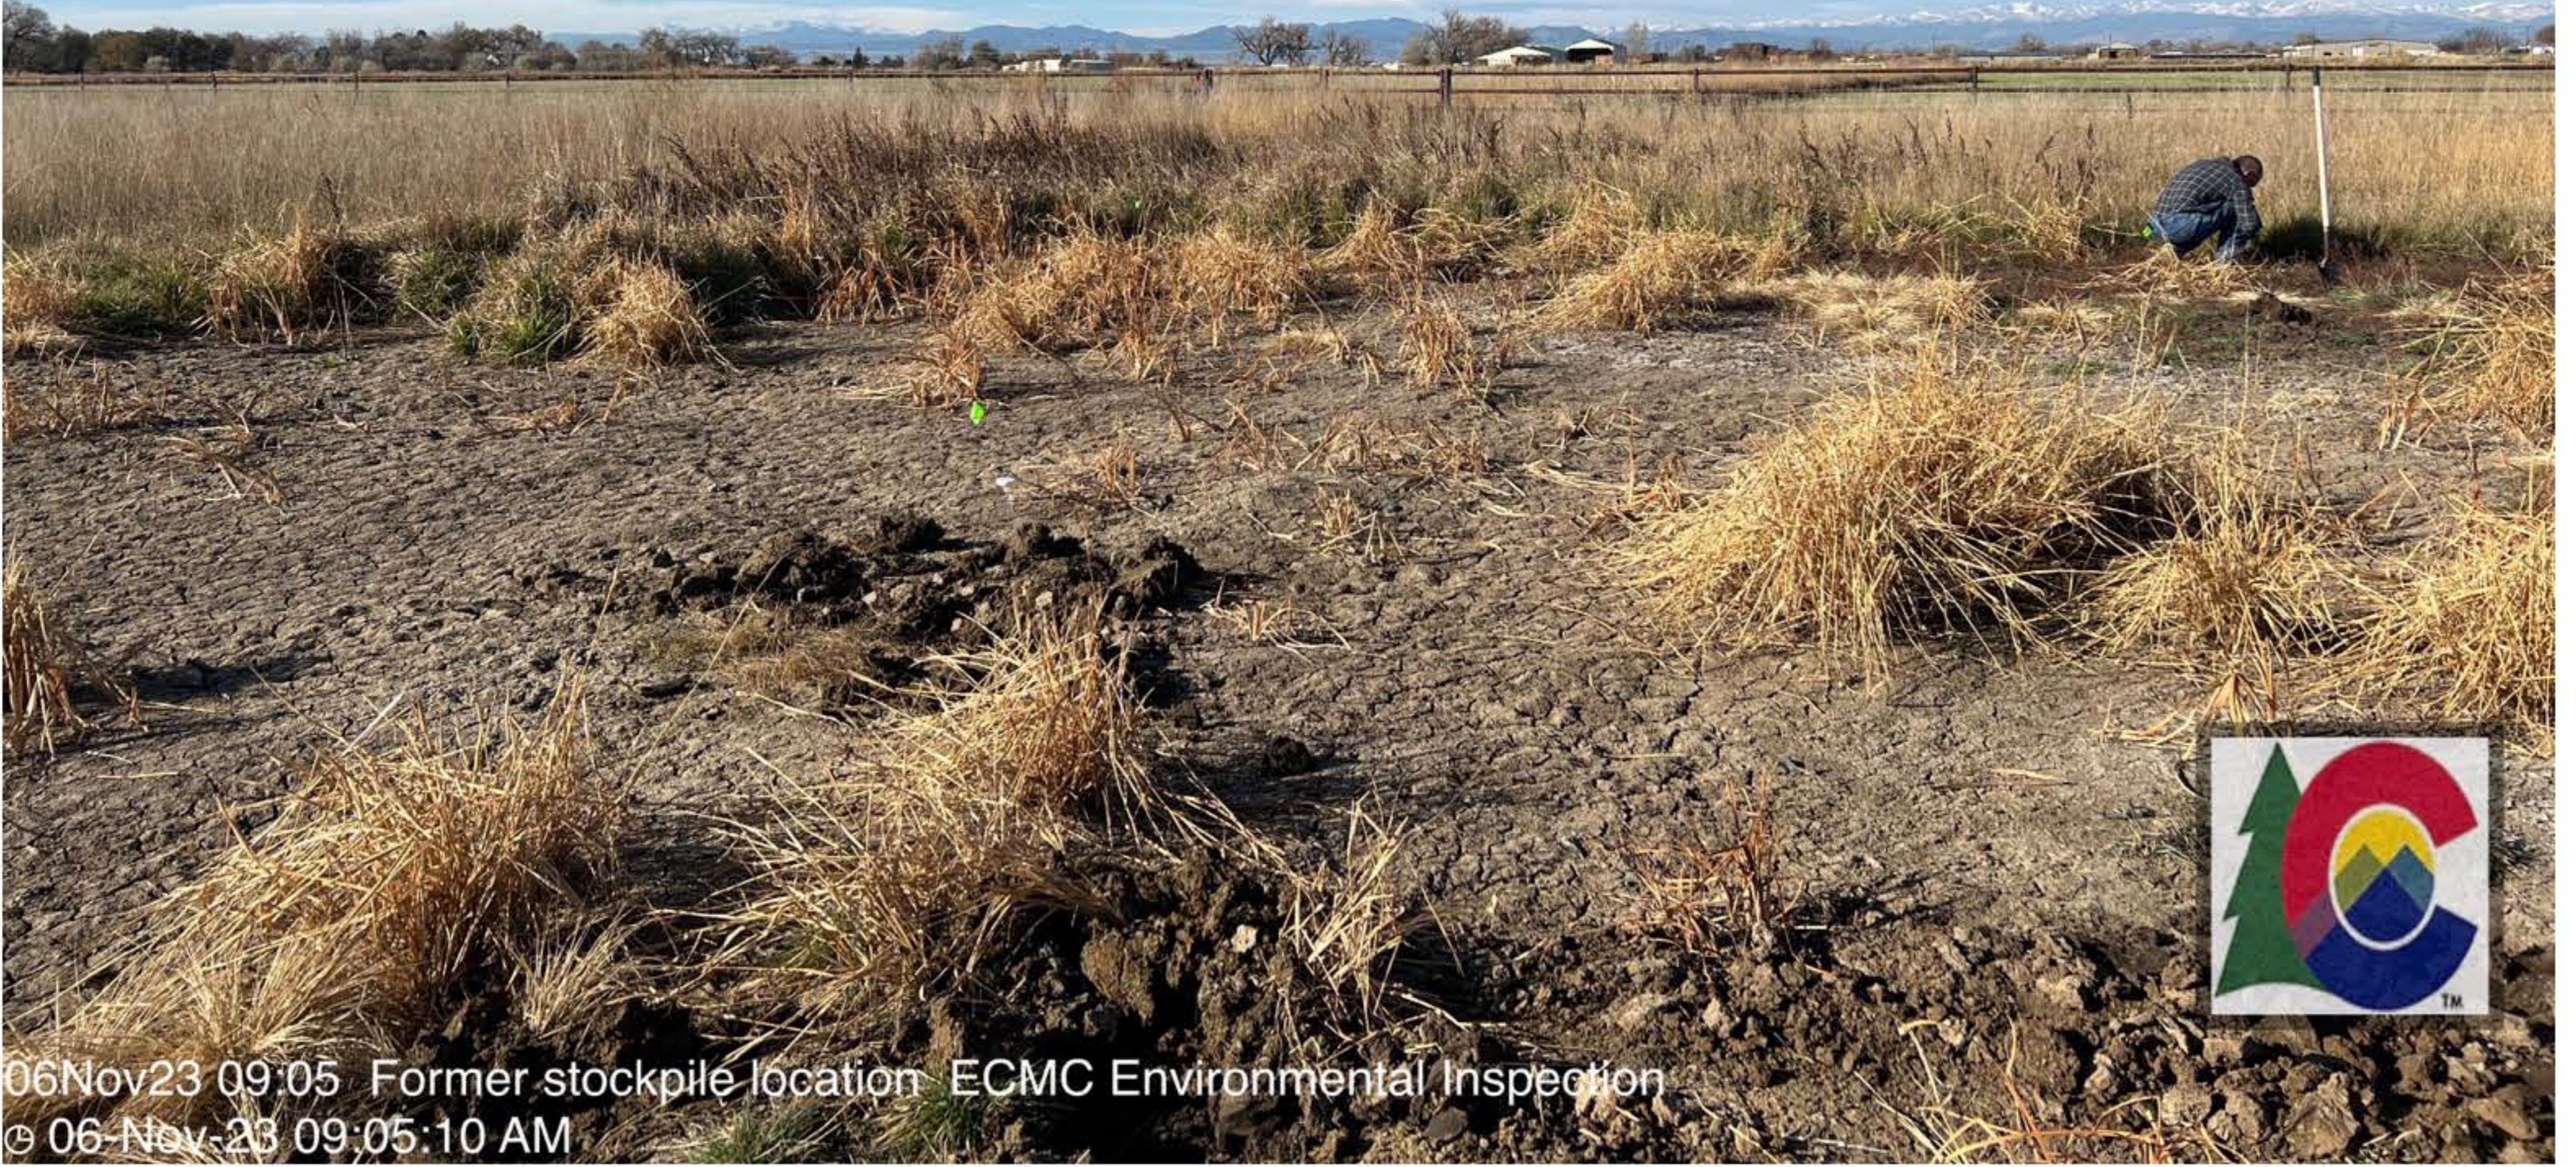
06Nov23 09:05 Former stockpile location ECMC Environmental Inspection
© 06-Nov-23 09:05:10 AM

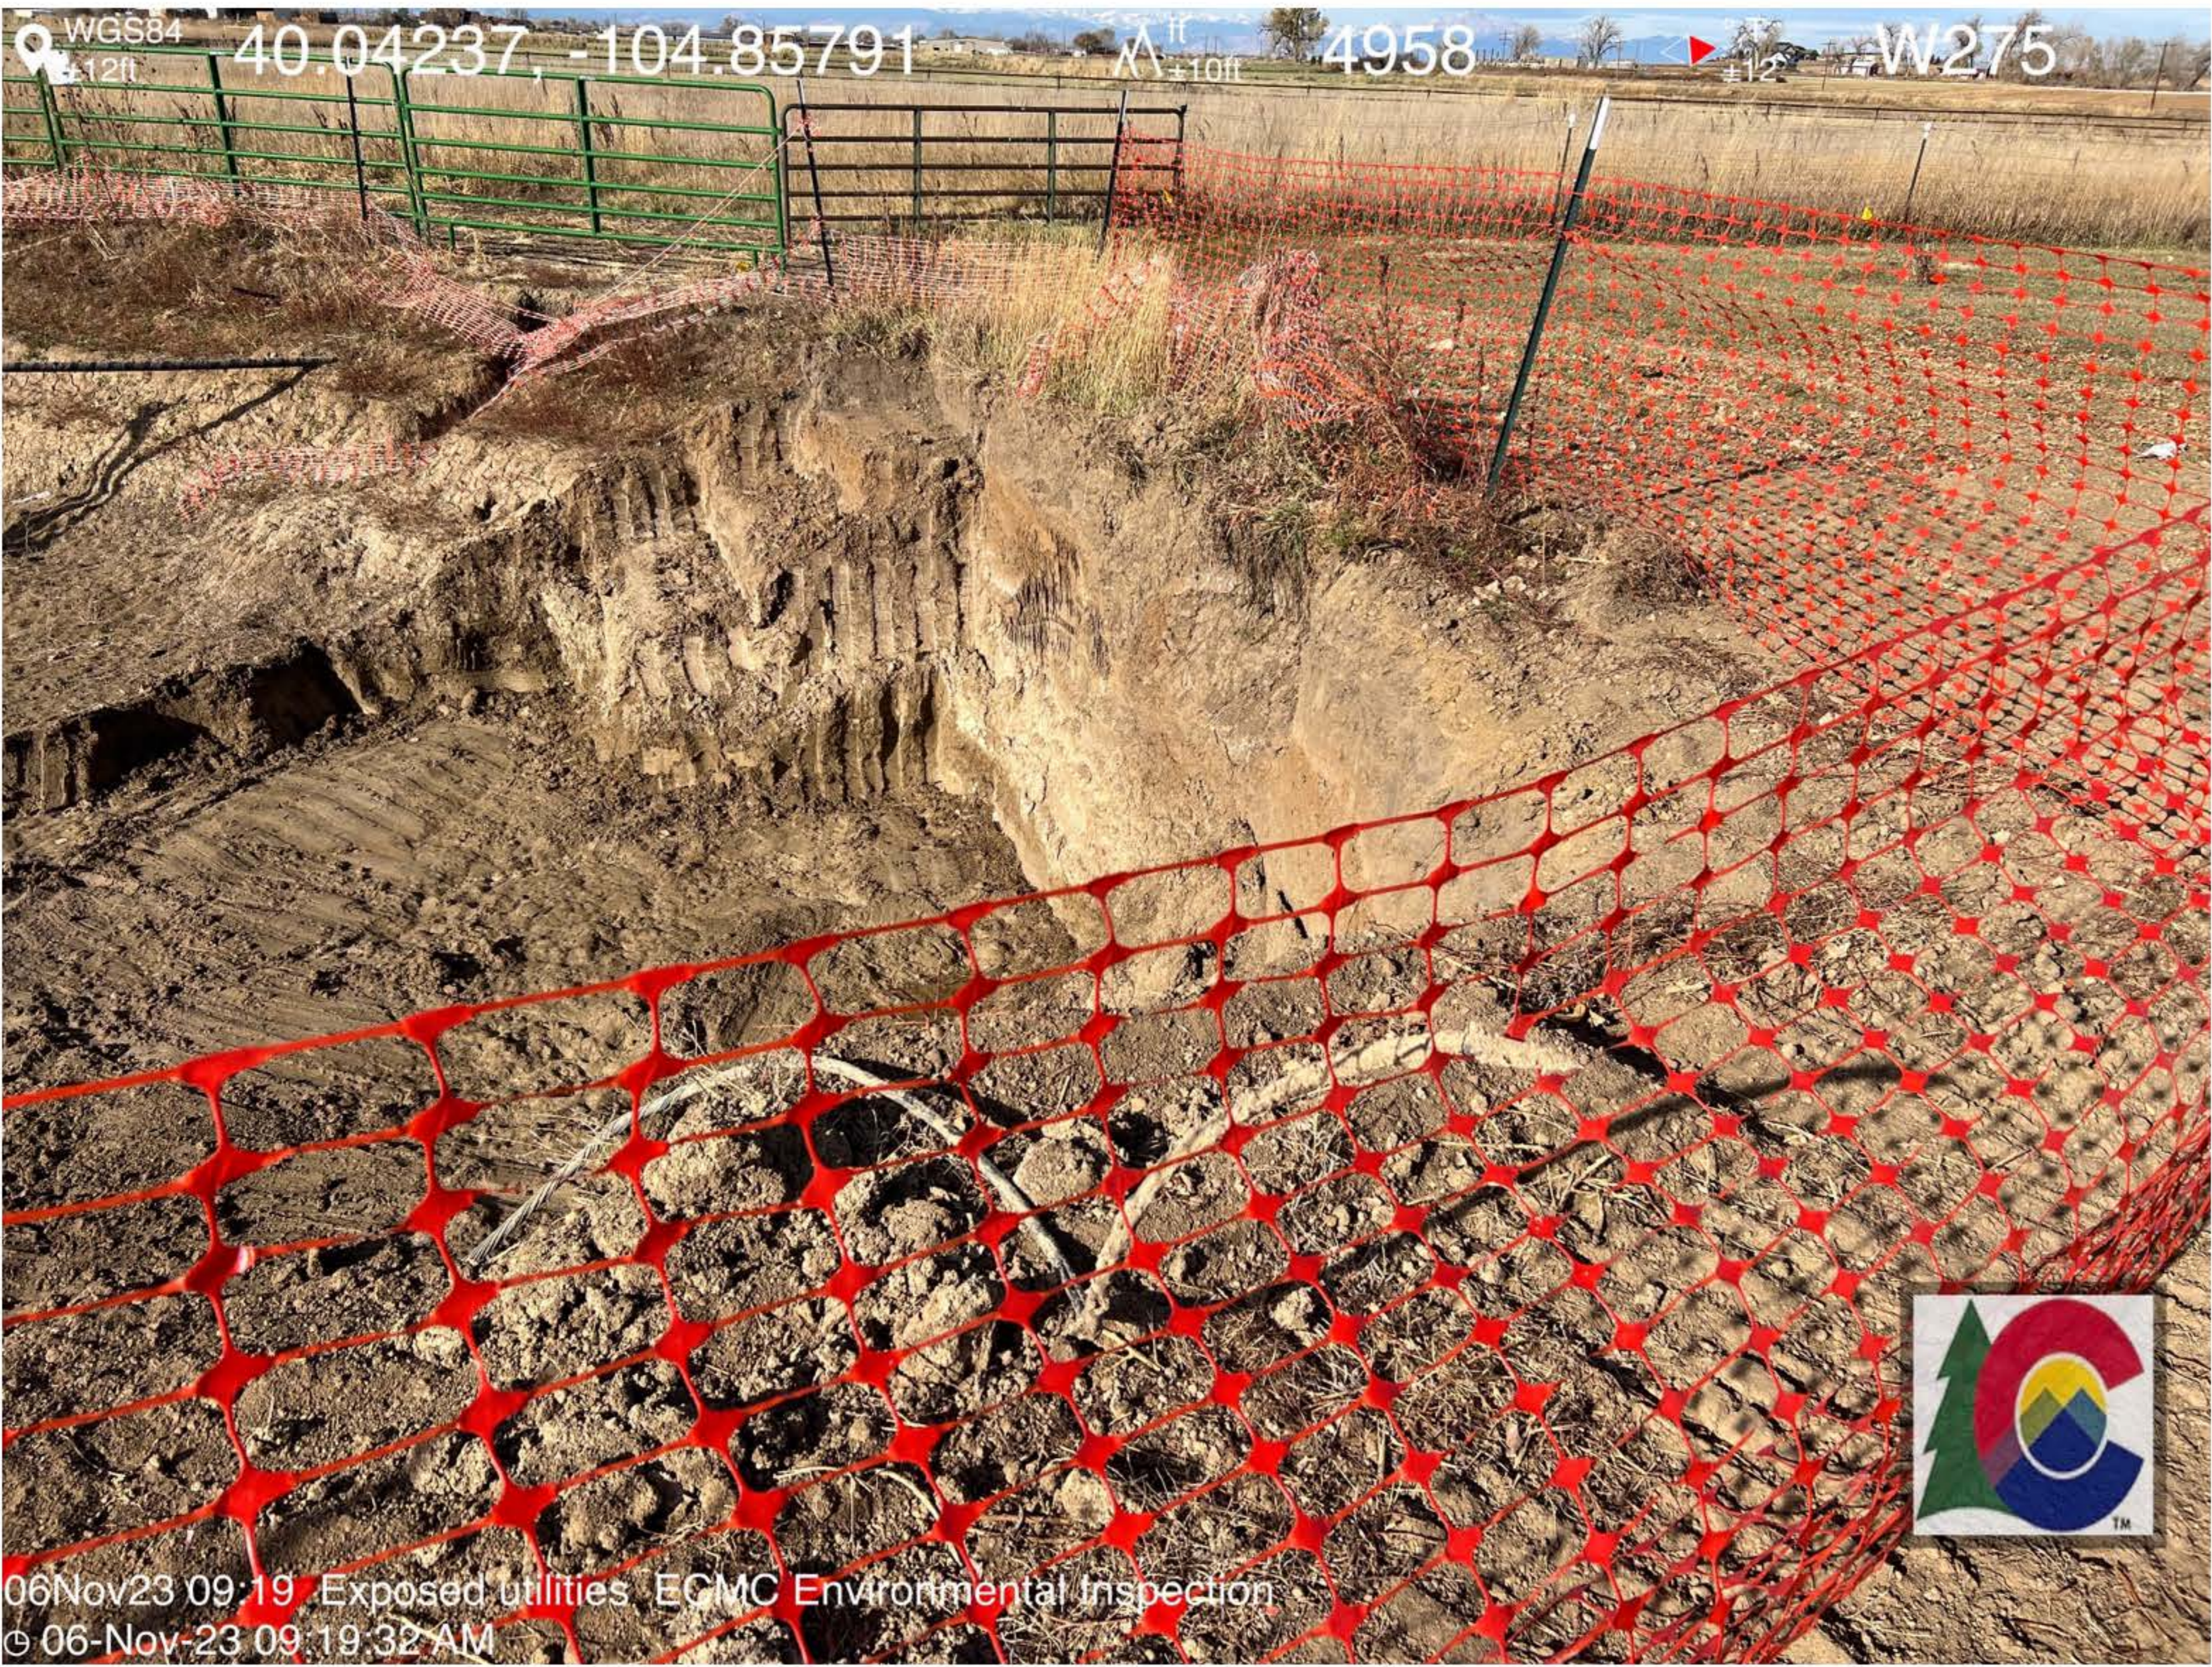
06Nov23 09:19 Inadequate fencing - EMC Environmental Inspection
© 06-Nov-23 09:19:30 AM

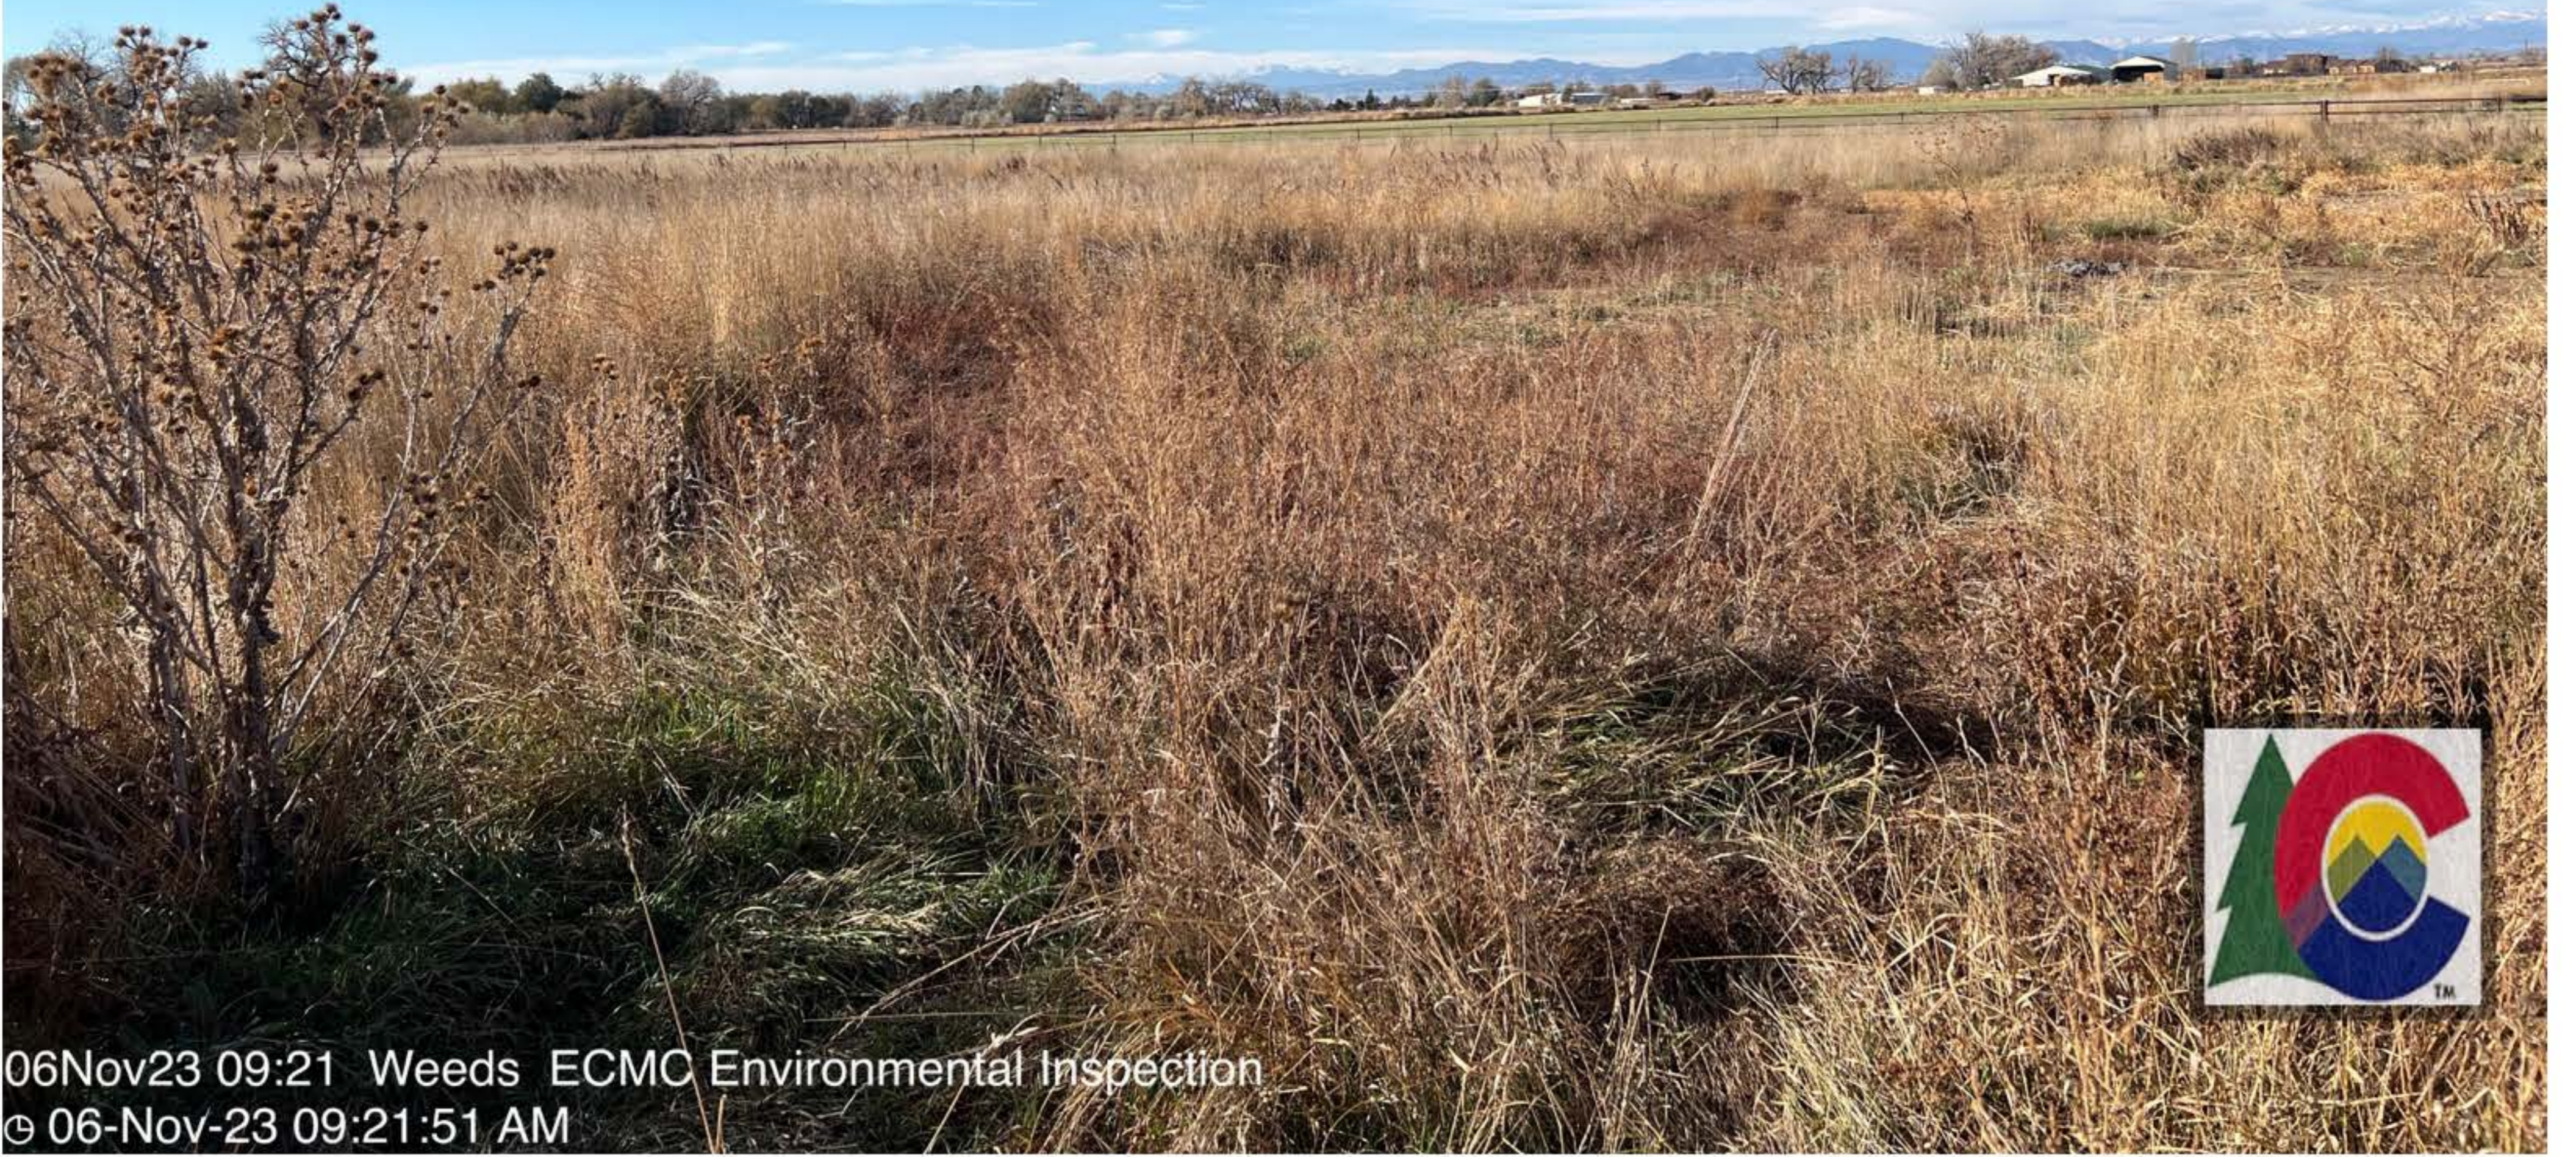
06Nov23 09:21 Weeds ECMC Environmental Inspection
© 06-Nov-23 09:21:51 AM
