QB ENERGY OPERATING LLC ROLES-67S93W 13NESE (J13W) Facility # 334558

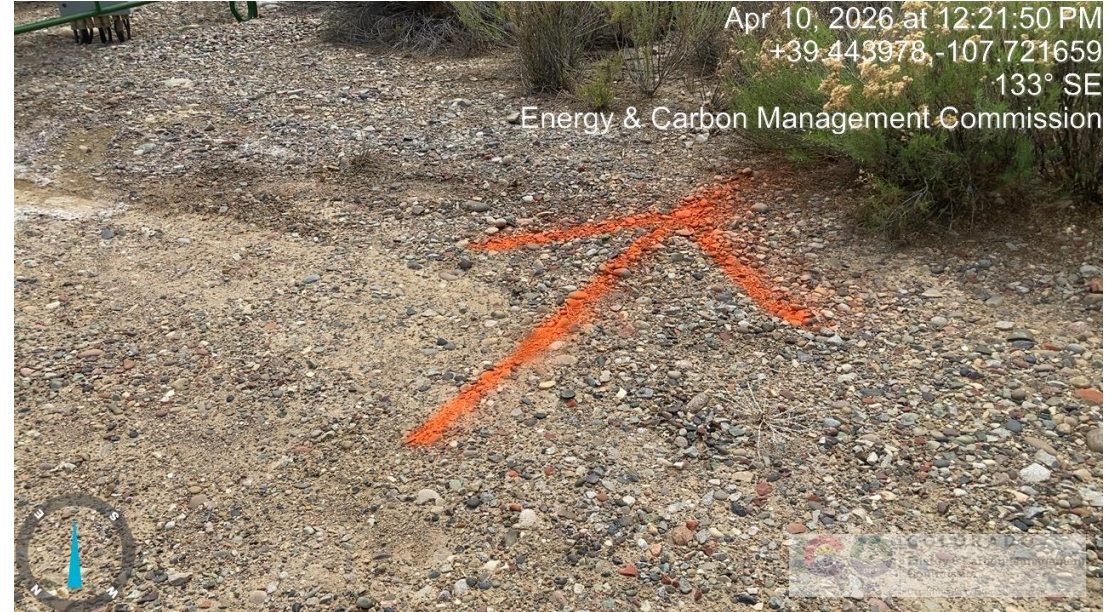
Spill/release area.

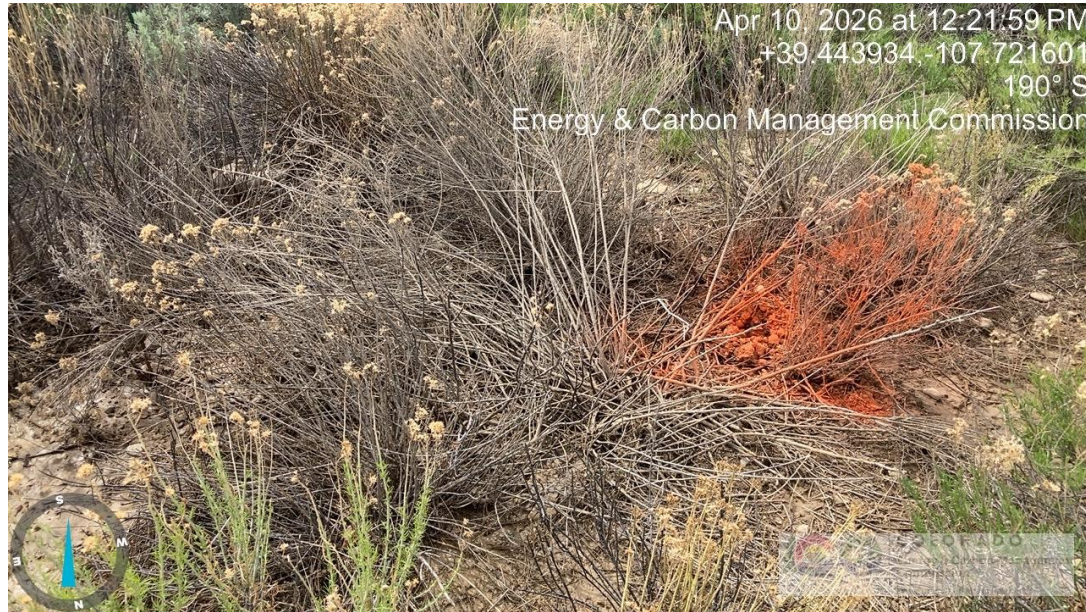
Spill/release area.

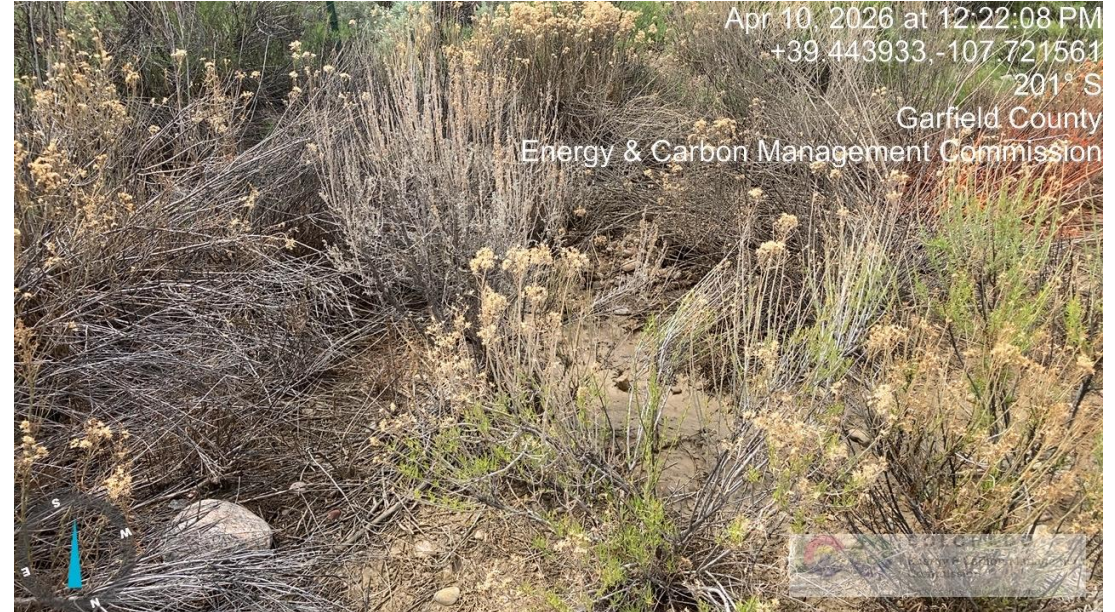
Spill/release area.

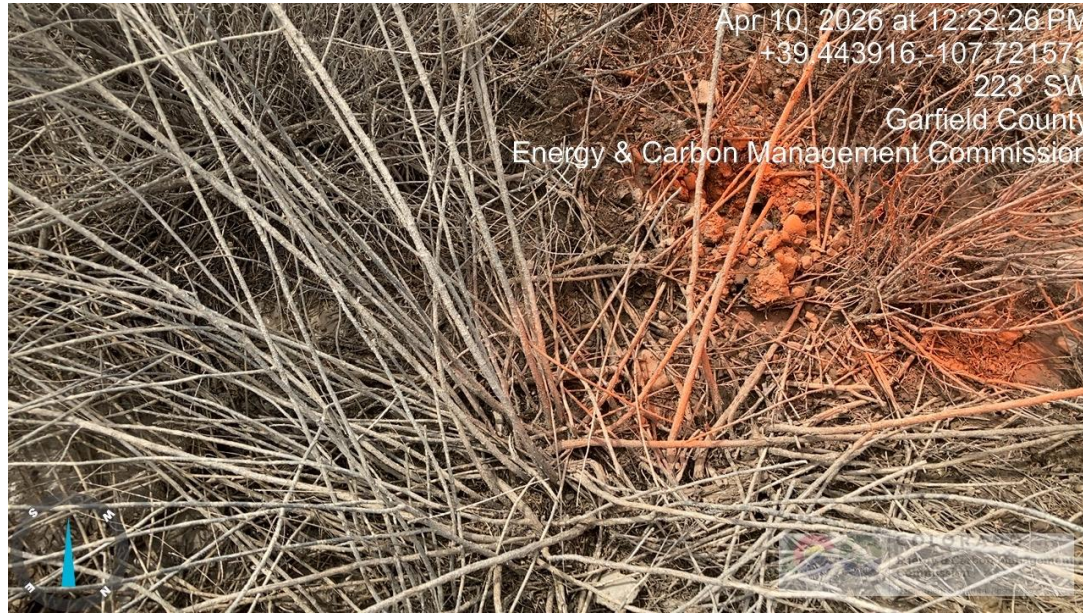
Spill/release area.

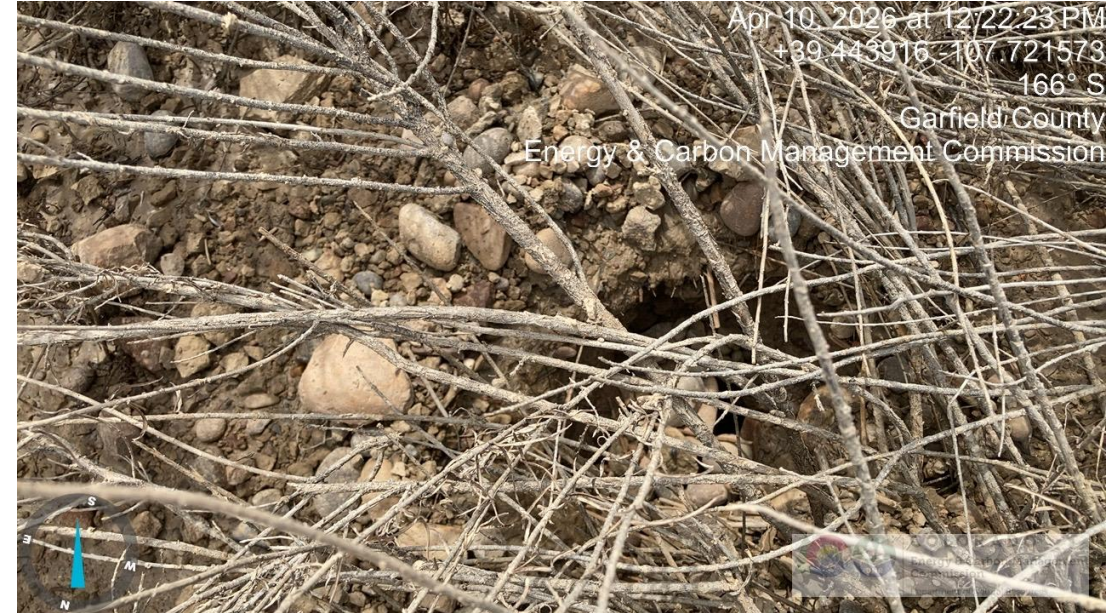
Spill/release area.
